Job No: 615478.6240
18 February 2015

Clough and Associates
321 Forest Hill Road
Waiatarua
Auckland 0612

Quarry Road Site Report – Ground Penetrating Radar Survey

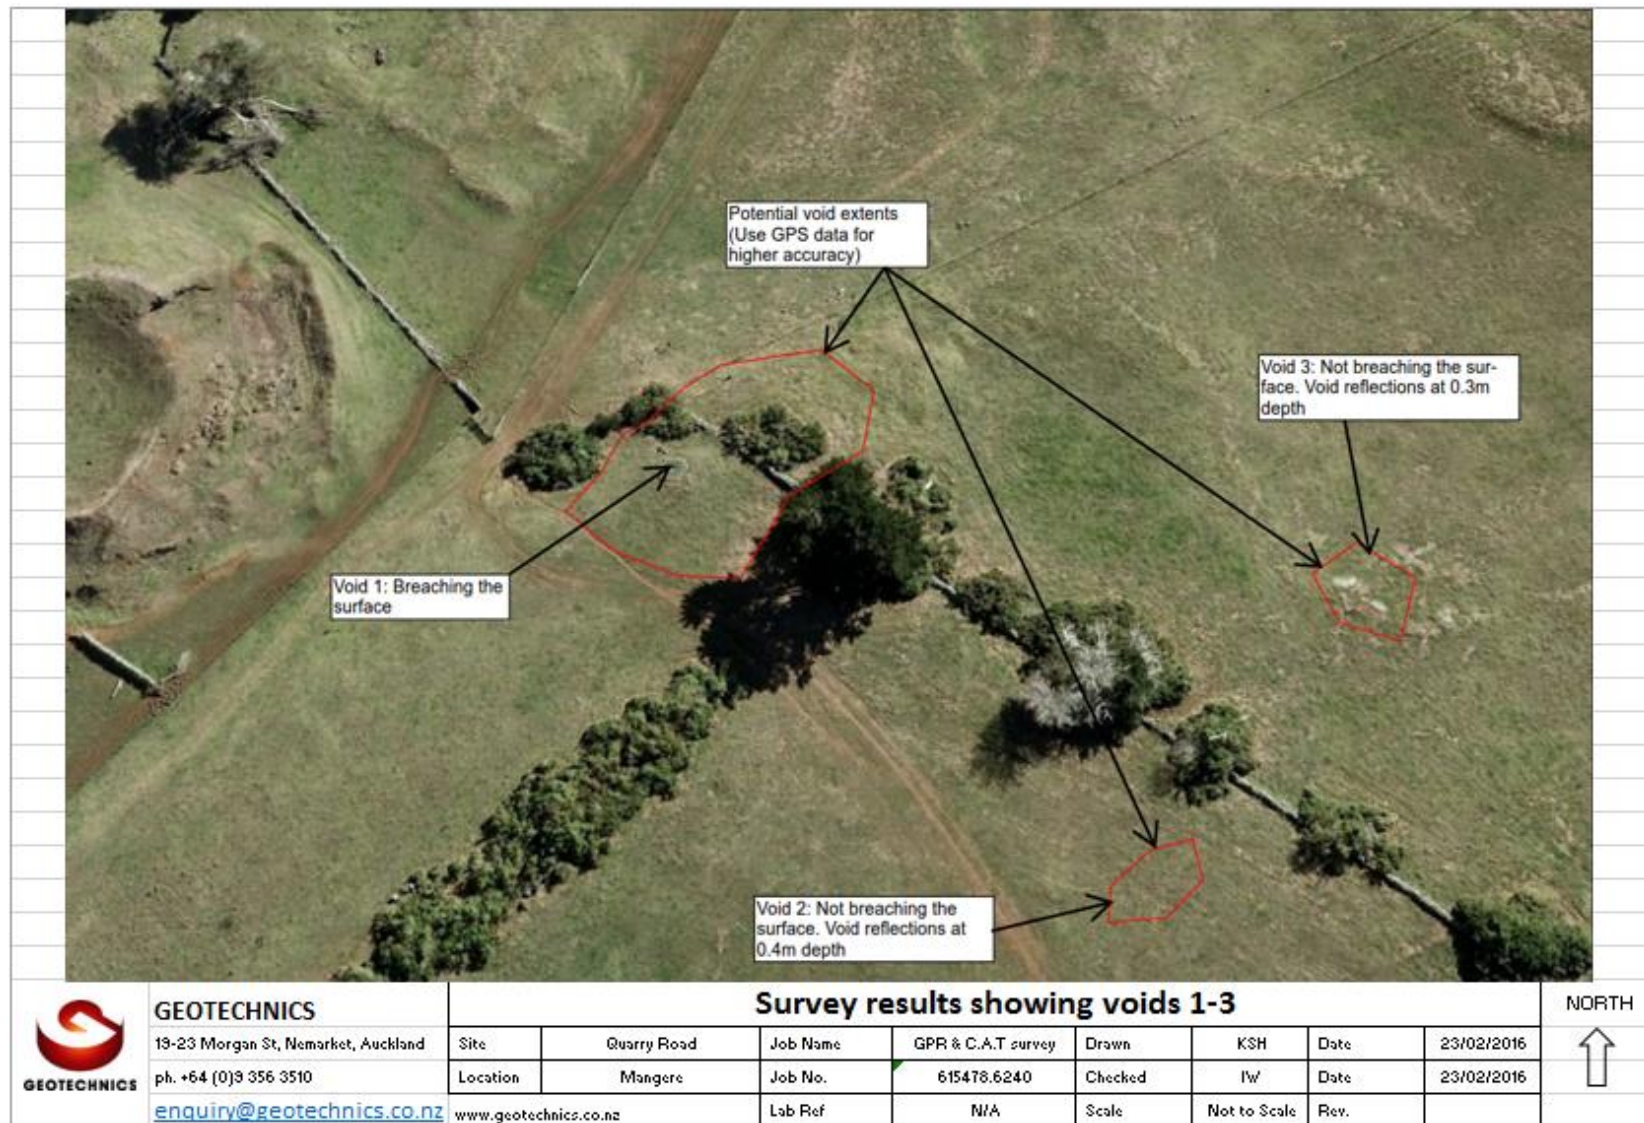
Survey site plan showing voids

The extent of the flow is visible from the surface, the location and extent of the voids are indicated in this report.

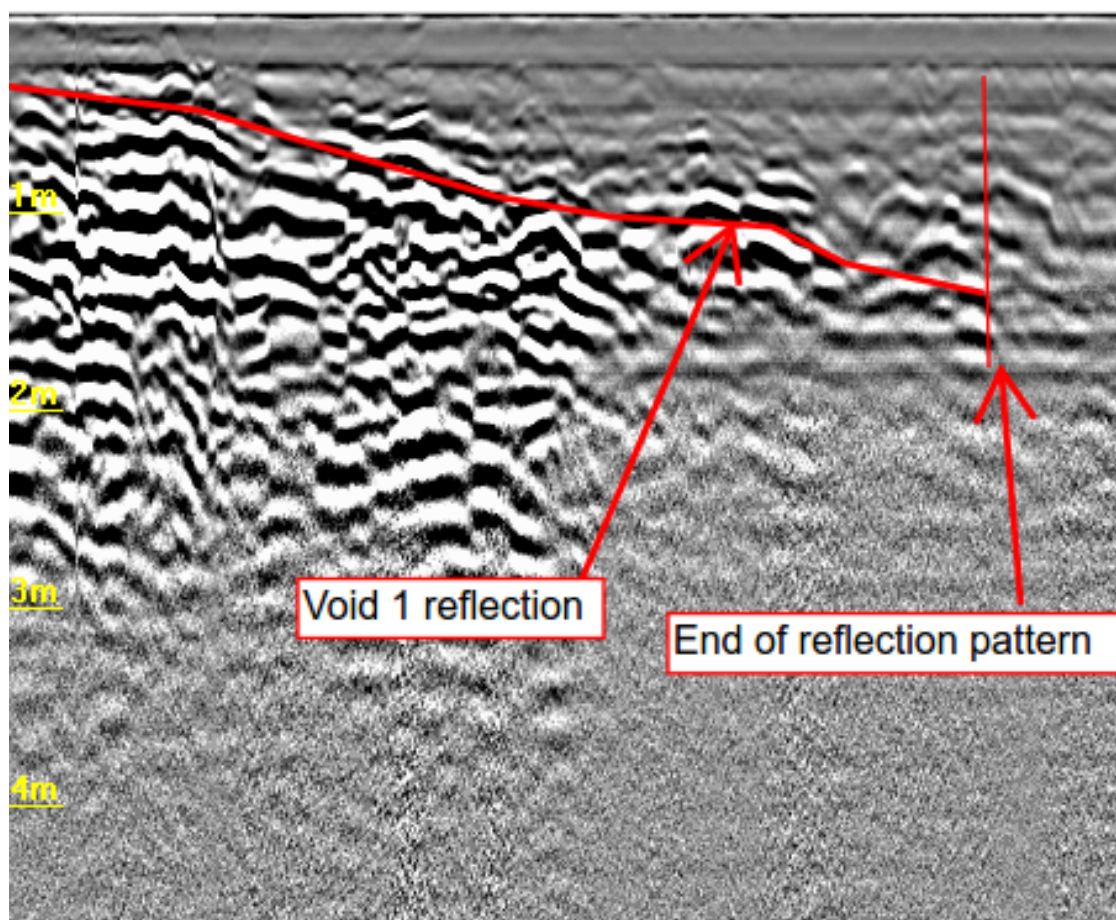
Example of void 1 reflection

The 'voids' identified in this survey are indicated by a dramatic change in density, which shows up as an anomaly or reflections that differ from the surrounding material. Examples of this are shown in the screenshots of the radar data below.

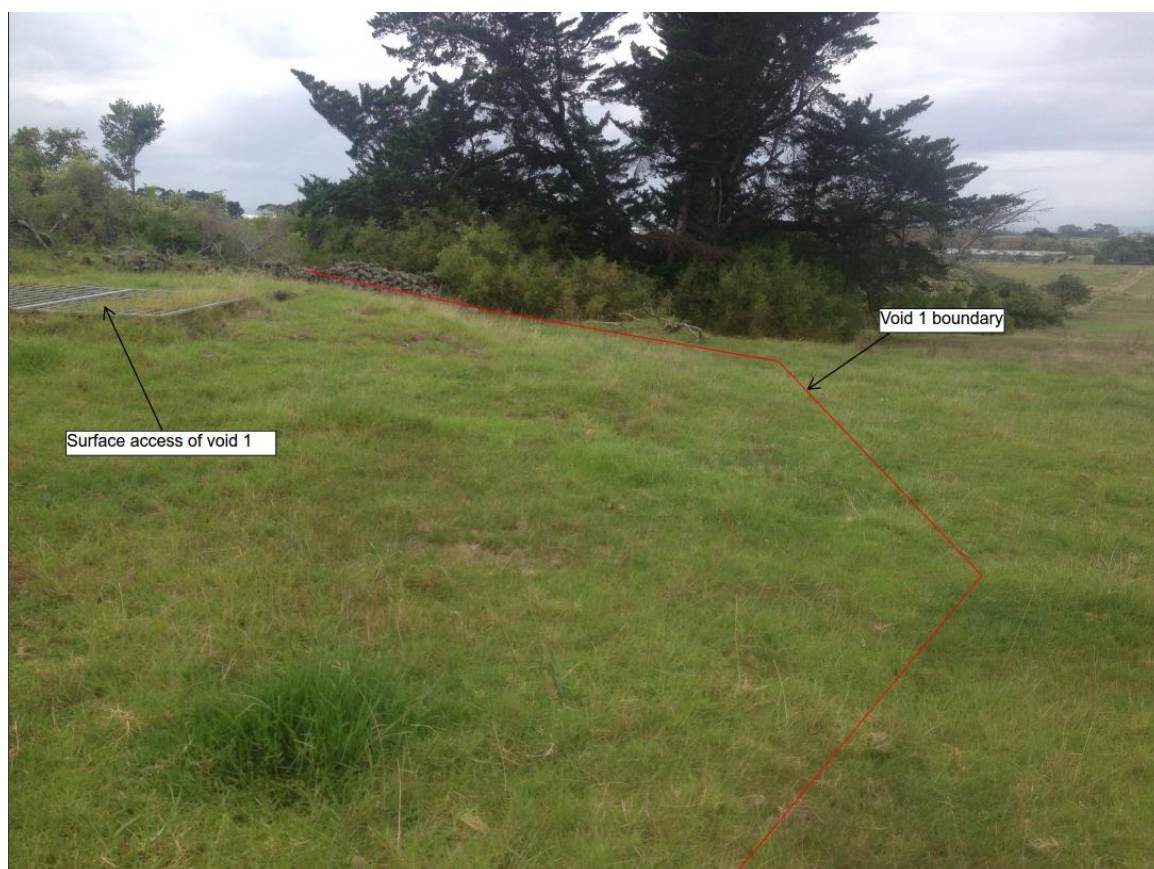
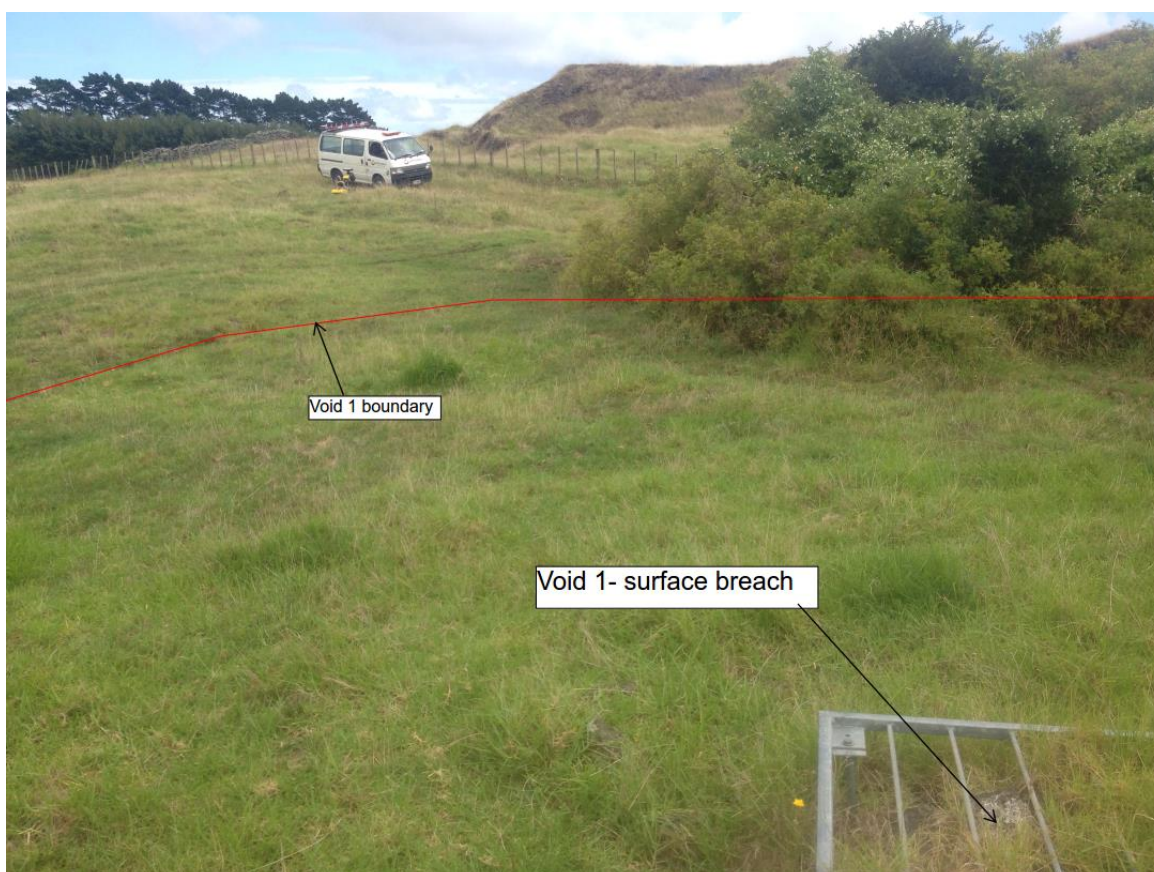
Void 1

The images below are annotated to better show the location of the identified voids, and the extent of the discovered anomaly. We identified the extent of the main void indicated by your representative on site, however there are limitations to the survey such as survey obstructions i.e vegetation. As well as the depth limitation which in this area was around 3metres at most, however this level of depth penetration should be enough to identify any large voids present in the survey area.
