Preliminary Environmental Site Investigation

287 Tuhirangi Road

Makarau
Auckland

18.07.2017

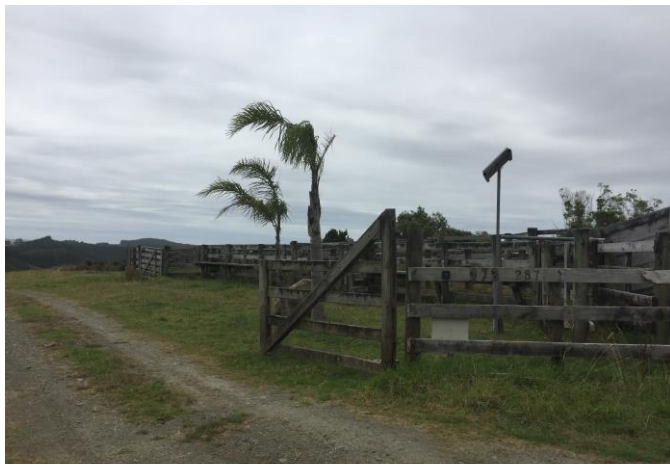
Photograph 1: Site entrance (with off-site farm race to the south of entrance)

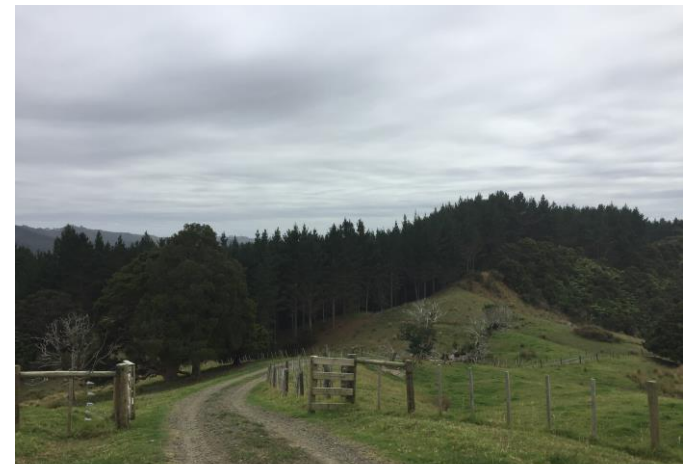
Photograph 2: Farm road in western portion of site (looking northeast)

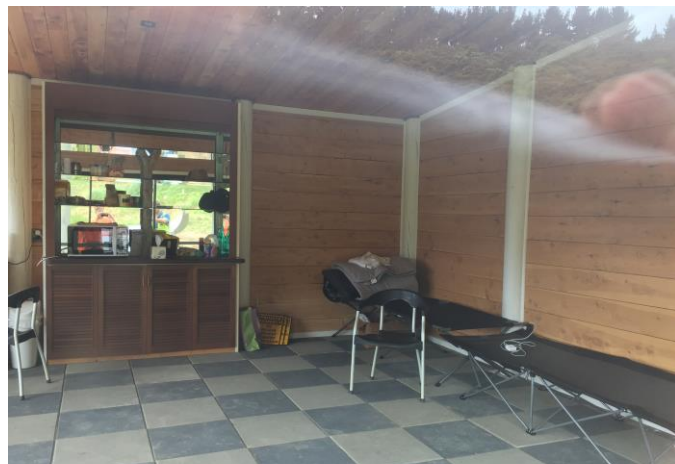
Photograph 3: Interior of one-room dwelling

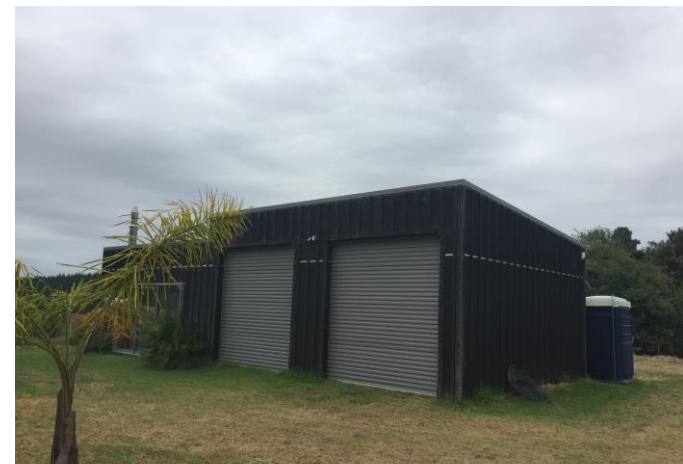
Photograph 4: Exterior of one-room dwelling and associated shed

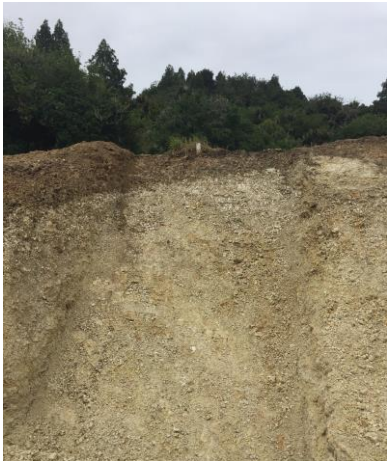
- Nickel in sample SS01 – 1.0 (soil sample collected at a depth of 1 m below ground surface from the Bay 1 excavation sidewall) – concentration of 109 mg / kg exceeded both the regional background criterion of 35 mg / kg and the permitted activity criterion of 105 mg / kg.
- Cadmium in sample SED01 (sediment sample collected from the gully in the southern portion of the site) – concentration of 0.7 mg / kg exceeded the regional background criterion of 0.65 mg / kg.

Photograph 5: Sample location SS01 (southern face of Bay 1 excavation)

As discussed above, the nickel detection is considered anomalous; however, it is recommended that the material be resampled as part of redevelopment earthworks to confirm baseline nickel concentrations in the site soil.

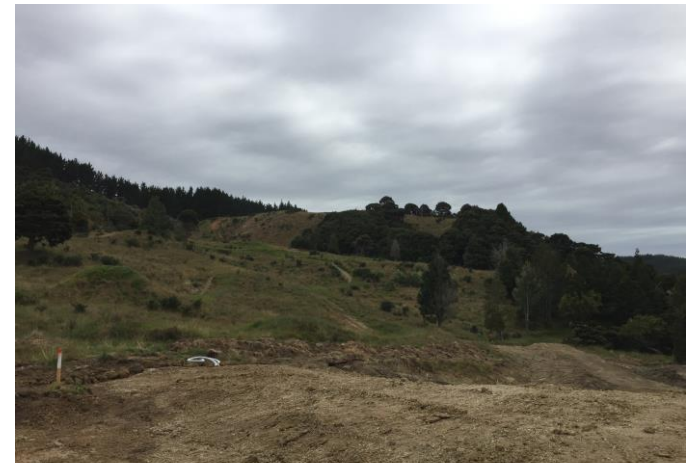
Photograph 6: Standing on future road looking northeast toward disused motocross track

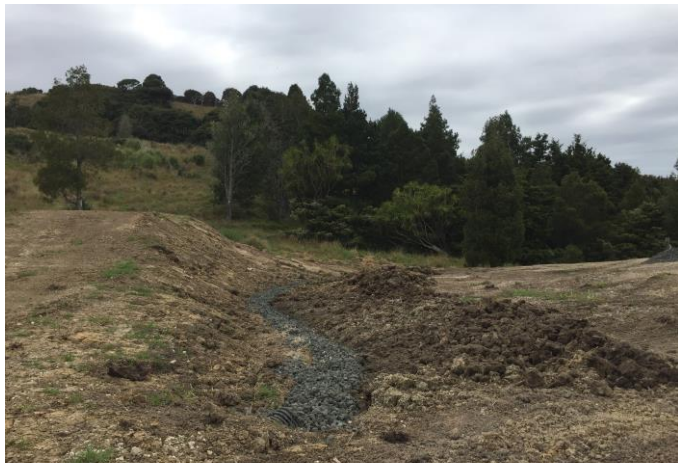
Photograph 7: Partially piped overland flow path in vicinity of new road

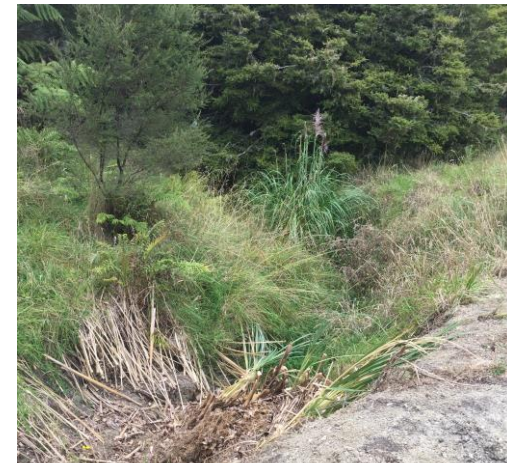
Photograph 8: Current head of central gully (down gradient from partially piped overland flow path)

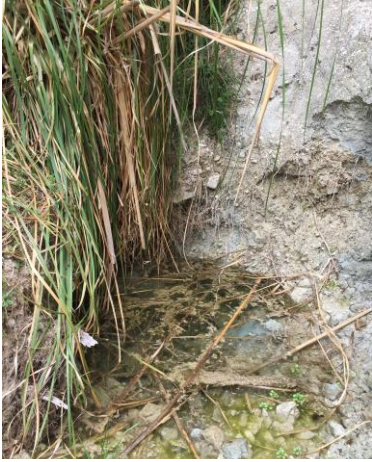
Photograph 9: Location of surface water sample SW01 and sediment sample SED01
Storage shed located on western boundary

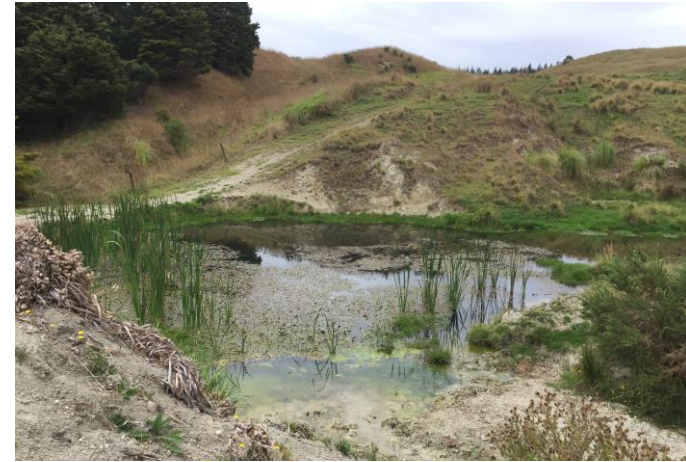
Photograph 10: Pond behind dam

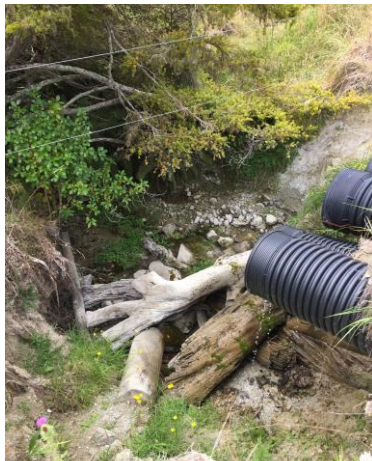
Photograph 11: Dam outlet

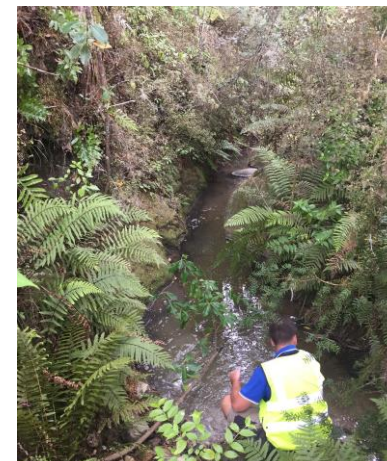
Photograph 12: Location of surface water sample SW02 and sediment sample SED02

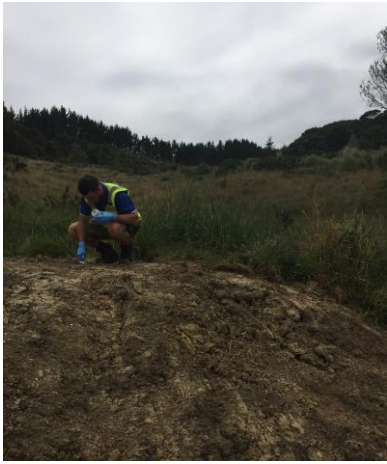
Photograph 13: Location of soil sample SS02

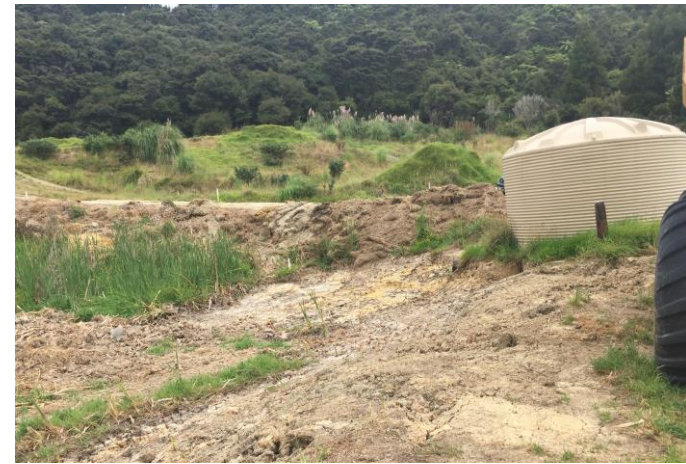
Photograph 14: Small dry retention pond and water tank behind (west) of one-room dwelling
