Application for Resource Consent:

Mr and Mrs J Book

139 Sturges Rd, Henderson

Assessment of Effects

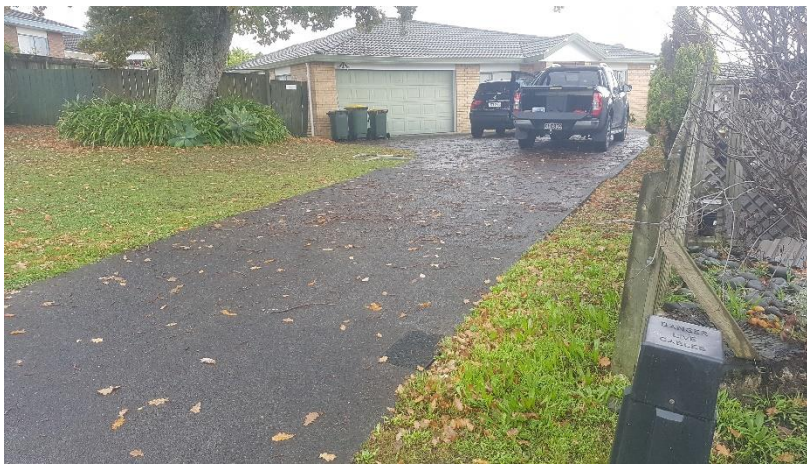
Acorns have fallen on cars, these cannot be parked close to the tree because of the risk of surface and wind shield damage. Leaves build up has also caused surface damage on one of the vehicles contributing to rust.

To minimize damage to vehicles, these have to be parked at the end of the driveway or the street.

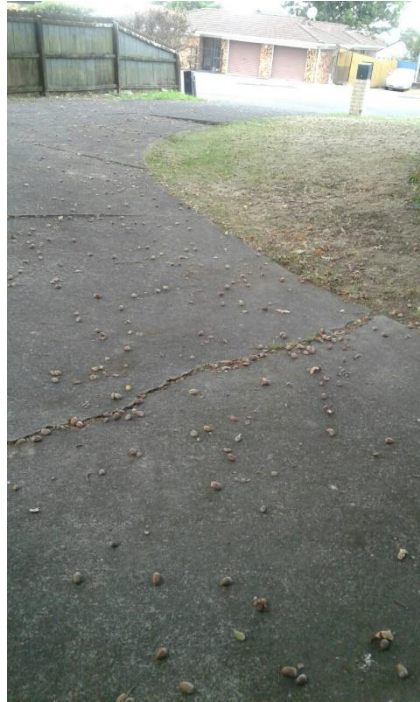
Image shows acorns on the ground, picture taken in Feb 2019, and large amounts of acorns it can be very dangerous to slip on these. These acorns also reach the foot path area.

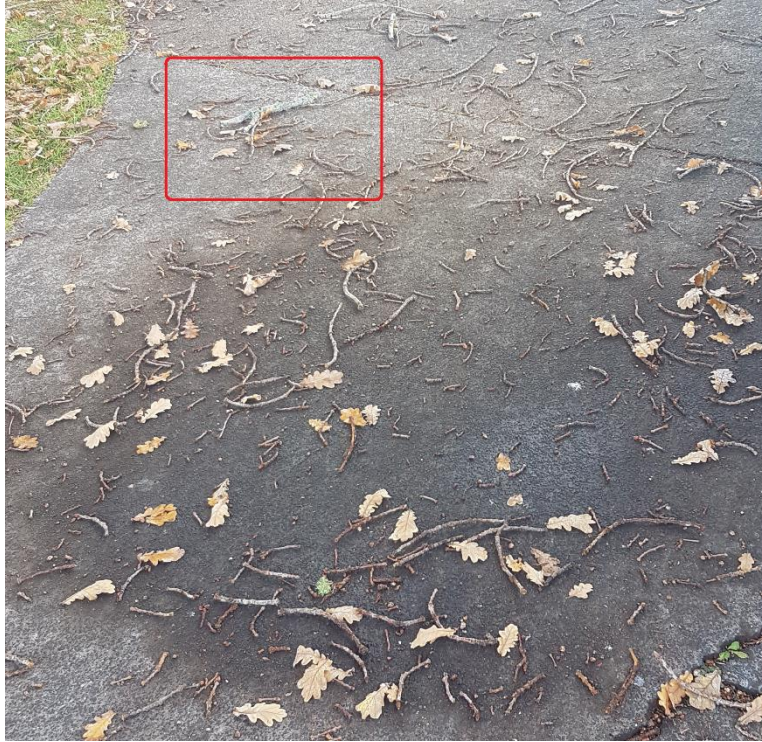
A few months later, May 2019, there is different type of debris, this image show other debris from the tree on the driveway only a few days after cleaning.

In red it has also been highlighted that a branch that that is substantial enough in size to cause injury or damage to vehicles.

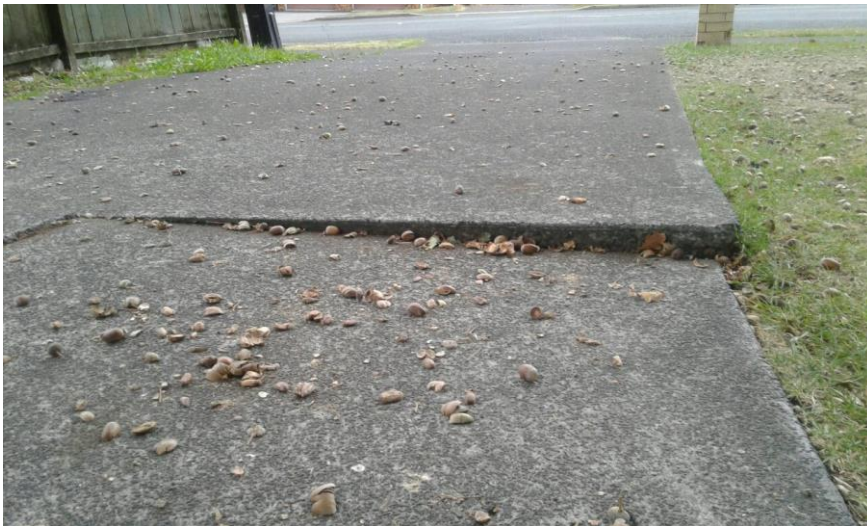
Roots have caused some areas of the driveway to lift causing making it dangerous for pedestrians

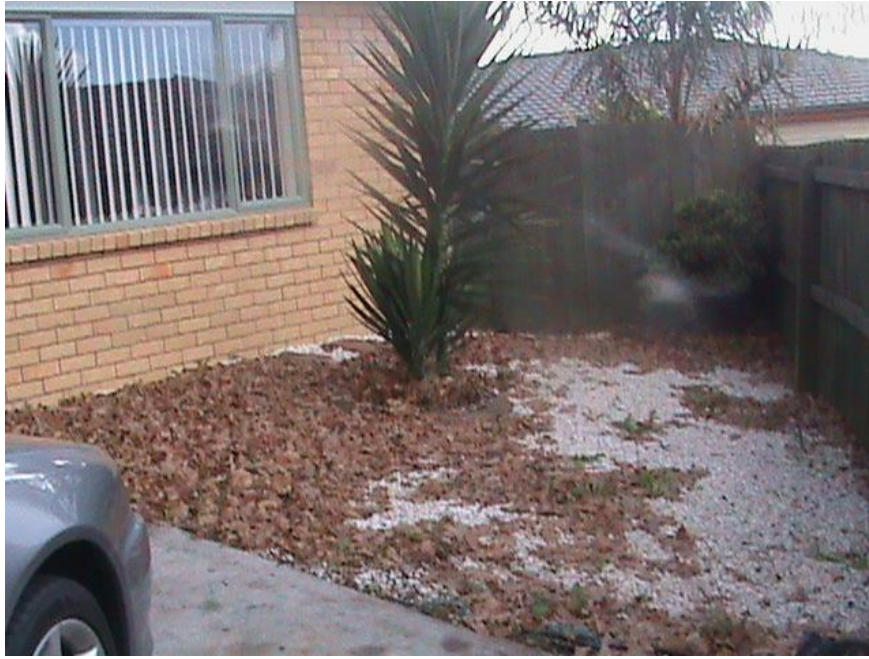
This image is an example of that shows large numbers of leaves and debris that is highly flammable.

The large volumes of leaves, poses a fire hazard to this property and neighbouring properties. It is not practically possible to keep the property and surrounding properties clean, it would require a number of hours per day. There is more evidence of the extent of the cleaning required in the "Professional cleaning" section below.

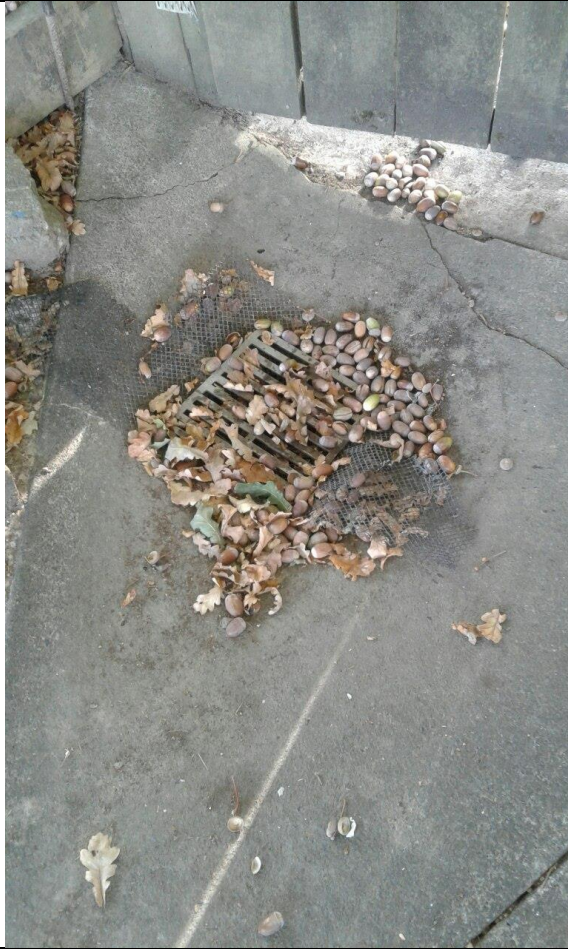
Acorns blocking drainage systems.

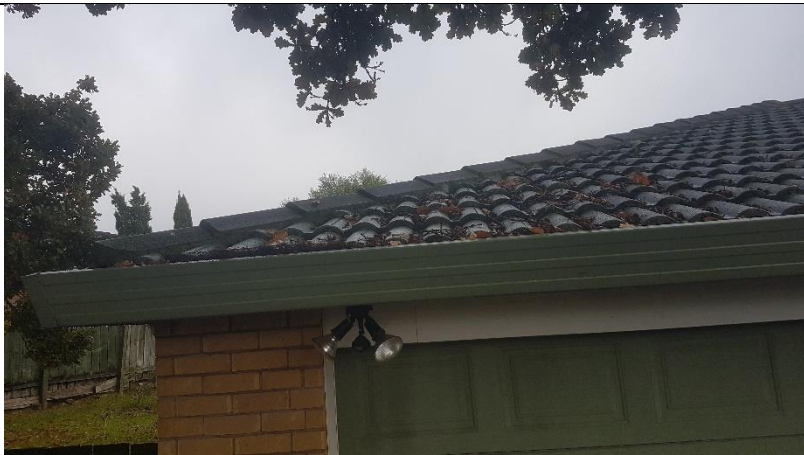
Leaves in roof and gutter from overhanging branches that are likely to cause blockage and damage.

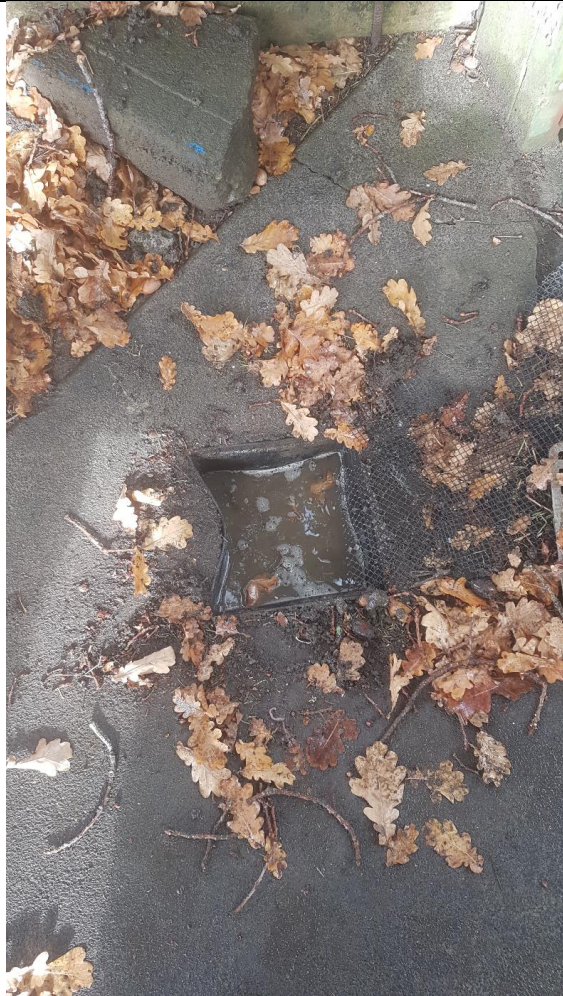
Drain system blockage from tree roots.

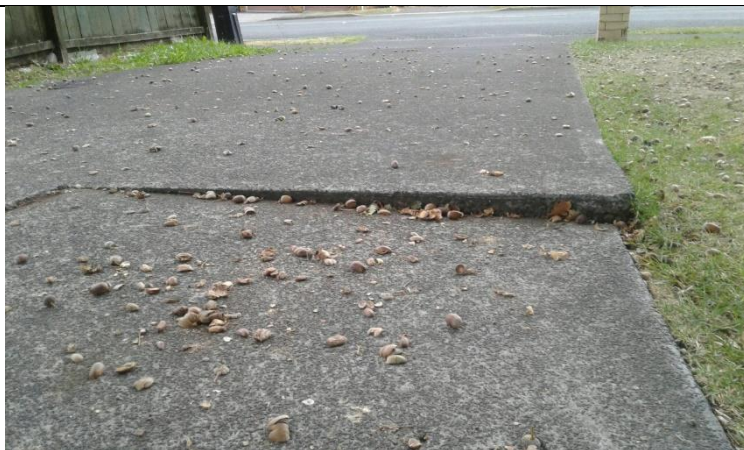
There are a number of cracks in the driveway, these are particularly noticeable in areas of the driveway that are closest to the tree.

Driveway damage lifting and cracking.

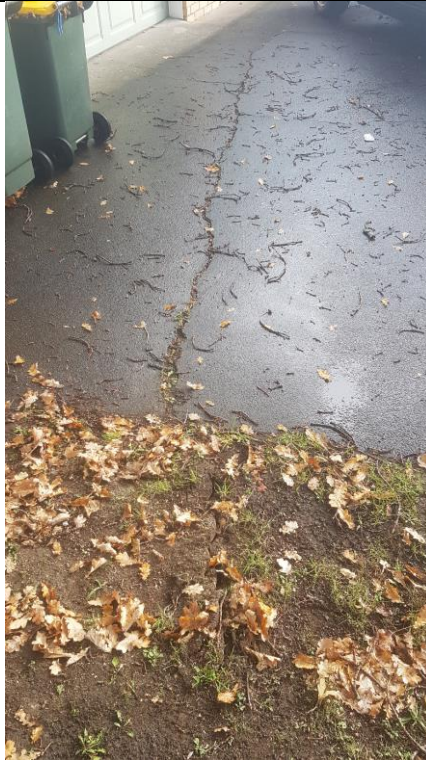
Based on the length of the cracks the direction and the number of them there are serious concerns around the long terms impact of this to the house.

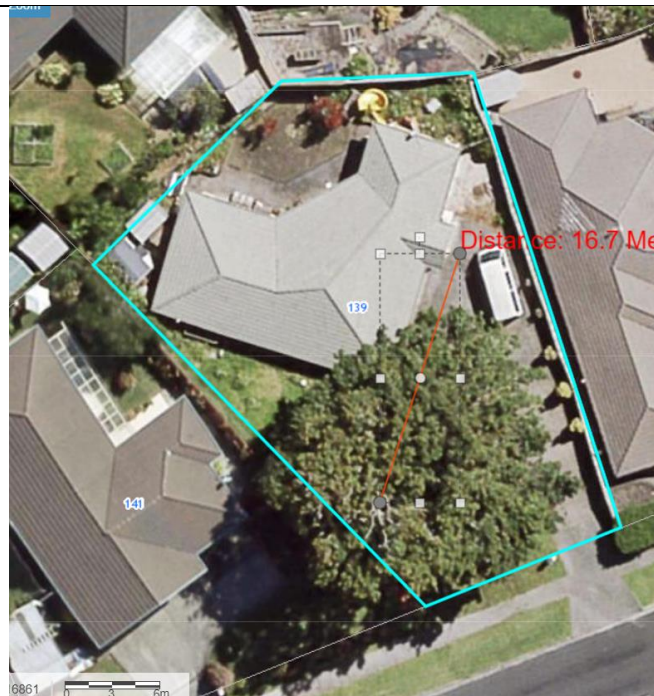
Some of these cracks can be seen at around 17 meters away from the trunk of the tree.

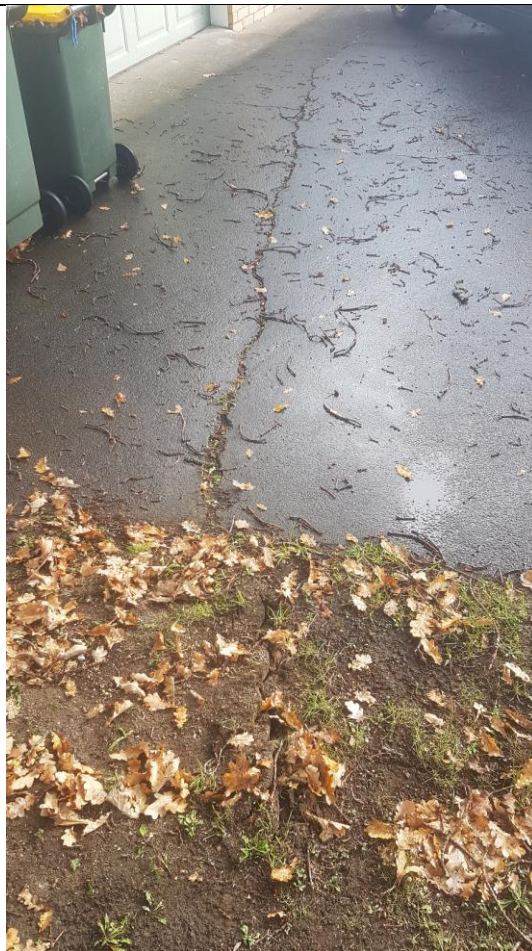
Excavation #1

Root activity was found in the direction of the crack, 2 roots of approximately 2 cms in diameter each, just below the concrete.

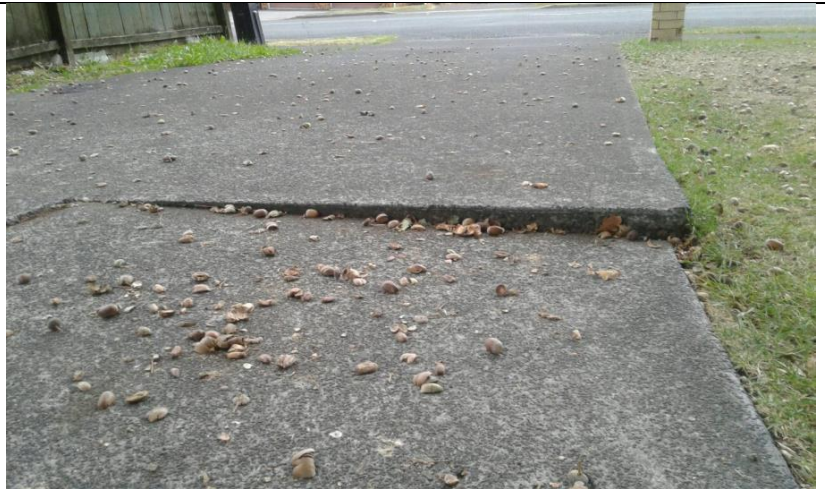
Excavation #2

Initial excavation did not show any root activity in this area.

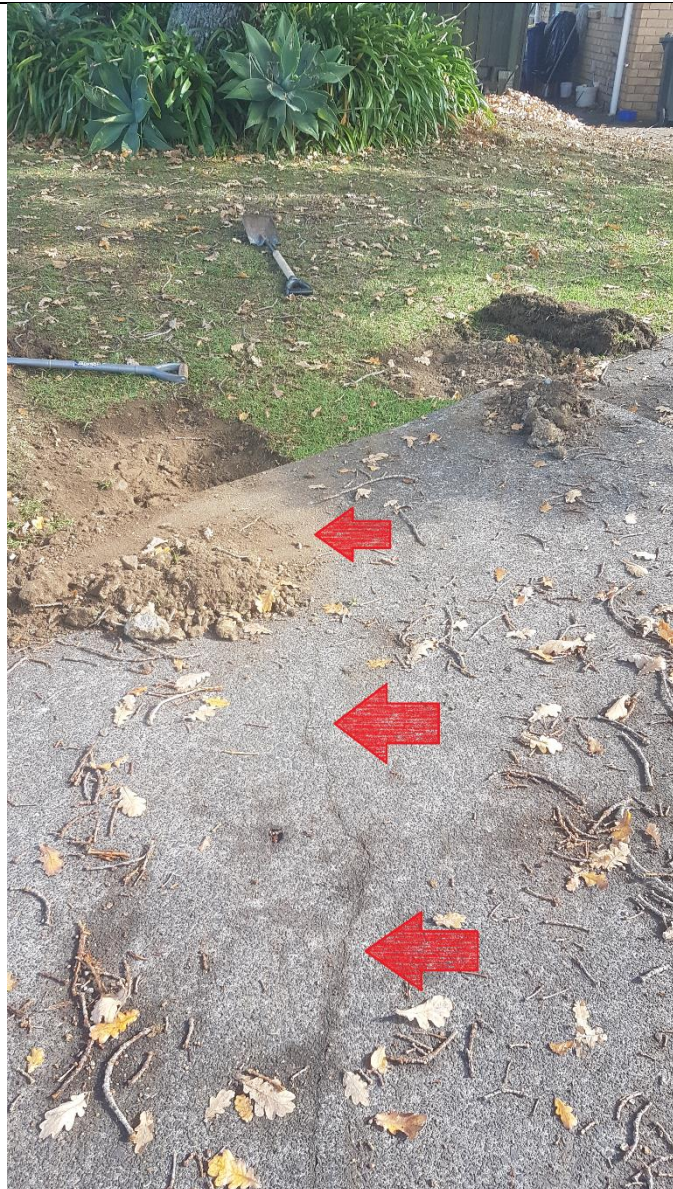
Root activity was found under this crack, also approximately 2cms in diameter and consistent with the crack found above.

Exploratory excavations showed that root activity is significantly enough and destructive at distances that are at least equal to the distance of the house from the tree.

Root activity shows that even a 2 cm root in diameter, can exert a significant amount of force, it is able to lift a concrete pad around 8cms and likely to be the cause to crack concrete up to 17 meters from the tree trunk and is likely to cause further damage to the driveway and likely to cause structural damage to the house perhaps neighbours property.

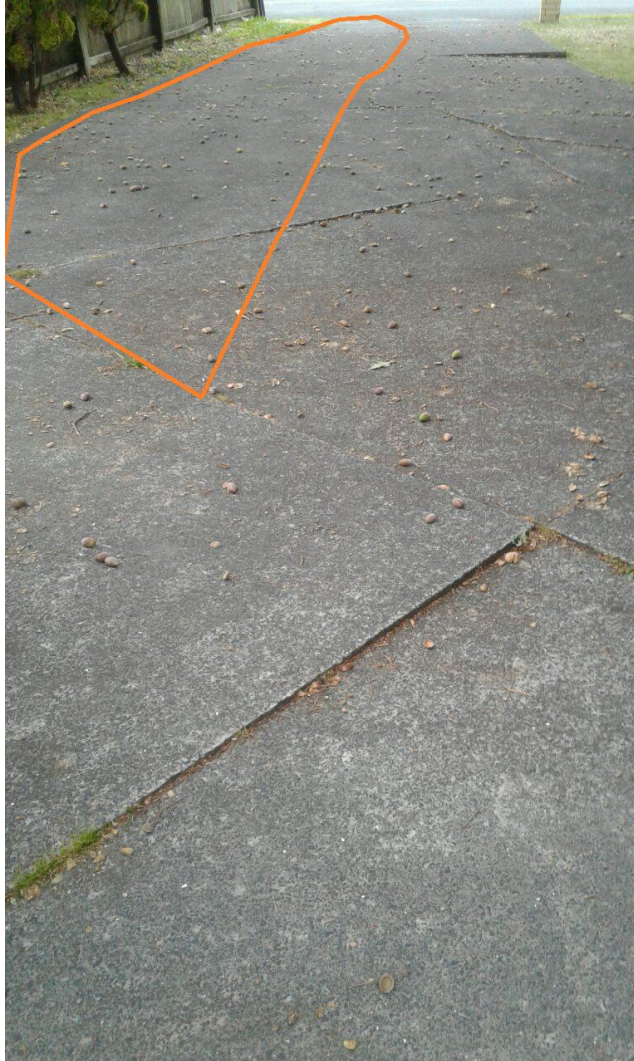
This image of the driveway shows the actual distances that the acorns reached, it is a good indication that our conservative 1.6 meters lateral debris travel distance could be too low.

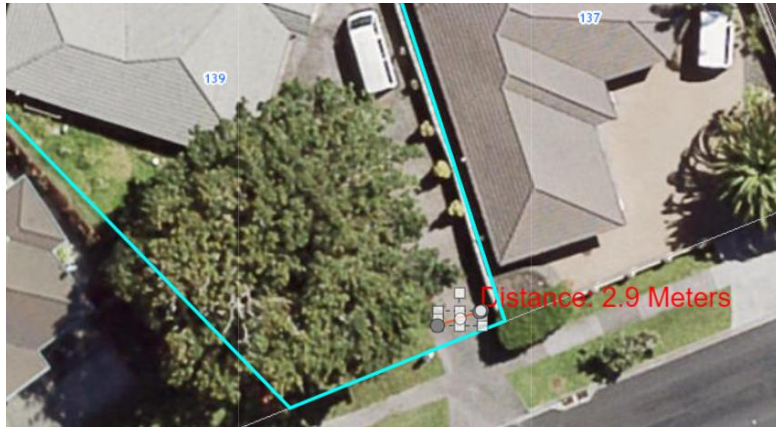
From measured distances it is likely that these could more around 2.9 meters, which would indicate that a volume much **larger than 60%** of the tree crown would need to be removed.

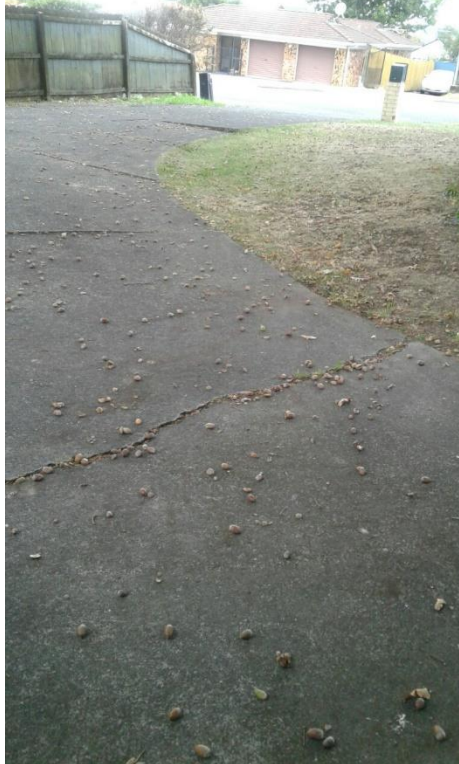
After the acorns fall, leaves and twigs fall from the tree for a number of weeks.

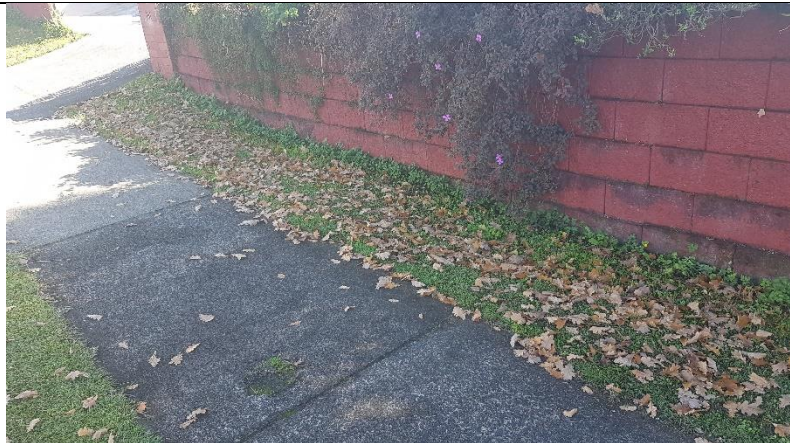
Neighbour's property, 33 meters away from the tree.
