PRELIMINARY SITE
INVESTIGATION -
CONTAMINATION

362 JONES ROAD, HUNUA

Project No.	33250	Approved for Issue	
Version No.	1	Name	Sean Finnigan
Status	Final	Signature	 
Authors	E Bish & A Field	Date	04/04/2024
Reviewer	S Finnigan

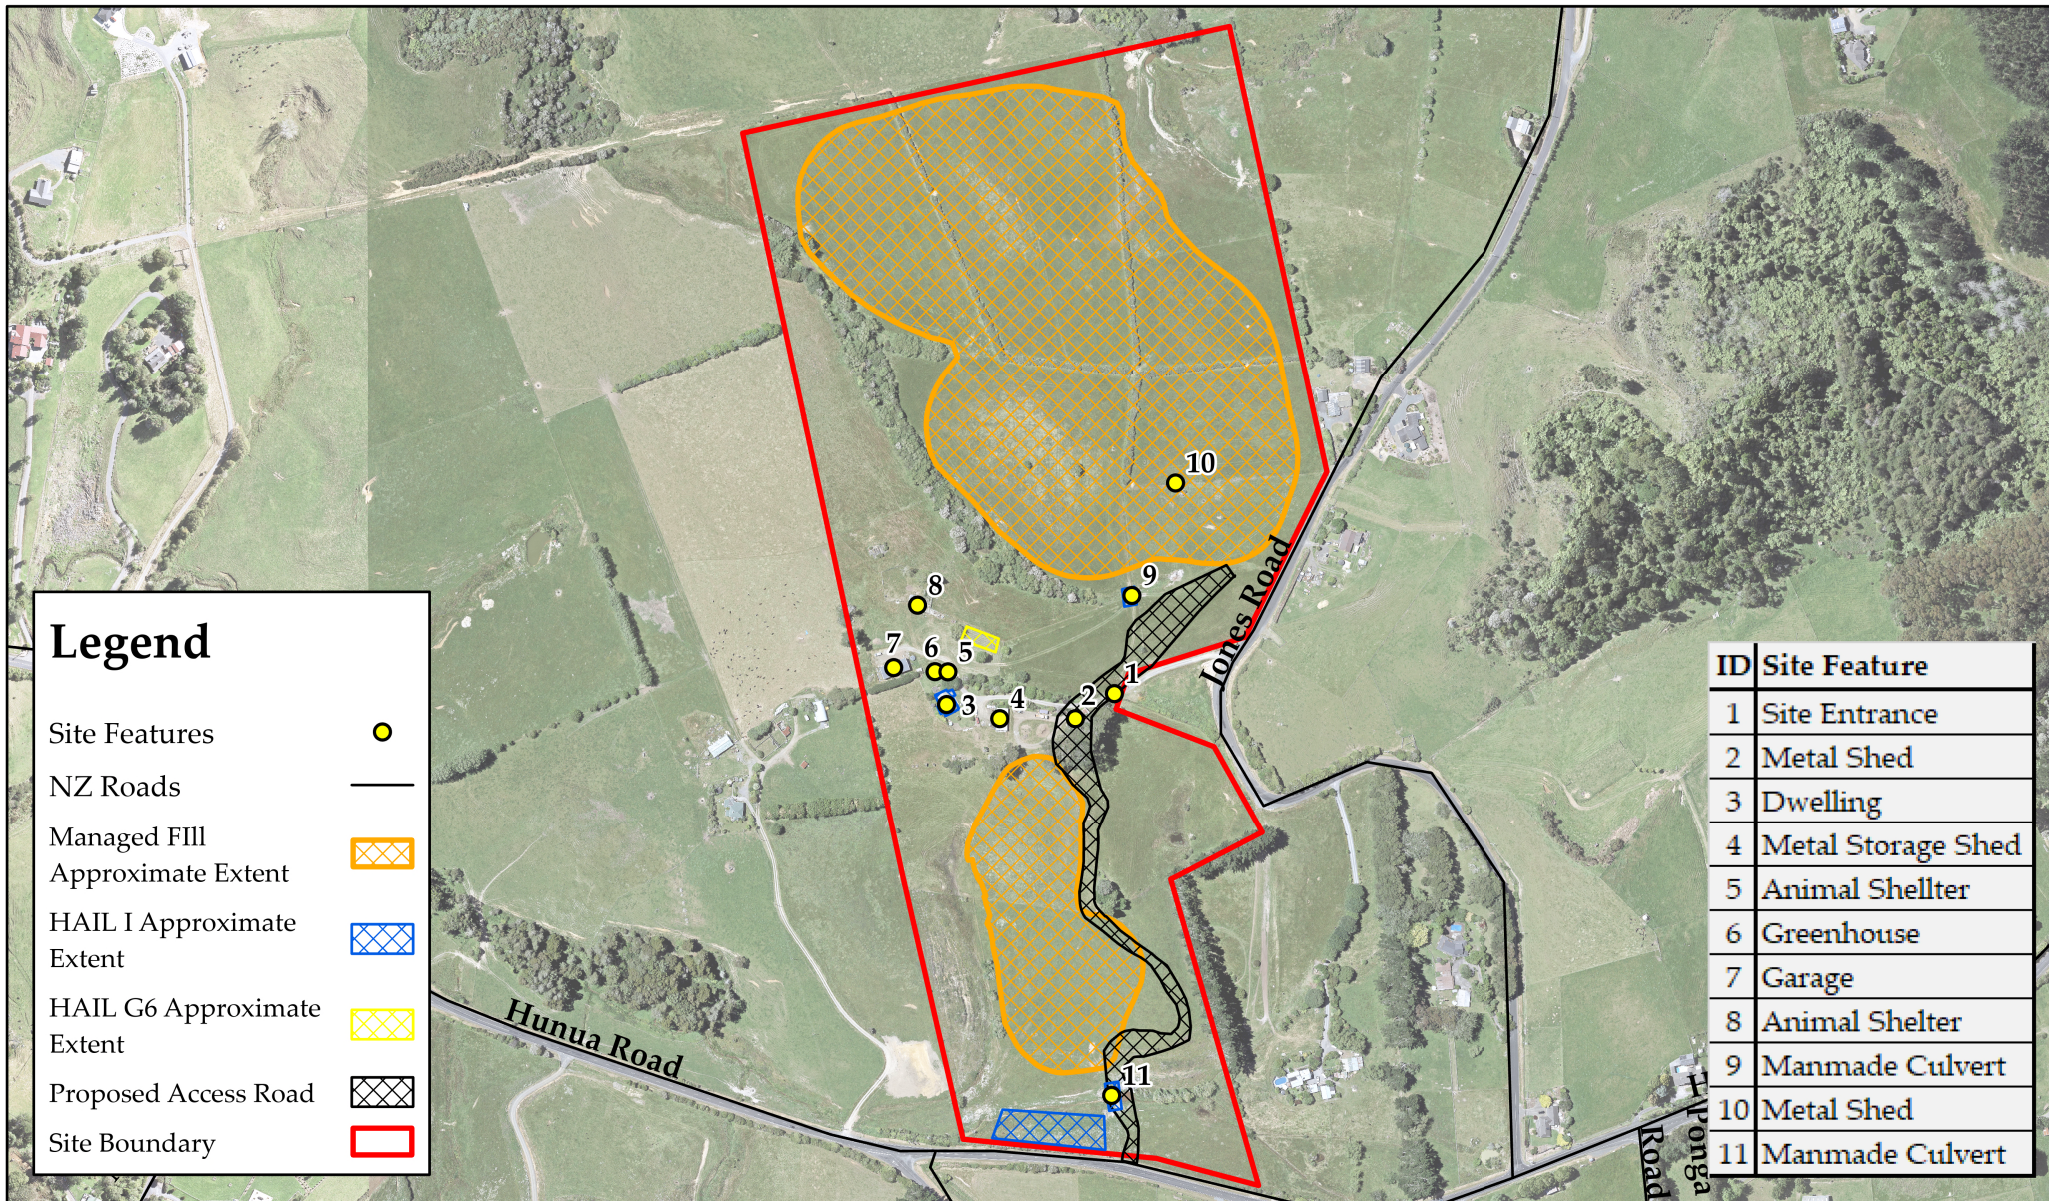
Figure 2: Site Features Plan

- Two culverts were observed during the site walkover within the site development area. The aerals confirm that there are both culvert crossings from 1944, but the southern culvert disappears by 1960, then is visible again by 1977. This may be the old culvert that was relaced and that was observed in the walk over. The interview with the current owner indicated they are not aware of any fill on site or in relation to the culverts. As the southern culvert is within the proposed access road location and potentially subject to uncertified fill, as shown in figure 2, HAIL activity I does apply to the site.

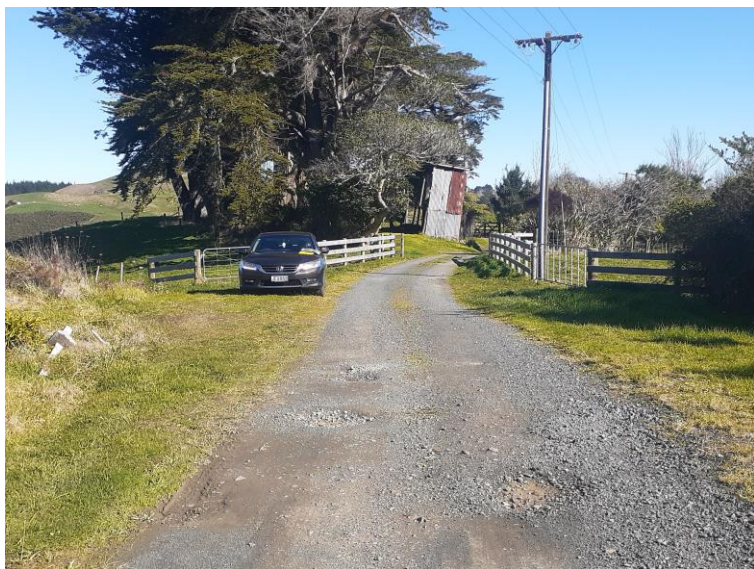
Access to driveway from the East

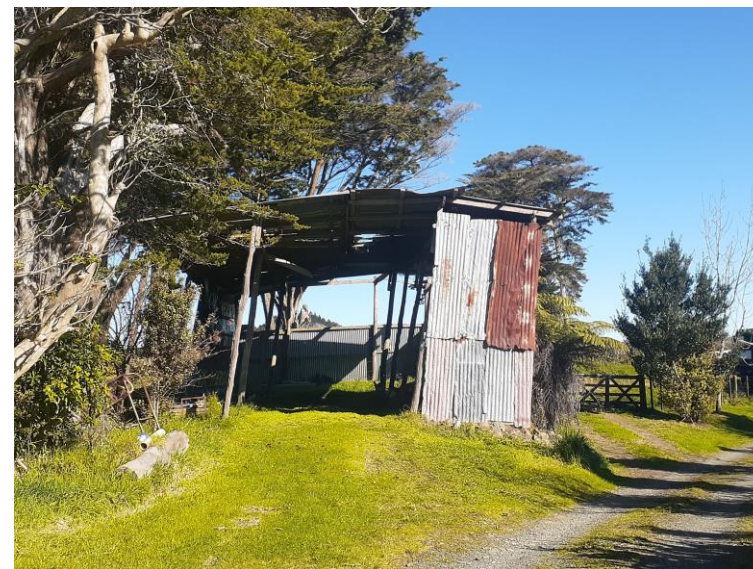
Metal shed left of the driveway

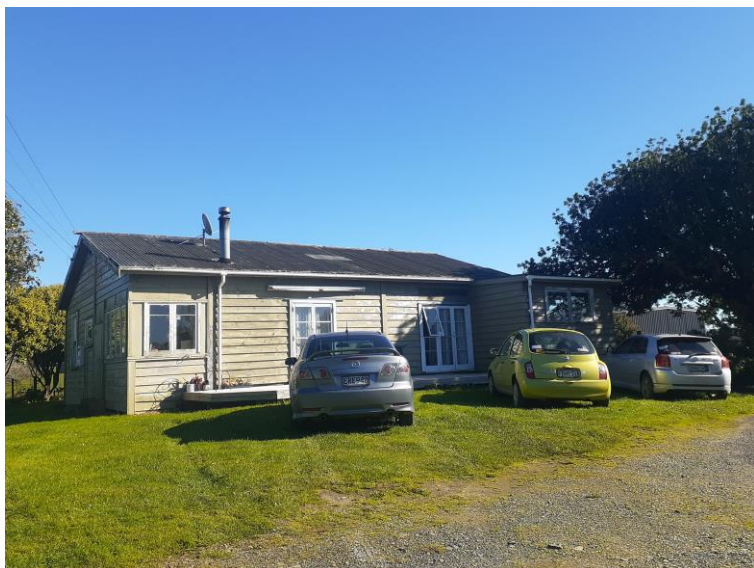
The gravel driveway led from the eastern site entrance and passed a large, empty metal shed before leading to a residential dwelling on the central west side of the site. The dwelling was observed to be constructed on raised piles, consisting of timber weatherboards, tin roof, and PACM (potential asbestos containing material) soffits. Baseboards were not observed. The materials were partially painted and were in an average condition. The potential for soil contamination from degraded building materials was noted in this area.

East Façade of dwelling

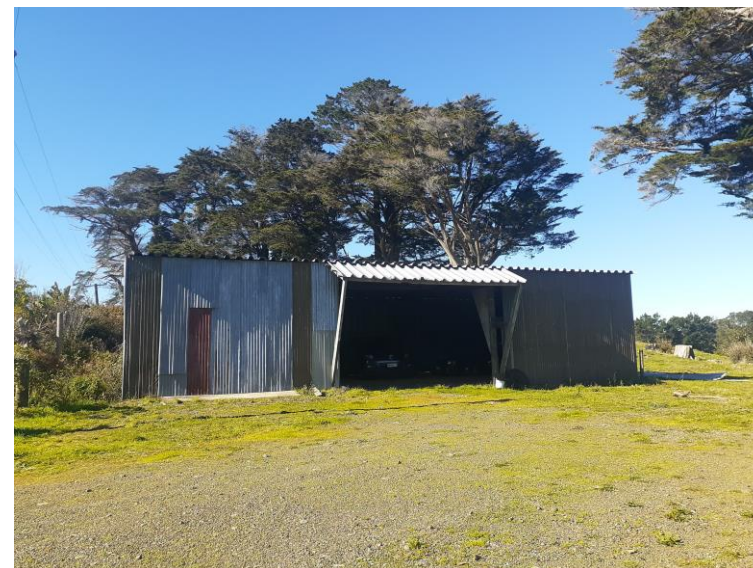
Opposite the dwelling was a larger metal shed used as storage for three vehicles. The ground surface inside this shed was exposed soil. No signs of spills or staining were observed and therefore, no soil contamination risk exists at this time.

Metal storage shed looking East of dwelling

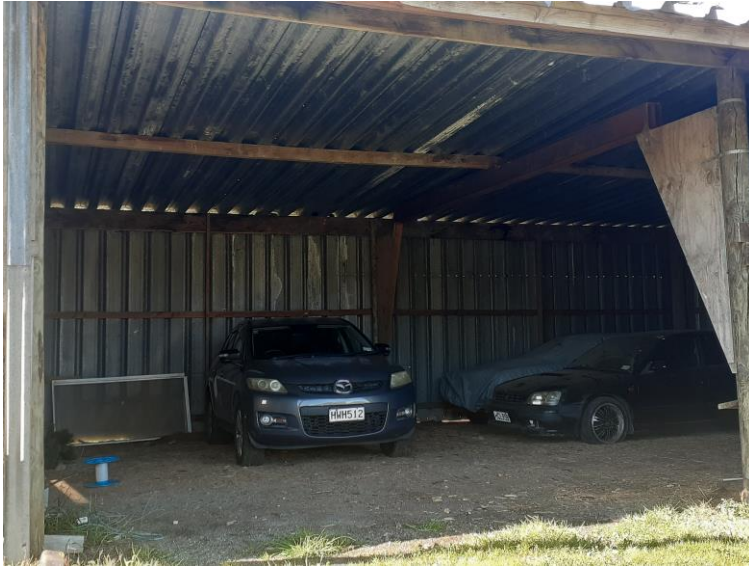
Interior of Metal storage shed

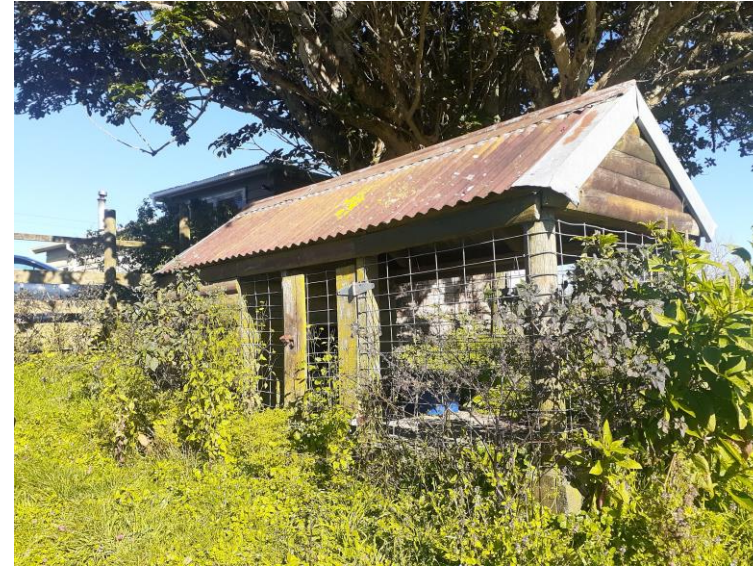
Continuing northwest, the driveway led past a small animal shelter, constructed with unpainted timber, with a tin roof. No signs of soil contamination were identified in this area of the site.

Animal shelter North of dwelling

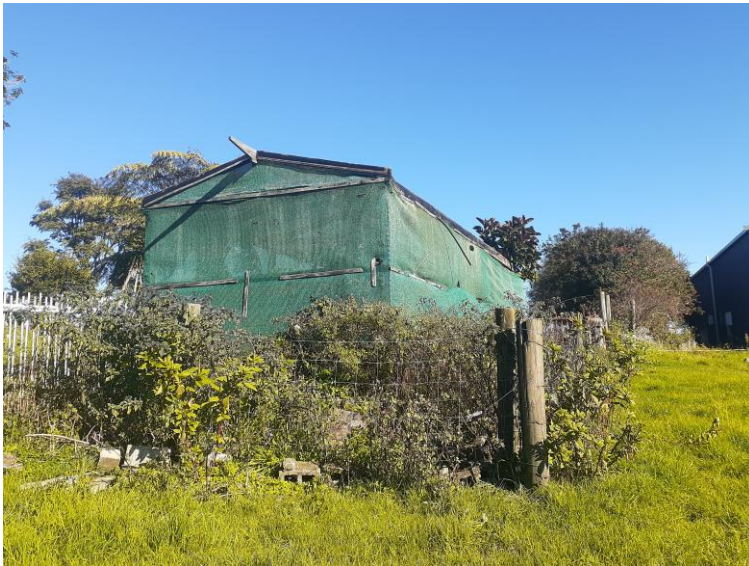
Past the small animal shelter, a small residential greenhouse, made from timber and mesh netting was observed. No signs of soil contamination were identified in this area of the site.

Greenhouse North of dwelling

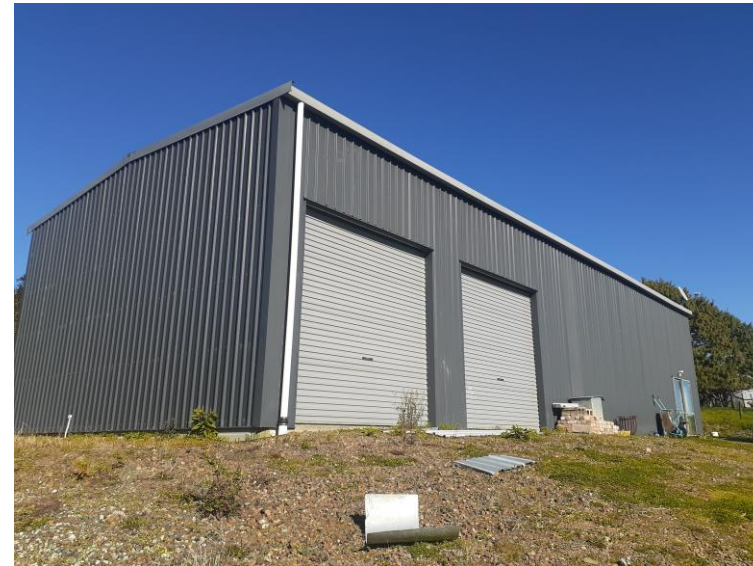
The end of the driveway led to a large newly built garage, which was built on a concrete foundation and had metal cladding and a metal roof. All materials appeared painted and in good condition and are not considered to pose a soil contamination risk at this time.

Garage looking from the end of the driveway

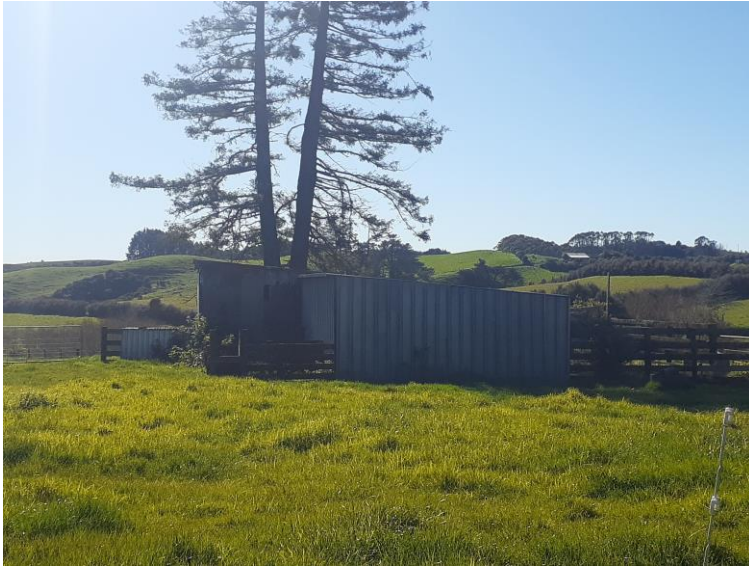
North of this garage was a larger animal shelter, constructed with cement blocks and tin cladding, with surrounding timber fence posts. No signs of soil contamination were identified in this area of the site.

Animal shelter looking north of the garage

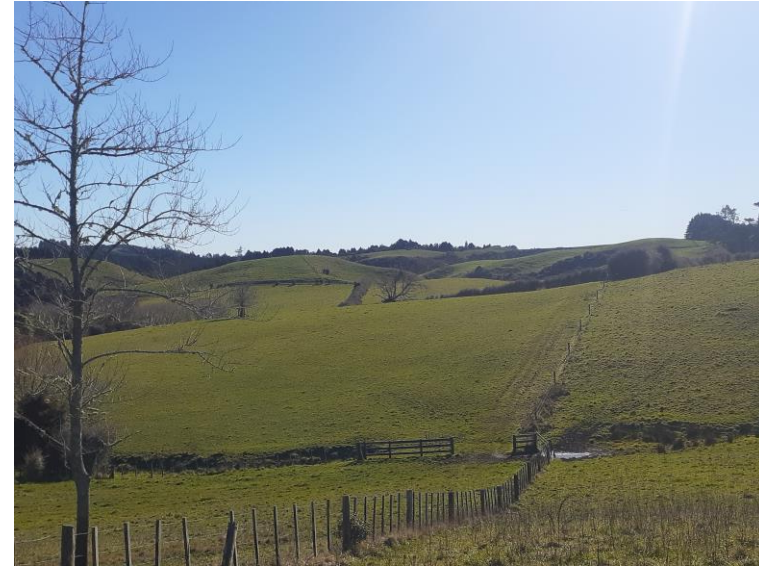
At the beginning of the driveway, looking north, a culvert was observed. Adjacent to the culvert, on the top of a hill, a small metal shed was observed. Signs of potentially uncertified filling were observed around the culvert.

North paddock and culvert looking from the driveway access

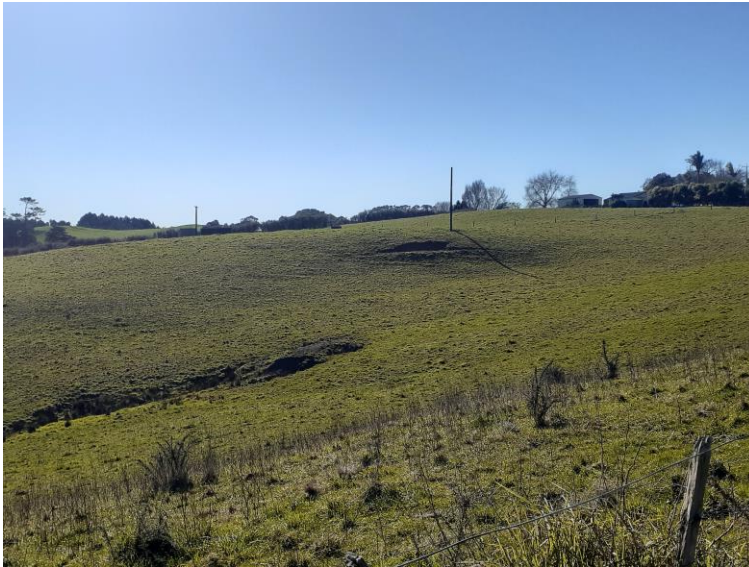
Erosion and metal shed in the distance, looking north east from the driveway access

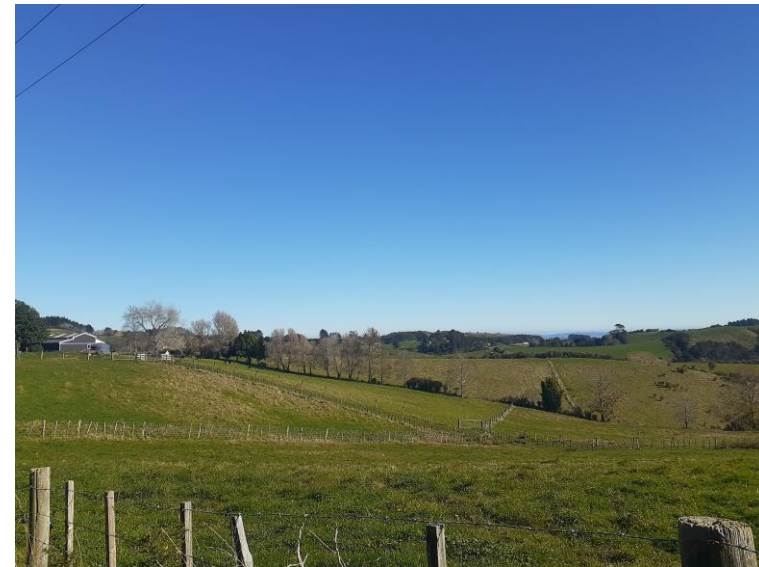
Further north on Jones Road, the northern portion of the site was observed to comprise mainly grassed paddocks on moderately steep hills. No signs of soil contamination were identified in this area of the site.

North paddock looking from East on Jones road

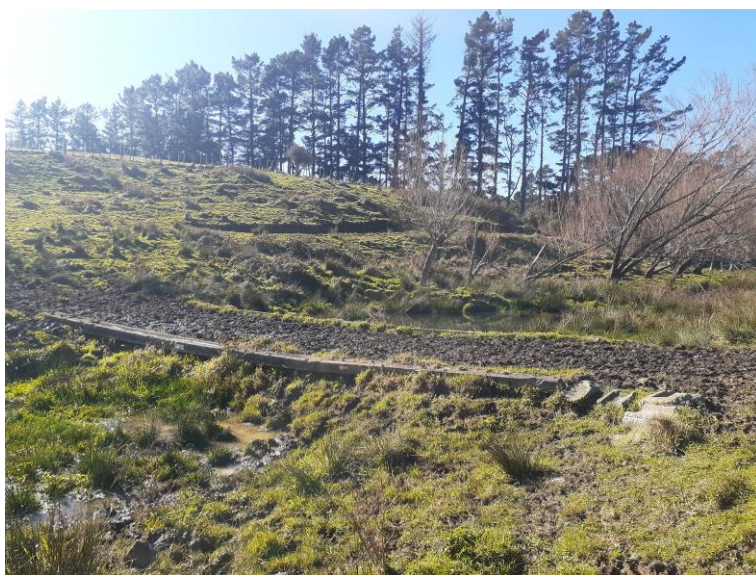
South-east of the driveway there was a grassed gully. At the southernmost portion of the site, which borders Hunua road, there was a grassed paddock accessed via a wooden gate. At the bottom of the hill within this paddock, there was another culvert and adjacent on the bank was an old damaged culvert pipe, which appeared to be made of concrete. The culvert crossing in use was constructed using telephone poles, while the material used to fill the culvert was not visible. Signs of potentially uncertified filling were observed around the culvert.

Manmade culvert in South paddock

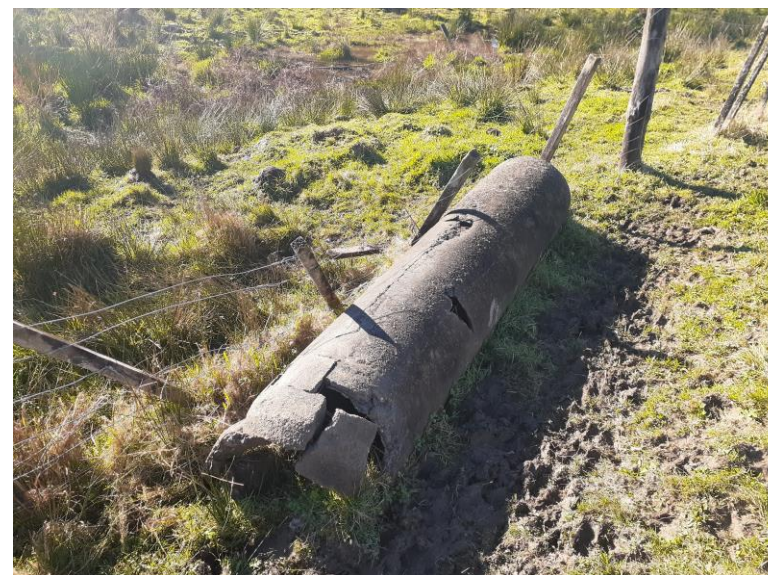
Old damaged culvert Southeast of existing culvert
