31 July 2024

WWLA1219

Dominion Road and Valley Road Apartments, Mt Eden – Ground Contamination Review

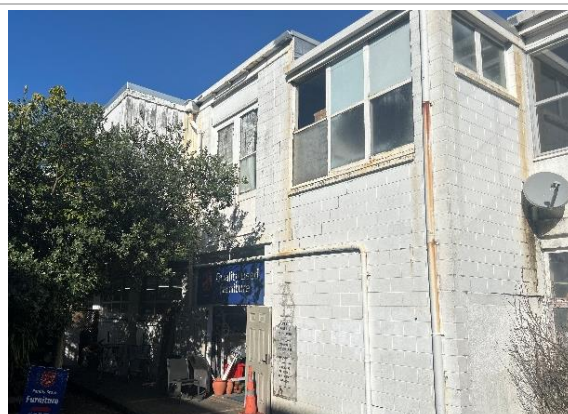
198-202 Dominion Road (Photographs 1-4)
<ul style="list-style-type: none"> • The property has three adjoining double-storey buildings, constructed of concrete block with some portions covered in texture plaster and fibrolite. Joinery is mixed timber and aluminium, and where flaking paint is noted there is a red primer (indicating potential use of lead-based paint). • Current occupants of the buildings include a boxing studio, Salvation Army store, and clothing manufacturer. A vacant space was most recently occupied by the Red Cross. • The driveway and carpark surrounding the buildings are asphalt, with only very minimal exposed soil for decorative planting. Asphalt is in moderate condition. • Our inspection of the location of an underground fuel storage tank (UST) described in the PSI and DSI as having been removed, suggest some of the associated structure such as the concrete lined pit may be present (Photo 4).

Photograph 2: Rear of Salvation Army building. Fibrolite visible.

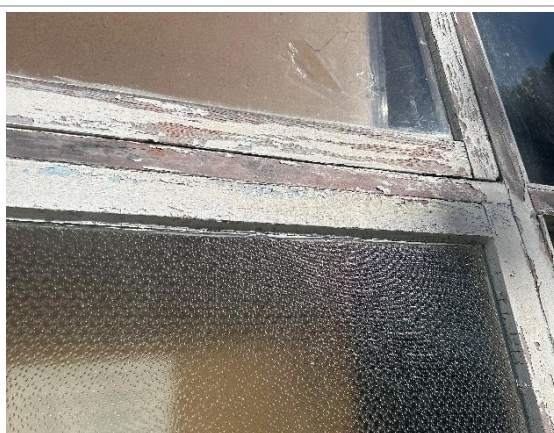
Photograph 3: Paint flaking on joinery indicating possible lead based primer.

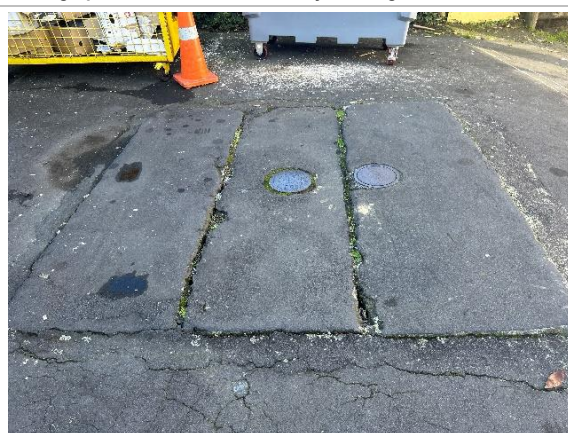
Photograph 4: Location of possible UST or separator.

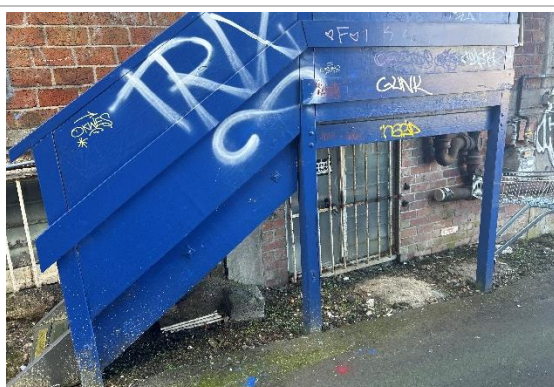
- This property contains four buildings, generally of brick or concrete block construction. Textured plaster cover and cladding repairs are frequent throughout all buildings. Repair materials include fibre cement sheeting and corrugated metal.
- Current and former (recently vacated) occupants include a café, tattoo shop, architect, coffee shop and cosmetics retailer. The coffee shop is located in the former automotive engineering building and contains a workshop at the eastern end of the building.
- Exposed soil is visible underneath the staircase at the rear of 214-216 Dominion Road. Fragments of potential ACM were observed at the ground surface.

Photograph 7: Staircase at rear of 214 Dominion Road with small amount of exposed soil and suspected ACM fragments.

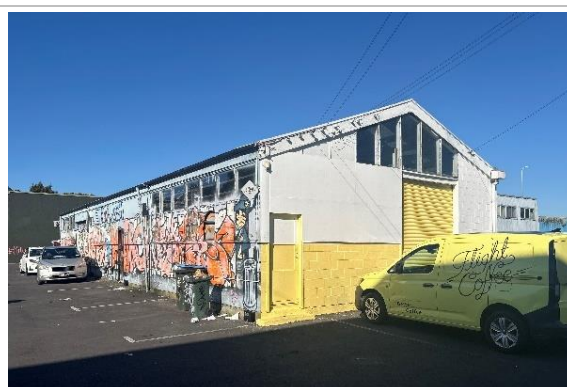
Photograph 8: Coffee shop at 222 Dominion Road in the former automotive workshop.

Comparison with current site conditions observed by WWLA	<ul style="list-style-type: none"> • Since the time of the PSI (2016) the automotive engineering business has vacated the site and the building is now occupied by a coffee shop. No other significant changes in land use since 2016 were observed. • Due to the age of many of the buildings across the landholdings, lead-based paint is expected to have been used in the past, although given the extensive pavement coverage the potential for it to have impacted soil is low. HAIL Activity I (accidental release of contaminants) may apply if lead levels exceed human health and/ or environmental levels.
WWLA comment	In our view the PSI fulfils the requirements as defined in the CLMG1 ⁴ , with the WWLA site inspection (July 2024) filling the information gap between 2016 and current day. We concur with the HAIL activities identified with the addition of potential for impacts on soil associated with lead-based paint use.

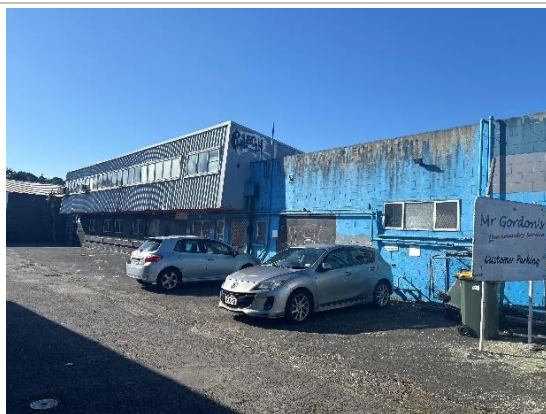
- This property contains a single-storey building that was vacant at the time of the inspection. The most recent occupant was the commercial laundry and a hairdresser.
- The building is of concrete block construction with texture plaster, and a mix of timber and aluminium joinery.
- Concrete and asphalt surrounds the building on all sides and was in moderately good condition.

Photograph 9: The rear (northern side) of the commercial laundry at 115-117 Valley Road.

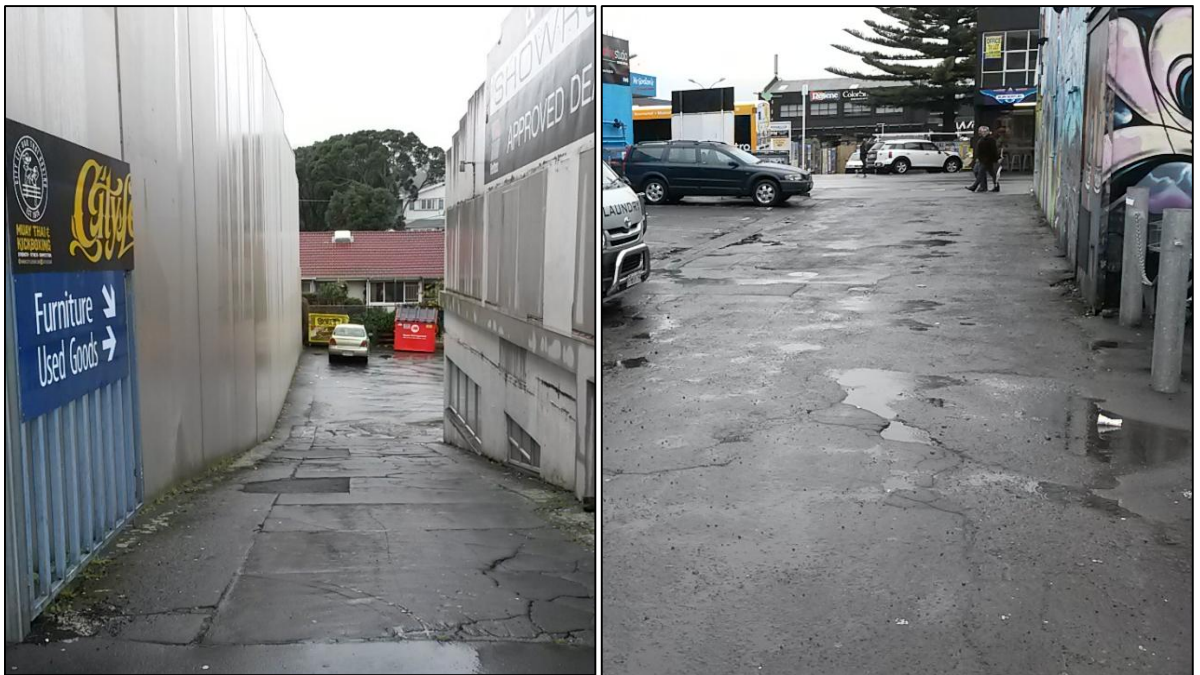
- The vast majority of the site is sealed with asphalt. The condition of the asphalt is poor in some areas, including the accessway at 216 Dominion Road and the accessway and parking area at 117 Valley Road, which are extensively cracked and patched with asphalt and concrete (Photographs 2 and 3). The asphalt covering the central area of the site (218 and 222 Dominion Road, Photograph 1) and the concrete car park outside 113 Valley Road are in relatively good condition.

Photographs 2 and 3: Areas of cracked and patched asphalt at the 216 Dominion Road accessway (left) and the 117 Valley Road accessway (right).

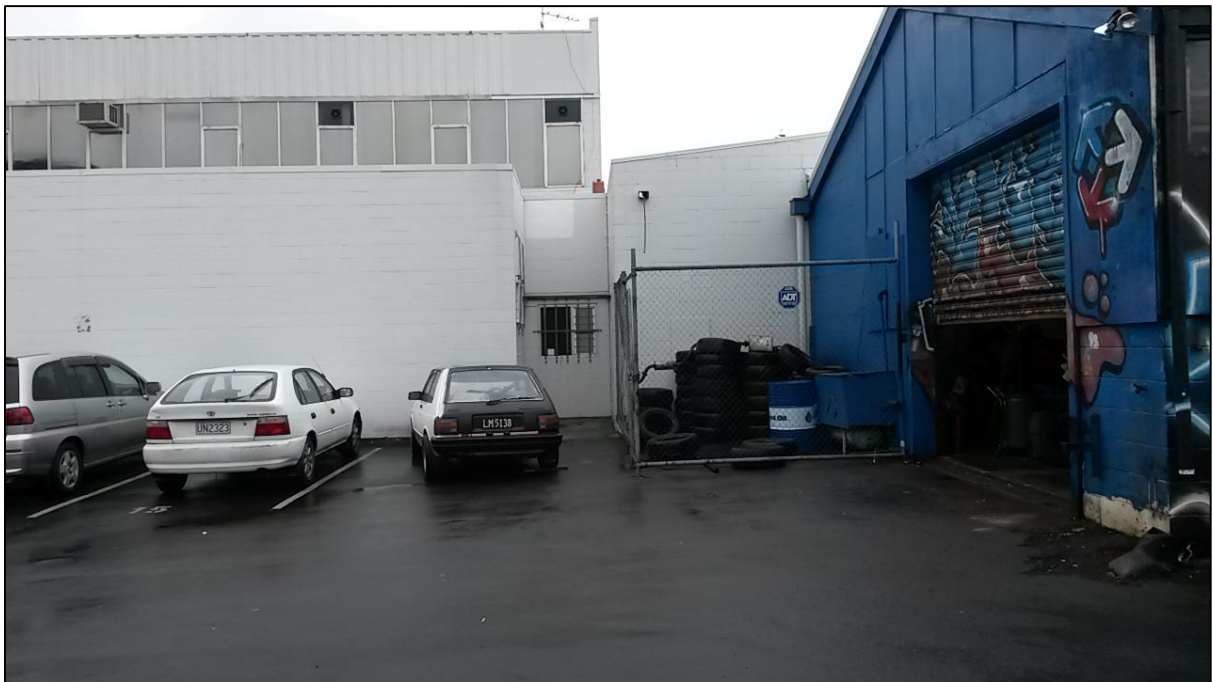
- A chain link cage locked with a combination lock was located behind the auto engineering workshop at 222 Dominion Rd (Photograph 5). This cage contained piles of tyres tidily stacked and at least one drum. No surface staining was evident around this caged area.

Photograph 5: The chain link cage containing tyres and an oil drum, located outside the rear of the auto engineering workshop (right).
