Bayswater Marina Holdings Limited 21 Sir Peter Blake Parade Bayswater Marina

Preliminary Site Investigation Report

June 2021

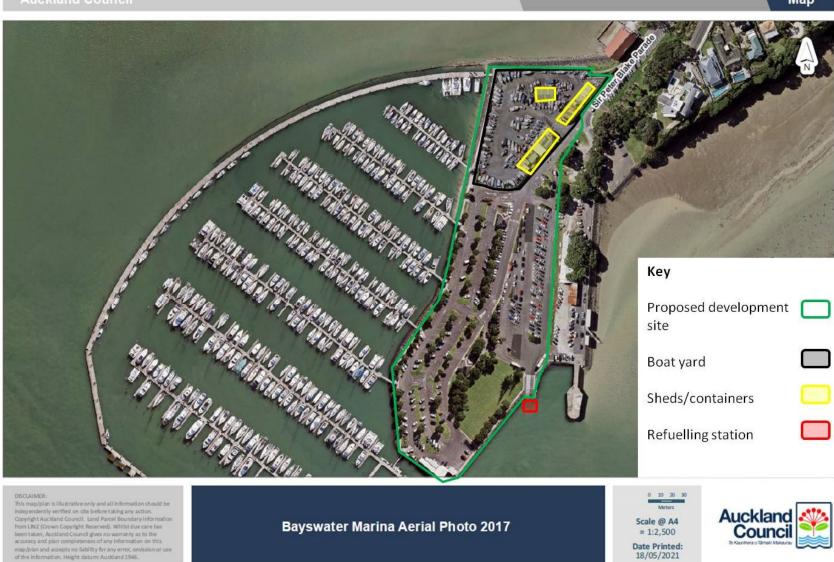
Figure 3: Current Site Layout - Bayswater Marina Map Source: Auckland Council Geomaps, May 2021 Мар

Figures 3 and 4, in Appendix A, shows the current site layout. The site is predominantly landscaped carparking with a few office buildings to the south, and a boat yard for storage and servicing/maintenance in the northern portion of the site. Marina berths are located west of the site.

The boat yard, which has a gravel base is approximately 6,500 m² and mainly used to store power boats and trailers. There is a shed and several containers located in the boat yard area.

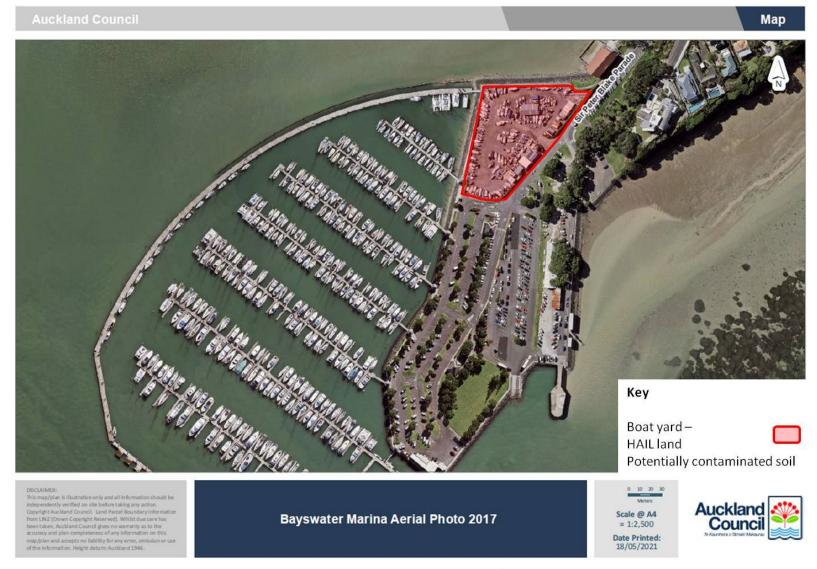
Figure 4: Preliminary Conceptual Site Model – Before Soil Sampling Map Source: Auckland Council Geomaps, May 2021

Figure 4 in Appendix A, outlines a preliminary Conceptual Site Model (CSM) for the site, prior to soil sampling being undertaken. This CSM shows the location of any potential contamination spots on the site.

The soils in the boat yard area may contain contaminants associated with marine vessel maintenance activities.

The land is considered to be potentially contaminated under the NESCS regulations as shown in Figure 4 the conceptual site model. Several HAIL activities were identified (associated with storage of hazardous substances, and other land subject to accidental or intentional release of hazardous substances) and different areas of the site are potentially contaminated by various contaminants.

- That a detailed contaminated site investigation (DCSI), involving soil sampling is carried out in accordance with NESCS regulations prior to any earthworks occurring in the area of the boat storage and maintenance area. This investigation is required to determine if the soil on the site has been contaminated by previous land uses and if so, what degree of remediation maybe or may not be required for the land.
