# Geotechnical and Environmental Due Diligence Review to Support Plan Change Application

## Drury Metropolitan Centre Plan Change

Drury  
Auckland

13.08.2019  
13451.000.000\_20

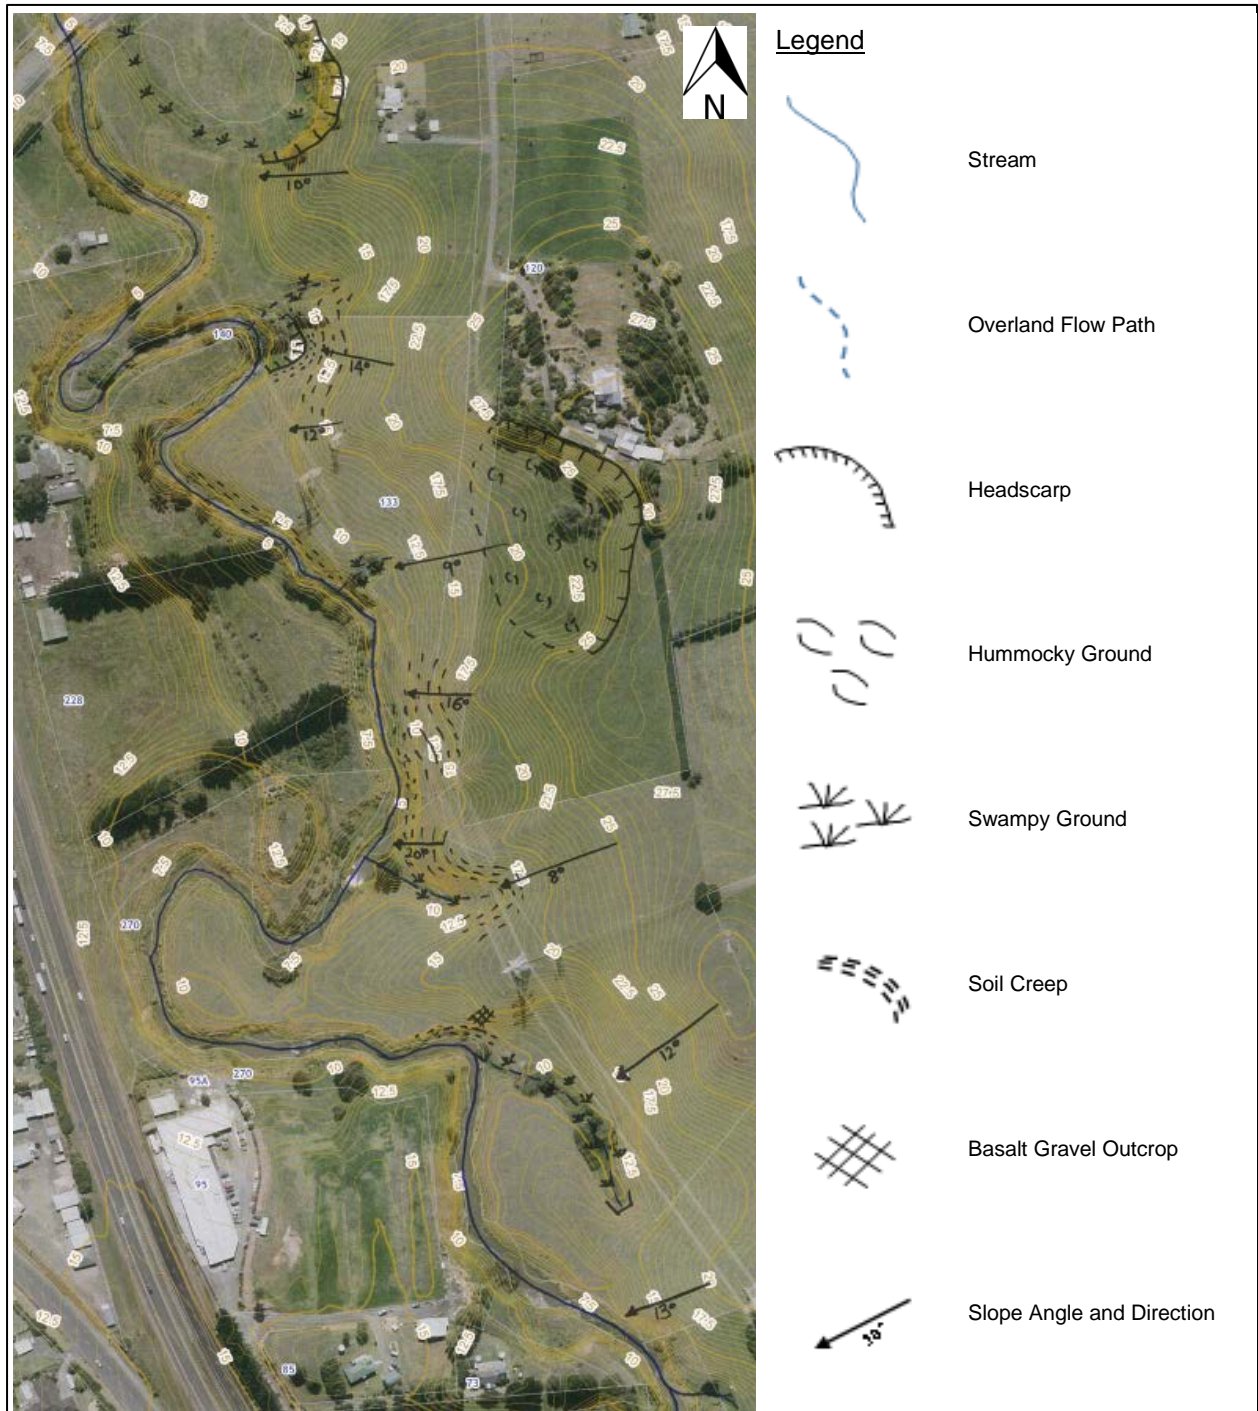
**Figure 2: Geomorphological Map of Western Slopes**

The Hingaia Stream delineates the western extent of the study area. A series of short, shallow tributary gullies were observed on the eastern side of the stream, extending into the toe of the western slopes. These features were observed to be shallow, with over-steepened flanks and swamp-type hydrophilic vegetation in the base. Surface water was not observed, but is likely to be present in winter months during periods of persistent rainfall.

Soil creep was observed on some steep slopes (typically greater than 18 degrees) in the form of soil ridges and terracing, and had locally been exacerbated by stock movements.

Over-steepened stream banks were observed on the western side of the stream, with evidence of local slumping occurring, which is inferred to be associated with stream erosion of the toe of the embankment. Sub-vertical stream banks were not observed on the eastern side of the stream within the study area, though not all portions of the stream could be accessed at the time of our walkover assessment.

A shallow headscarp approximately 30 m wide was observed in the northern portion of the study area, adjacent to a bend in the stream where active stream erosion is occurring. The crest of the headscarp extends approximately 25 m upslope from the stream edge.

A large headscarp measuring approximately 150 m wide was observed adjacent to the dwelling at 120 Flanagan Road, extending to the south on the flank of the ridge. The land below the scarp is broad and hummocky over approximately 100 m length, beyond which it slopes at approximately 9 degrees towards Hingaia Stream. No evidence of tension cracks, consecutive headscarps or groundwater springing was observed in the vicinity of this feature.

A rubbly basalt outcrop was observed in a track cutting on the southern side of the east-west lobe that offsets the stream in the southern portion of the study area. The cutting exposed rounded basalt gravel, cobbles and boulders in a weakly cemented, fine grained matrix. This lobe is inferred to be part of the ancient lava flow mapped across the site.

Aside from the features mapped below, no other significant geomorphic features were observed on the western slopes within the study area. The undulating slopes do not appear to be presently subject to slope instability beyond the areas of creep and toe erosion identified.

With few exceptions, the absence of pronounced, large-scale instability features suggests that the landform is inherently stable with episodic soil creep and small rotational failures likely to occur as a result of loss of toe support and elevated groundwater levels.

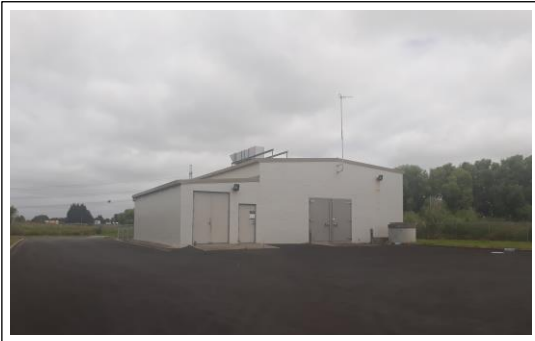
Pump Station on NW Boundary

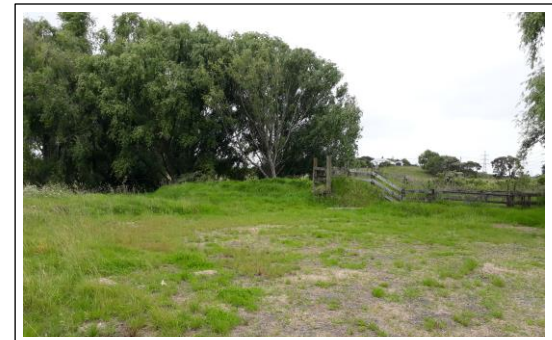
Farm Race along Western Boundary

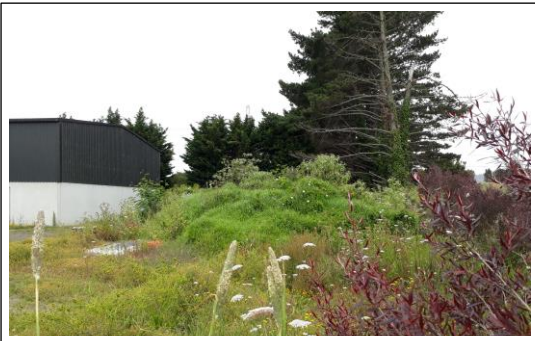
Stockpiled Material along Western Boundary

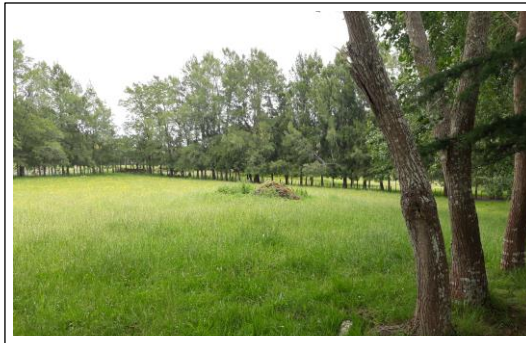
- The southern portion of site is former pastoral land which has been subdivided for residential land use. The site slopes gently to the south. One burn pit was identified in the southeast paddock.

Farm Land in Southern Portion of Site with Burn Pit in Foreground
