Project Reference: 20995

Revision A

14/03/2025

## **A PROPOSED PRIVATE PLAN CHANGE FOR 70, 70A AND 70B LISLE FARM DRIVE, PUKEKOHE.**

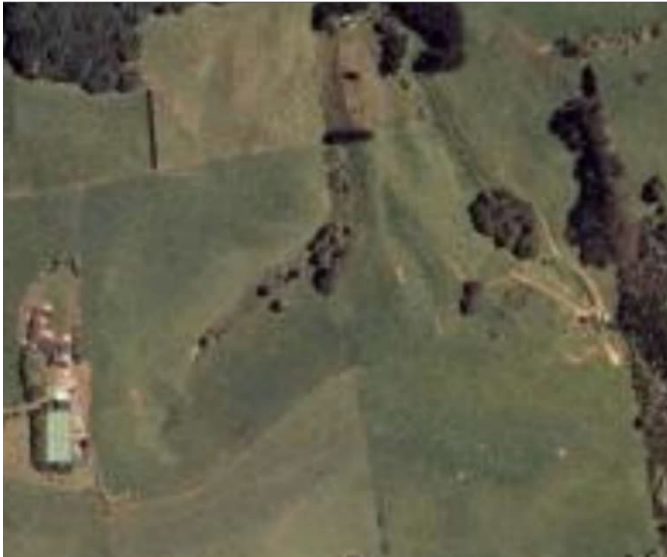
**Insert A (left):** Aerial image from 2003/2004 showing northeast portion of site. *Image retrieved from Auckland Council Geomaps on 10.03.22*

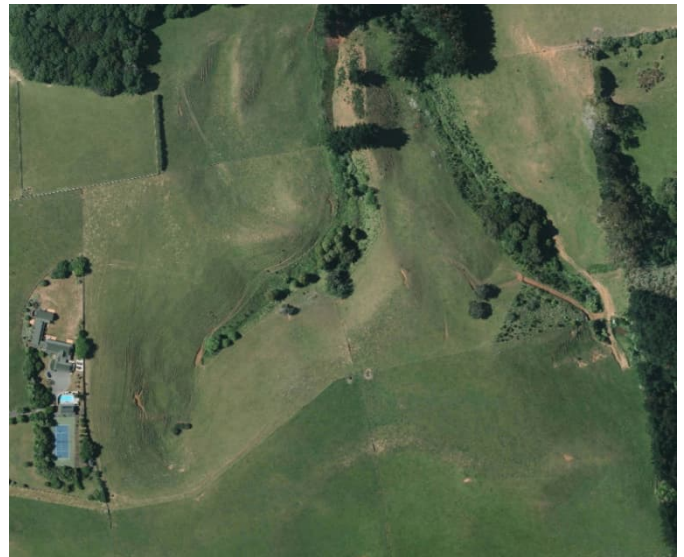
**Insert B (below):** Aerial image from 2010/2011 showing northeast portion of site. *Image retrieved from Auckland Council Geomaps on 10.03.22*

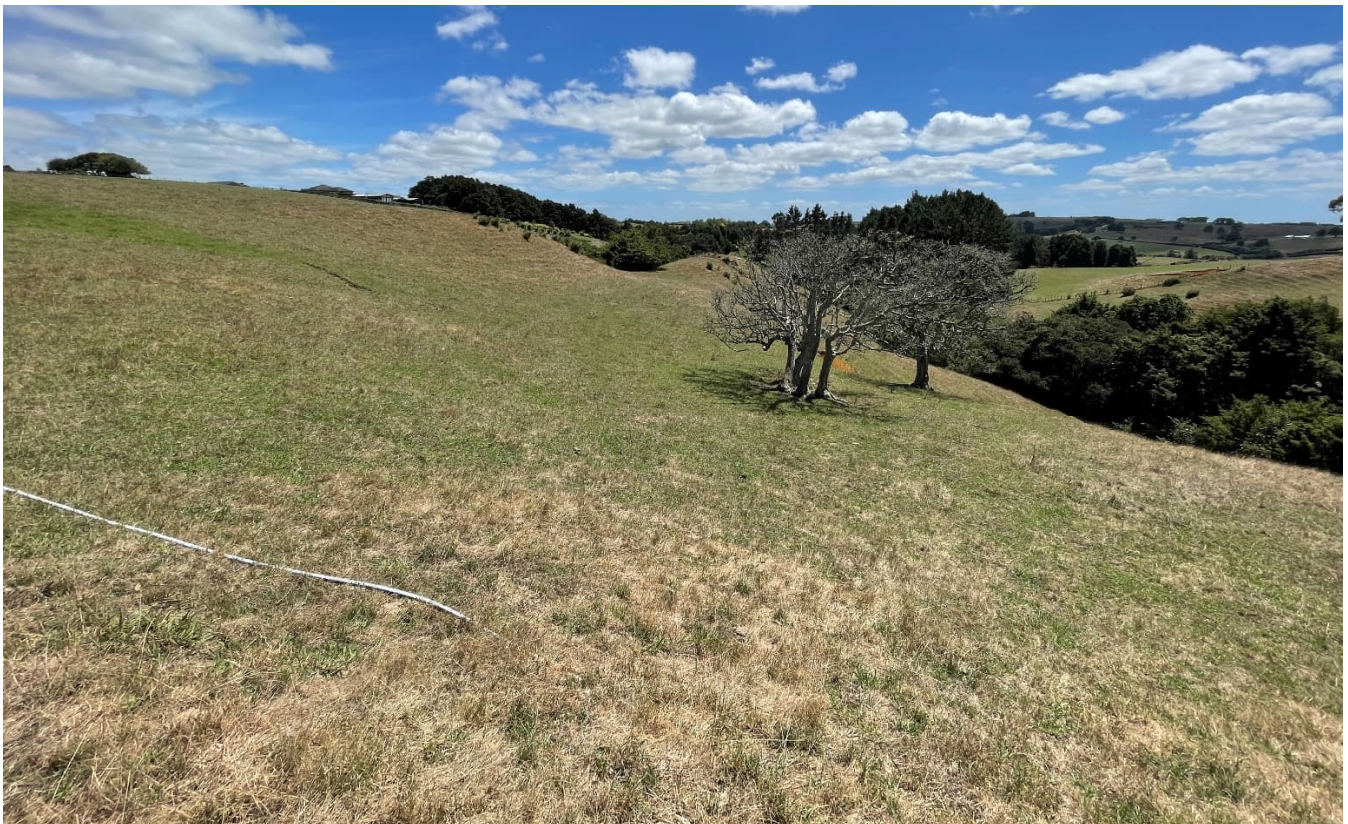
Within the south-western portion of this area, a large arcuate (relict) landslide is present with soil creep (gradual, shallow seated movements of the steeper slopes. Soil creep is a function of expansive soil movements caused by shrink-swell between seasons and gravity, exacerbated by the movement of livestock (commonly referred to as 'sheep tracks').

Photo 1: Typical steep hillside with soil creep with gully.

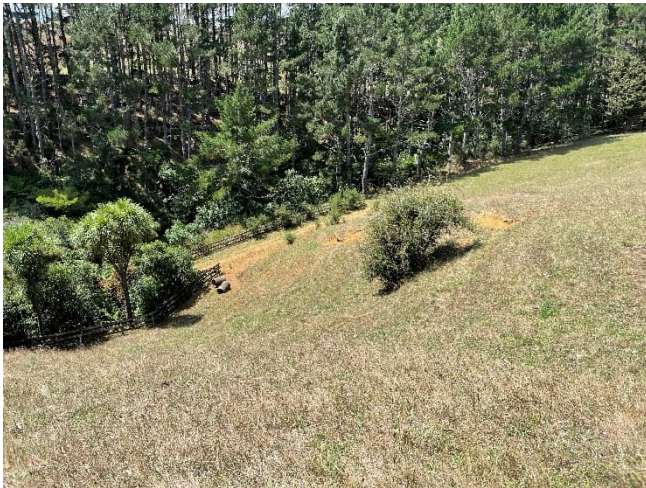
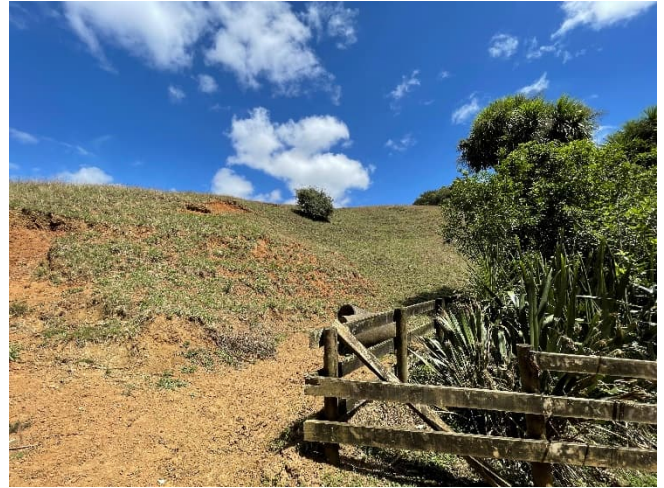
Landform within the southern portion of this area is hummocky, likely caused by historic land movements, and/or groundwater springs / overland flow erosion. Reeds identified near the southern most slip indicative of a high groundwater and subsequently an active slip area.

Photo 2a &b: Typical large scale slope instability features with reeds indicative of high groundwater.

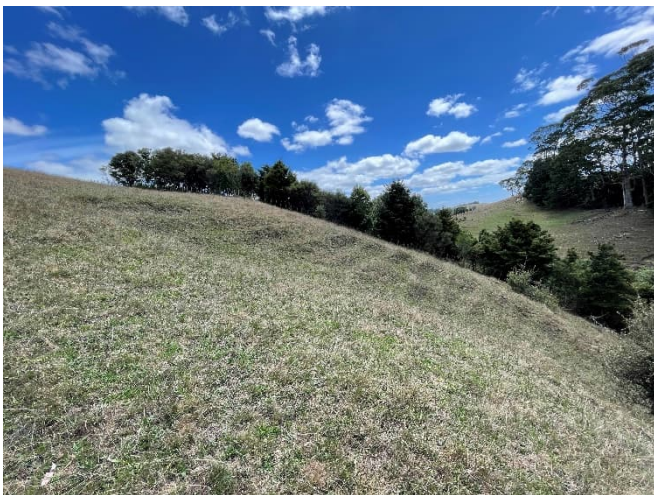
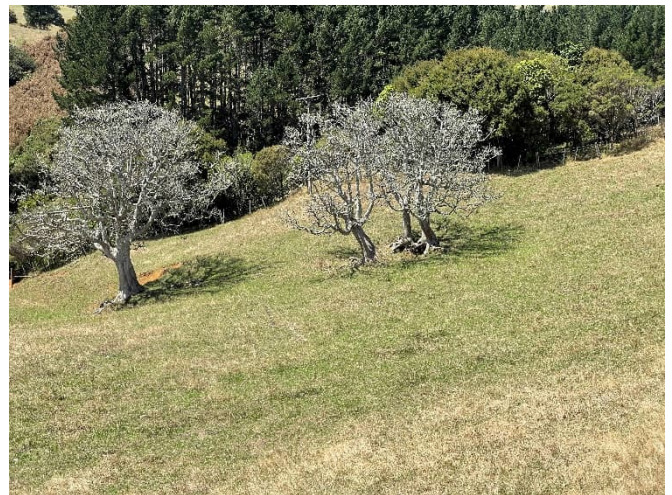
Photo 3a & 3b: Typical soil creep on steeper portions and inferred instability (leaning trees) on hummocky ground.

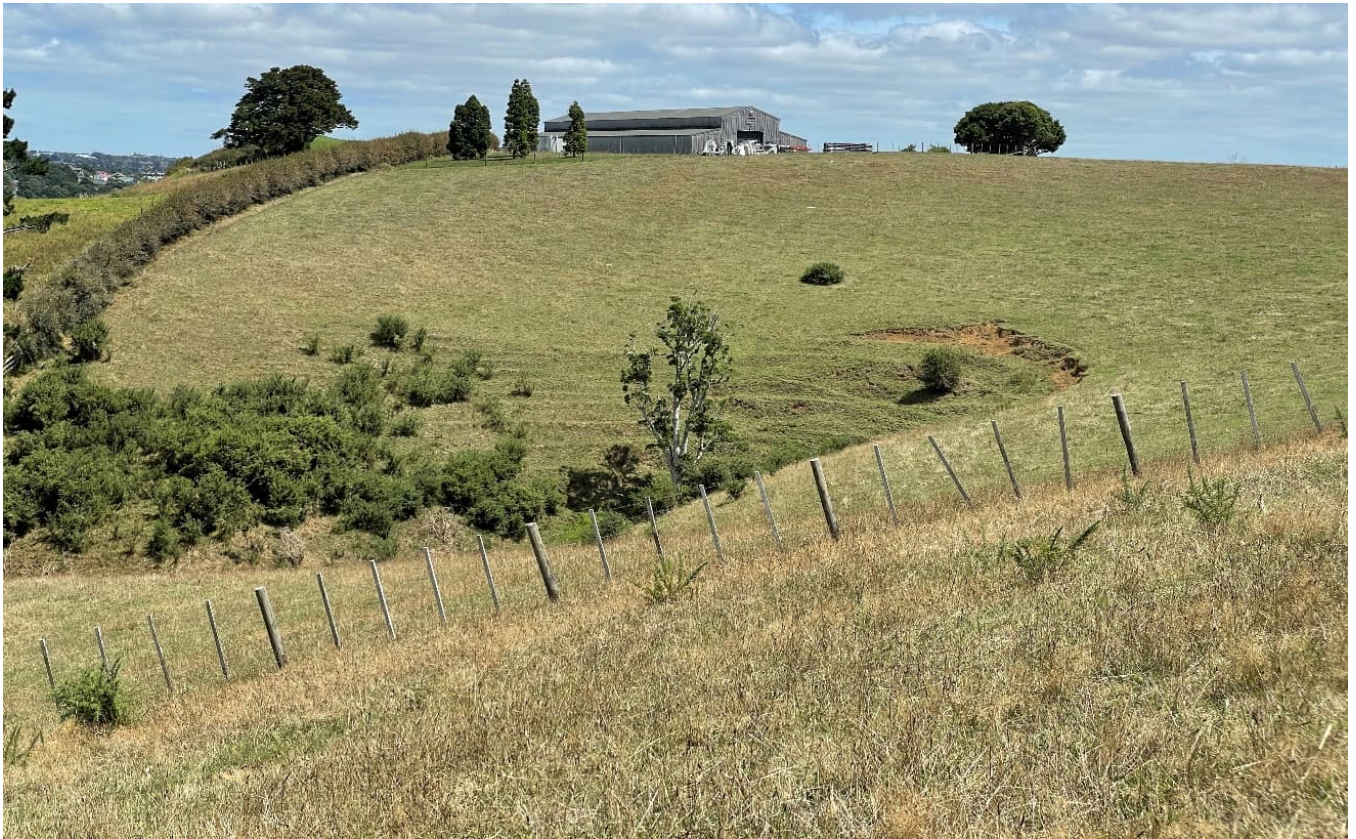
A large arcuate slip (likely to be relict) is located in the south-western portion of the site, with minor circular failures below. Soil creep is more prevalent on the western portion of the slip and becomes more widespread as the terrain becomes steeper. A larger active slip is located east of the slip discussed above, with soil creep below. Minor slips are located downslope with steepening of the topography. An area of reed growth was identified towards the low-lying south portion of this area, indicating possible high groundwater.

Photo 4: Typical steep slope with arcuate slip beneath ridgeline.

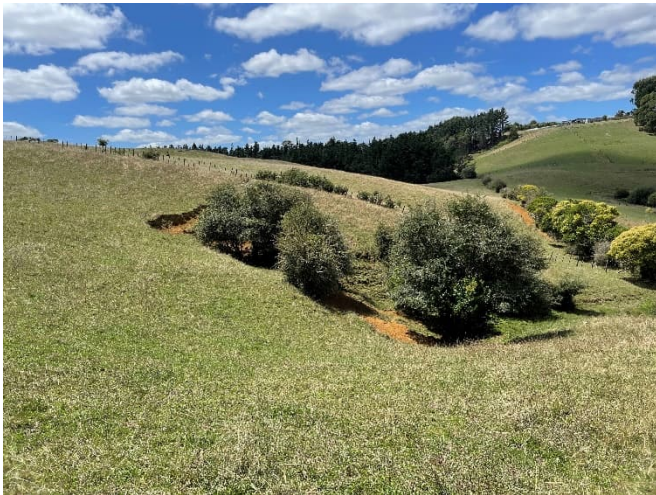
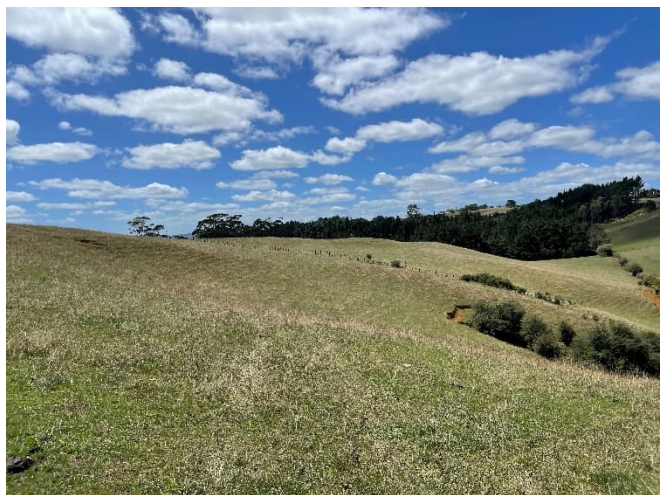
Photo 5a & b: Typical of soil creep and gully with large scale slope instability.

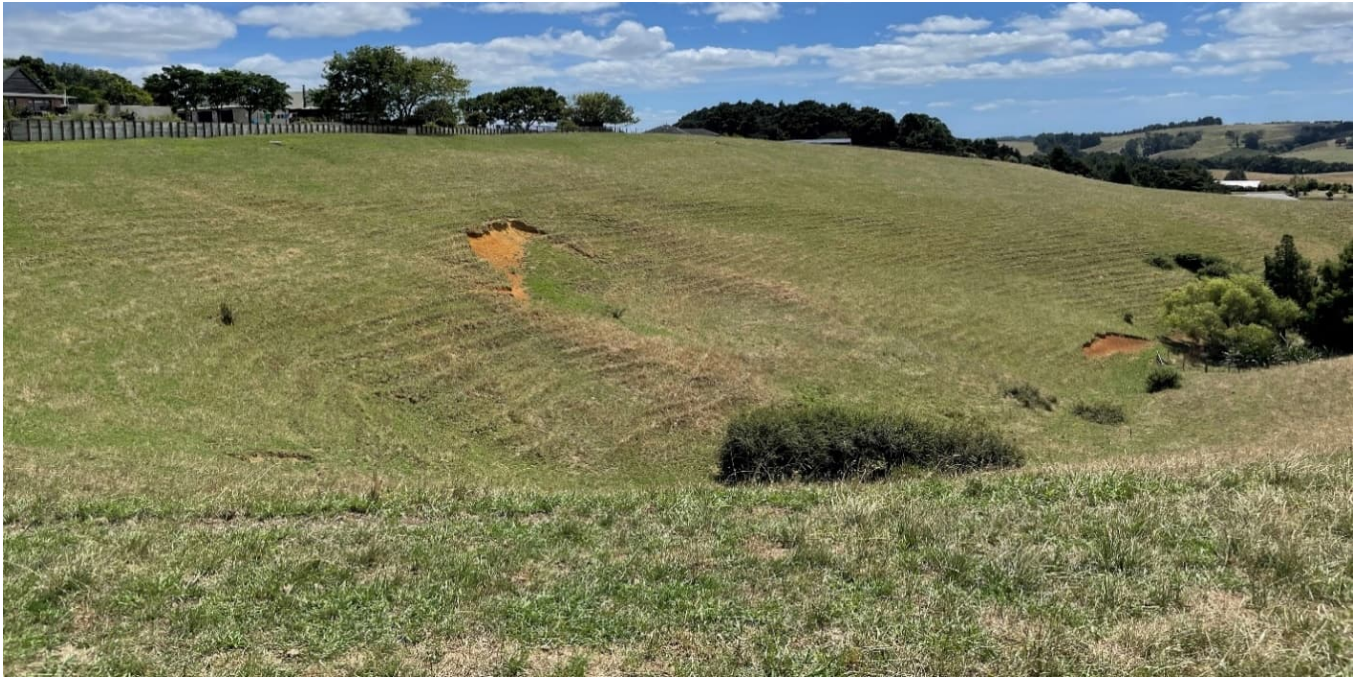
A large active arcuate slip is located west of the gully, beneath the existing residential dwelling. Soil creep is noted across the slopes, additionally numerous smaller active and relic slips downslope of the large arcuate slip and an

associated debris flow. Three drainage pipes associated with the existing dwelling were observed upslope of crest of the slip, creating associated overland flow paths scouring the area directly below. Reeds were observed at the base of the slope near the tributary gully indicating high groundwater.

Photo 6: Arcuate slip located west of the gully, below the ridgeline.

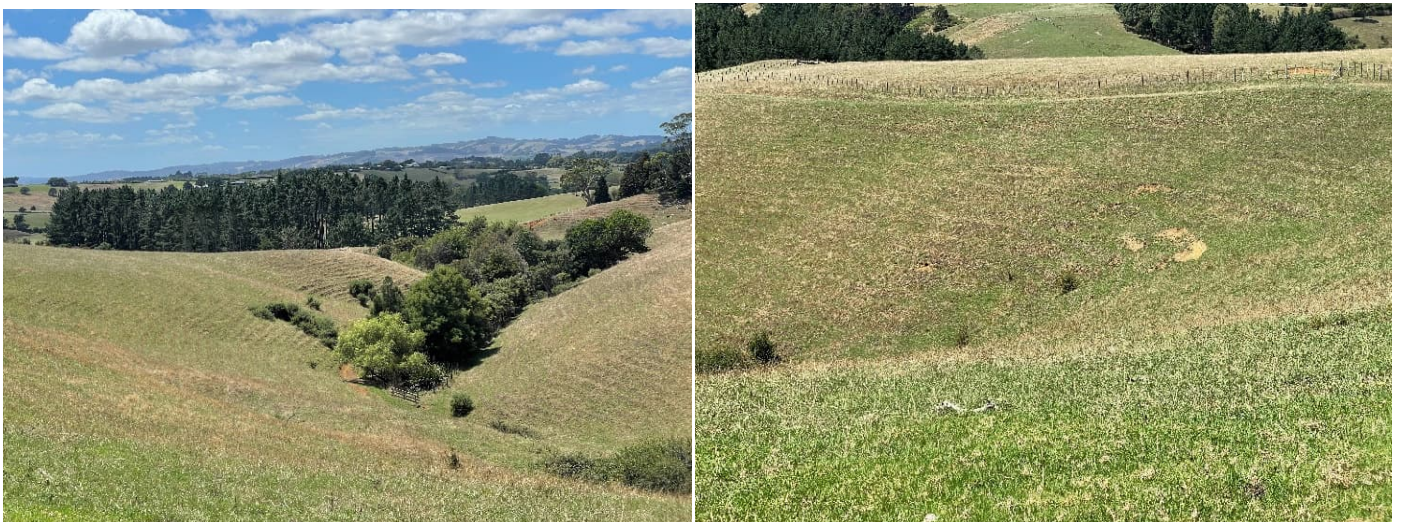
Photo 7a & b: Typical soil creep and shallow instability on steeper portion of the site.

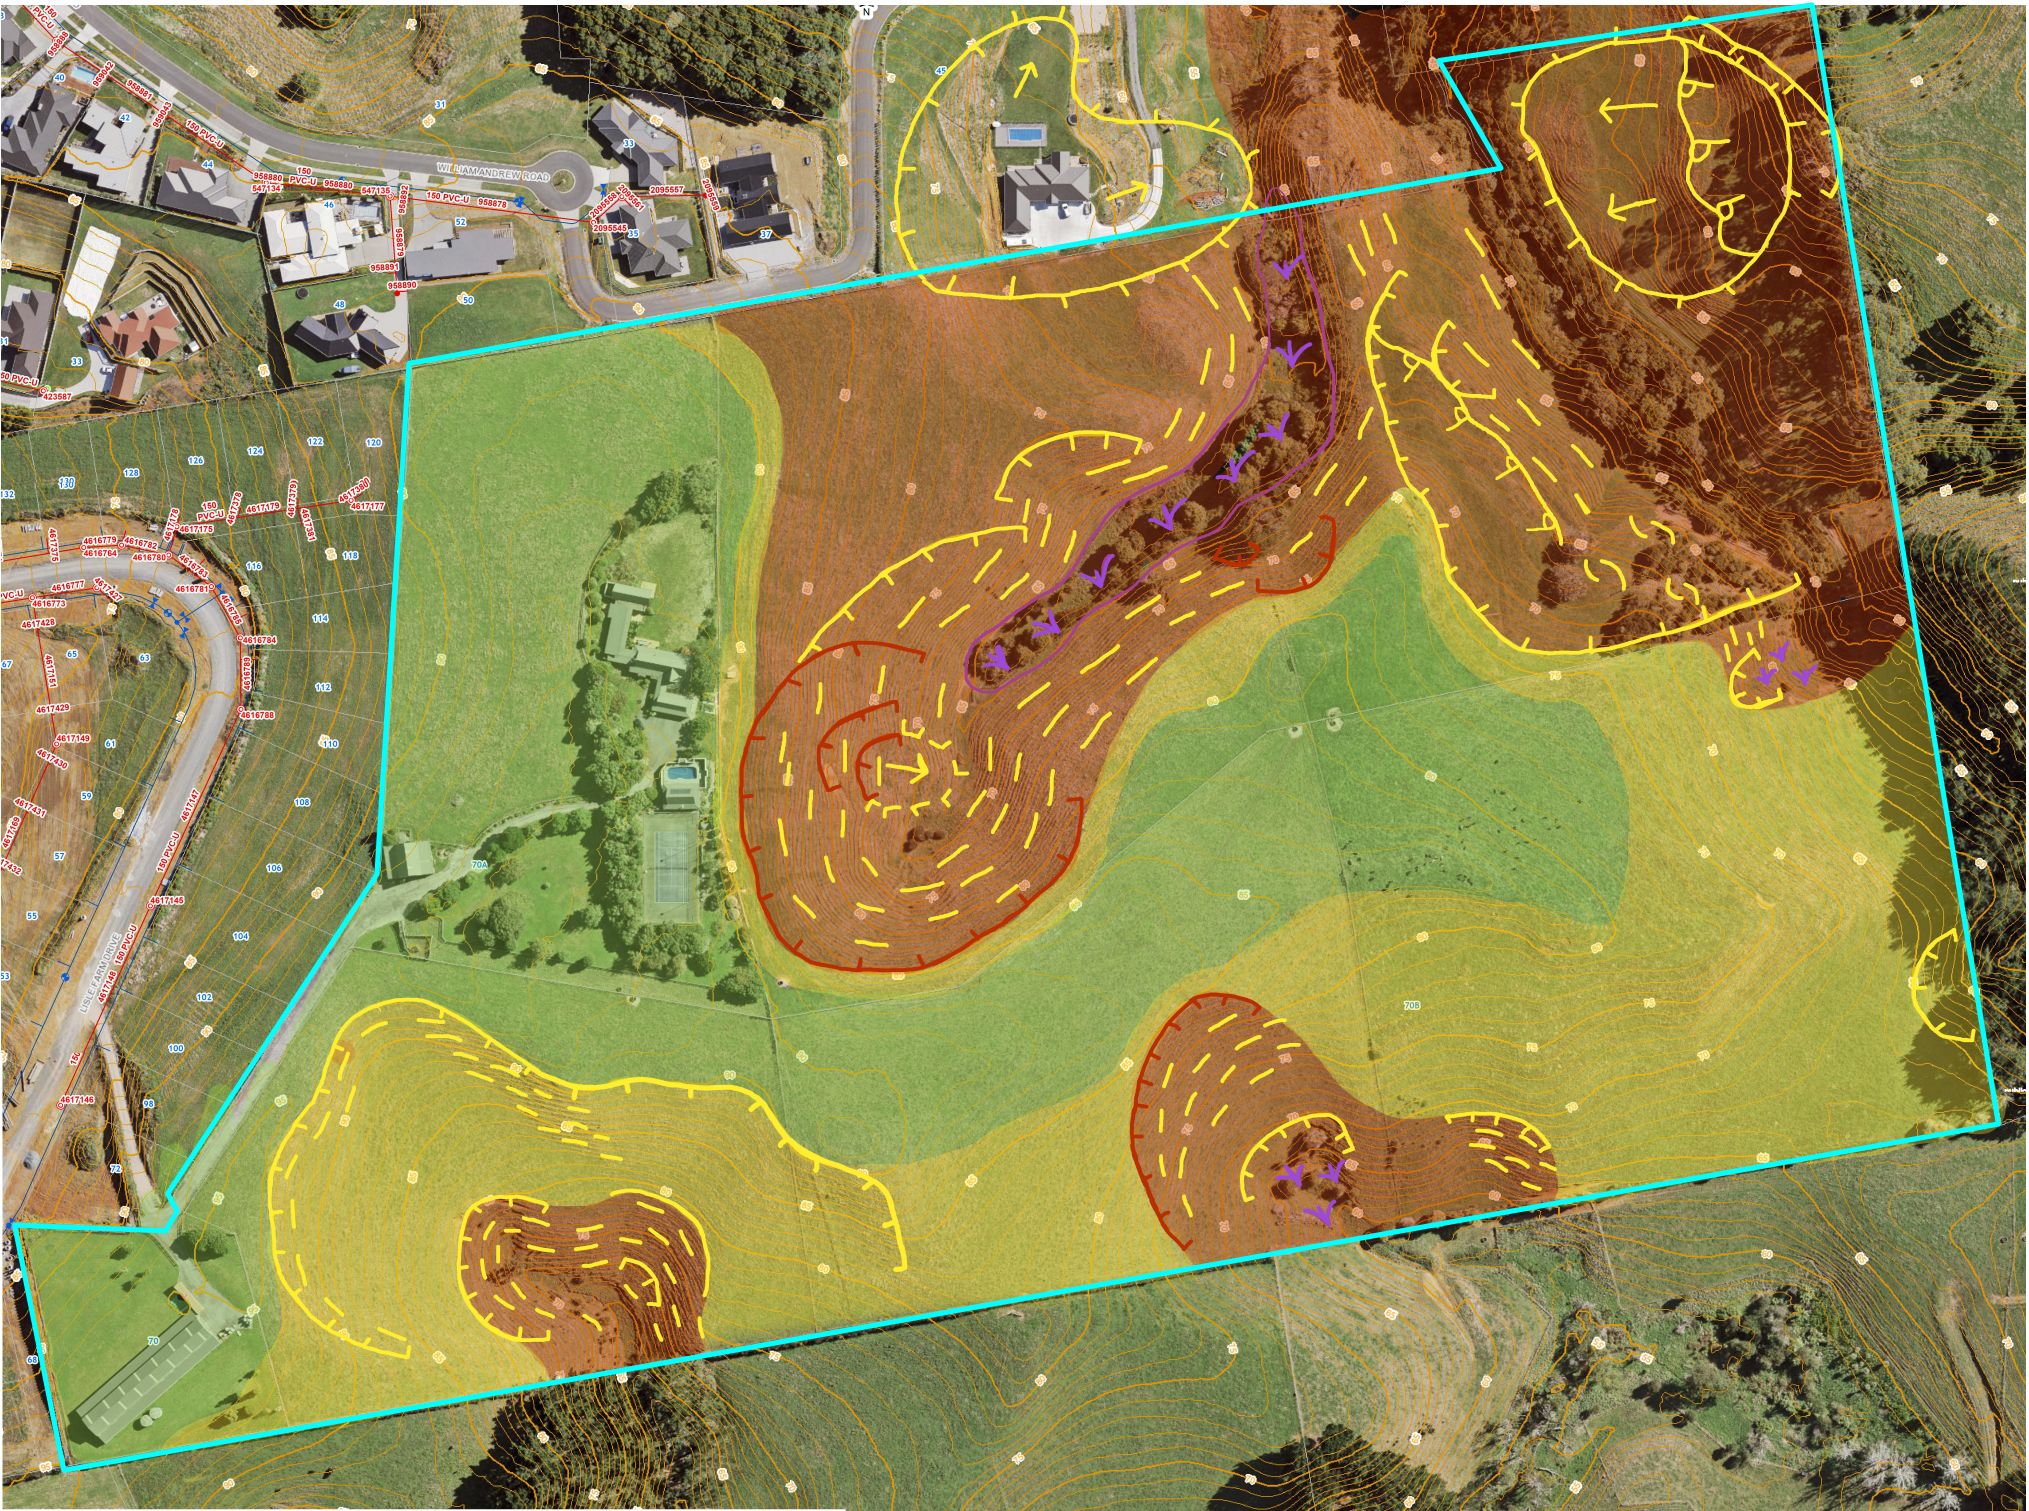
Based on our site observations and as depicted on the attached Geomorphic Hazard Map (see Figure 03). The main geotechnical constraints to the development on this site relates to slope instability. We have used a 'traffic light' system to show identified areas of inferred low (Area A; green) and medium (Area B; yellow) geotechnical risk of slope instability, with the remainder of the site (Area C; red) being classified as containing ground that is inherently steep, and/ or already contains geomorphic signs of slope instability, and/ or is in close proximity to such ground. Further details are given on Figure 03, which is summarised as follows:

- Area A (Low Risk): Suitable for build NZS3604-type structures with little to no geotechnical inputs required on account of slope instability; slope gradients flatter than 1(v) in 4(h) and no obvious geomorphic signs of slope instability.
- Area B (Medium Risk): Generally containing slope gradients steeper than 1(v) in 4(h) and/ or close proximity to steeper slopes and/or geomorphic instability features and/ or displays evidence of soil creep; requires geotechnical site investigations and analyses on account of slope stability.
- Area C (High Risk): Considered too steep and/or contains obvious signs of larger scale slope instability that would likely preclude economical residential development.
