Project Number #18882.000.001

**Preliminary Environmental Site
Investigation**

80 McLarin Road, Glenbrook, Auckland

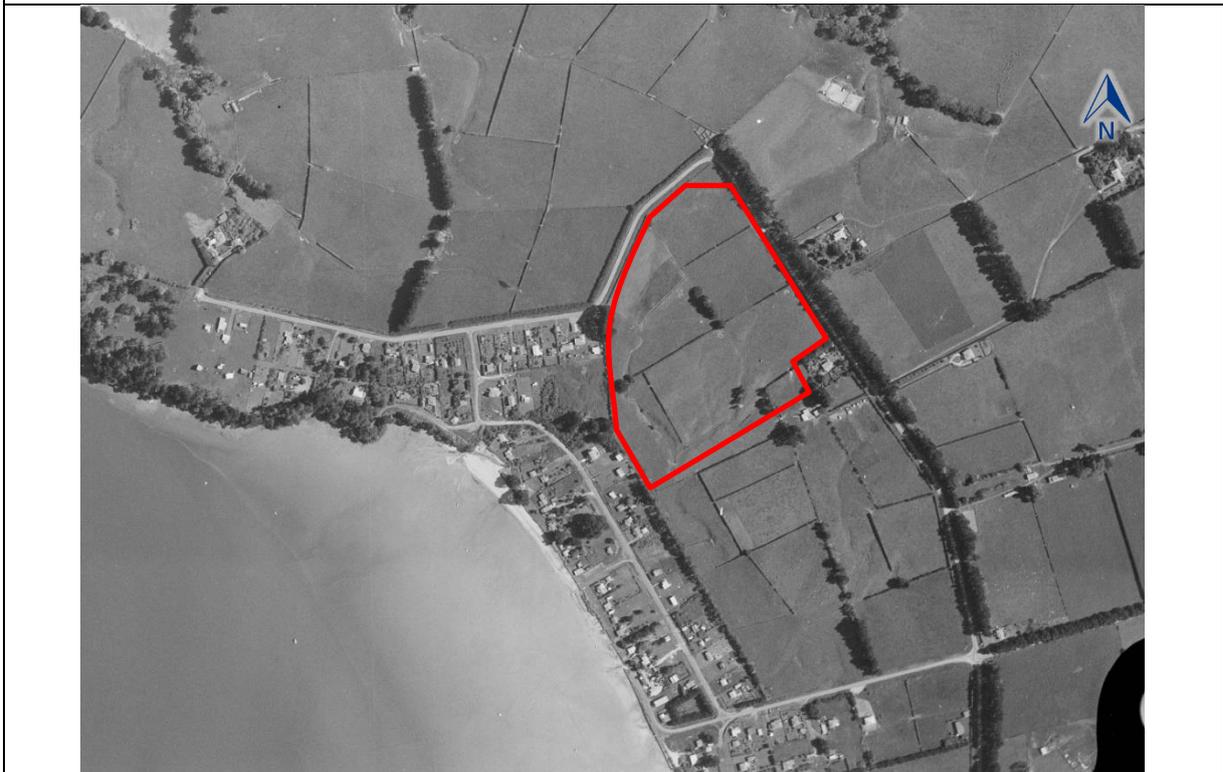
1961 (Retrolens NZ)

Residential development appears to have occurred to the west and southwest of the site. Minimal vegetation is present on-site. Appears to be fences / hedges between paddocks. No other significant changes observed to the site or surrounding area.

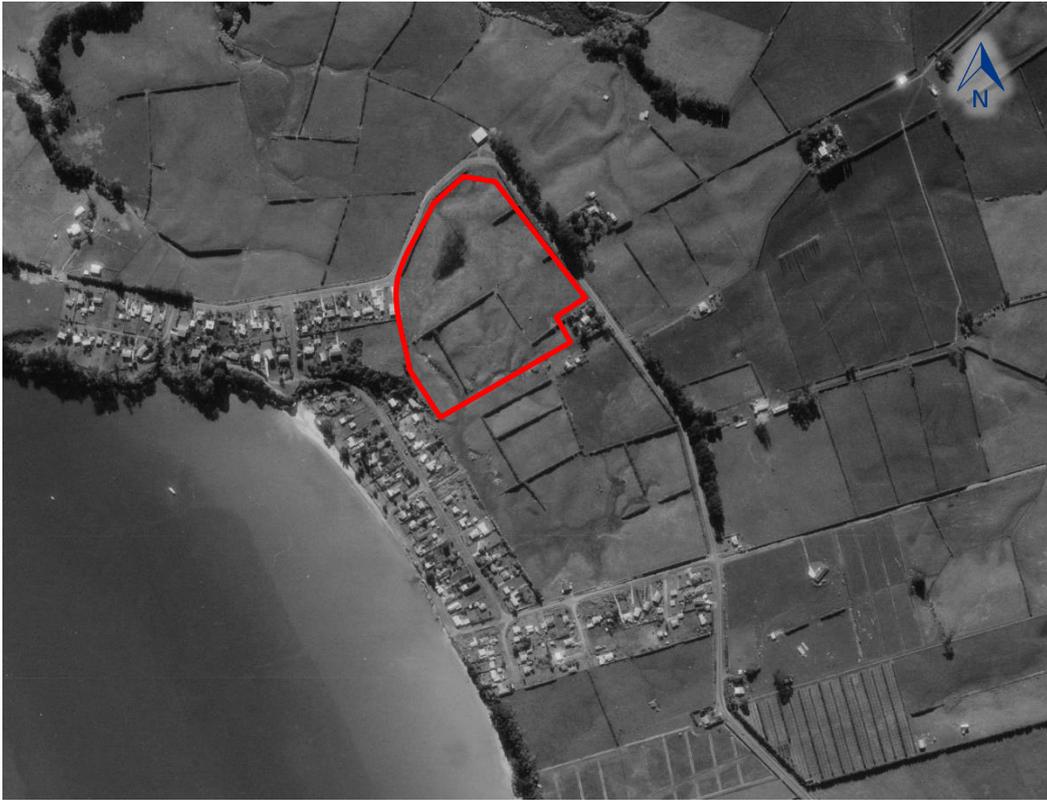
1981 (Retrolens NZ)

A small shed may now be present in the southwestern quadrant of the site. No significant changes observed to the surrounding area.

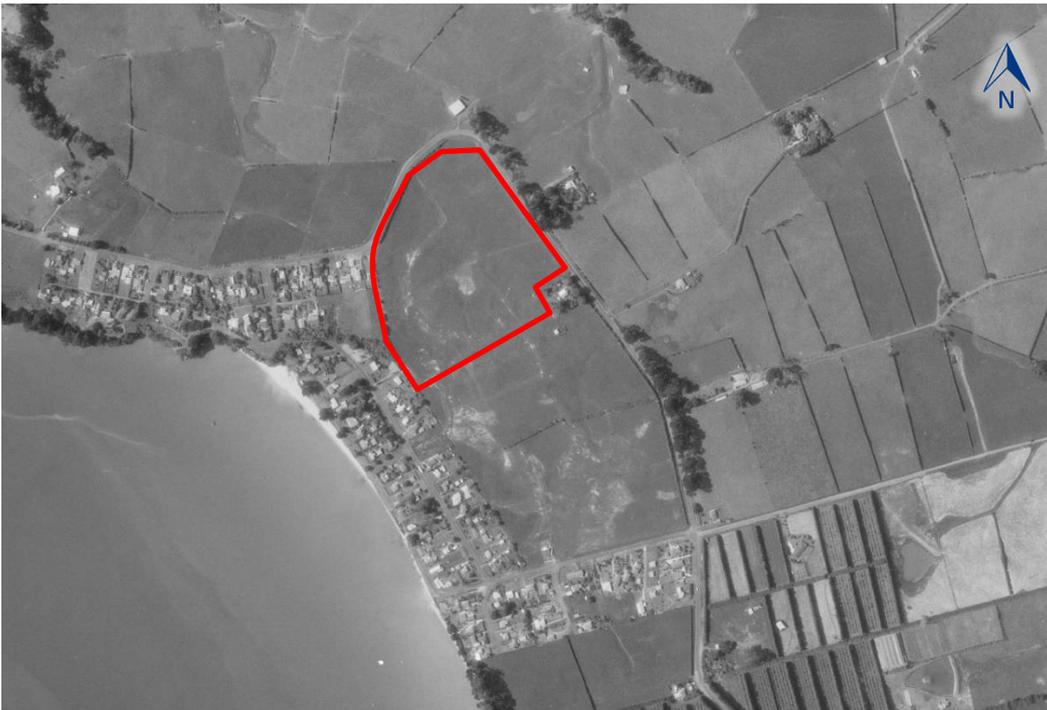
1987 (Retrolens NZ)

The fences / hedges between paddocks appear removed. No significant changes observed to the site or the surrounding area.

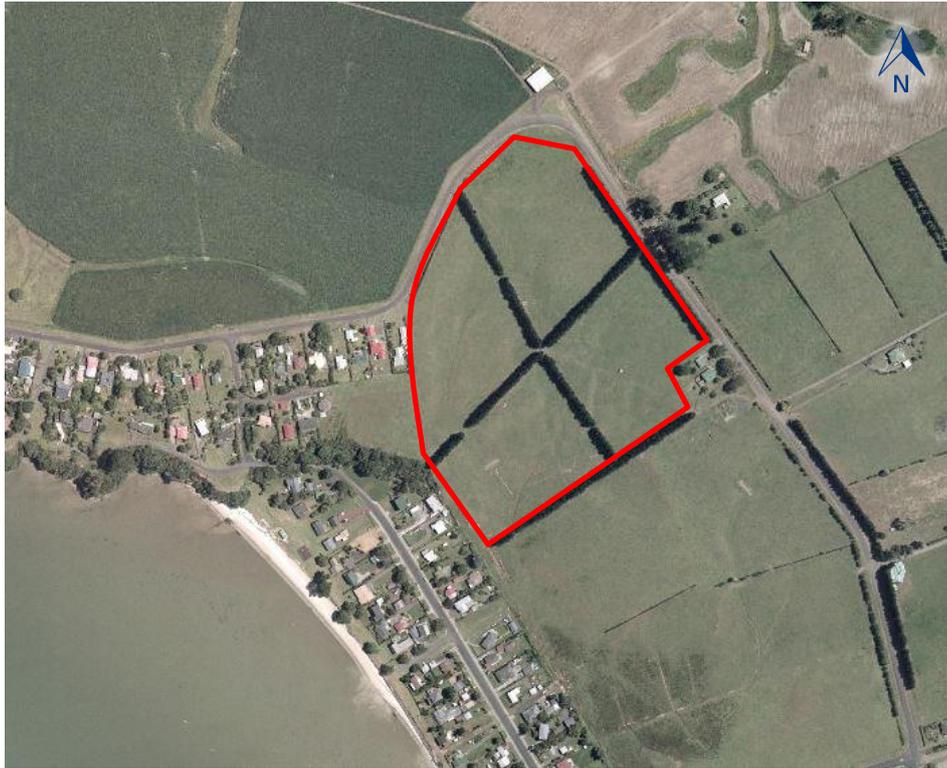
2006 (Auckland Council GeoMaps)

The site has been partitioned into four paddocks, separated by hedges / shelterbelts. There appears to have been a change in land use to the property to the north. Earthworks appear underway to the east of the site. No significant changes observed to the site or the surrounding area.

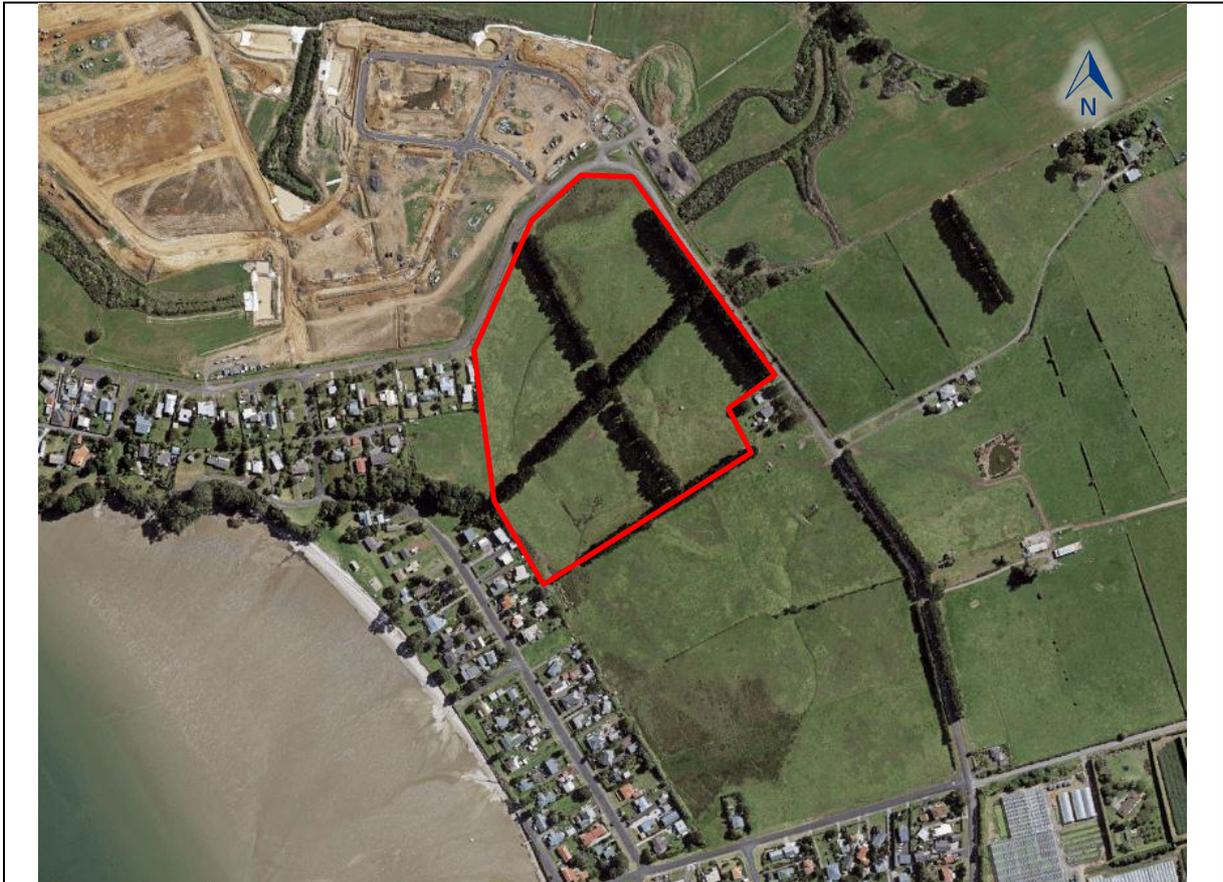
2017 (Auckland Council GeoMaps)

Significant earthworks observed to the north of the site. Shelterbelts within the site boundary and along the eastern boundary appear denser. No other significant changes observed to the site or the surrounding area.

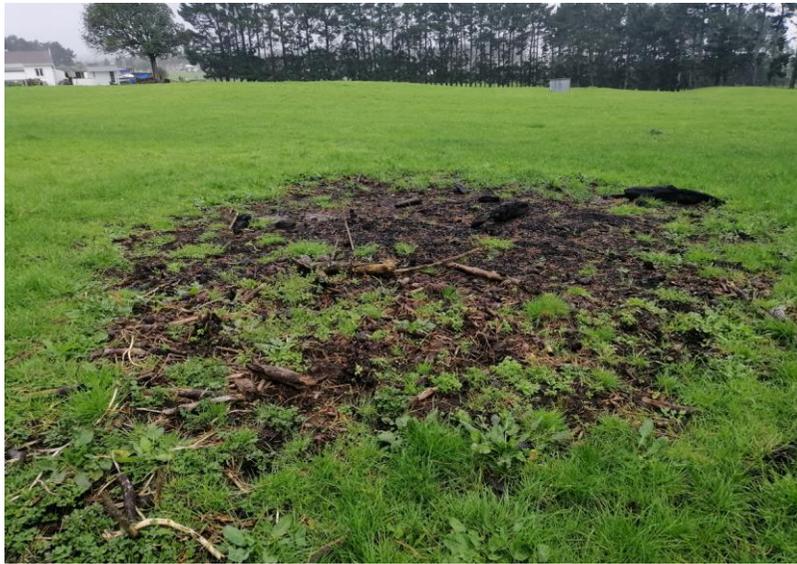
Potential for On – Or – Off – Site Migration of Contaminants	There is potential for on-site contaminants (if present) to migrate off-site via overland flow paths and ephemeral streams. However, no significant contaminant sources were observed.
Visible Signs of Contamination	A burn pit was identified in the eastern area of the site, (Appendix 3; Photograph 3).

Photograph 3: Burn pit in the centre of the site, near the eastern site boundary.

Contaminants may be present in topsoil above regional background levels, meaning that topsoil excavated from site could not be disposed as cleanfill or re-used on another earthworks site without Auckland Council approval. It is recommended that prior to or as part of future redevelopment works, a Suitably Qualified and Experienced Practitioner (MfE, 2012) is engaged to sample topsoil for laboratory analysis of heavy metals / metalloids and organochlorine pesticides at a minimum rate of 1 per 1,000 m³ of topsoil to be disturbed. These data shall be used to assess disposal and re-use options for excess topsoil generated during the redevelopment works.
