Project Number 21253.000.001

Preliminary Environmental Site Investigation

9, 33 & 49 Heights Road, Pukekohe, Auckland

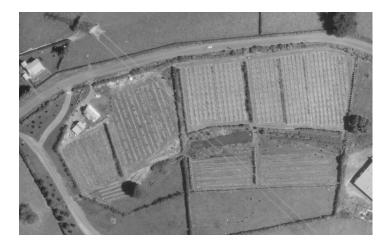
Council records indicate 33 & 49 Hights Road have been utilised for historical horticulture activities (this can be seen in the below 1981 aerial image), further the potential for contamination associated with storage of materials from a tractor maintenance and repair centre at 33 Heights Road may need to be considered.

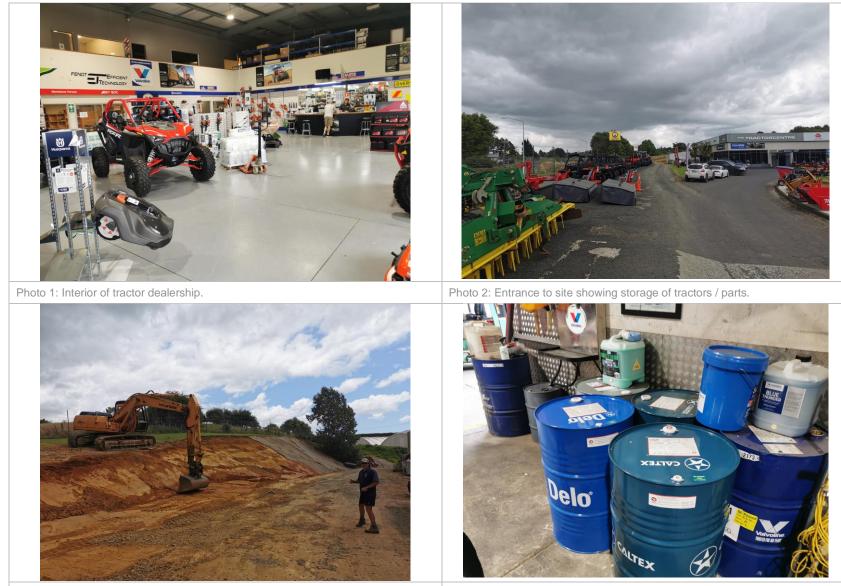
Photo 3: Earthworks area to the south of tractor centre.

Photo 4: Drums within workshop (situated on concrete pad in good condition).

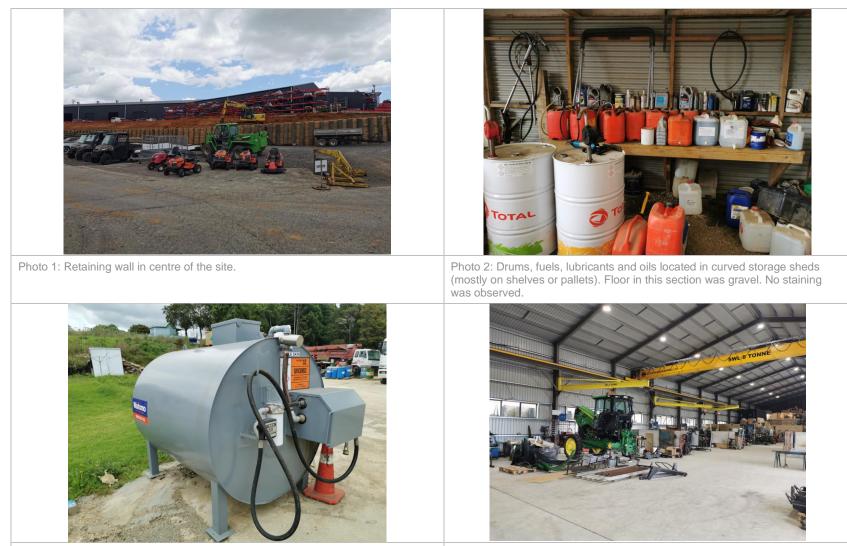
Photo 3: Above ground storage tank.

Photo 4: Interior of engineering firm.
