# **Schedule of Condition Prepared For AUCKLAND COUNCIL** 139 Beach Road Castor Bay Auckland SEPTEMBER 2024 P24-0186

REPORT TITLE	Schedule of Condition
PROJECT NUMBER	P24-0186
CLIENT	Auckland Council
CLIENT CONTACT	Roma Leota

The premises is located at 139 Beach Road, on a sloping site within the grounds of Kennedy Park. The building is a timber framed, single storey structure with a corrugated fibre cement roof and timber joinery. This report was commissioned to provide an updated assessment on the condition of the premises following a prior condition and asbestos assessment in 2018 by Hampton Jones Property Consultancy Ltd.

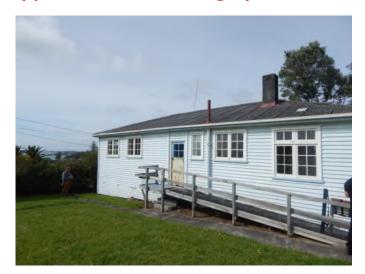
### Photograph 1

Overview of the front elevation.

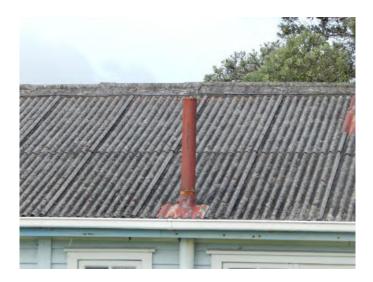
### Photograph 2

Overview of the asbestos cement roof sheets.

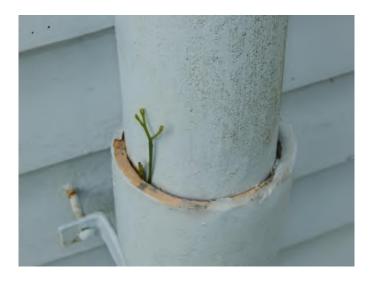
### Photograph 3

Vegetation growth protruding from the asbestos cement downpipe bracket.

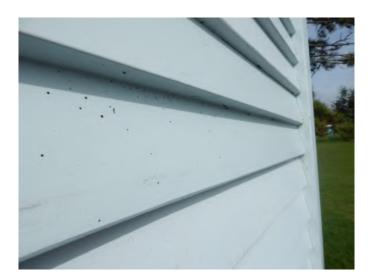
Flight holes from borer beetle noted to the timber weatherboards.

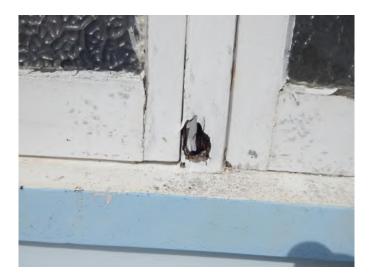
### Photograph 5

Further evidence of rotted timber window joinery.

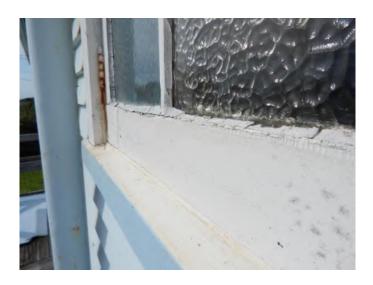
### Photograph 6

Evidence of timber decay to the glazing bead.

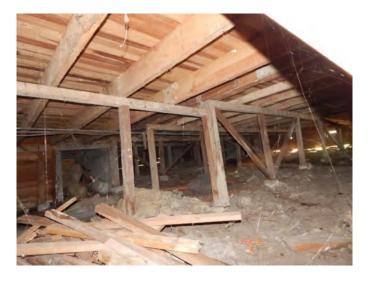
### Photograph 9

No visible connections between the structural members within the subfloor were evident.

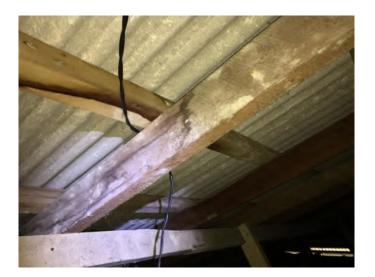
Borer infestation and evidence of water ingress was noted within the ceiling void.

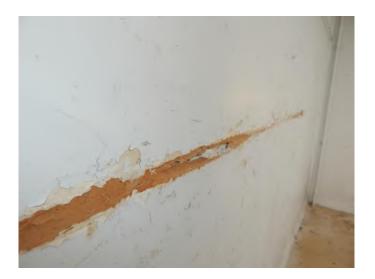
### Photograph 11

Internal wall linings were in poor condition and require substantial repairs/replacement.

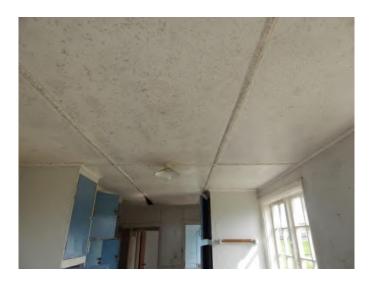
### Photograph 12

Widespread mould growth present to the kitchen particle board ceiling linings.

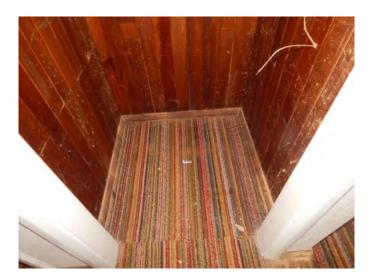
Widespread borer infestation noted to the timber wall linings within the cupboard to the hallway.

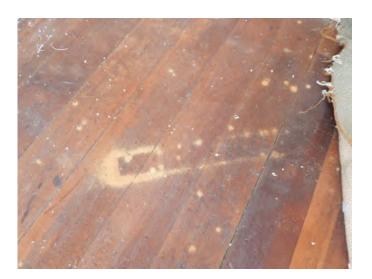
### Photograph 14

Frass from borer beetle within the internal timber door evident to the floor covering.

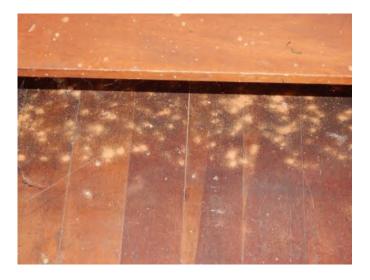
### Photograph 15

Further evidence of borer beetle infestation with the timber floor lining and skirting boards.

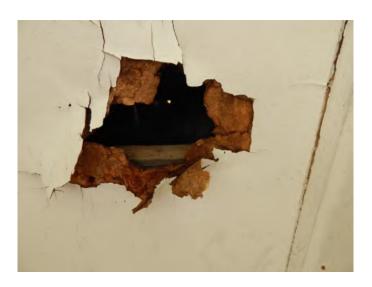
### Photograph 17

Damage and water ingress noted to the ceiling lining within bedroom 3.
