Devonport-Takapuna Local Board Workshop Programme

Attachment A – Condition Report for Claystore Heritage Building

AMIS Asset Assessor team has carried out an assessment for the general condition of **Claystore Devonport** located at 27 Lake Road in Devonport on behalf of Nicky Aziz on behalf of Kaitlyn White (Senior Renewals Coordinator).

Devonport Claystore Workshop

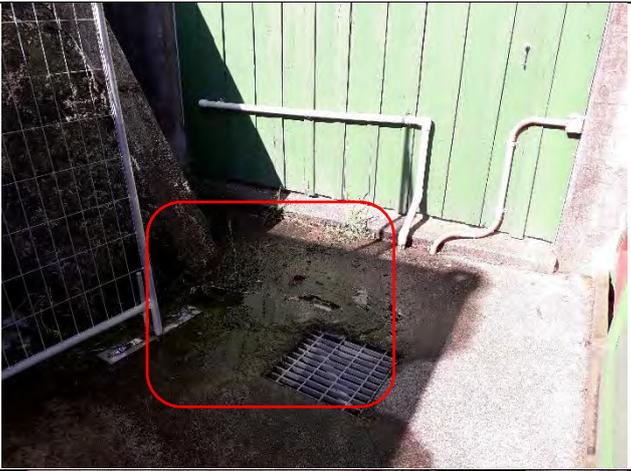
2.5	External Defects	Photos
1	Thick moss growth on the south east corner of the building near the cesspit. It is slippery for the pedestrian to walk on this.

1. To clean the moss from on the south east corner near the cesspit.
2. To remove the protruding nail from the external cladding in east elevation.
3. To replace the corroded steel pipe clamp in east elevation.

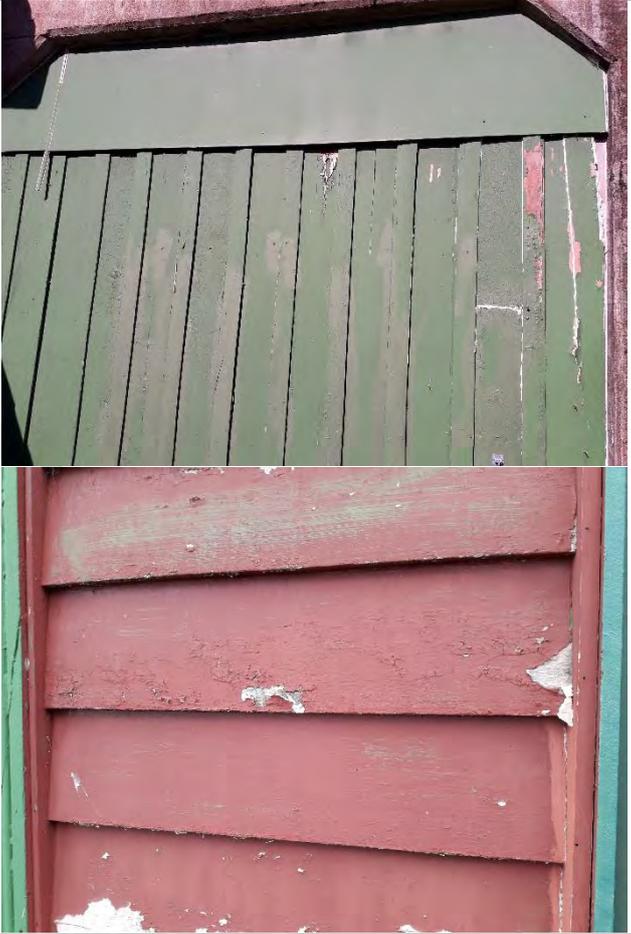
2	In general, the external paint is in poor condition (peeled off in all elevation) and need to be renewed in short term.

3. To replace all the decayed and broken timber wall external cladding of the building,
4. To completely re-painting the whole external wall cladding of the building.

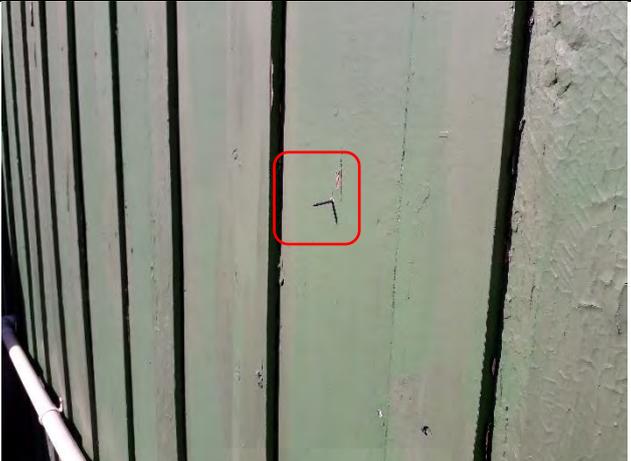
3	Nail protruding from the external cladding in east elevation.

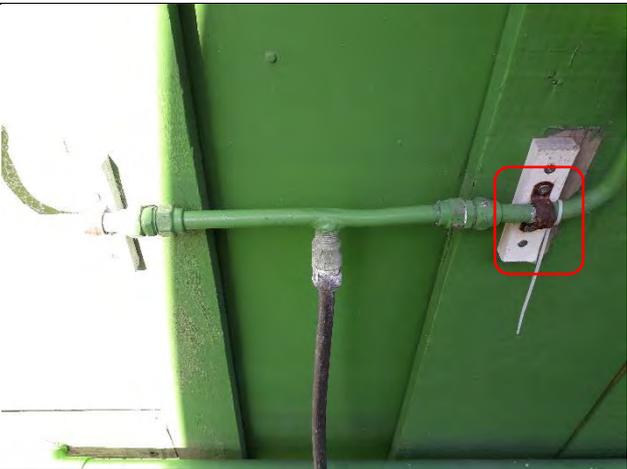
4	Heavily corroded steel pipe clamp in east elevation.

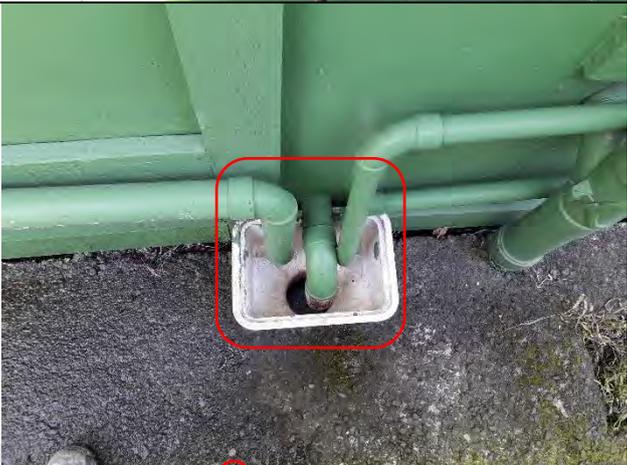
5	Gully trap grill is missing. In east elevation.

4. To reinstate the missing gully trap in east elevation.
5. To temporarily fix the gap between the translucent cladding and steel roof cladding in the lower roof.

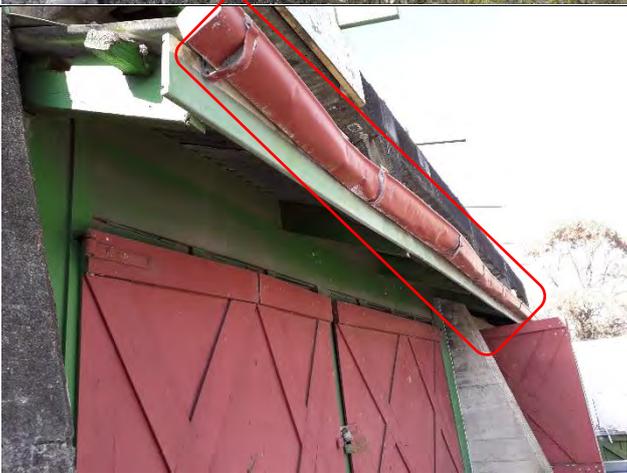
6	Badly deformed gutters in north elevation.

1. Complete replacement of roof cladding on the building. At the same time to also replace the heavily corroded flashing of the roof.
2. To replace the whole steel gutters in north elevation and connect it to the downpipes

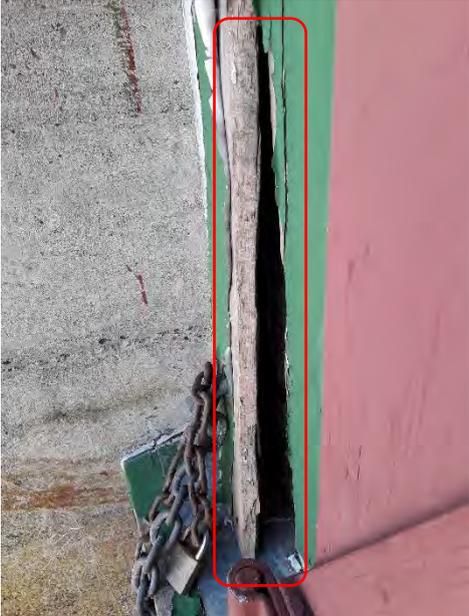
7	Broken timber on the opening in north elevation.

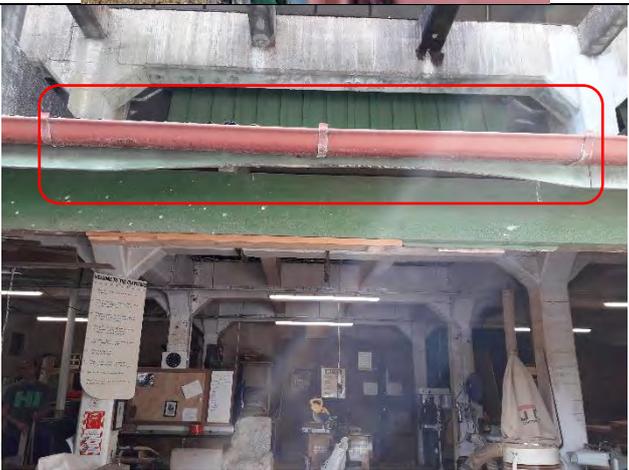
8	Broken timber fascia board in north elevation behind gutters.

5. To replace the broken fascia board in north elevation.
6. To replace/ re-painting the sign of the building.
7. To install grill/closure to the manhole/cesspit in the west of the building.

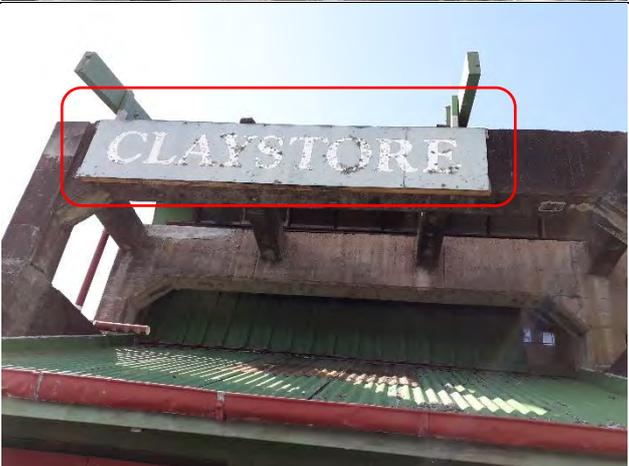
9	Sign of the building has deteriorated and might need to be replaced or restored.

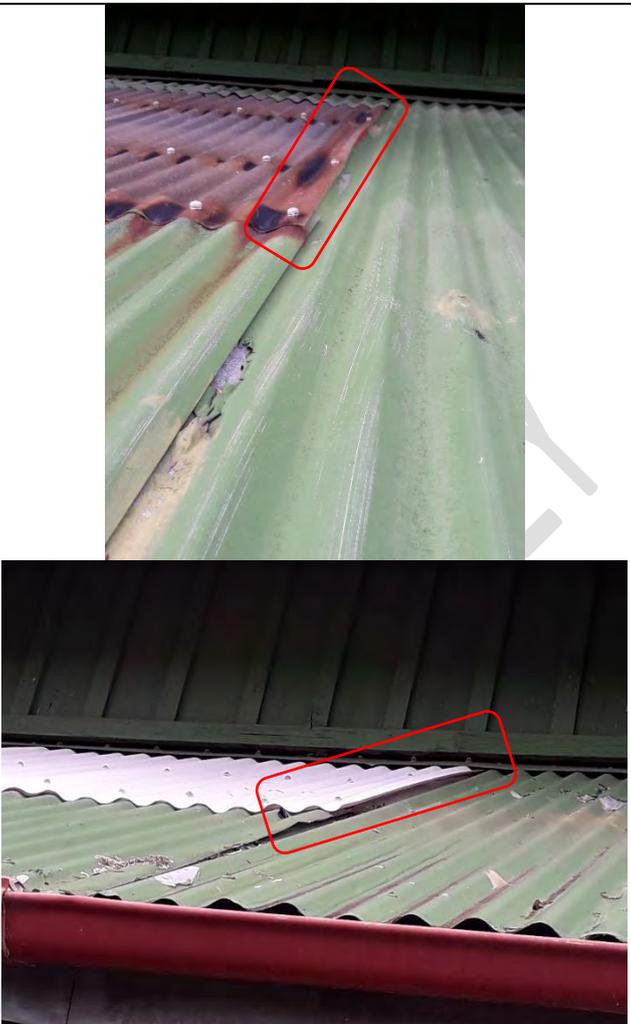
<p>10</p>	<p>Insufficient and improper lapping of lower roof cladding. This cause water to penetrate through the gap to inside of the building.</p>

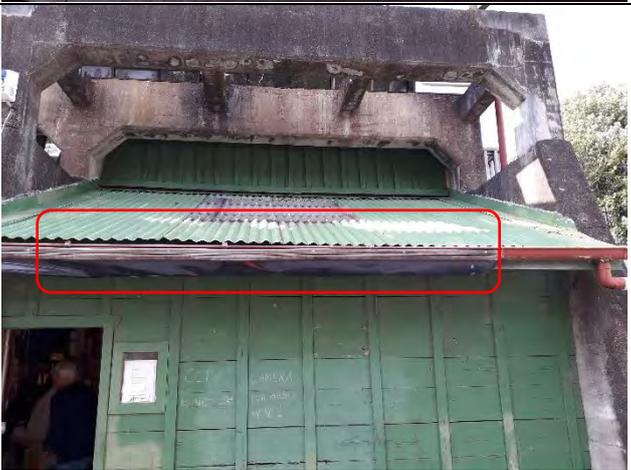
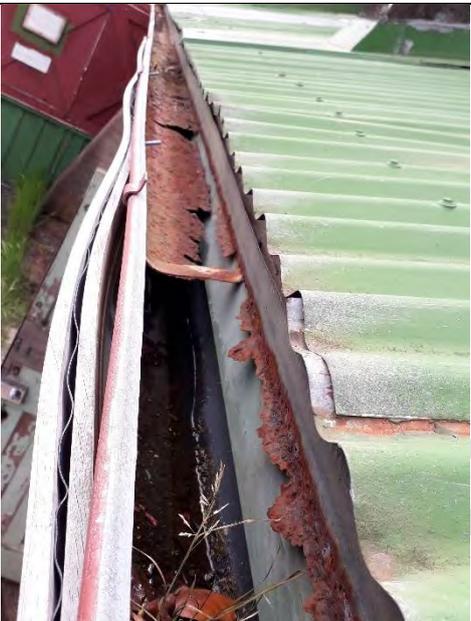
<p>10</p>	<p>Heavily corroded gutter replaced temporarily with clip fabric. Due to this, the storm water is not discharged properly through downpipes.</p>

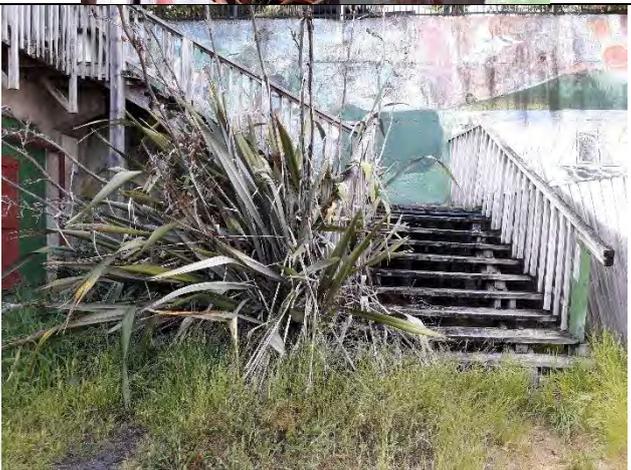
<p>11</p>	<p>Extensive vegetation growth on the western side of the building near the stairs.</p>

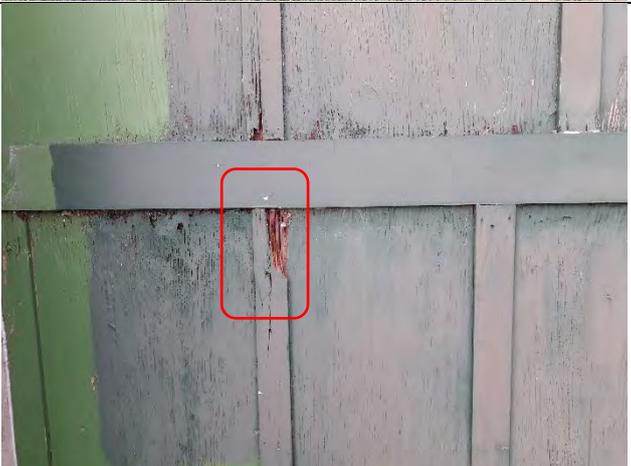
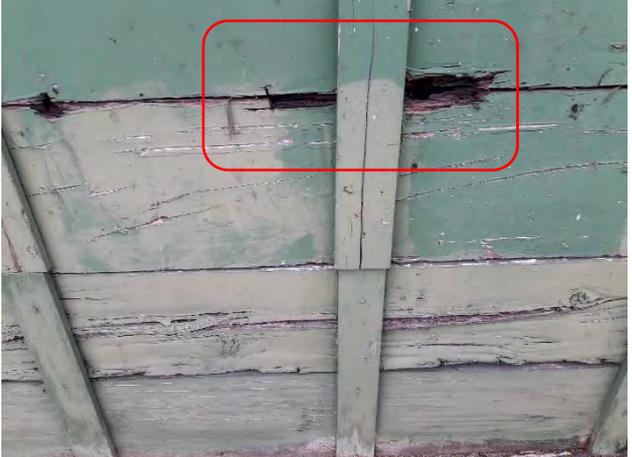
<p>12</p>	<p>There are a lot of decayed timber cladding (board and batten) in north, east, and west elevation (typical). Need to be replaced in short term.</p>

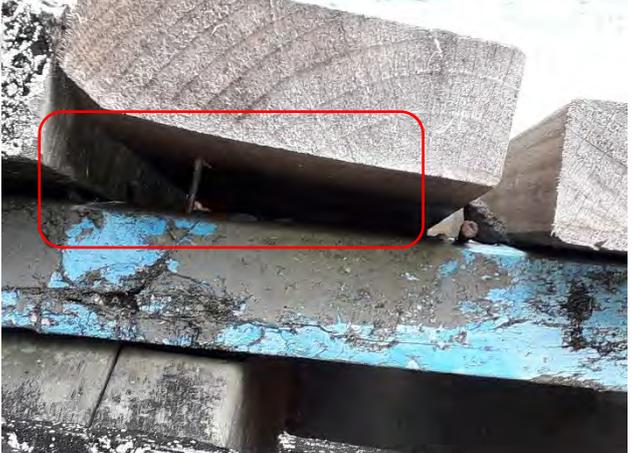
<p>14</p>	<p>Detached timber plank of the stairs to external stairs.</p>

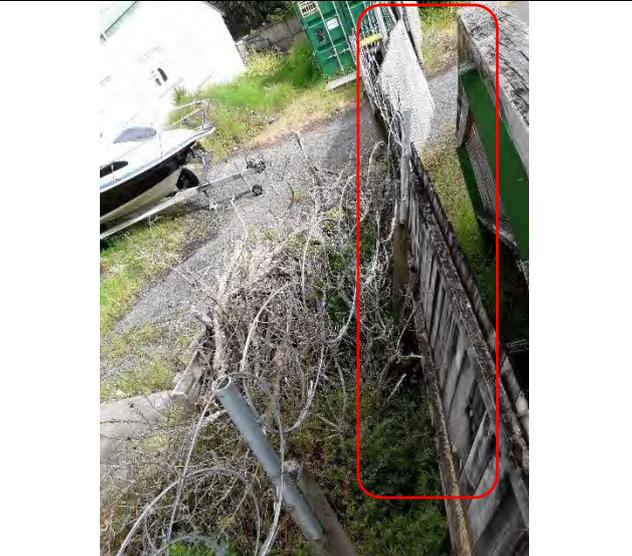
<p>15</p>	<p>Timber fence on the west of the property is leaning towards the external stairs and need to be replaced in short term.</p>

8. To renew the timber fence on the west of the building.
9. To engage certified windows installation contractor to rectify the defects to all timber windows joinery.

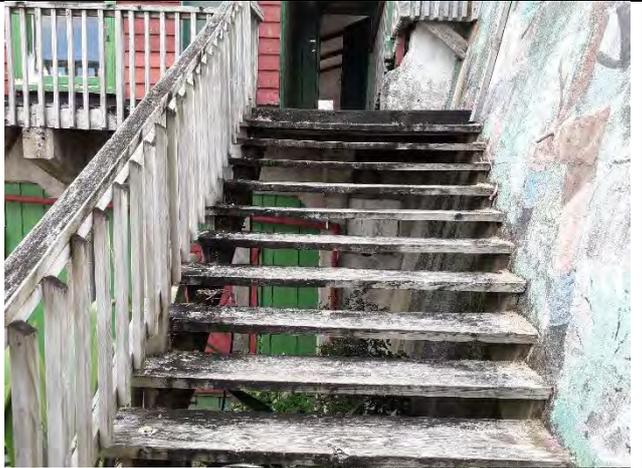
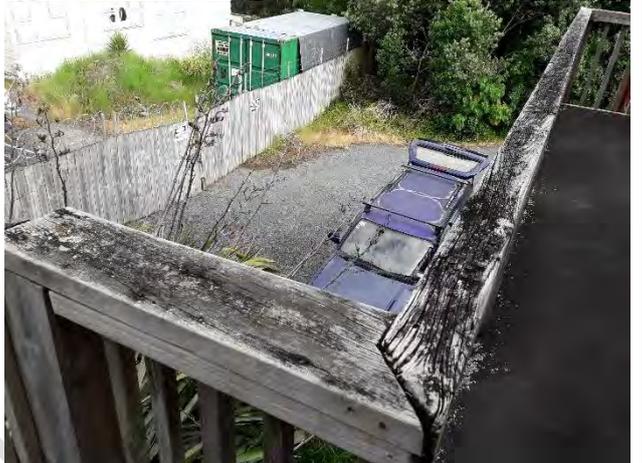
16 The timber steps and hand rail is unpainted and towards end of its life and need to be replaced in few years' time.

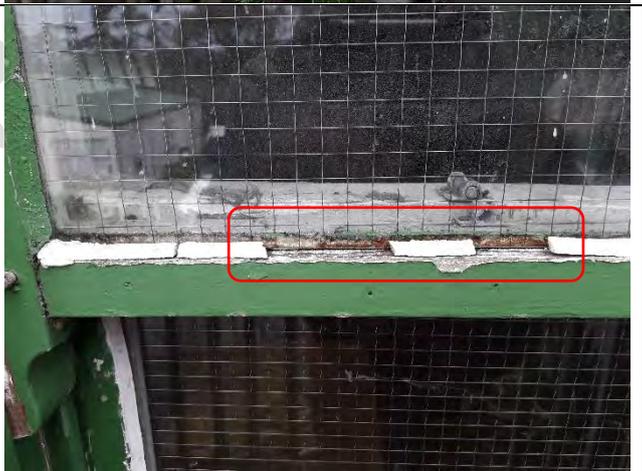
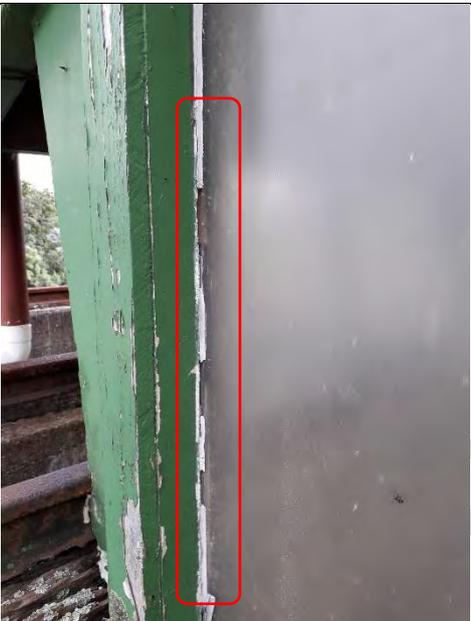
16 Timber joinery of all the windows is in poor condition (typical). The silicon seal applied has deteriorated and moisture ingress likely to occurred.

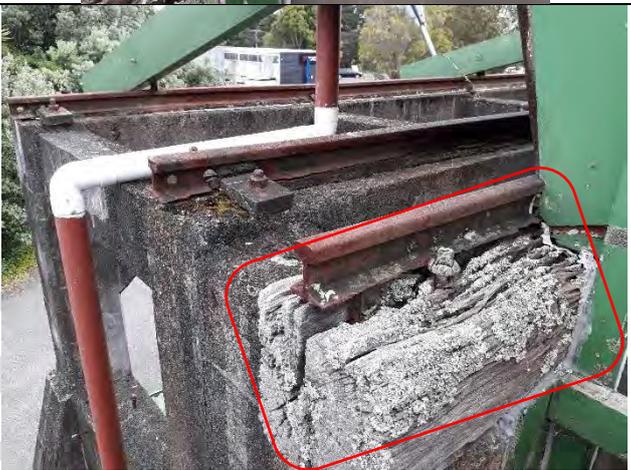
<p>17</p>	<p>Timber beam used to support the upper floor windows is heavily decayed.</p>

10. To replace the heavily decayed timber beam below windows joinery in the upper floor.
11. To install bottom flashing to the timber cladding on the entrance to the upper floor.

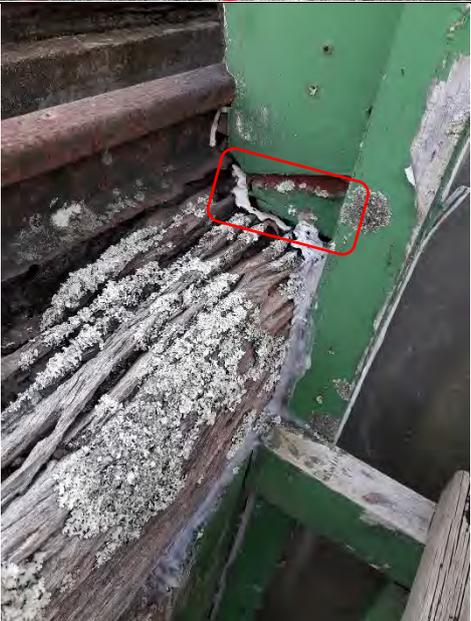
<p>18</p>	<p>The silicon Seal in between the timber beam and timber joinery has deteriorated.</p>

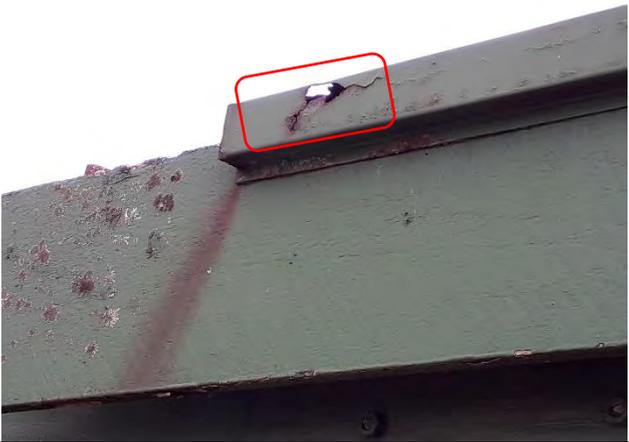
<p>19</p>	<p>Steel barge flashing of the roof in the west elevation is corroded and has hole on it.</p>

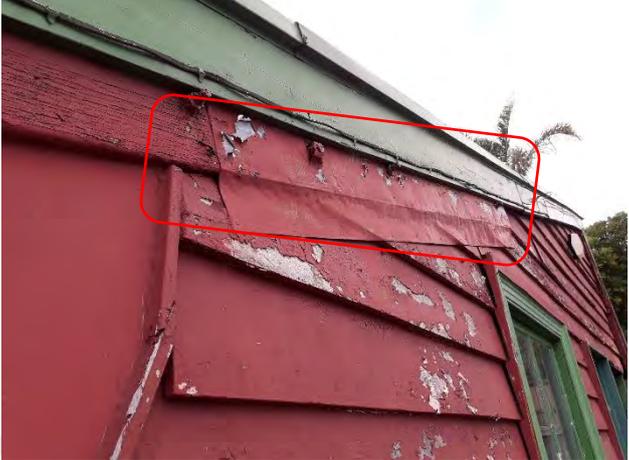
<p>20</p>	<p>Patch up of decayed in the timber cladding using steel sheet.</p>

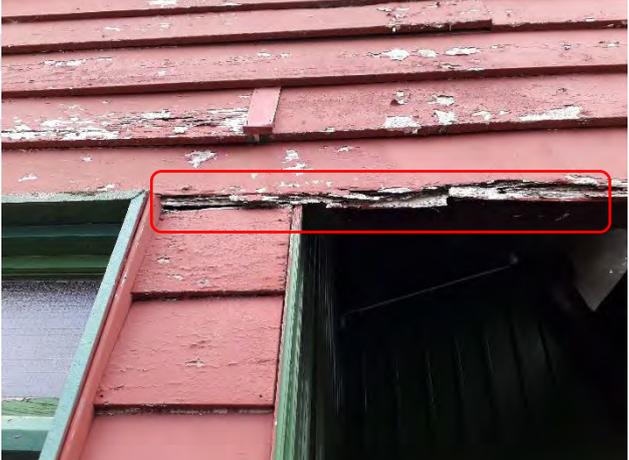
<p>21</p>	<p>No flashing to the bottom of timber cladding on the entrance to the upper floor.</p>

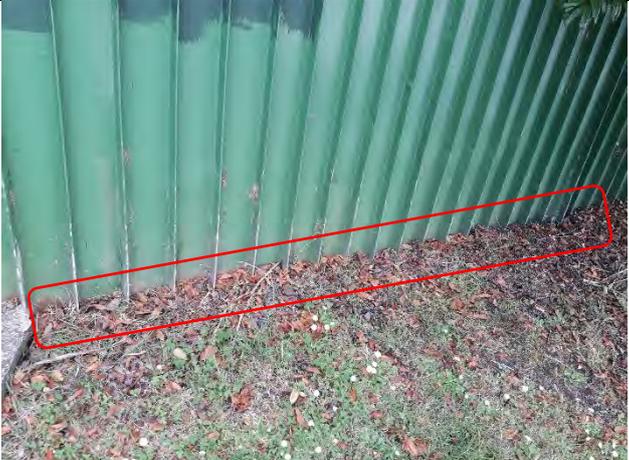
<p>22</p>	<p>Steel trough wall cladding on the southern elevation is partially buried on the ground (no ground clearance). Ground moisture will slowing ingress into the wall frame.</p>

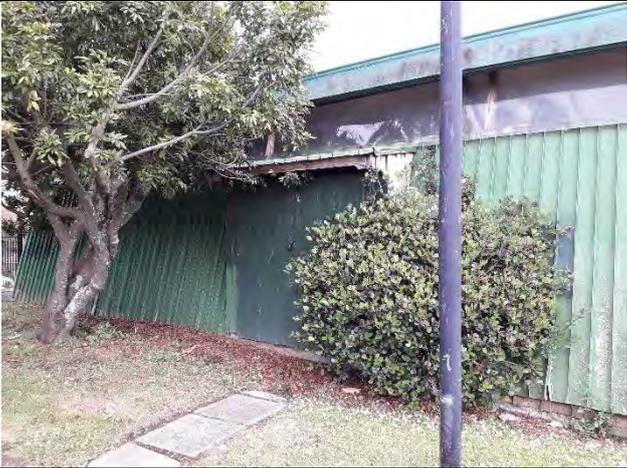
23	Vegetation growth encroaching the building envelope.

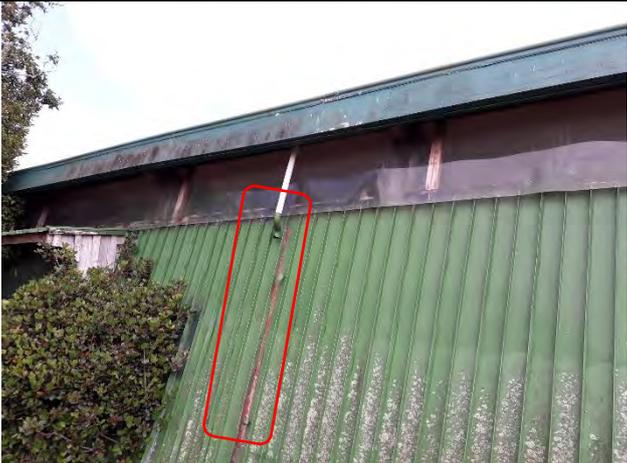
24	Broken pipe in the south elevation of the building.

9. To remove unused broken pipe in south elevation.
10. To replace the broken glass in electric meter cover in east elevation.
11. To seal hole and penetration to wall cladding in all elevation.

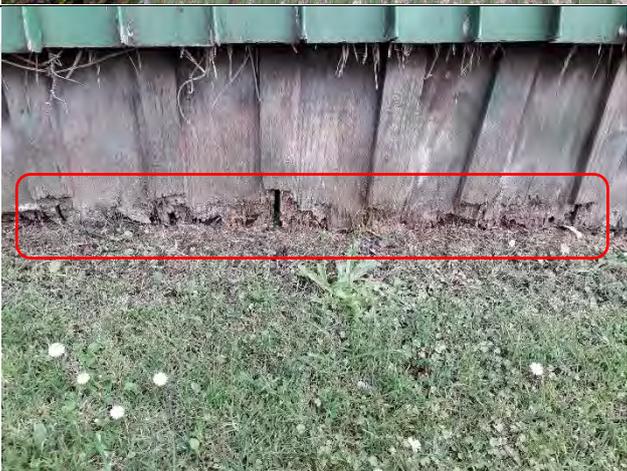
25	Decayed bottom timber cladding in south elevation due to contact with the ground (typical).

13. To replace the decayed timber weatherboard in south elevation.
14. To install gutters and downpipes to the toilet extension in east elevation and connect it to storm water network.

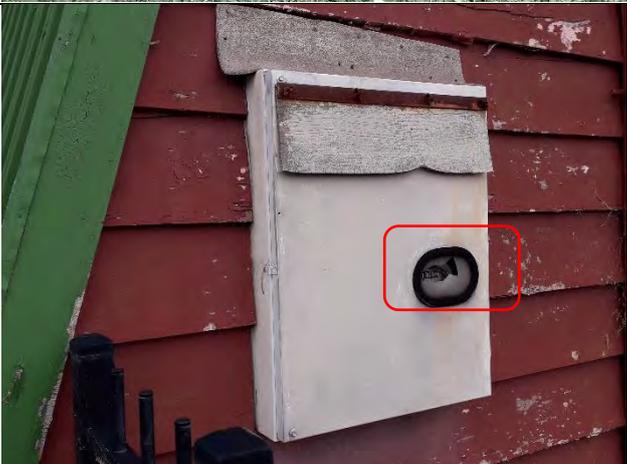
26	Broken glass in electric meter box in south east corner.

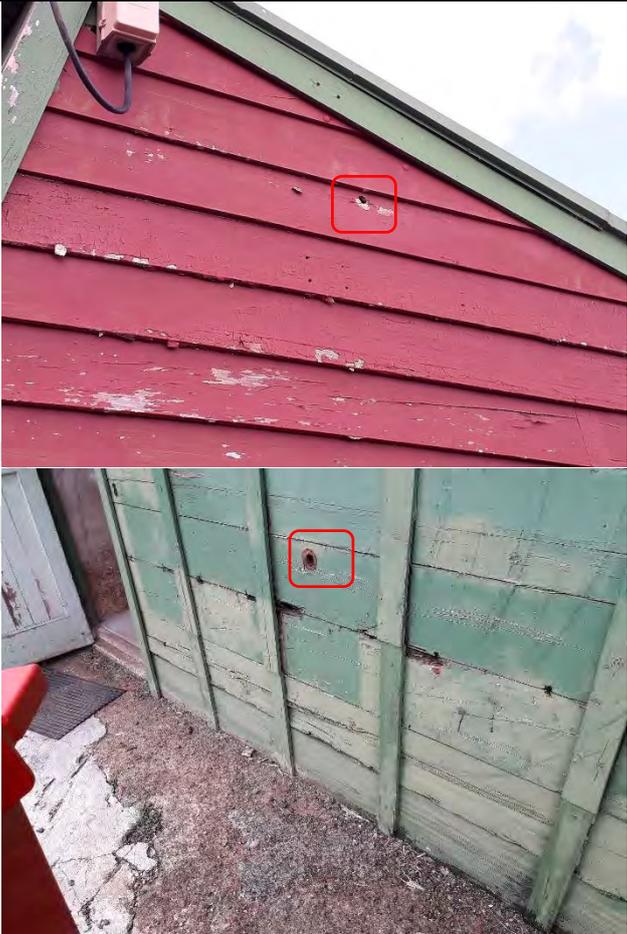
<p>28</p>	<p>Hole/penetration in wall cladding is not sealed properly,</p>

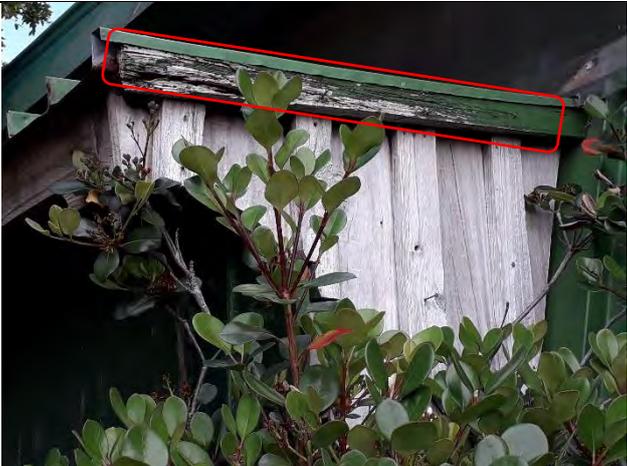
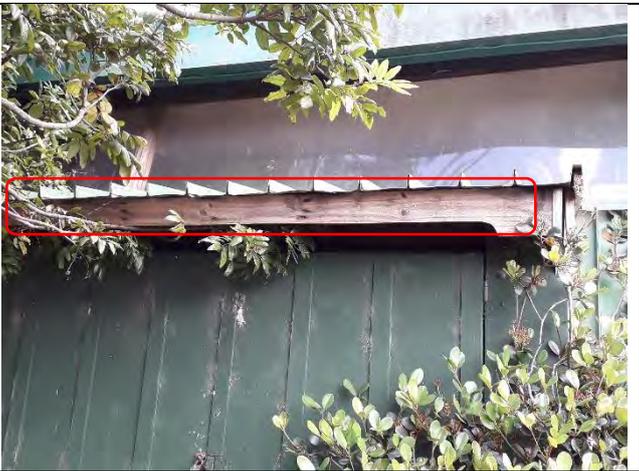
<p>29</p>	<p>a. Heavily decayed timber barge on the south. b. Unpainted timber cladding.</p>

15. To replace decayed timber barge flashing in south elevation and paint the timber cladding near it.
16. To replace all the missing soffit on the upper floor.

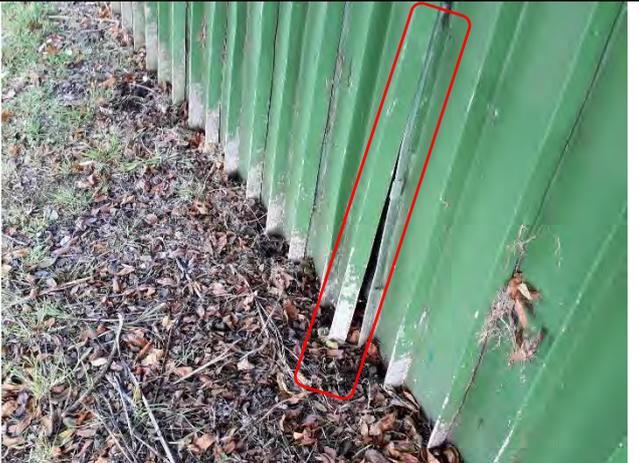
30	Detached lapping between steel wall cladding in south elevation.

12. To fix the detached lapping between steel wall cladding in south elevation.
13. To replace the door handle in the upper floor door.
14. To fix the detached barge flashing of the toilet roof.

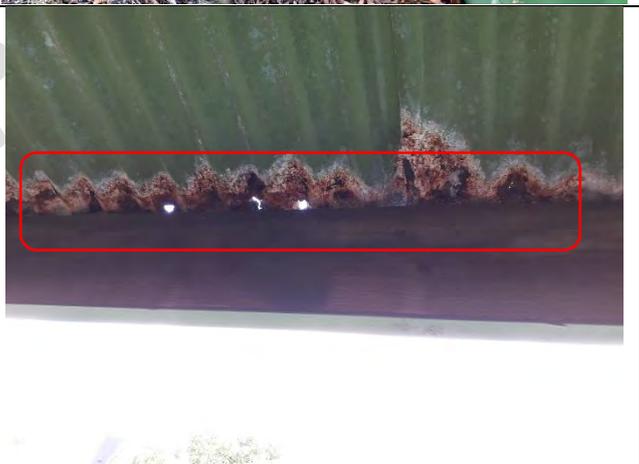
31	Heavily corroded upper roof with penetration in north elevation (typical). The roof cladding should be replaced.

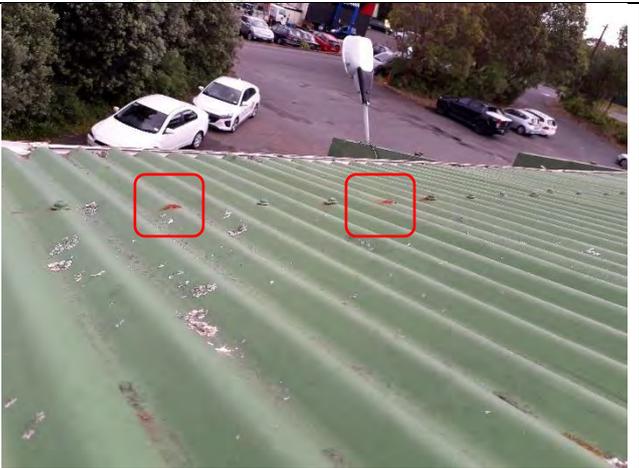
32	Missing few fixings on the roof

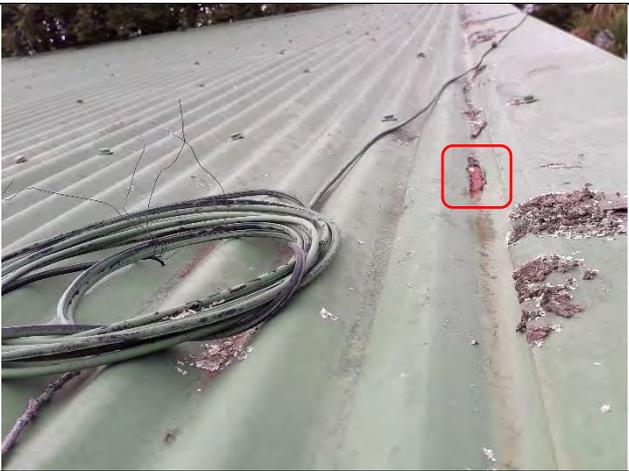
<p>33</p>	<p>Unused wires laying around in the roof. Heavily corroded roof.</p>

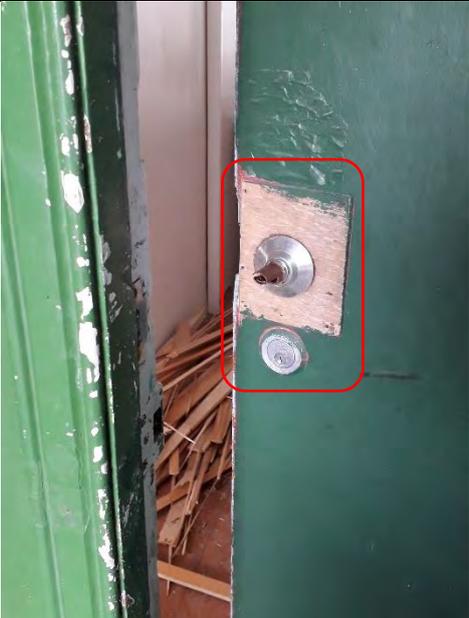
36	No proper door handle to the upper floor door

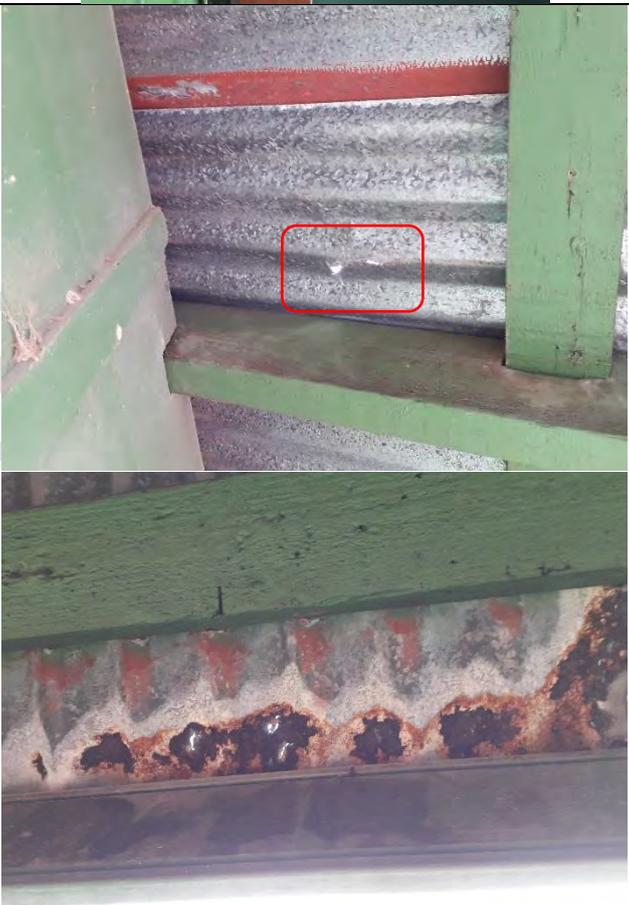
37	a. Penetration to the lower roof b. Heavily corroded lower roof (typical)

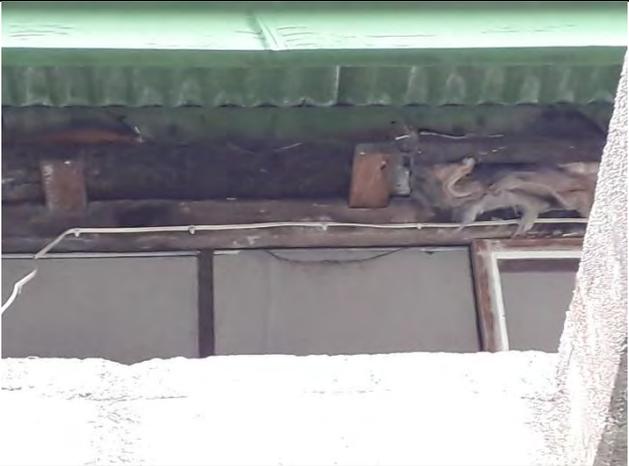
39	Missing soffit on the upper floor.

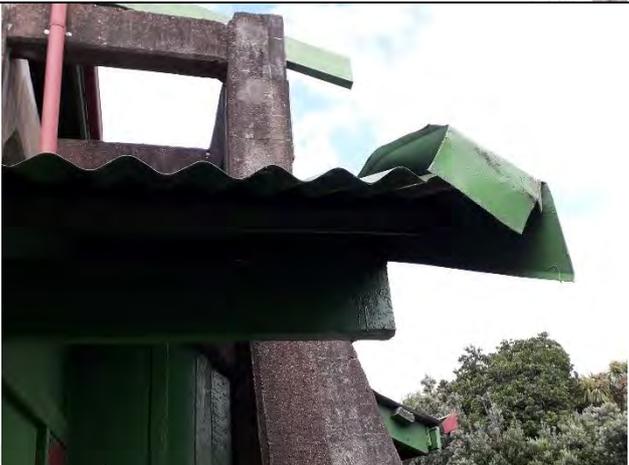
40	Detached barge flashing of the toilet roof in the north

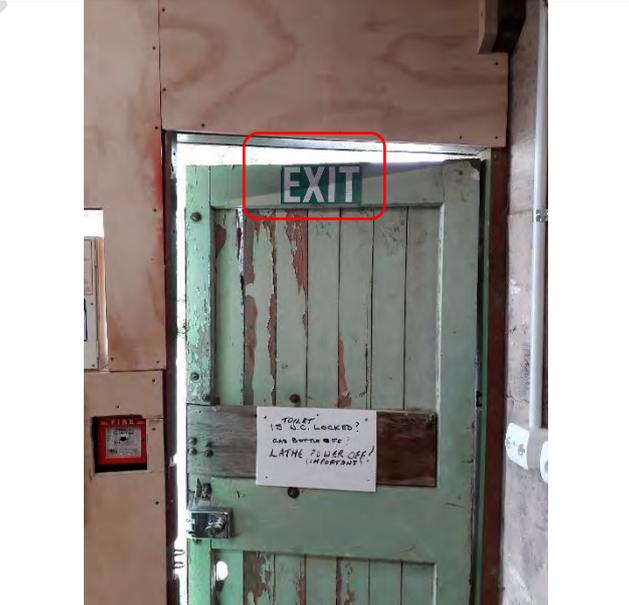
2.6	Internal Defects	Photos
1	<p>a. Exit sign supposed to be installed on the wall above the door.</p> <p>b. Paint defects of the internal door</p>

15. To move the exit sign on the ground floor to the wall above the door.
16. To temporarily close all penetration through the broken glass windows in upper floor.

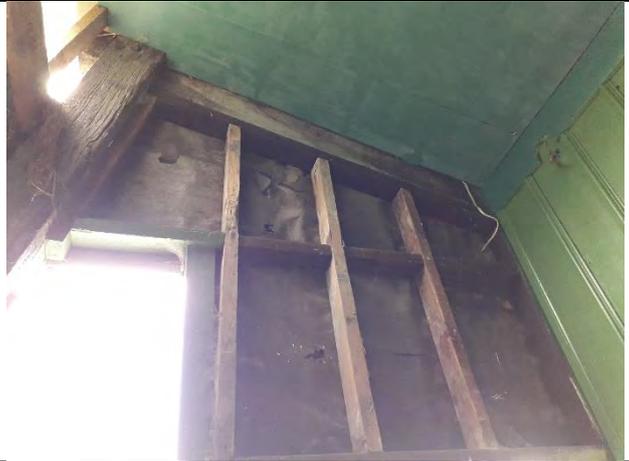
<p>2</p>	<p>Wall underlay of the upper floor entrance deteriorating and have hole in it. It is recommended to replace the underlay and install lining on the frame.</p>

17. To replace the wall underlay of the upper floor entrance and installing wall lining to protect the wall frame.
18. To replace all the corroded fixing of the roof frame from the first floor.

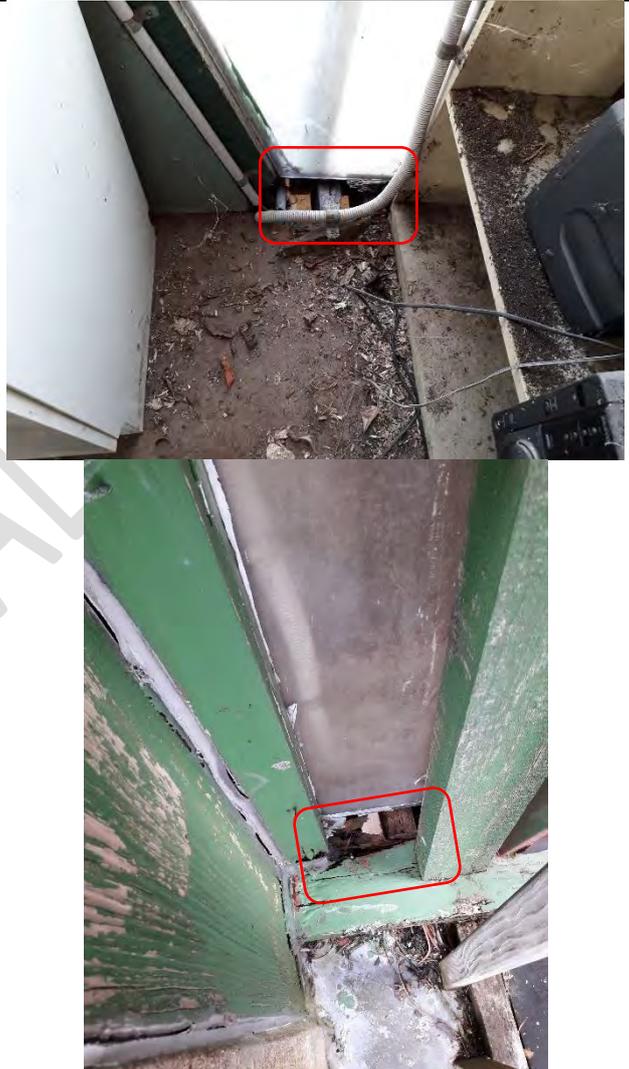
<p>3</p>	<p>Hole in the windows frame on the west elevation is decayed and have hole on it. The decay is likely caused by water ingress.</p>

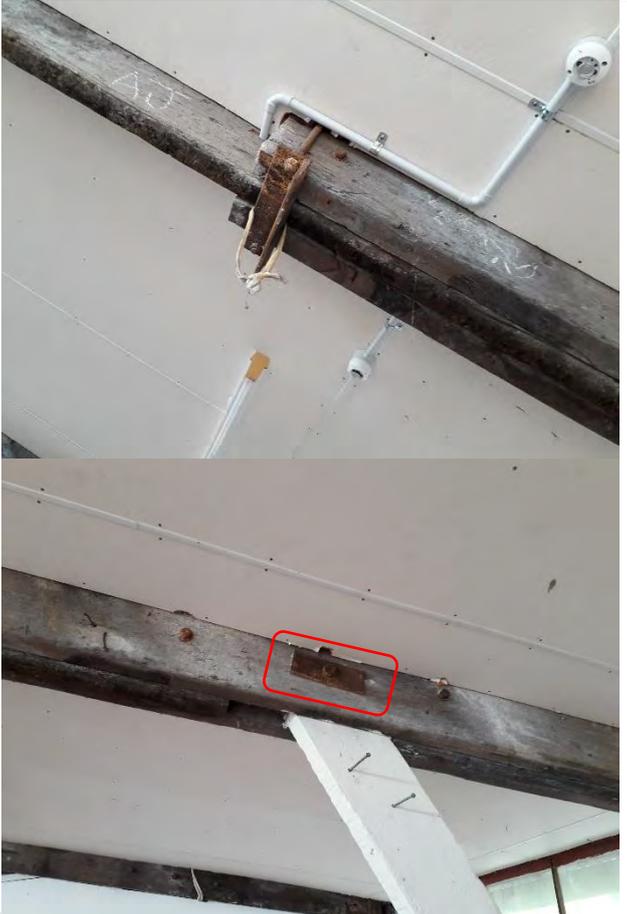
<p>4</p>	<p>Corroded fixings of the roof frame in the upper floor (typical).</p>

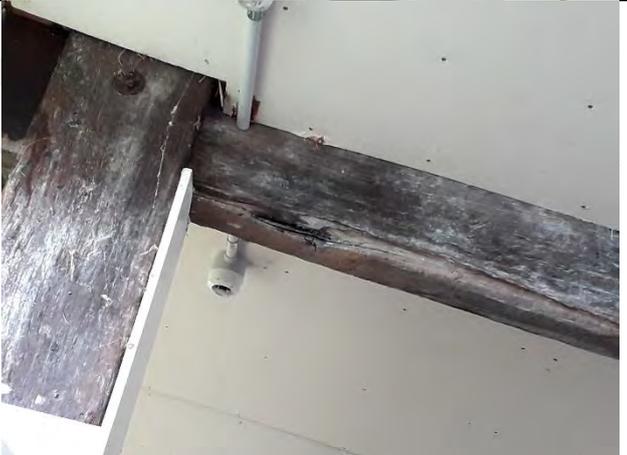
<p>5</p>	<p>Slightly decayed timber roof frame (typical).</p>

19. To selectively replace the decayed timber roof frame. Destructive test and sample test of the timber frame might be required before selecting the member to be replaced.

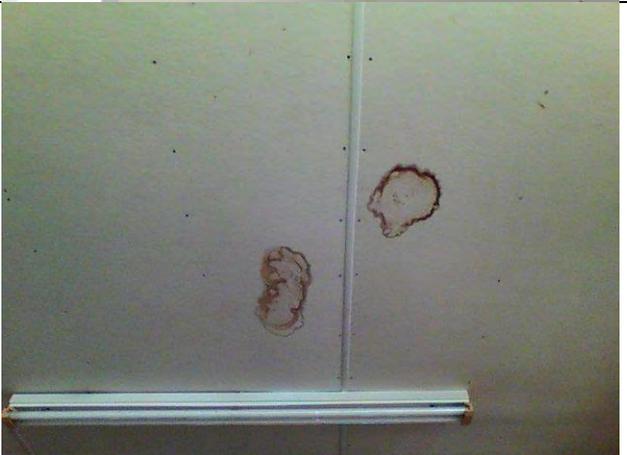
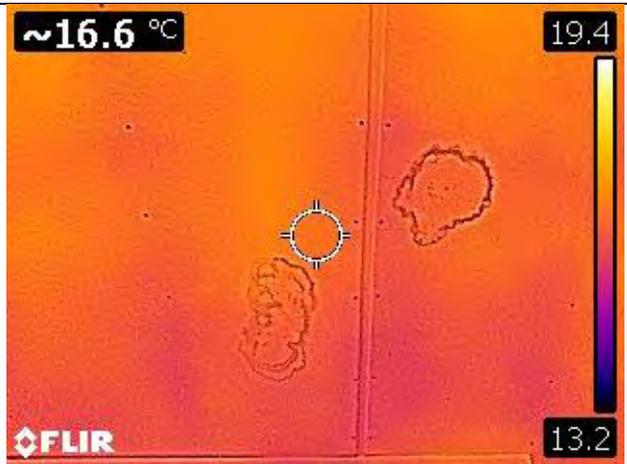
<p>5</p>	<p>There are multiple watermarks in the ceiling on the upper floor. However, based on the thermal camera, the leak might be historical and has been sealed.</p>

20. To re-paint the ceiling with watermark in the upper floor
21. To replace the broken glass windows in upper floor.
22. To upgrade the electrical switchboard.

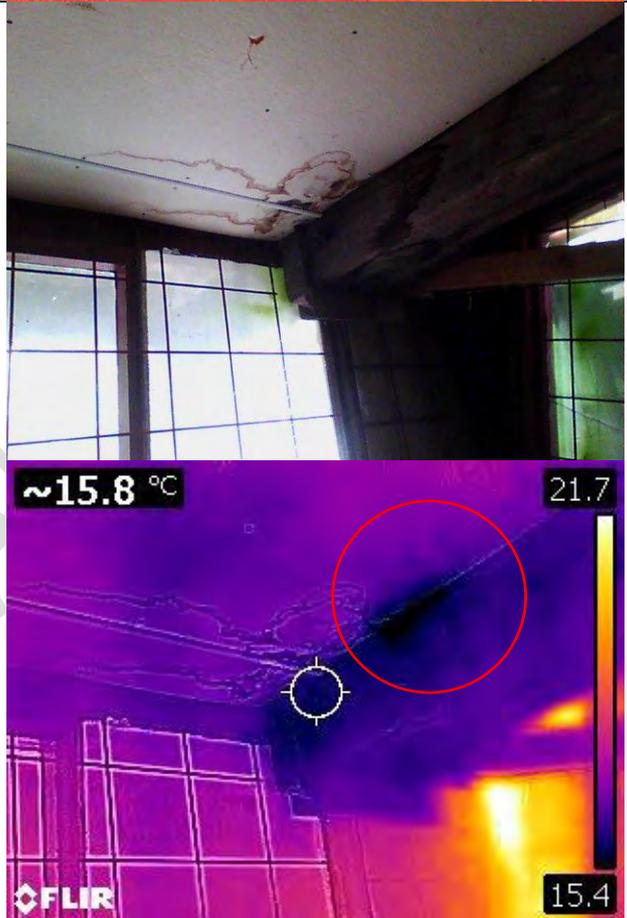
6	<p>Watermark on the ceiling in the north east corner of the upper floor. Based on the thermal camera, the moisture is still on the ceiling and timber roof frame (it is still leaking).</p>

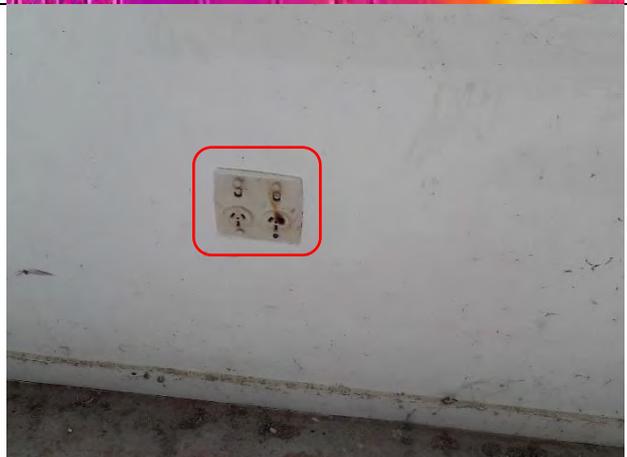
7	<p>Sign of overheating/burning on electric socket on the upper floor.</p>

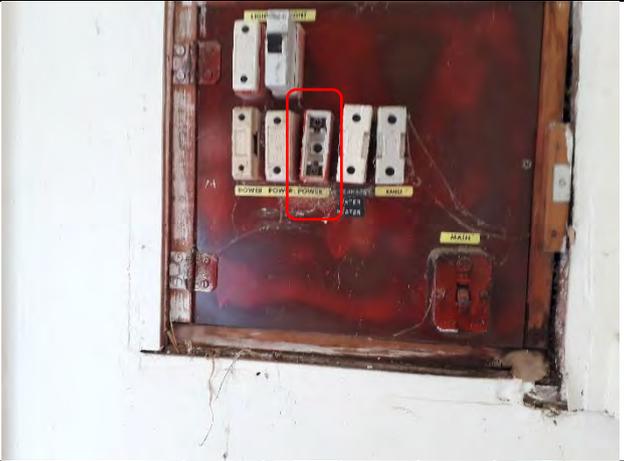
<p>8</p>	<p>Exposed conductor on the displaced MCB on the switchboard in upper floor. It is health and safety risk. Digital RFS has been raised to fix the problem.</p>

1. To rectify the exposed conductor in the switchboard on the upper floor. The missing circuit breaker should be closed or reinstalled. Separate digital RFS has been submitted by the assessor to rectify the defects.

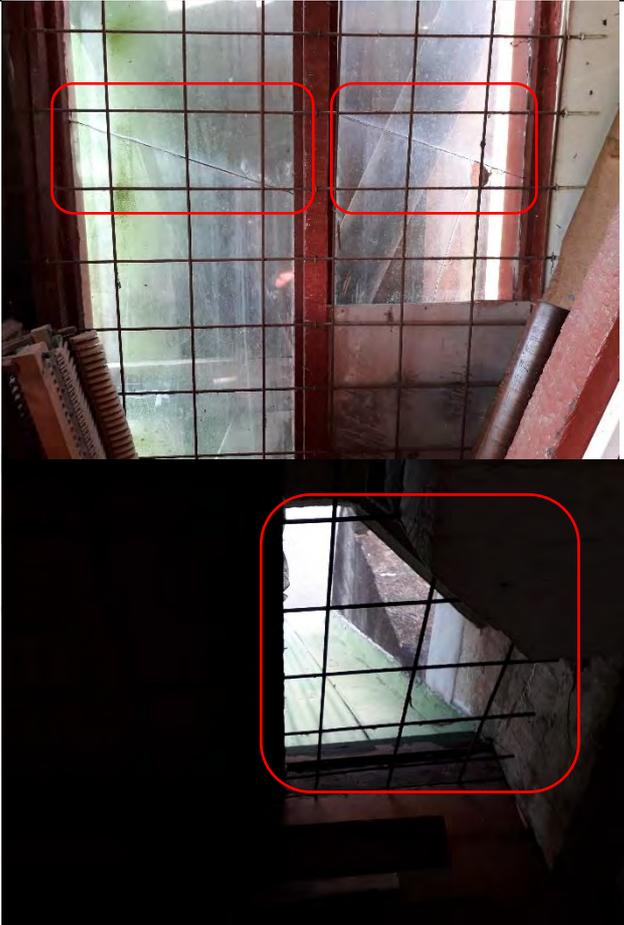
<p>9</p>	<p>Broken glass windows on the upper floor.</p>

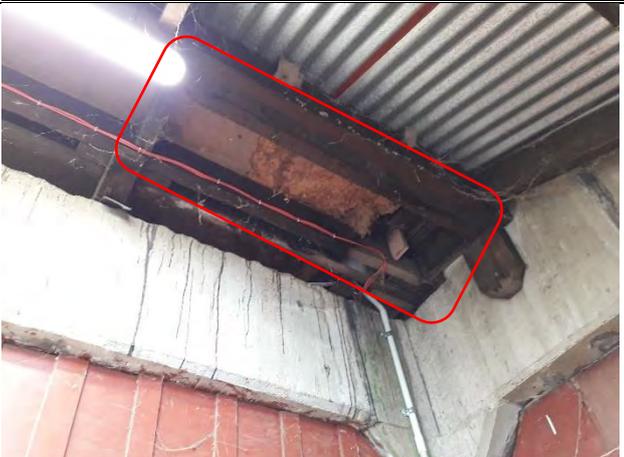
<p>10</p>	<p>Sign of moisture ingress on the ceiling on the ground floor</p>

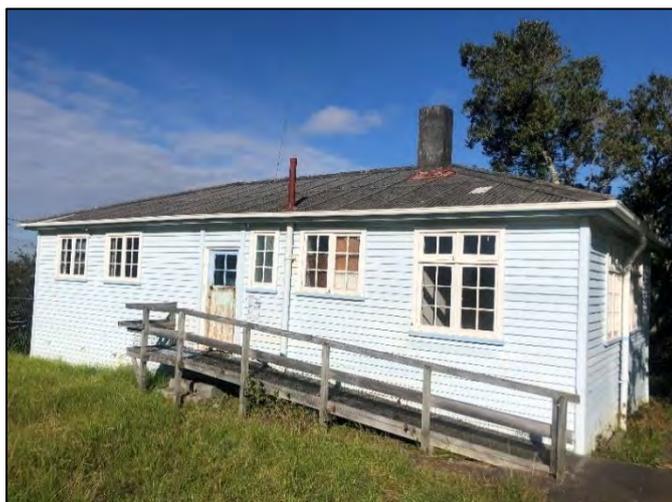
Rear side of building. Note corrugated asbestos cement roof and remnant of earlier lead flashing at the base of the chimney. Note also plastic spouting.

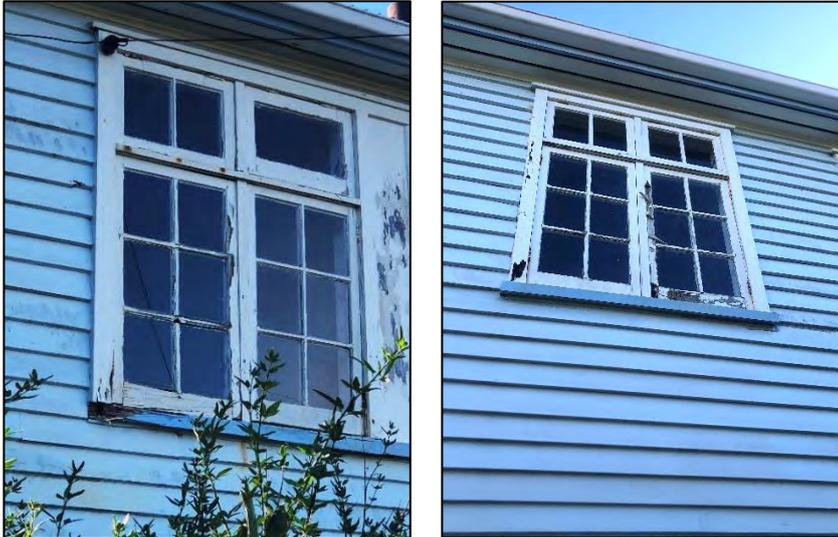
Decay in window joinery, in sill and facing (left) and sash members (right).

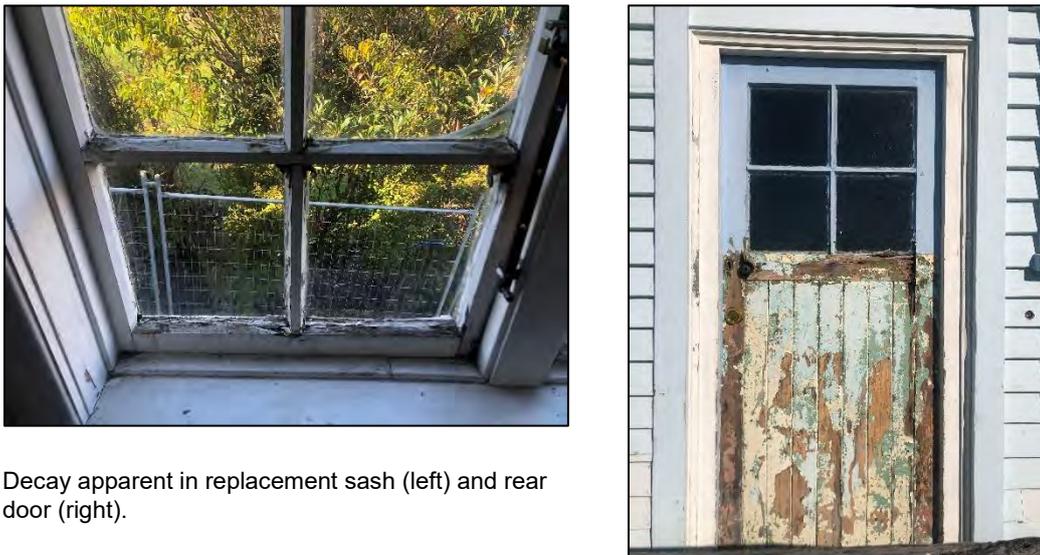
Decay apparent in replacement sash (left) and rear door (right).

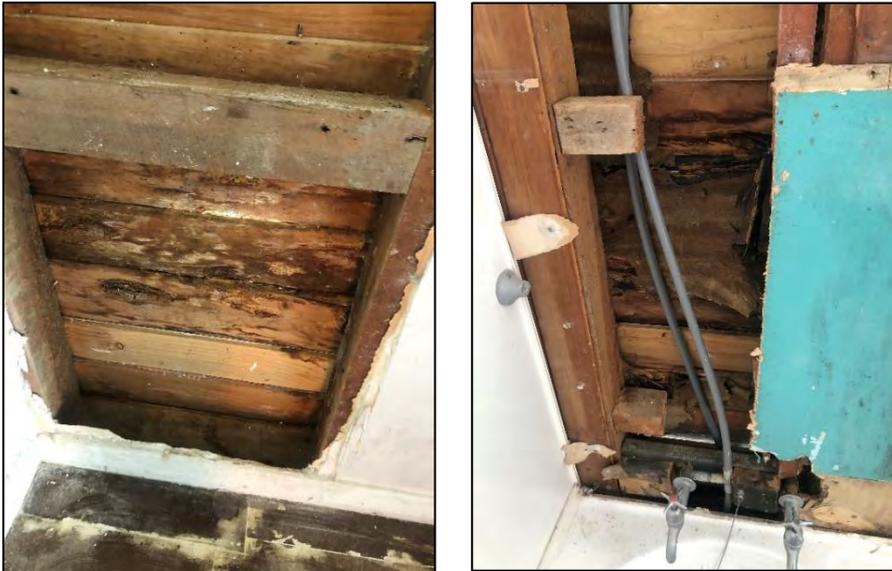
Areas of decayed weatherboards. The timber framing in these areas should be checked.

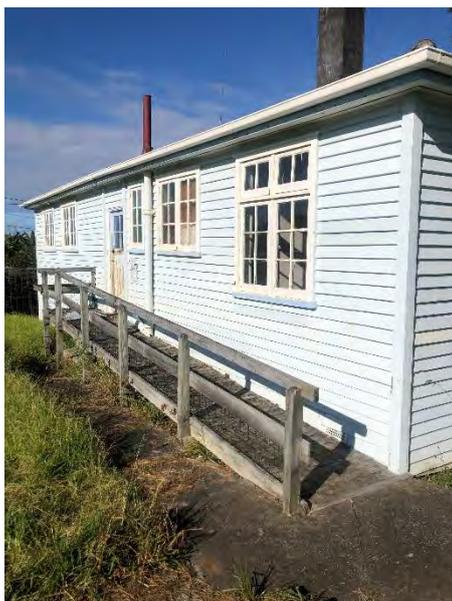
At the back door, the steps remain although a timber ramp has since been constructed over them. The ramp has been poorly built and never painted and is in poor condition. At the front door, there is some evidence of the steps settling with a gap opening between the steps and the rest of the building.
