On-site Wastewater Education Programme

Tryphena, Great Barrier Island

Prepared for: Great Barrier Island Local Board

June 2017

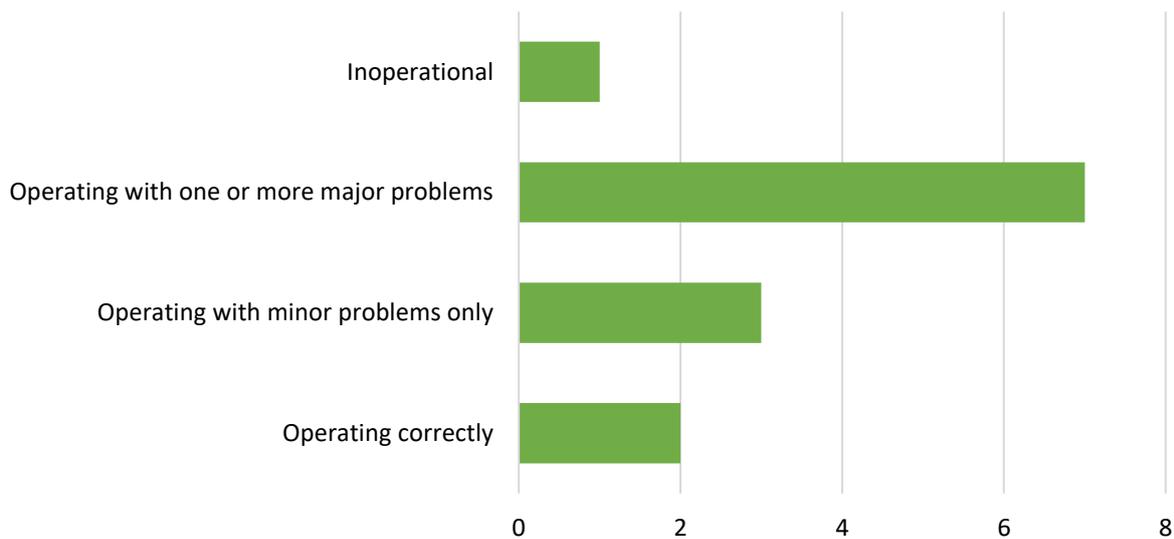
Figure 9: Overall assessment of inspected septic tanks

Of the 13 septic tanks that were inspected:

- 1 had a major fault that rendered it in-operational for treatment purposes (the tank was cracked and effluent was observed leaking from a side wall);
- 7 were operating with one or more major problems;
- 3 were operating with minor problems only;
- 2 were operating correctly.

Examples of major operational problems included:

- Disposal field failure (3)
- Pipes allow inappropriate discharge of sewage (2)
- Tank lid is unsealed (2)
- Tank is not structurally sound (1)

Many of the septic tanks inspected also had one or more minor operational problems.

Examples of minor operational problems included:

- No access to tank lid (6)
- Tank requires desludging (1)
- T-piece not attached (1)
- Disposal field not located (1)

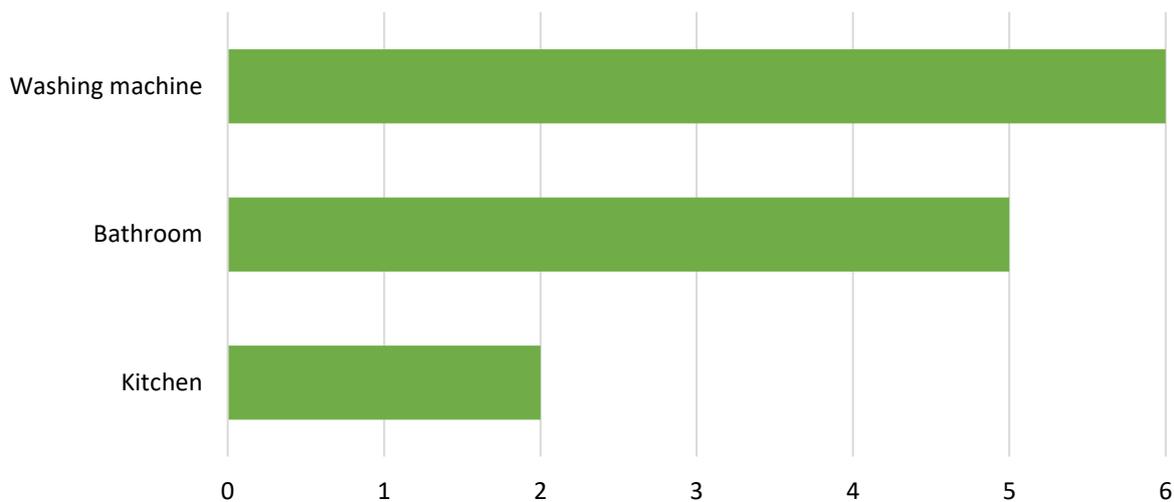
Figure 10: Greywater diversion at inspected properties

As observed during the household survey, it is relatively common for Tryphena residents to divert their greywater away from their wastewater system. Of the 13 properties visited during the septic tank inspections, 6 were diverting some or all of their greywater (see Figure 10). The alternative greywater solutions on these properties included discharges to soak pits, trenches, or directly on to landscaped areas. While there was not time to inspect these greywater solutions, this would be a worthwhile focus for future inspections.
