# Ambridge Rose Retirement Village

## COASTAL HAZARD INVESTIGATION REPORT

APRIL 2025

Bronwen Gibberd  
4D Environmental Ltd

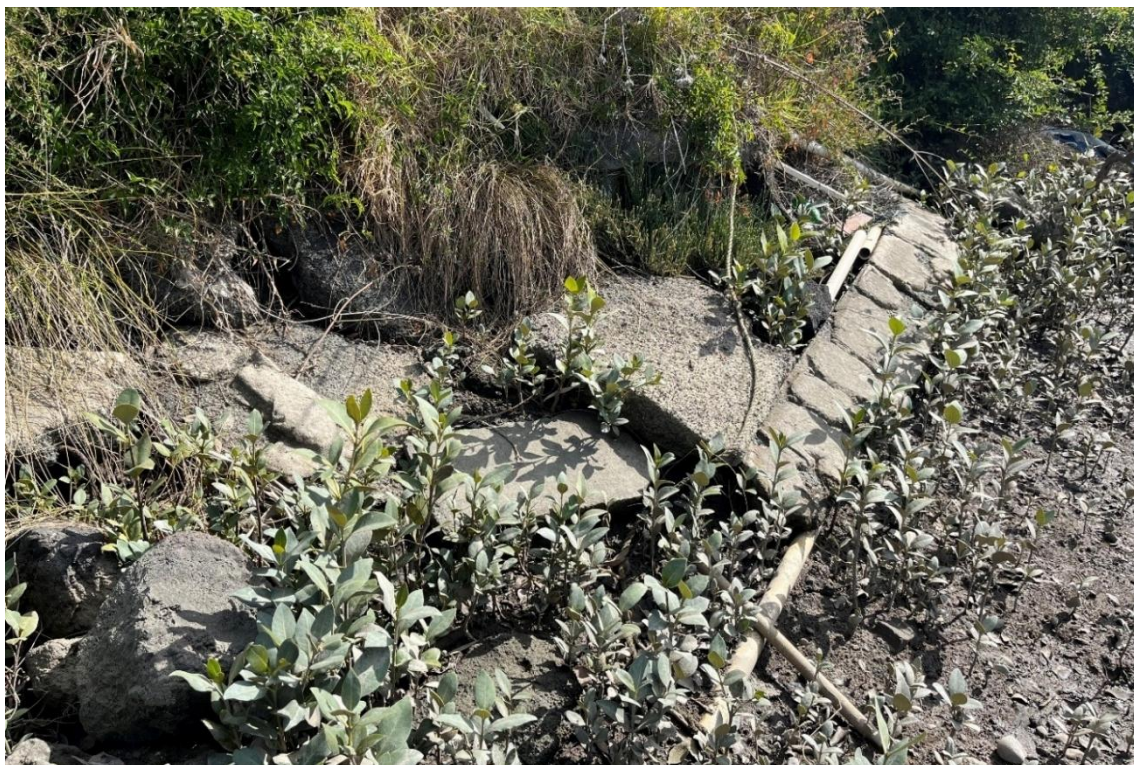
There are several existing retaining walls and toe protection structures along the frontage. Most are in a poor state of repair, and none appear to be recent, or formally engineered. All the existing seawalls appear to be informal, privately built structures, each contained within a single property. Most toe walls are made from loose or stacked rock, or concrete blocks (e.g. Figure 6), which have been placed presumably to limit ongoing undermining of the toe of the slope. An erosion scarp approximately 0.5 m high exists along much of the foreshore where there is no protection (Figure 7). There is only a minor horizontal offset between the structures and the unprotected shoreline. The baseline applied for coastal erosion hazard mapping has been smoothed to reflect an unprotected shoreline.

*Figure 6: Informal armoring structures at the toe of the slope (149 Edgewater Drive).*

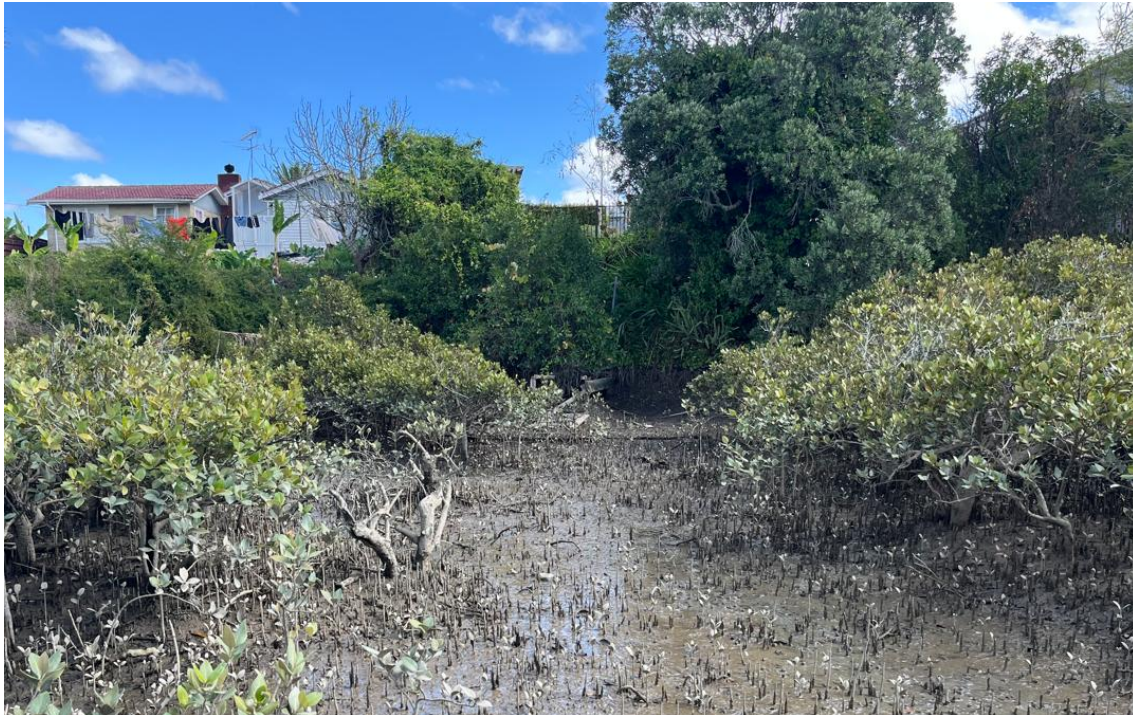
There is no evidence of ongoing mangrove progradation, or upper wetland vegetation at the shore, as might be expected in a highly accretionary environment. The toe of the slope extends below the high tide level and the presence of the small erosion scarp and the numerous erosion protection structures suggest that the shoreline is subject to slow erosion by coastal processes. It is very difficult to determine erosion rates in this area, except to conclude that rates are slow.

*Figure 7: Vegetated bank and exposed substrate at the toe of the slope (153 Edgewater Drive).*

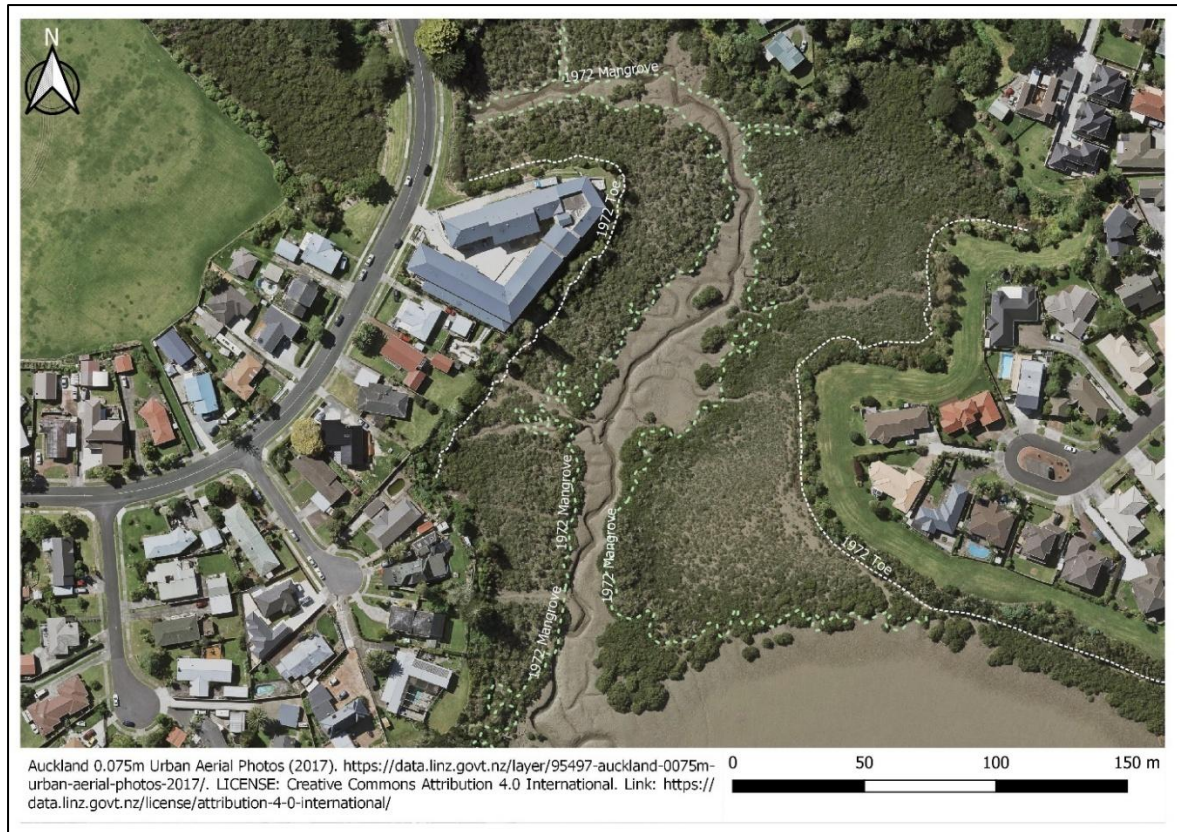
It is difficult to accurately define the toe of slope due to shading and the presence of heavy vegetation. However, the mapping exercise provided good evidence that erosion at the site has been very slow over the last 50-60 years. There was no evidence of widespread erosion beyond the error of the photography and mapping. Along some very short stretches of coast, it appears erosion of up to 2 m may have occurred. Comparison of 1959 aerial photography available through Auckland Council Geomaps with recent (2017) imagery also suggests very little change in the shoreline over the last 65 years (Figure 8).

Mangrove coverage increased most rapidly between 1959 and 1972 and has increased measurably over the last 50 years (Figure 8). More recent rectified photographs available through Auckland Council GeoMaps, LINZ data service and Google Earth indicate that there has been no measurable change in mangrove cover since the late 1990s.

Figure 8: Aerial view of Pakuranga Creek (2017), illustrating position of the toe of cliff and extent of mangroves in 1972.

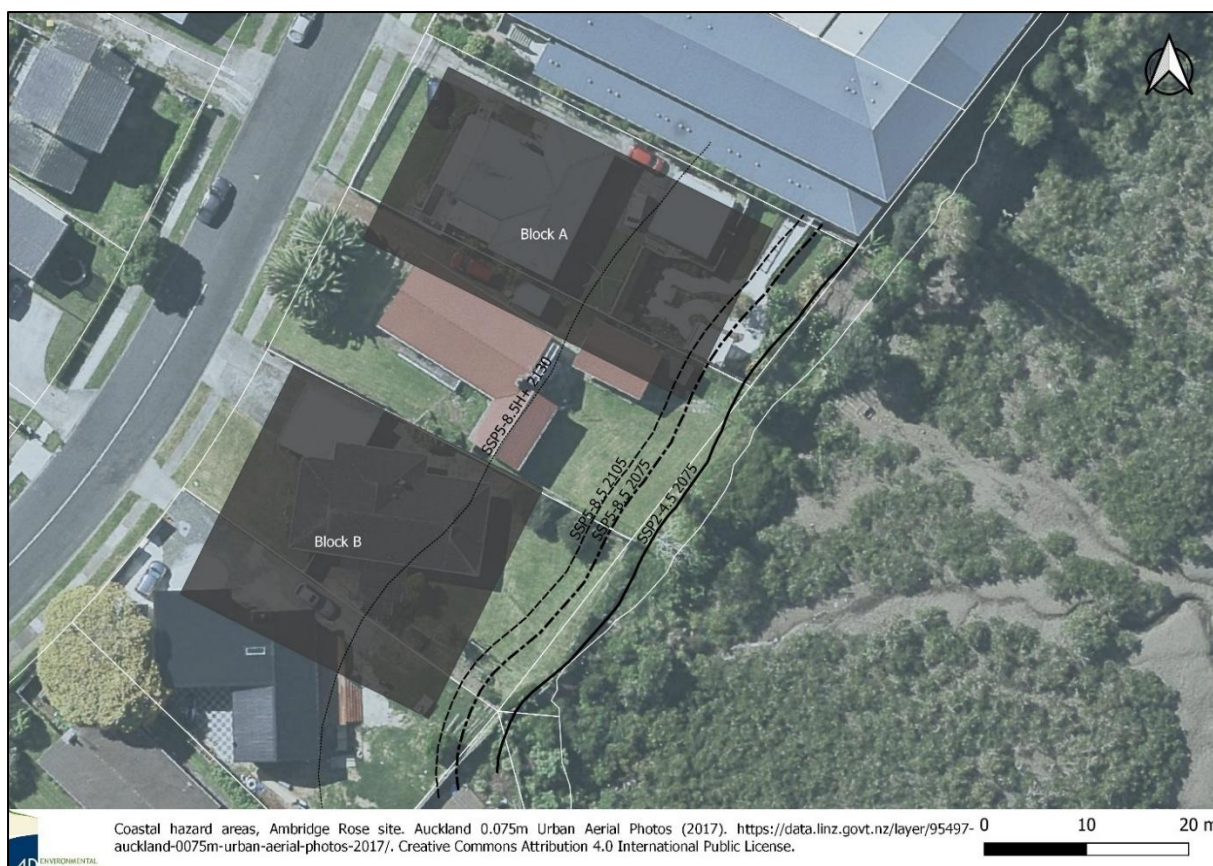
The 2130 SSP5-8.5M5H+ scenario presented here represents coastal hazard risk at a timeframe that is relevant to land use planning but exceeds the expected lifespan of the proposed development. This scenario represents the possible (but unlikely) underlying erosion rate of 10 m per century<sup>16</sup>, further accelerated by a high sea level rise trajectory. The coastal hazard areas are illustrated in Figure 9.

Figure 9: Coastal erosion hazard estimates, illustrated in relation to the footprint of the proposed buildings.

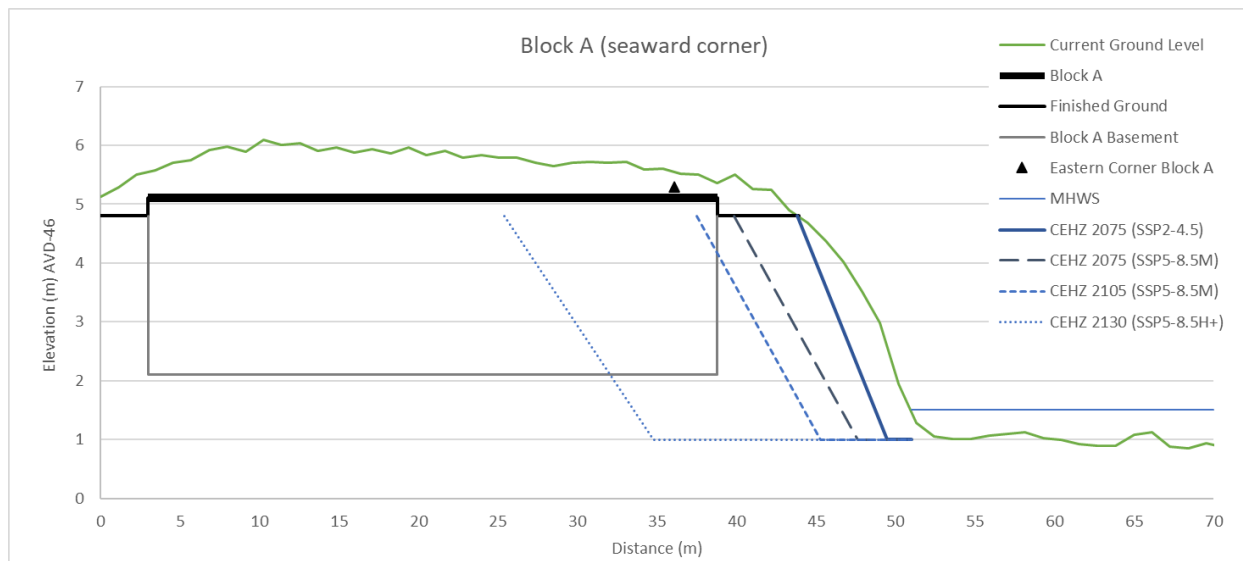
The basement of the proposed Block A is located approximately 6 m landward of the top of the coastal slope. Future erosion and associated slope adjustment beyond a 50-year timeframe could expose the basement wall. The seaward edge of Block B is likely to be landward of coastal erosion for at least 80 years.

Figure 10: Coastal erosion hazard in relation to the ground floor and basement of Block A.

The coastal erosion risk relates mostly to the implications of the exposure of the basement wall of Block A, and whether mitigation of this hazard is practicable or necessary. Coastal hazard risk is otherwise limited to landscaped areas and the access road seaward of Block B. Some form of monitoring and management plan may be advisable to consider potential actions in response to sea level rise and ongoing erosion.

- Regular (5-yearly) monitoring and brief report to include:
  - o coastal conditions (toe erosion, processes and vegetation, sea level)
  - o observations of slope instability
  - o reporting of any action required if deemed risk within ten years.
- Adaptation of access roads, hard landscaping features if necessary
- Construction of a retaining wall to protect buildings or critical infrastructure if necessary.

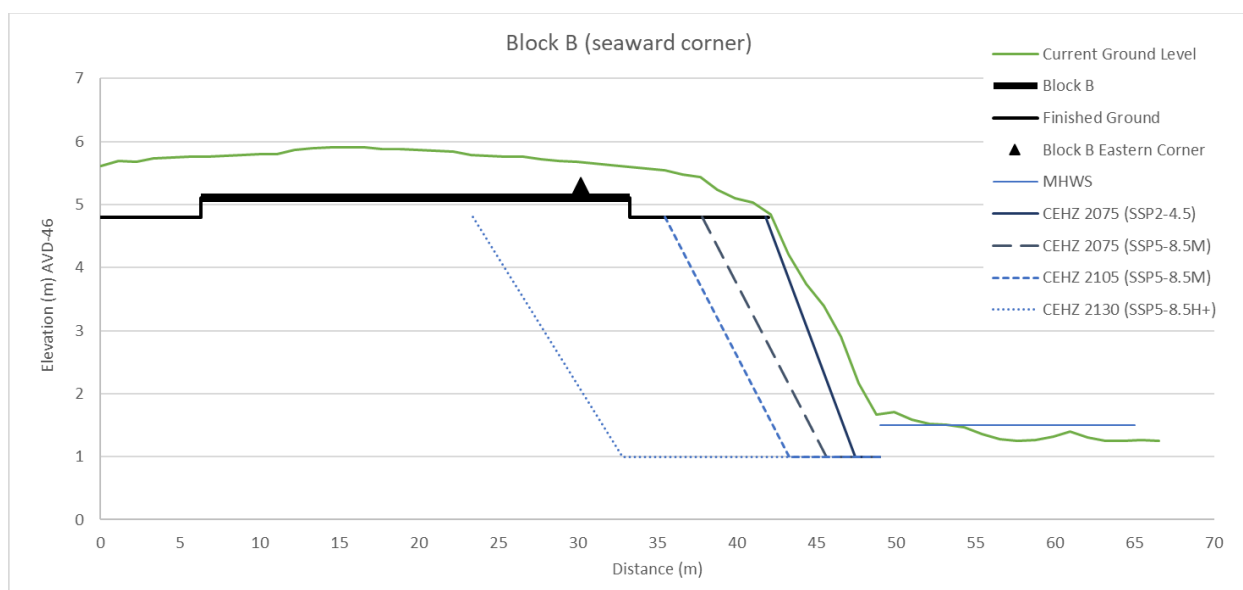
Figure 11: Coastal erosion hazard in relation to the ground floor of Block B.
