**REPORT PREPARED FOR:
ABIB (OAMARU) LIMITED**

**PRELIMINARY SITE INVESTIGATION
2127 KAIPARA COAST HIGHWAY
KAKANUI**

**Prepared by:
Groundwater and Environmental Services
PO Box 190
Cambridge
30 May 2022**

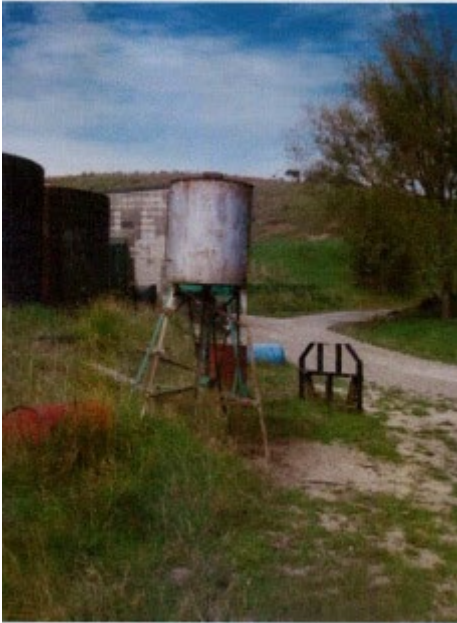
Fuel Storage Tank – 2010

The response also noted the presence of an above ground fuel storage tank on site in 2010. Follow up information obtained from council confirmed that the tank observed during a site visit by a council officer and that it was located beside the tanker loop. No visible hydrocarbon staining was observed on the ground beneath the tank at the time of the 2010 site visit. A copy of the council officer's photograph of the tank is reproduced below.

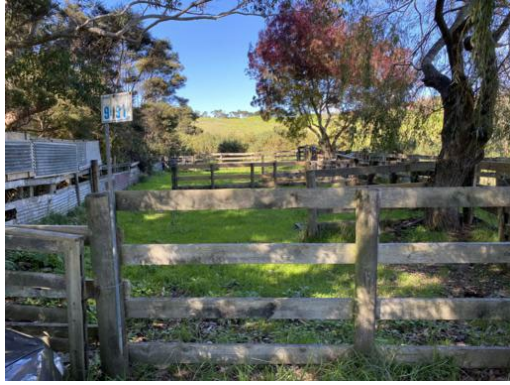
Stockyard – location 1

- The stock loading ramp, race and yards in the north of the property (location 1). This is an area where stock spraying could potentially have taken place and resulted in contamination of the ground;
- The former sheep yard area (location 8). This is also an area where stock spraying could potentially have taken place and resulted in contamination of the ground; and
- The location of the two above ground fuel tanks (location 10) where fuel leaks could have resulted in contamination of the underlying ground.

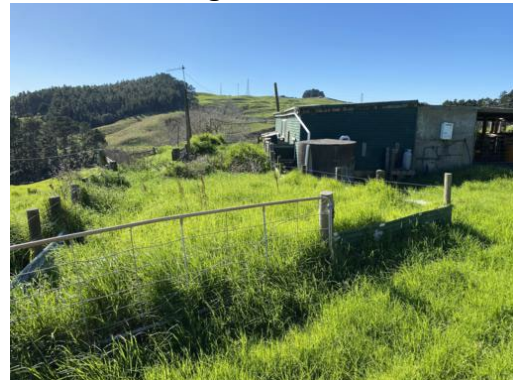
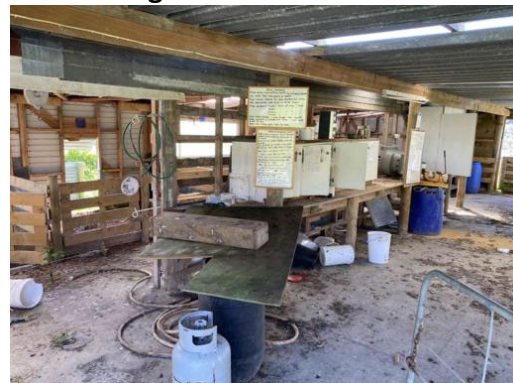
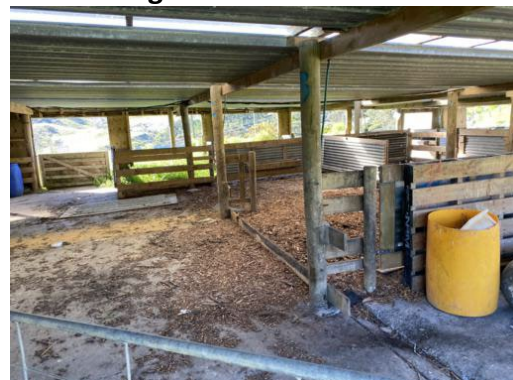
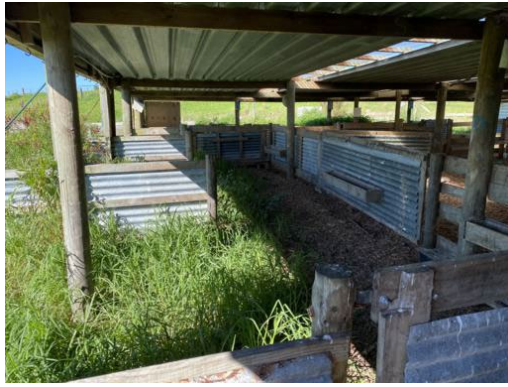
9. The calf rearing shed located on the north-east side of the tanker track had stockyards on its north-west and south-east sides. Small quantities of farm chemicals were stored inside the shed however there are no indications of spills to ground of hazardous materials.

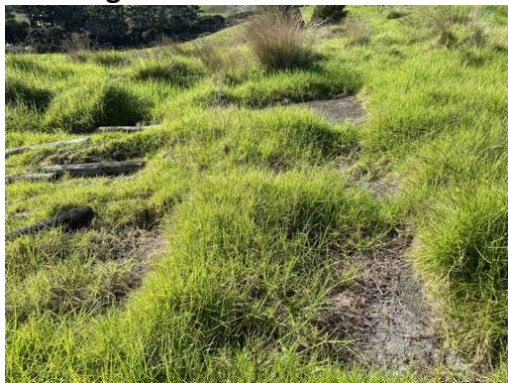
Concrete pad – location 8

HAIL ID	Description	Assessment
A.8	Livestock dip or spray race operations	Possible Possibility of livestock spray operations at inspection locations 1 (stock loading ramp, race and yard) and 8 (former sheep yard) No evidence for the presence of livestock dip or spray race structures elsewhere on the property
A.10	Persistent pesticide bulk storage or use	Highly unlikely No commercial horticulture activity identified
A.17	Storage tanks or drums for fuel, chemicals or liquid-based	Confirmed Aboveground farm fuel storage tanks were observed on site in 2010 and during the inspection in 2022 (location 10 on Figure 4)
B.2	Electrical transformers	Confirmed Power pole mounted electrical transformer identified on site in the north-east of inspection location 8
G.3	Landfill sites	Highly unlikely No indications for the presence of potentially hazardous fill or buried rubbish on the property
G.5	Waste disposal to land (excluding where biosolids have been used as soil conditioners)	Highly unlikely No indications for any waste disposal to land at the property other than spreading of treated dairy shed effluent
