22 April 2024

Cabra Developments Limited Unit 9B, 30 Foundry Road Silverdale Auckland 0932

Private Plan Change Geotechnical Assessment - Cabra Sites, Hobsonville, Auckland (Our Reference: 23849.000.006\_04)

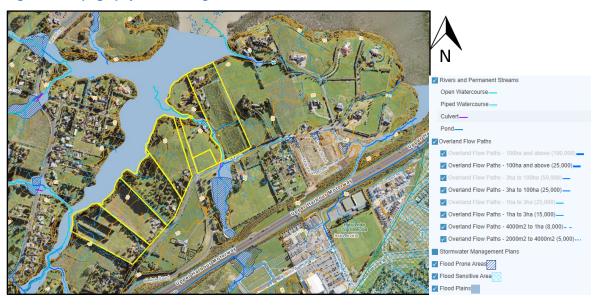
Figure 3: Topography and Drainage

The Auckland Council GeoMaps Catchments and Hydrology layer (Figure 3) identifies areas of land that could be affected by flooding during and / or following periods of heavy rain. Portions of the site labelled as flood prone, or flood plains are limited to areas immediately adjacent to Waiarohia Inlet and its associated tributaries, including the pond.

Evidence for localised swampy ground, surface ponding and associated softened ground was observed in the vicinity of overland flow paths on the sites assessed by ENGEO.

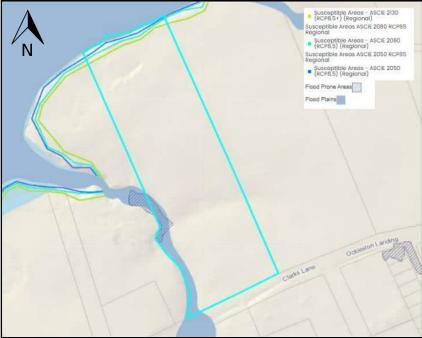
Figure 1: Auckland Council Hazard Map

The Auckland Council GeoMaps layer 'Flood Plains & Flood Prone Areas' identifies areas of land in Auckland that could be affected by flooding during and / or following periods of heavy rain. Portions of the site labelled as flood prone or flood plains are shown in Figure 1 and are limited to areas adjacent to the western boundary, in the southern portion of the site.

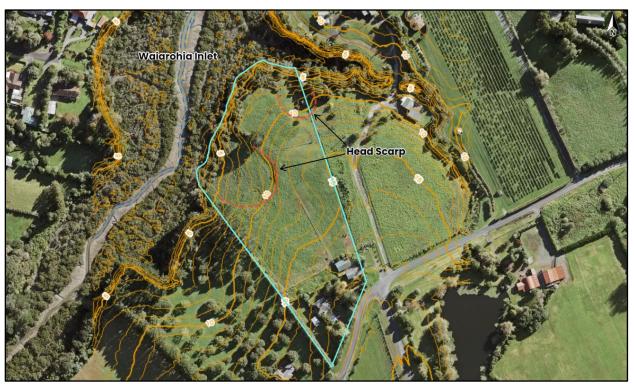
The topography on-site displays two distinctive concave landslide head scarps and associated debris lobes located towards the northern end of the site failing towards to Waiarohia Inlet. The western landslide has failed in the north-western direction, whilst the eastern landslide has failed in the northern direction. There is a total cross fall of approximately 16 metres across site in the south-eastern to north-western direction. The land south of the landslides and coastal margins has an approximate slope angle of 2°. The head scarp of the western landslide has an approximate slope angle of 19°, whilst the head scarp of the eastern landslide has an approximate slope angle of 8°. The steepest slope of the coastal margin sits at 51°, whilst the shallowest sits at 11°.

NTS. Aerial imagery from LINZ. Site boundary shown in blue. Contours shown in orange.

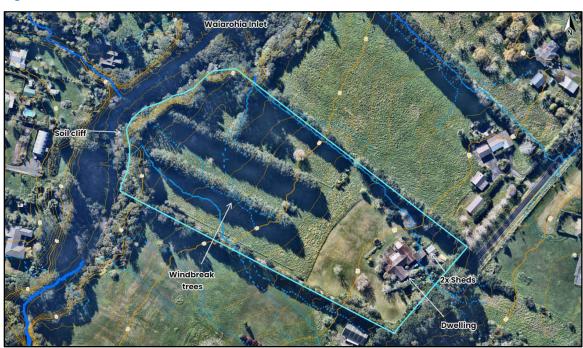
Figure 1: Site Features Plan

The site falls from Sinton Road in the east down to the north-western boundary as a gentle slope of approximately three degrees. Minor changes in elevation can be noted along the alignment of the overland flow paths throughout the site. A site plan is presented in Appendix 1.

NTS. Aerial imagery from Nearmaps. Site boundary shown in light blue. Overland flow paths shown in dark blue. Contours shown in orange.
