Map3 - Bank and Channel Modification Type & Extent

Client **AUCKLAND COUNCIL**
Project **NGAKAROA WAR**

Project no. **P01644**
Date **16 Jun 2018**

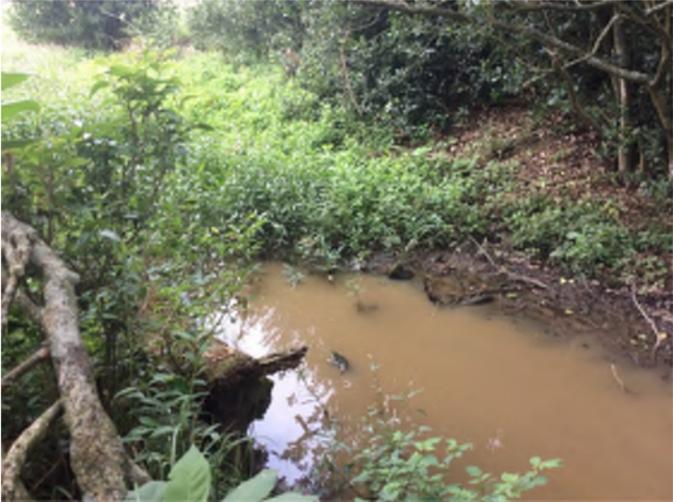
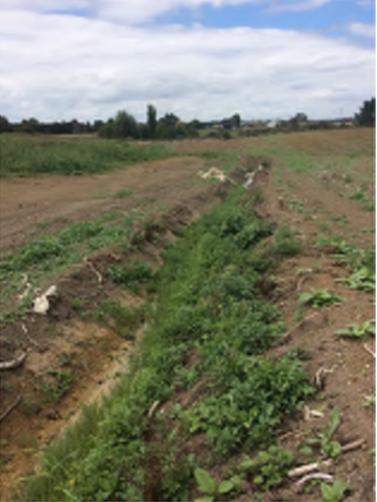
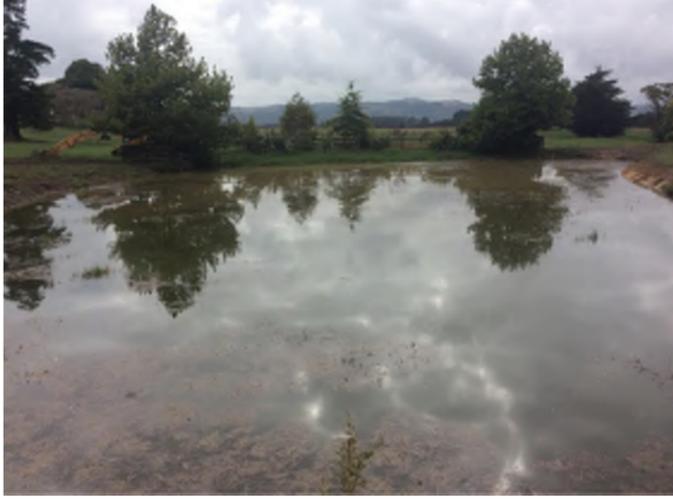
ID	Issue Description	Site Example One	Site Example Two	Site Example Three
MKG_12	<p>Market gardens present on the true left bank of the reaches. After rain events the gardens are contributing to high sediment loads in nearby streams. A channel running through the market gardens (site example 2) appears to be repeatedly dug out and loose sediment inputs are entering the nearby watercourses.</p>

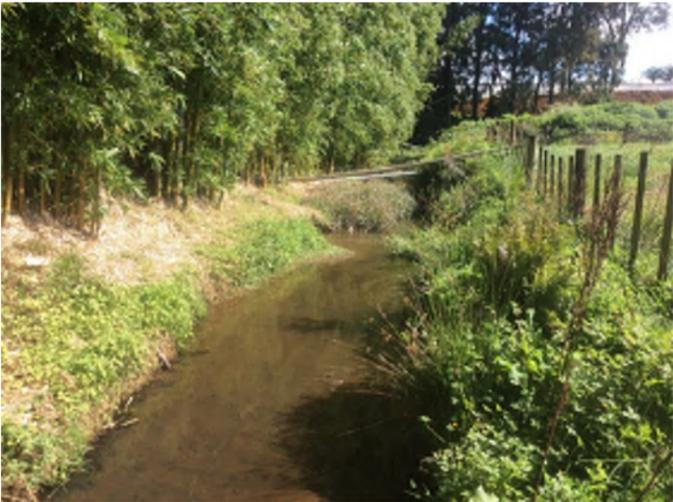
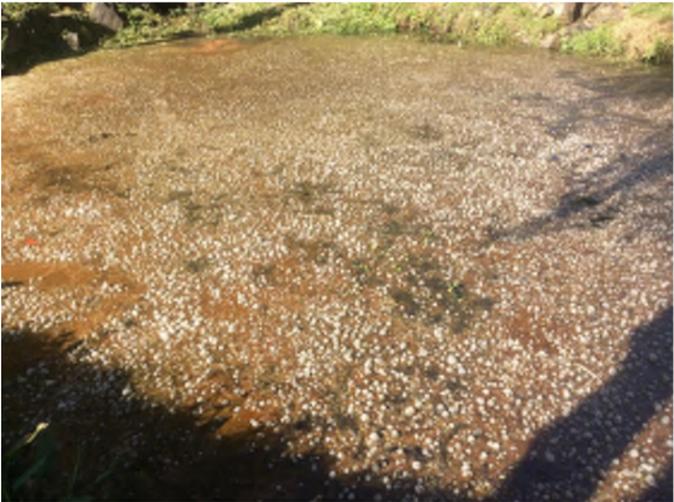
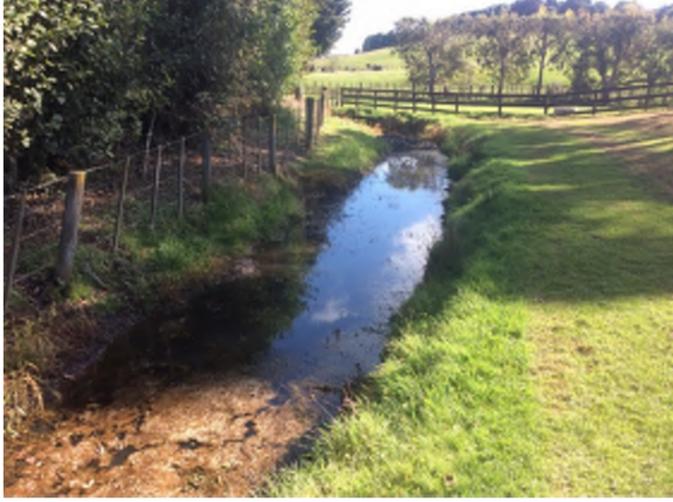
MKG_05	<p>Two neighbouring residents reported erosion issues and sedimentation of the waterways on the western perimeter of their properties, which are downstream of market gardens. The stream has deep, fine sediment, with sediment benches present throughout the reach. Large amounts of filamentous algae are present on the substrate. Further downstream, the stream surface is covered in red-brown algae and gas bubbles are evident on disturbance. Springs were common and appear to be contributing to bank erosion in places. There is evidence of slumping along both banks. Ponding is occurring at one point of the reach due to a build-up of rock washed from the neighbouring glasshouses.</p>

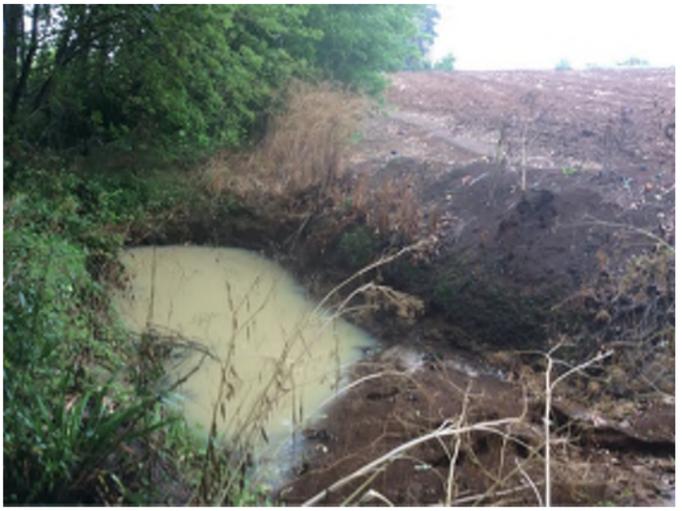
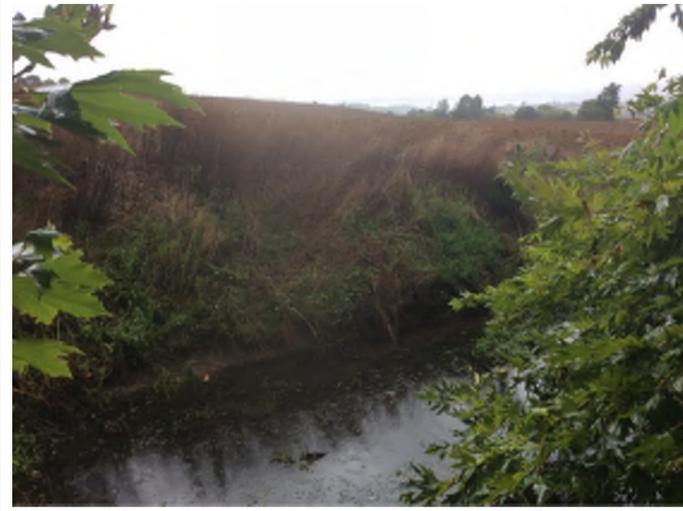
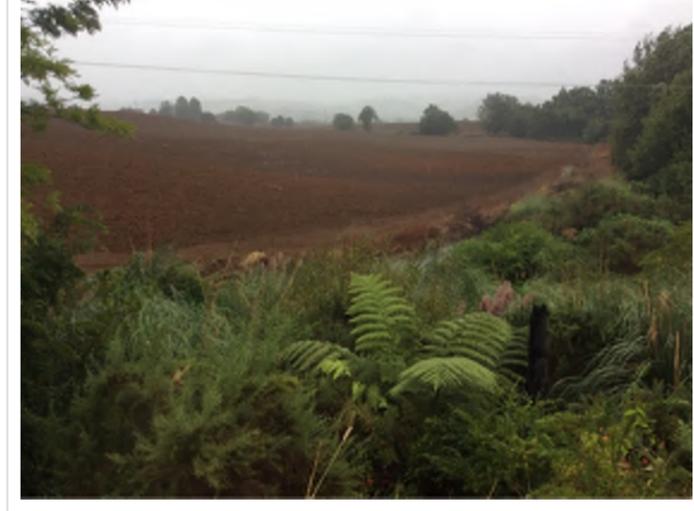
<p>MKG_06</p>	<p>The stream reach is between two market garden lots, with evidence of loose fine sediment to 0.5 m depth in the stream. On the True Left Bank there is exposed soil which has been recently dug over approximately 2 m from stream edge, with minimal to no vegetated buffer. Severe erosion also noted at outlet from dam, indicating damaging flashy stream flows during rain events.</p>

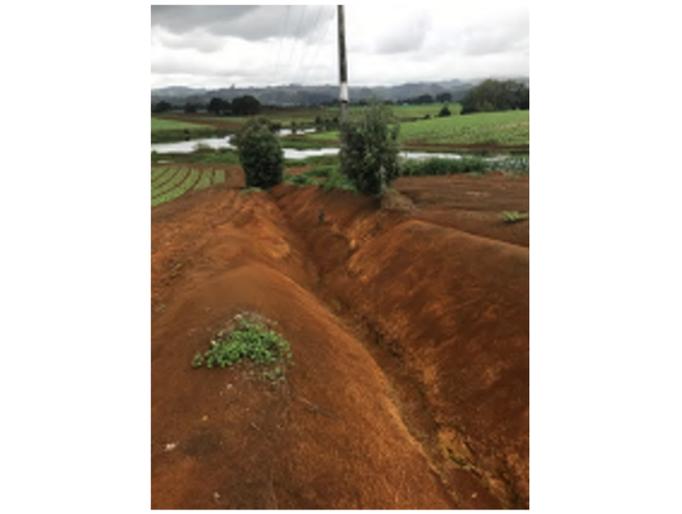
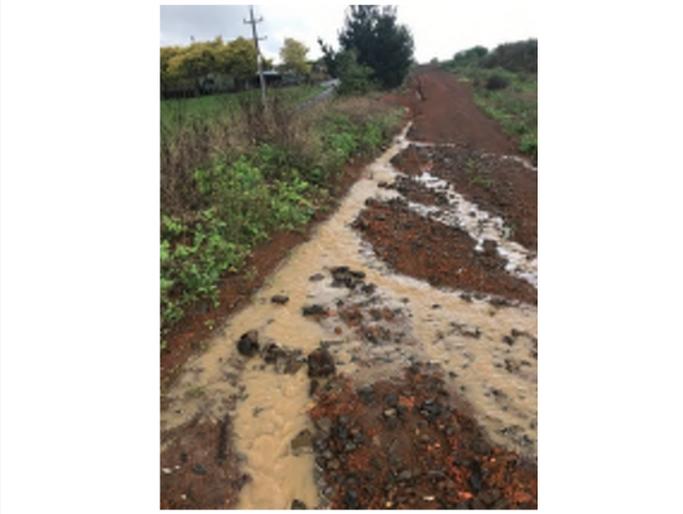
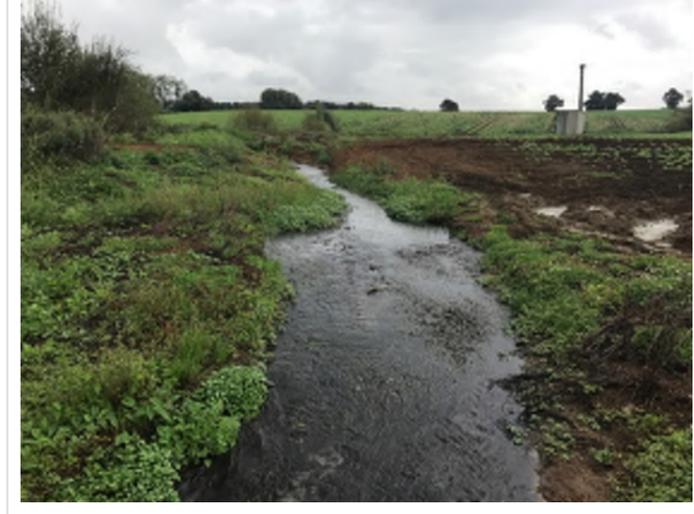
<p>MKG_07</p>	<p>Overland scour noted to be flowing into the farm ponds on the market garden land. Downstream reaches were noted to have high sediment percentages (70%). Ponds in this locality were noted to have high presence of algae.</p>

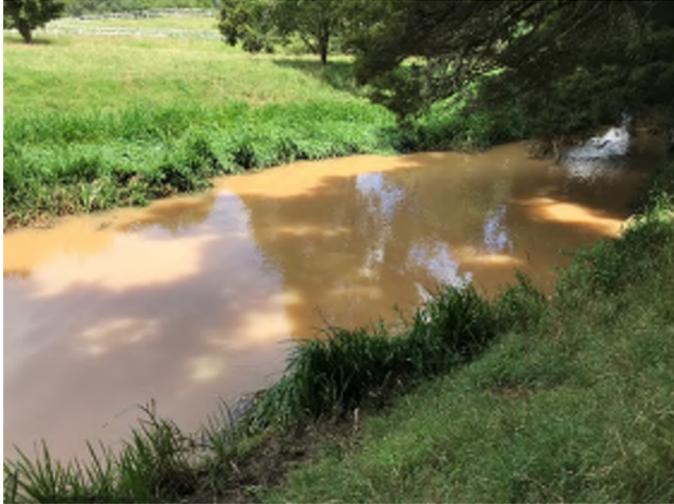
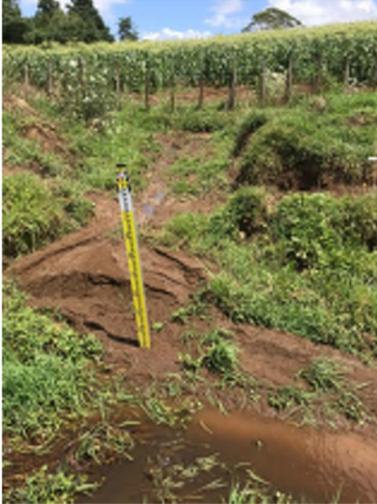
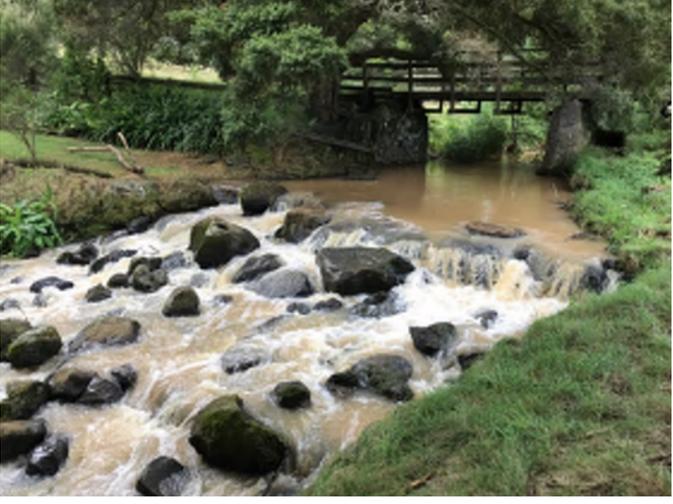
ID	Issue Description	Site Example One	Site Example Two	Site Example Three
MKG_08	Significant soil run off going into the stream reaches from the market garden. Evidence of the effects of this can be seen in the discolouration of the water downstream of the market garden site.

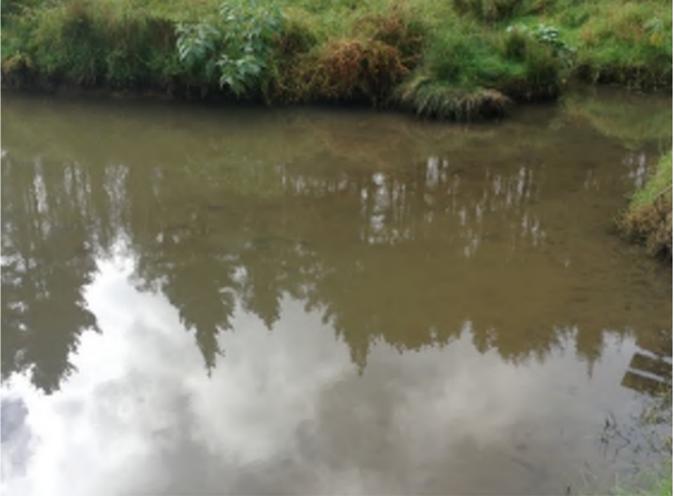
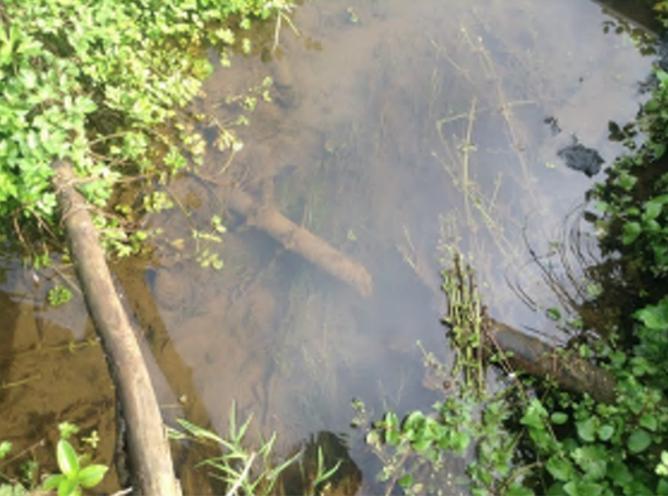
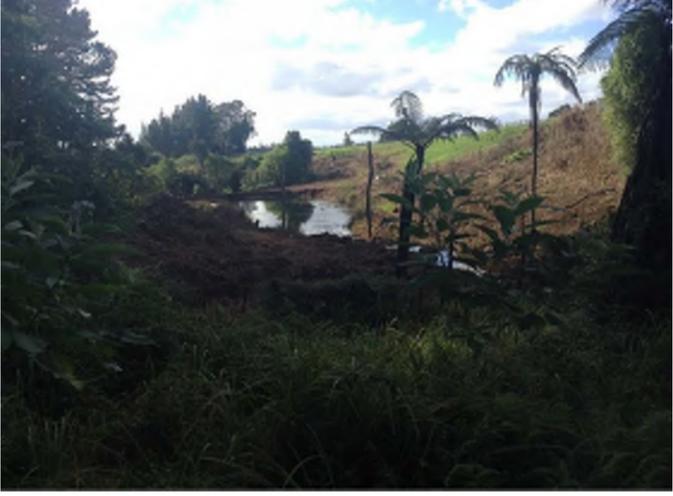
MKG_01	Large, shallow farm pond with evidence of heavy sediment deposition and Potentially associated with sub-division works upstream and potentially unconsented dam. Not associated with market gardens.

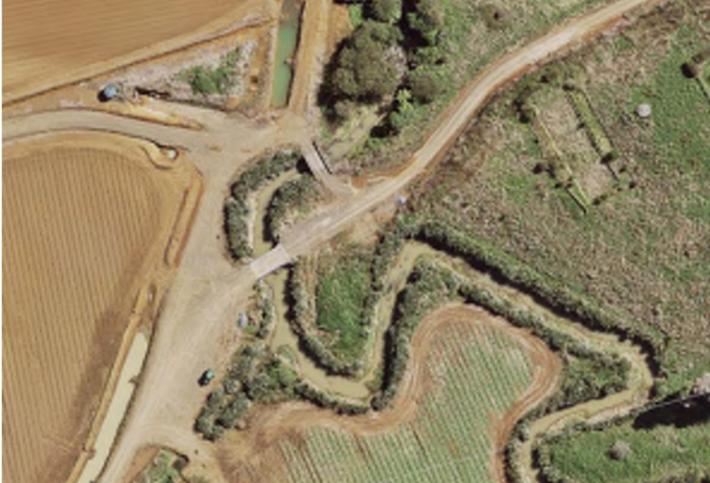
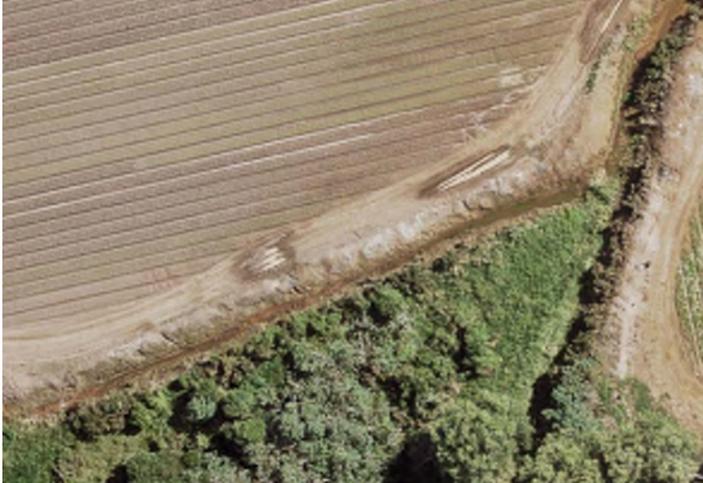
MKG_09	Extensive market gardens within this property, however access was not possible for the field teams. From the aerial photography the riparian vegetation is set back 5 m for many reaches, streams appear to have high turbidity. No on-site photos available.

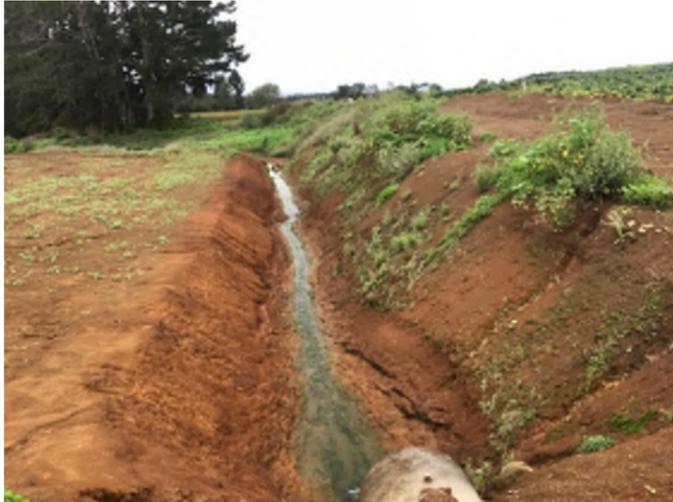
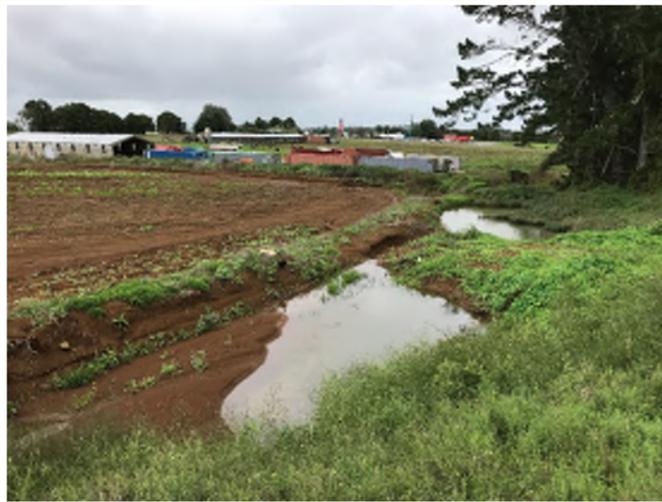
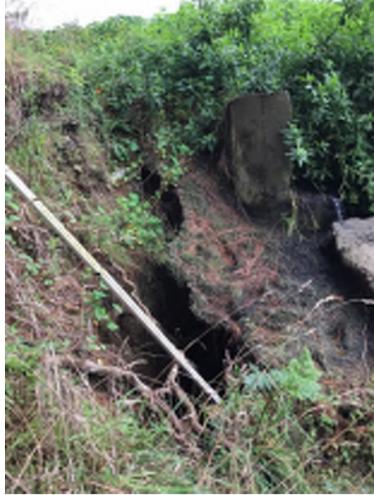
ID	Issue Description	Site Example One	Site Example Two	Site Example Three
MKG_13	<p>Exposed earth no riparian buffers present. Online sediment pond with large benches of deposited sediment.</p> <p>Redundant culvert crossing downstream with outlet structure collapsed and severe erosion.</p>

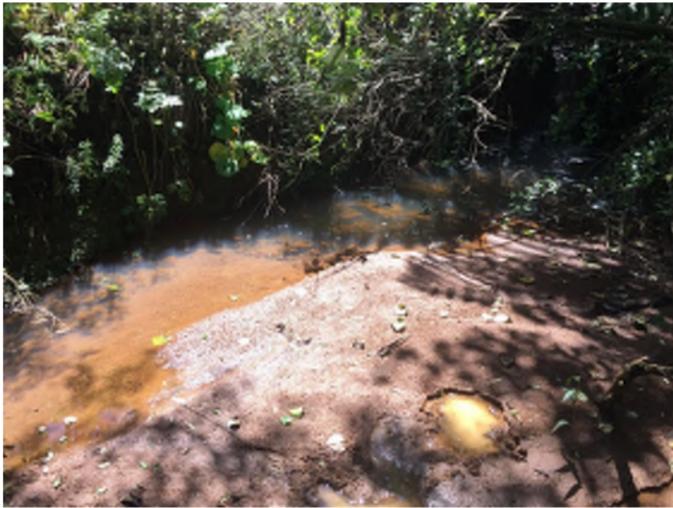
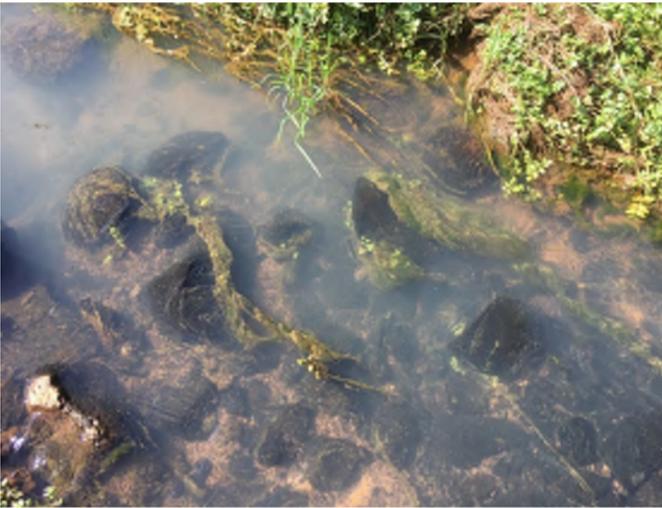
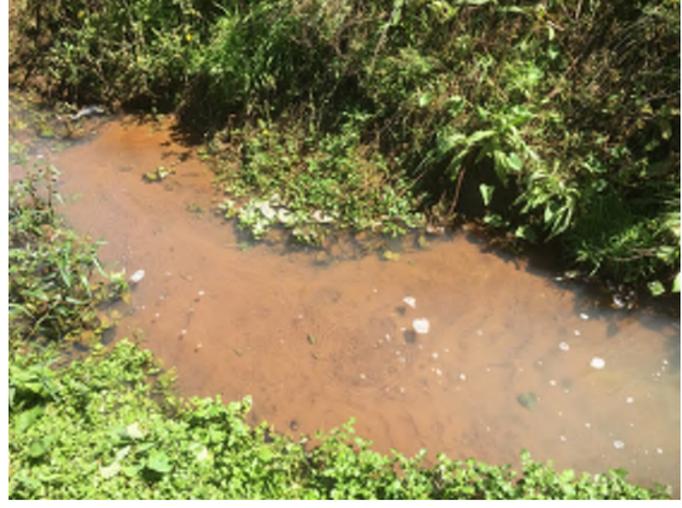
MKG_10	<p>The market gardens are located on both banks of the channel. The water was cloudy. The channel has large benches of poorly consolidated sediment. Further upstream, reaches are predominantly hard bottom but with a layer of fine sediment.</p>

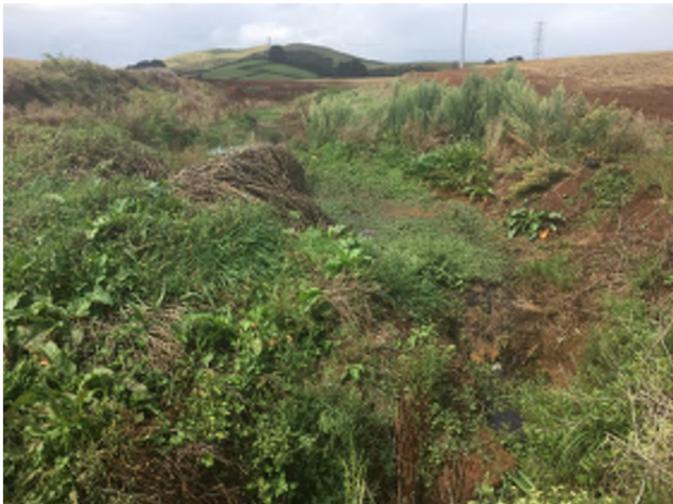
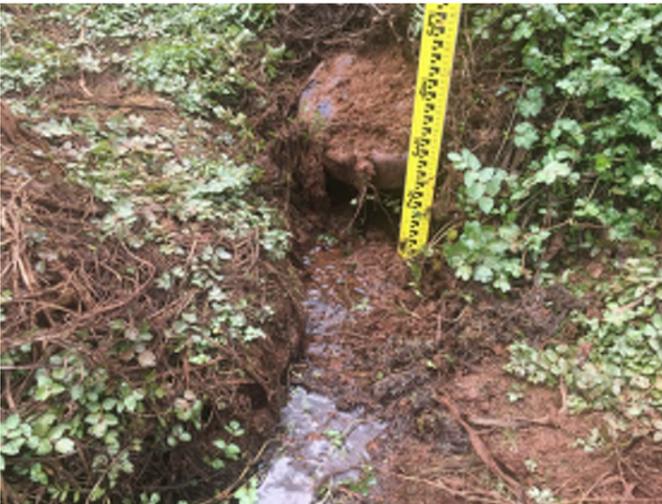
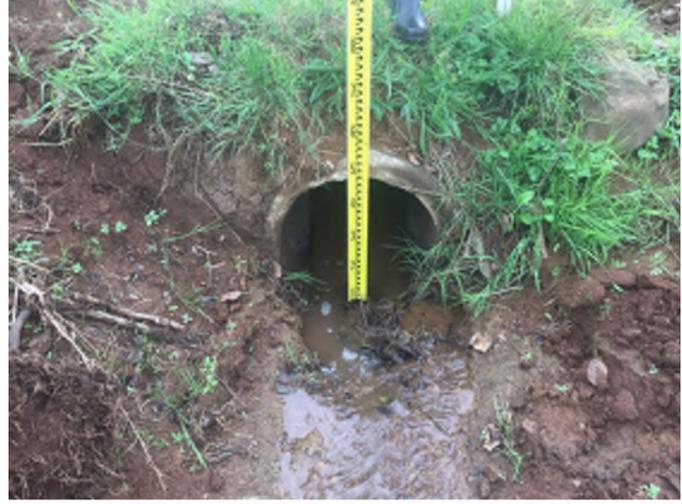
MKG_11	<p>The stream reach is between two market garden lots, with evidence of fine sediment deposition.</p>

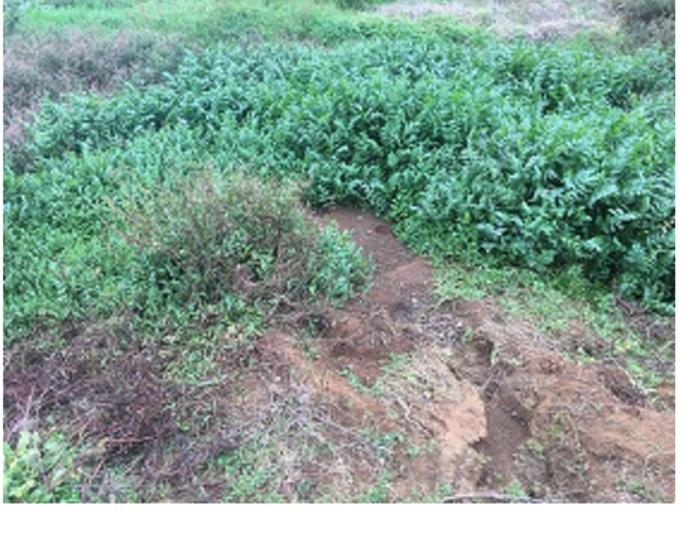
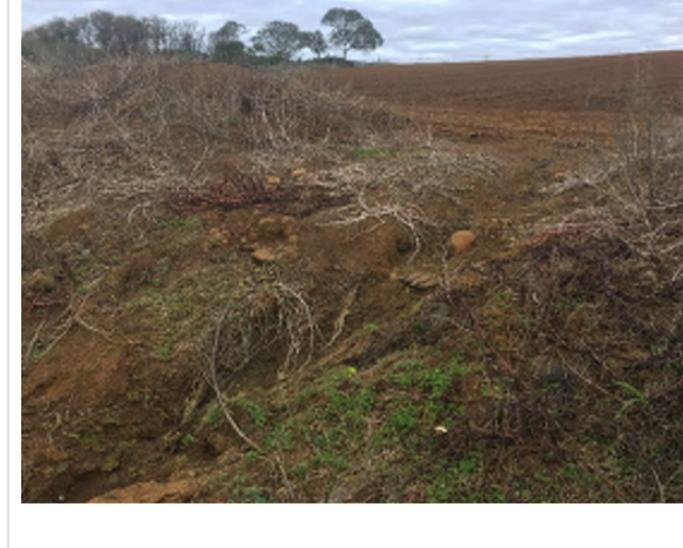
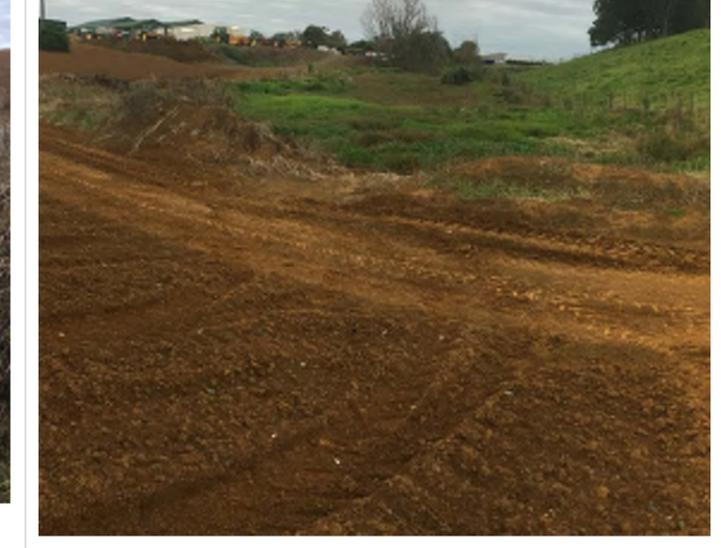
<p>MKG_03</p>	<p>Immediately adjacent to market garden on TLB. Wide stream dominated by water celery, which provide the only shade to the water's surface. Gap in bund at downslope end of large market garden. Evidence of channels forming from the market garden, with soil runoff going straight into stream. Large sediment bench across channel at this location. On a return visit to this reach, a thin hydrocarbon sheen on water surface and a strong fuel odour was noted.</p>

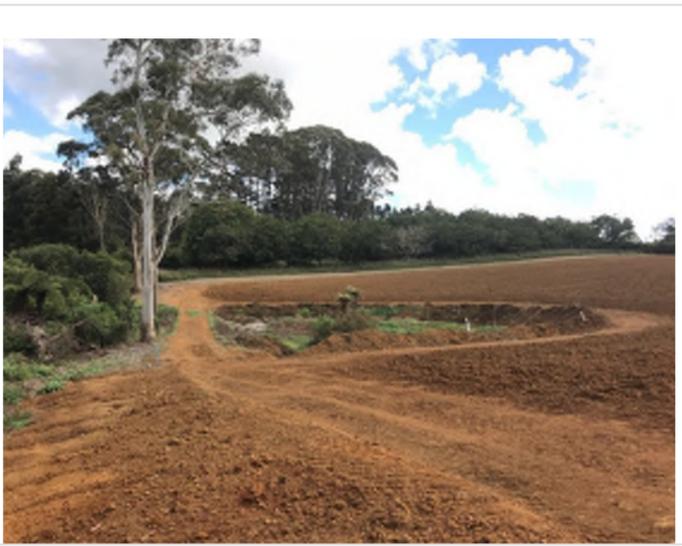
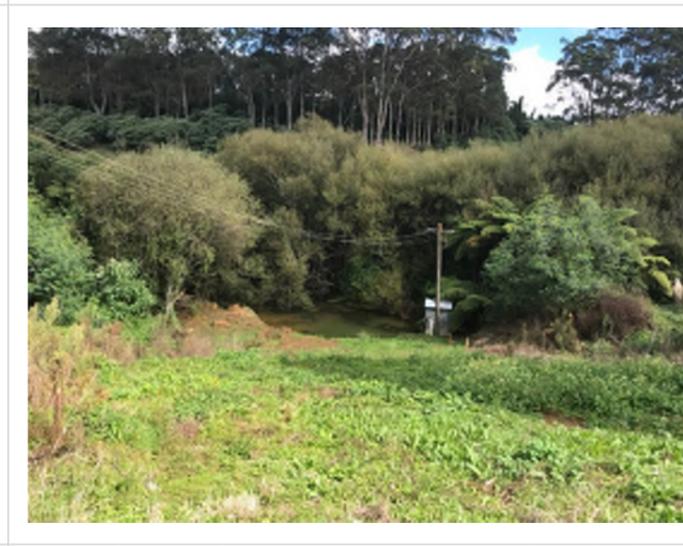
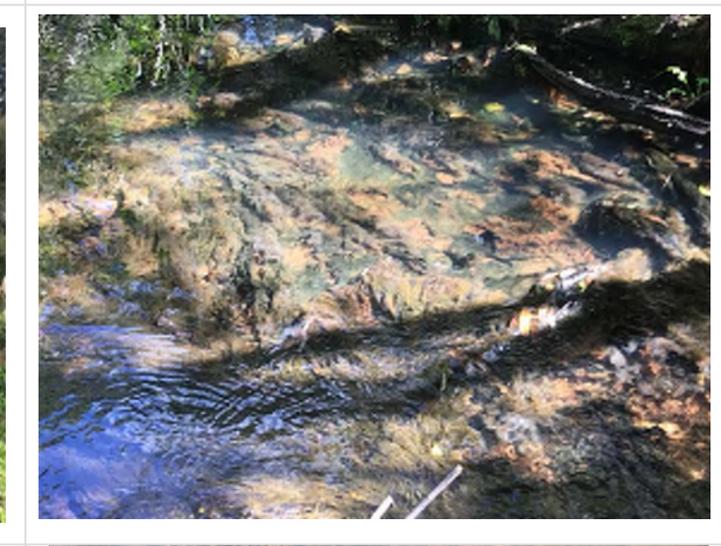
<p>MKG_02</p>	<p>Farm pond within boundaries of market garden. Pond has high algal growth, indicating excess nutrients in the waterway. Discharge to direct to main stream on southern perimeter via 400mm culvert. The main stream is dominated by willows and has high sediment deposition and dense mats of a variety of periphyton in-stream</p>

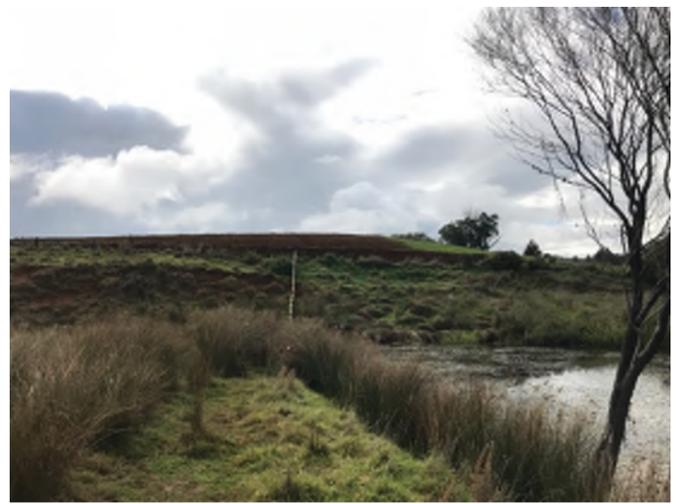
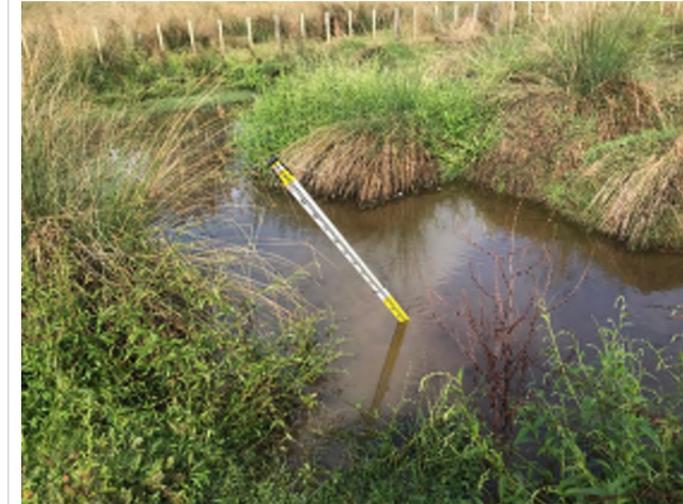
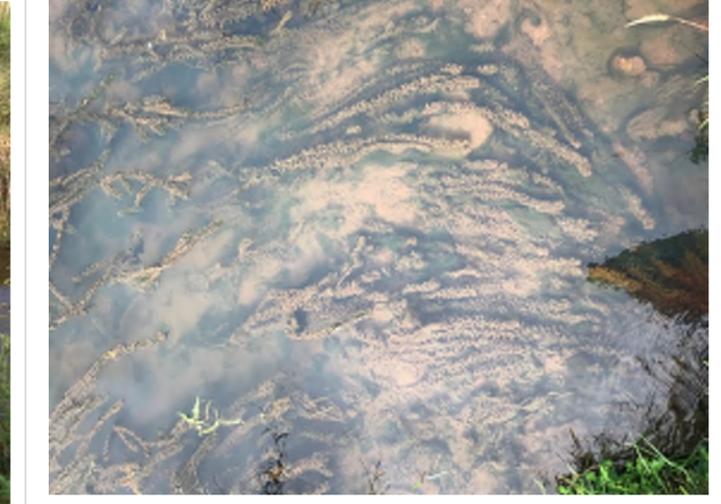
<p>MKG_04</p>	<p>Sediment deposition in a number ponds and waterways on the western border of the market gardens. Unconsolidated sediment depth of 0.7m noted in some ponds. Resident commented on recent construction of bund at the top of the hill to control sedimentation, but that high sediment discharge still occurs during rain events. Extensive riparian planting undertaken downstream.</p>
