Oira Catchment Watercourse Assessment Report (Draft)

June 2017

Oira Catchment

Watercourse Assessment Report

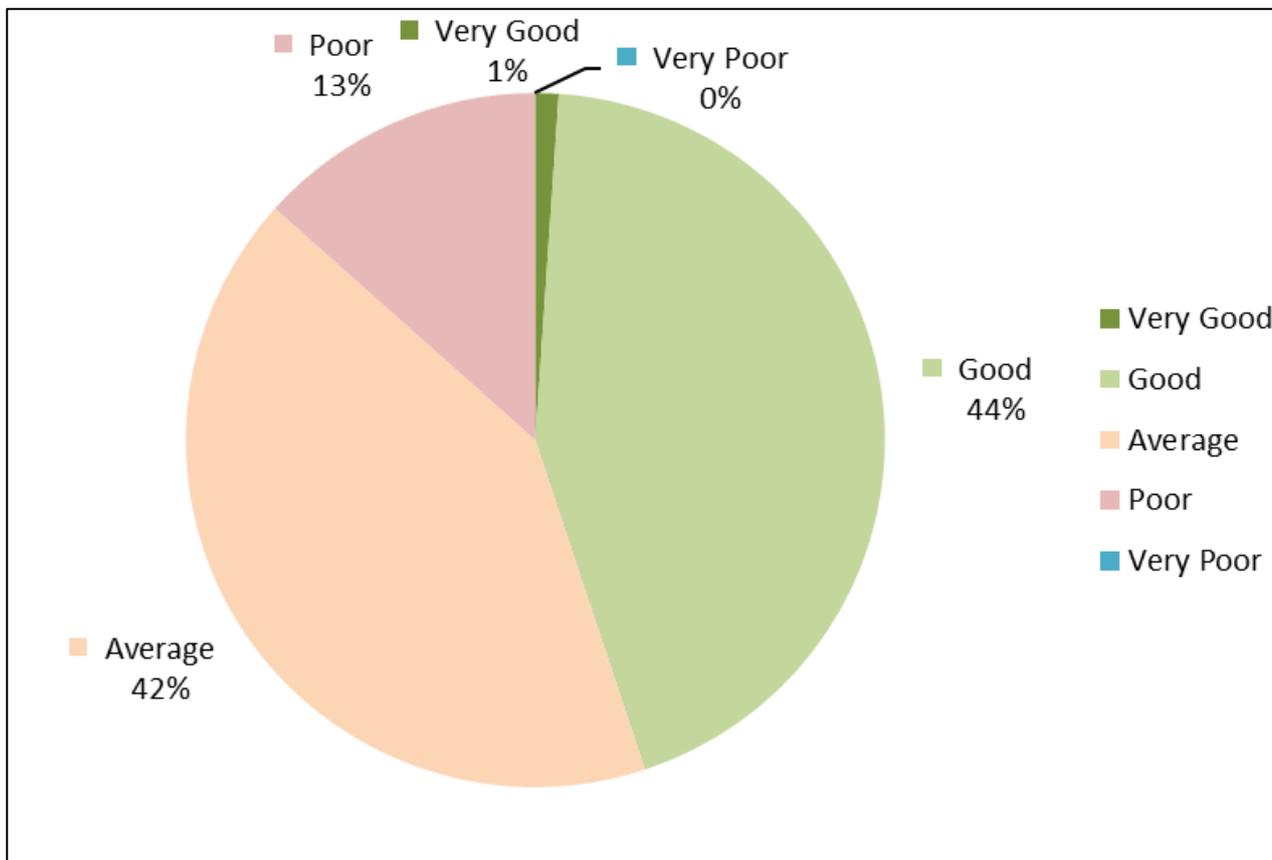
Figure 4: Oira Creek Outlets and Inlets Structures Condition Rating (of rateable inlets/outlets).

Most assets in the catchment were either in ‘average’ condition or in ‘good’ condition, representing 86% of rateable inlets/outlets (refer **Error! Reference source not found.**), and

27% of all inlets/outlets. Twenty-five inlets/outlets were considered in 'poor condition', representing 13% of rateable assets, and 4% of all assets. Two assets were in 'very good' condition and none were identified as being in 'very poor' condition.

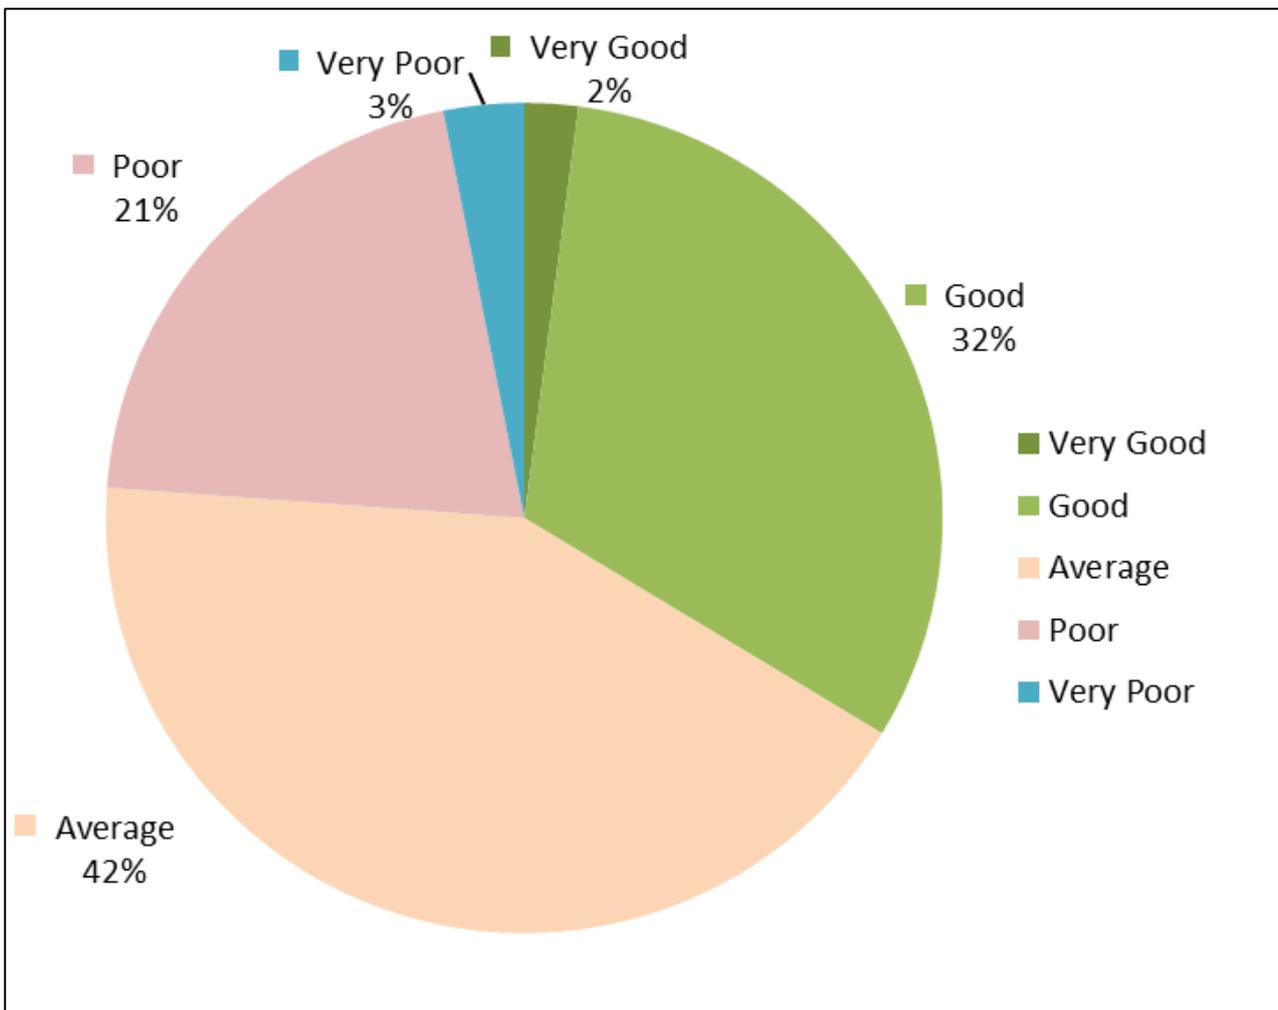
Figure 6: Oira Creek Culverts and Pipes Condition Rating (of rateable culverts/pipes).

Overall, approximately 50% of all culverts and pipes (representing 79% of rateable assets) in the catchment required some form of maintenance. Assets which had a condition rating of 'average', to 'poor' typically required structural repair, replacement or patching. Generally, assets with a rating of 'Average' required erosion protection and assets with a rating of 'good' required no maintenance; however, 64 pipes/culverts were noted as requiring routine maintenance by means of vegetation clearance or debris clearance. Vegetation clearance was required at two Auckland Council owned culverts. Erosion protection was required at the unknown owned pipe.

It is recommended these are the focus of any maintenance activities and should be communicated to the asset owner.

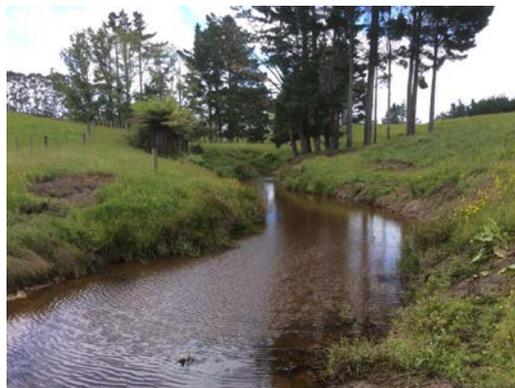
| Notes | <p>In its present state, the stream running through this enhancement opportunity is unfenced, unplanted and has been impacted by stock damage. Erosion issues are also present at the culverts leading into and out of the area.</p> <p>The land owner expressed an interest in fencing and replanting the area and as this site has good public visibility from State Highway 22, an excellent opportunity exists to involve the community in any enhancement project, thus improving the amenity value of the site. This could be achieved by involving school children from the nearby Karaka School in replanting the stream margins with native vegetation.</p> | | | | | | | |

Unfenced, unplanted section of stream

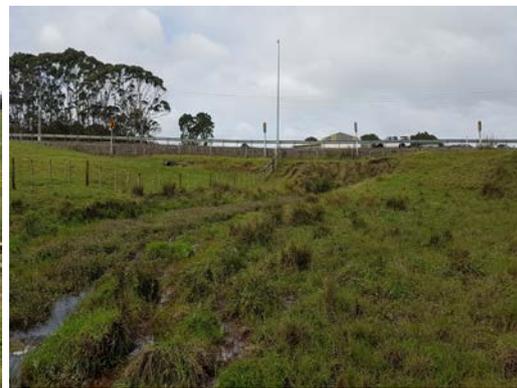
Stream visible from SH22

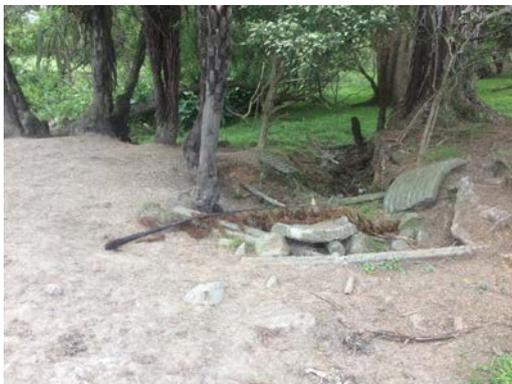
| Notes | <p>A wide, low gradient flood plain exists around a poorly channelised stream. The flood plain is currently dominated by weed species and is littered with debris and rubbish. The stream has the potential to offer good bankside spawning habitat but needs to be replanted with native species. The habitat could be further enhanced by removing the debris and rubbish, which may also present a future conveyance issue if left.</p> <p>At the upstream end of the site, improvements could be made to the artificial online pond. Some erosion issues, where trees have been felled are present, while the culvert that was in place appears to no longer function. The overflow channel may also be impacting fish passage upstream.</p> | | | | | | | |

Rubbish around old pond outlet point

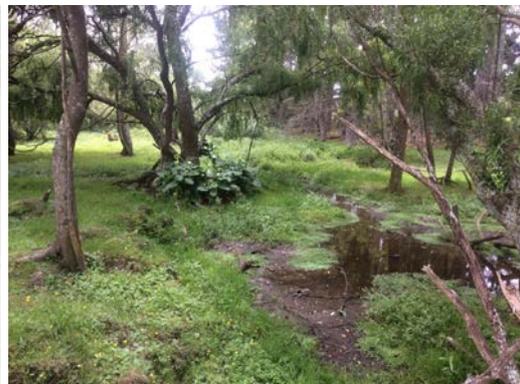
Weed infested low gradient banks

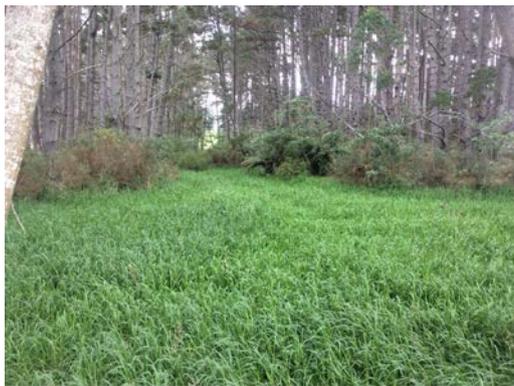
| Notes | <p>A series of farm ponds and perched culverts have likely created significant ecological and conveyance issues throughout this area. Poor drainage has resulted in a serious build-up of the noxious weed <i>Glyceria</i>. This ecologically damaging species, reduces the conveyance capacity of streams and rivers and poses a health risk to livestock (see section 3.1.3 for more details).</p> <p>While removing <i>Glyceria</i> from all three stream channels would require extensive weed control, large-scale clearances are economically cheaper than small scale clearances, in terms of a reduction of infested area per unit invested (Loo et al. 2009). In the upper catchment (eastern fork) there are currently landowners who are controlling <i>Glyceria</i> via spraying, therefore it is likely that approaching landowners to help combat the problem would be positively received. Improving the riparian margins within the reaches would also help to reduce the risk of infestations returning.</p> <p>Reconnecting the stream network through replacement of culverts that are perched above the water table would also provide benefits to the watercourse. A more consistent flow may help prevent <i>Glyceria</i> establishing across the channel, while the removal of significant fish barriers would improve the accessibility of upstream areas to native fish species.</p> | | | | | | | |

Glyceria choked watercourse

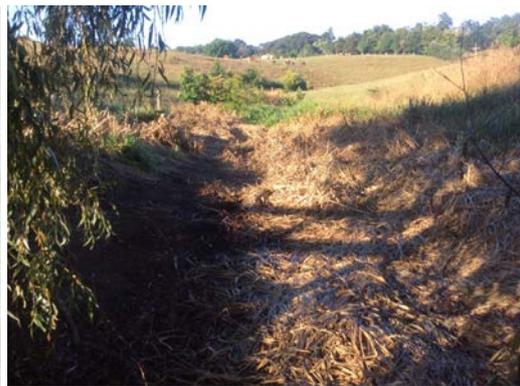
Stream section sprayed to control *Glyceria*

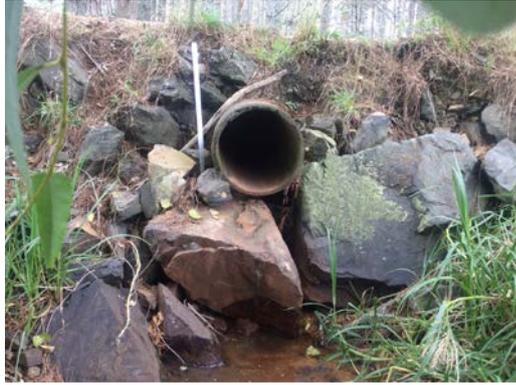
Perched culvert at downstream end of EO

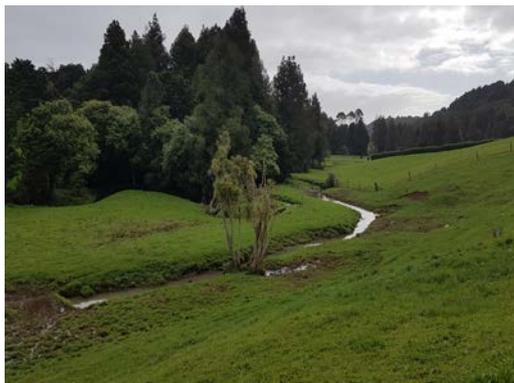
| Notes | <p>The streams running through this section of the catchment were observed to be the most degraded during the watercourse survey. A lack of fencing, combined with severe stock damage has resulted in significant erosion issues throughout the area, with multiple erosion hot spots identified.</p> <p>There is an overall absence of riparian vegetation and sections of the stream have been piped to increase the amount of space available for livestock grazing. Multiple perched culverts existed creating erosion issues and fish barriers are present. The incidence of mosquito fish presents further challenges to native fish.</p> <p>This area needs significant attention and the watercourse would benefit immensely from fencing and stock exclusion. Naturalising, including riparian vegetation planting and the daylighting of piped sections of stream would improve the stream function and increase habitat for native fish, while erosion protection and the incorporation of fish passage devices into many of the culverts would help to alleviate fish passage issues and culvert erosion.</p> <p>The proximity between this EO and EO_07 presents an opportunity to link the two areas forming a more continuous corridor of native riparian vegetation. A scenic reserve (SEA_T_5351) also exists directly downstream from this EO, providing further potential for ecological linkages.</p> | | | | | | | |

Unfenced, stock impacted watercourse

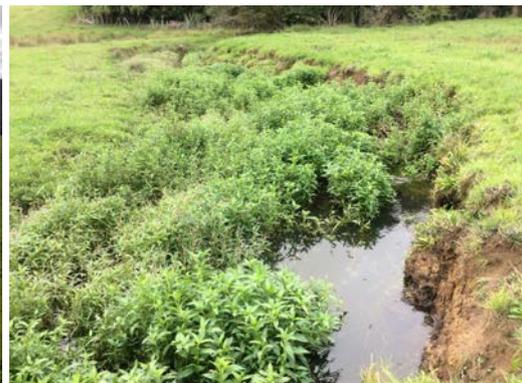
Eroded bank and thick macrophyte growth

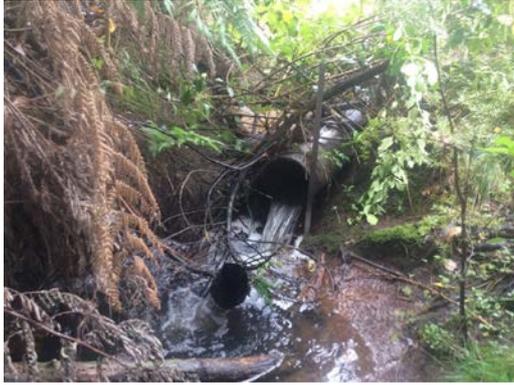
Perched culvert

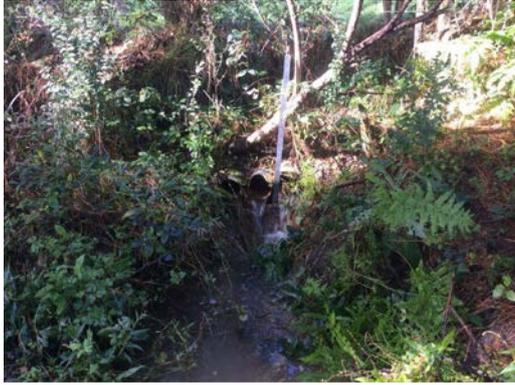
Undersized, perched culvert

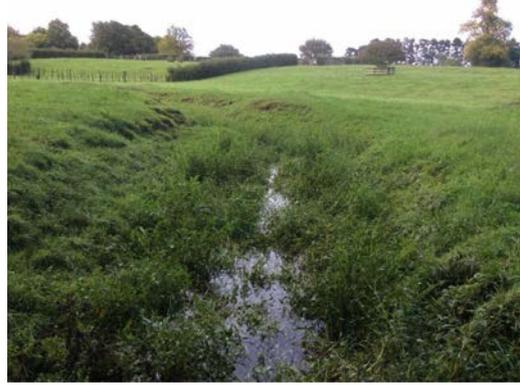
Unfenced, macrophyte choked watercourse

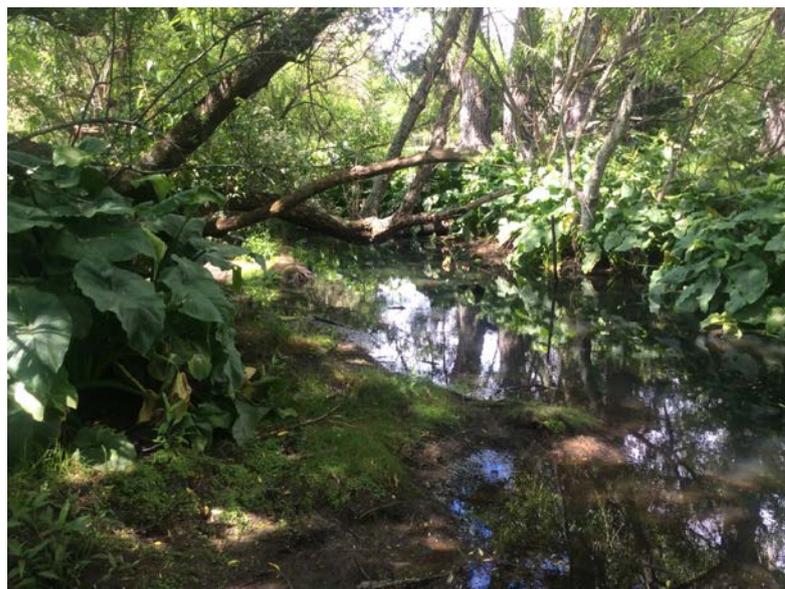
| Notes | <p>Two sections of the Oira Creek, in the lower catchment, are bound on the eastern side by land zoned as future urban. It is likely that the stream width along these sections is sufficient to trigger the requirement for the creation of an esplanade reserve when development of properties bordering the stream occurs.</p> <p>Any esplanade reserves would most likely become public/accessible land, increasing the amenity value of the stream. Developers also have a good opportunity to involve community groups with restoration projects, further boosting the amenity values. Riparian plants, removal of weed species and fencing (where stock may remain) would all be beneficial and help to improve the state of the stream.</p> | | | | | | | |

Stream section with multiple weed species.
