***DETAILED SITE INVESTIGATION
REMEDIATION ACTION PLAN
&
ASSESSMENT OF ENVIRONMENTAL EFFECTS
160 BREMNER ROAD
DRURY
AUCKLAND***

Project Name DSI, RAP & AEE
160 Bremner Road, Drury, Auckland
Project Number 0447.002.03
File Reference \\10.1.1.50\Focus Environmental Services\2016 Jobs\Bremner Road, Drury\01 Report\DSI Stage 1\160 Bremner Road\0447.002.03_DSI RAP & AEE.docx
Date August 2016

Detailed Site Investigation

Karaka & Drury Consultant Limited - 160 Bremner Road, Drury

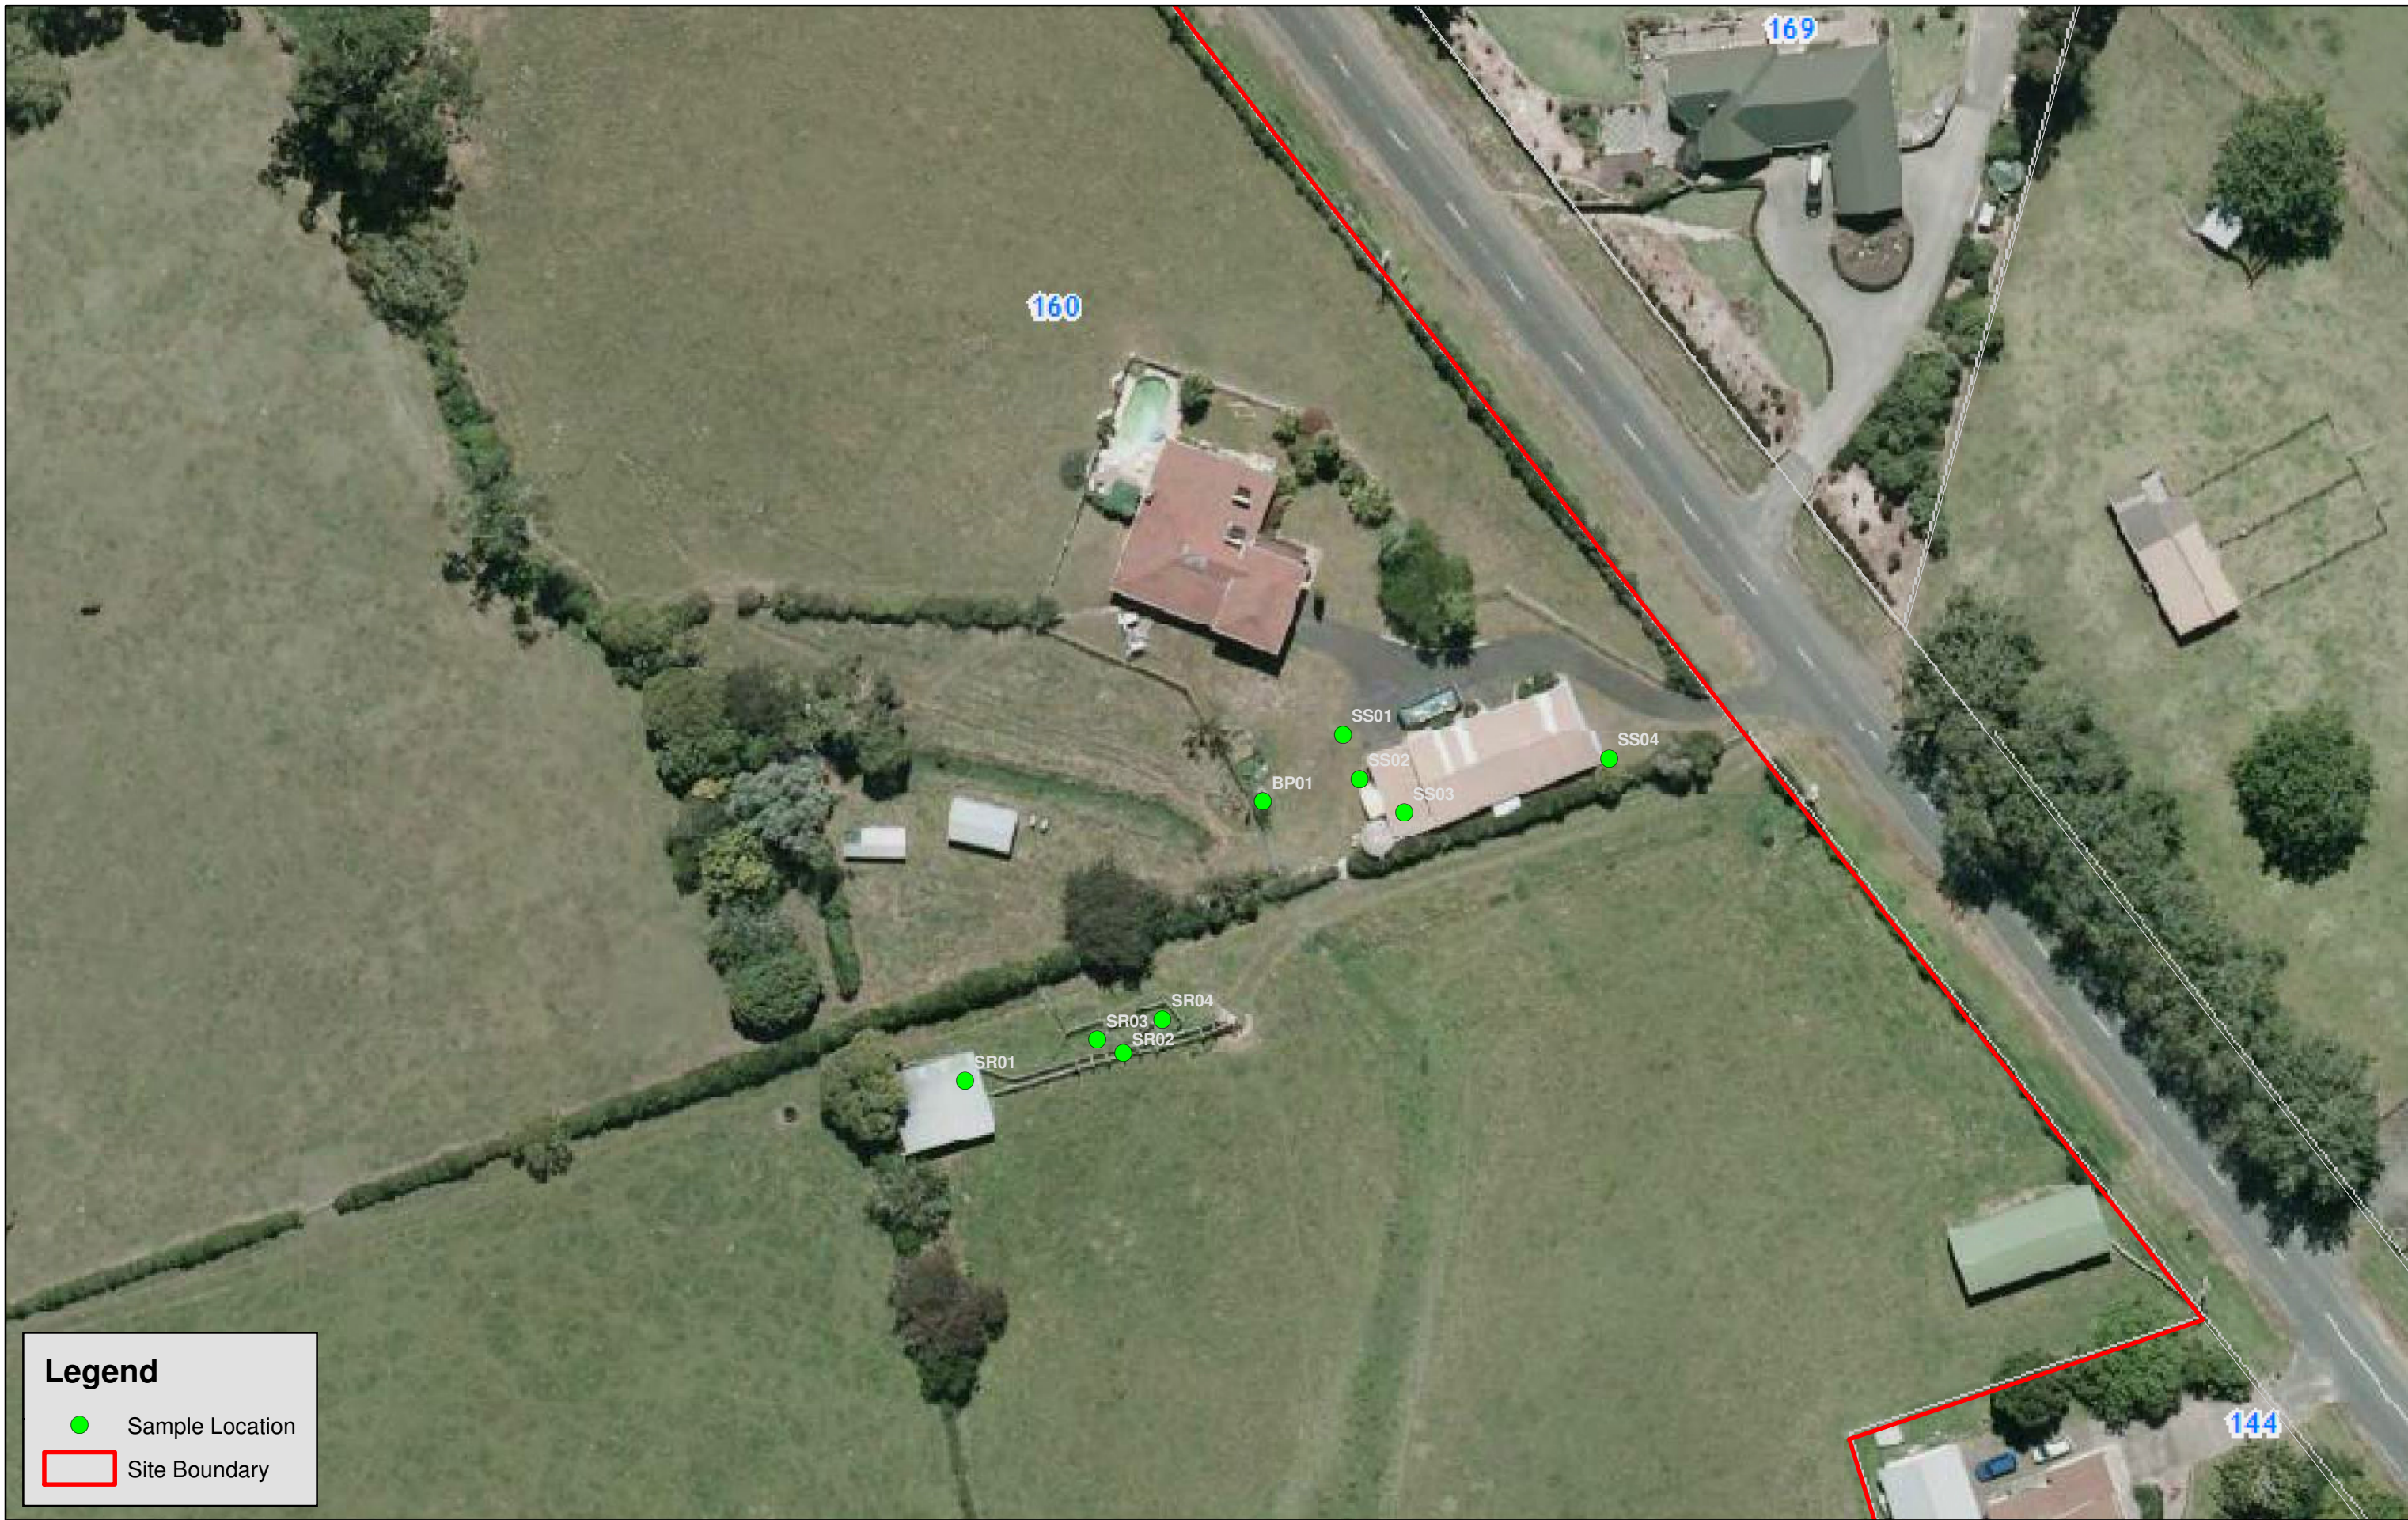
Figure 2 - Sample Location Plan

Four discrete surface samples (0.0-0.15 m) were taken from the area of the identified former printing workshop (160 SS01 - 160 SS04), one discrete surface sample (0.0-0.15 m) was taken from the area of burning identified (160 BP01), and four surface samples (0.0-0.15 m) were taken from the area of potential spray race operations (160 SR01 - 160 SR04)

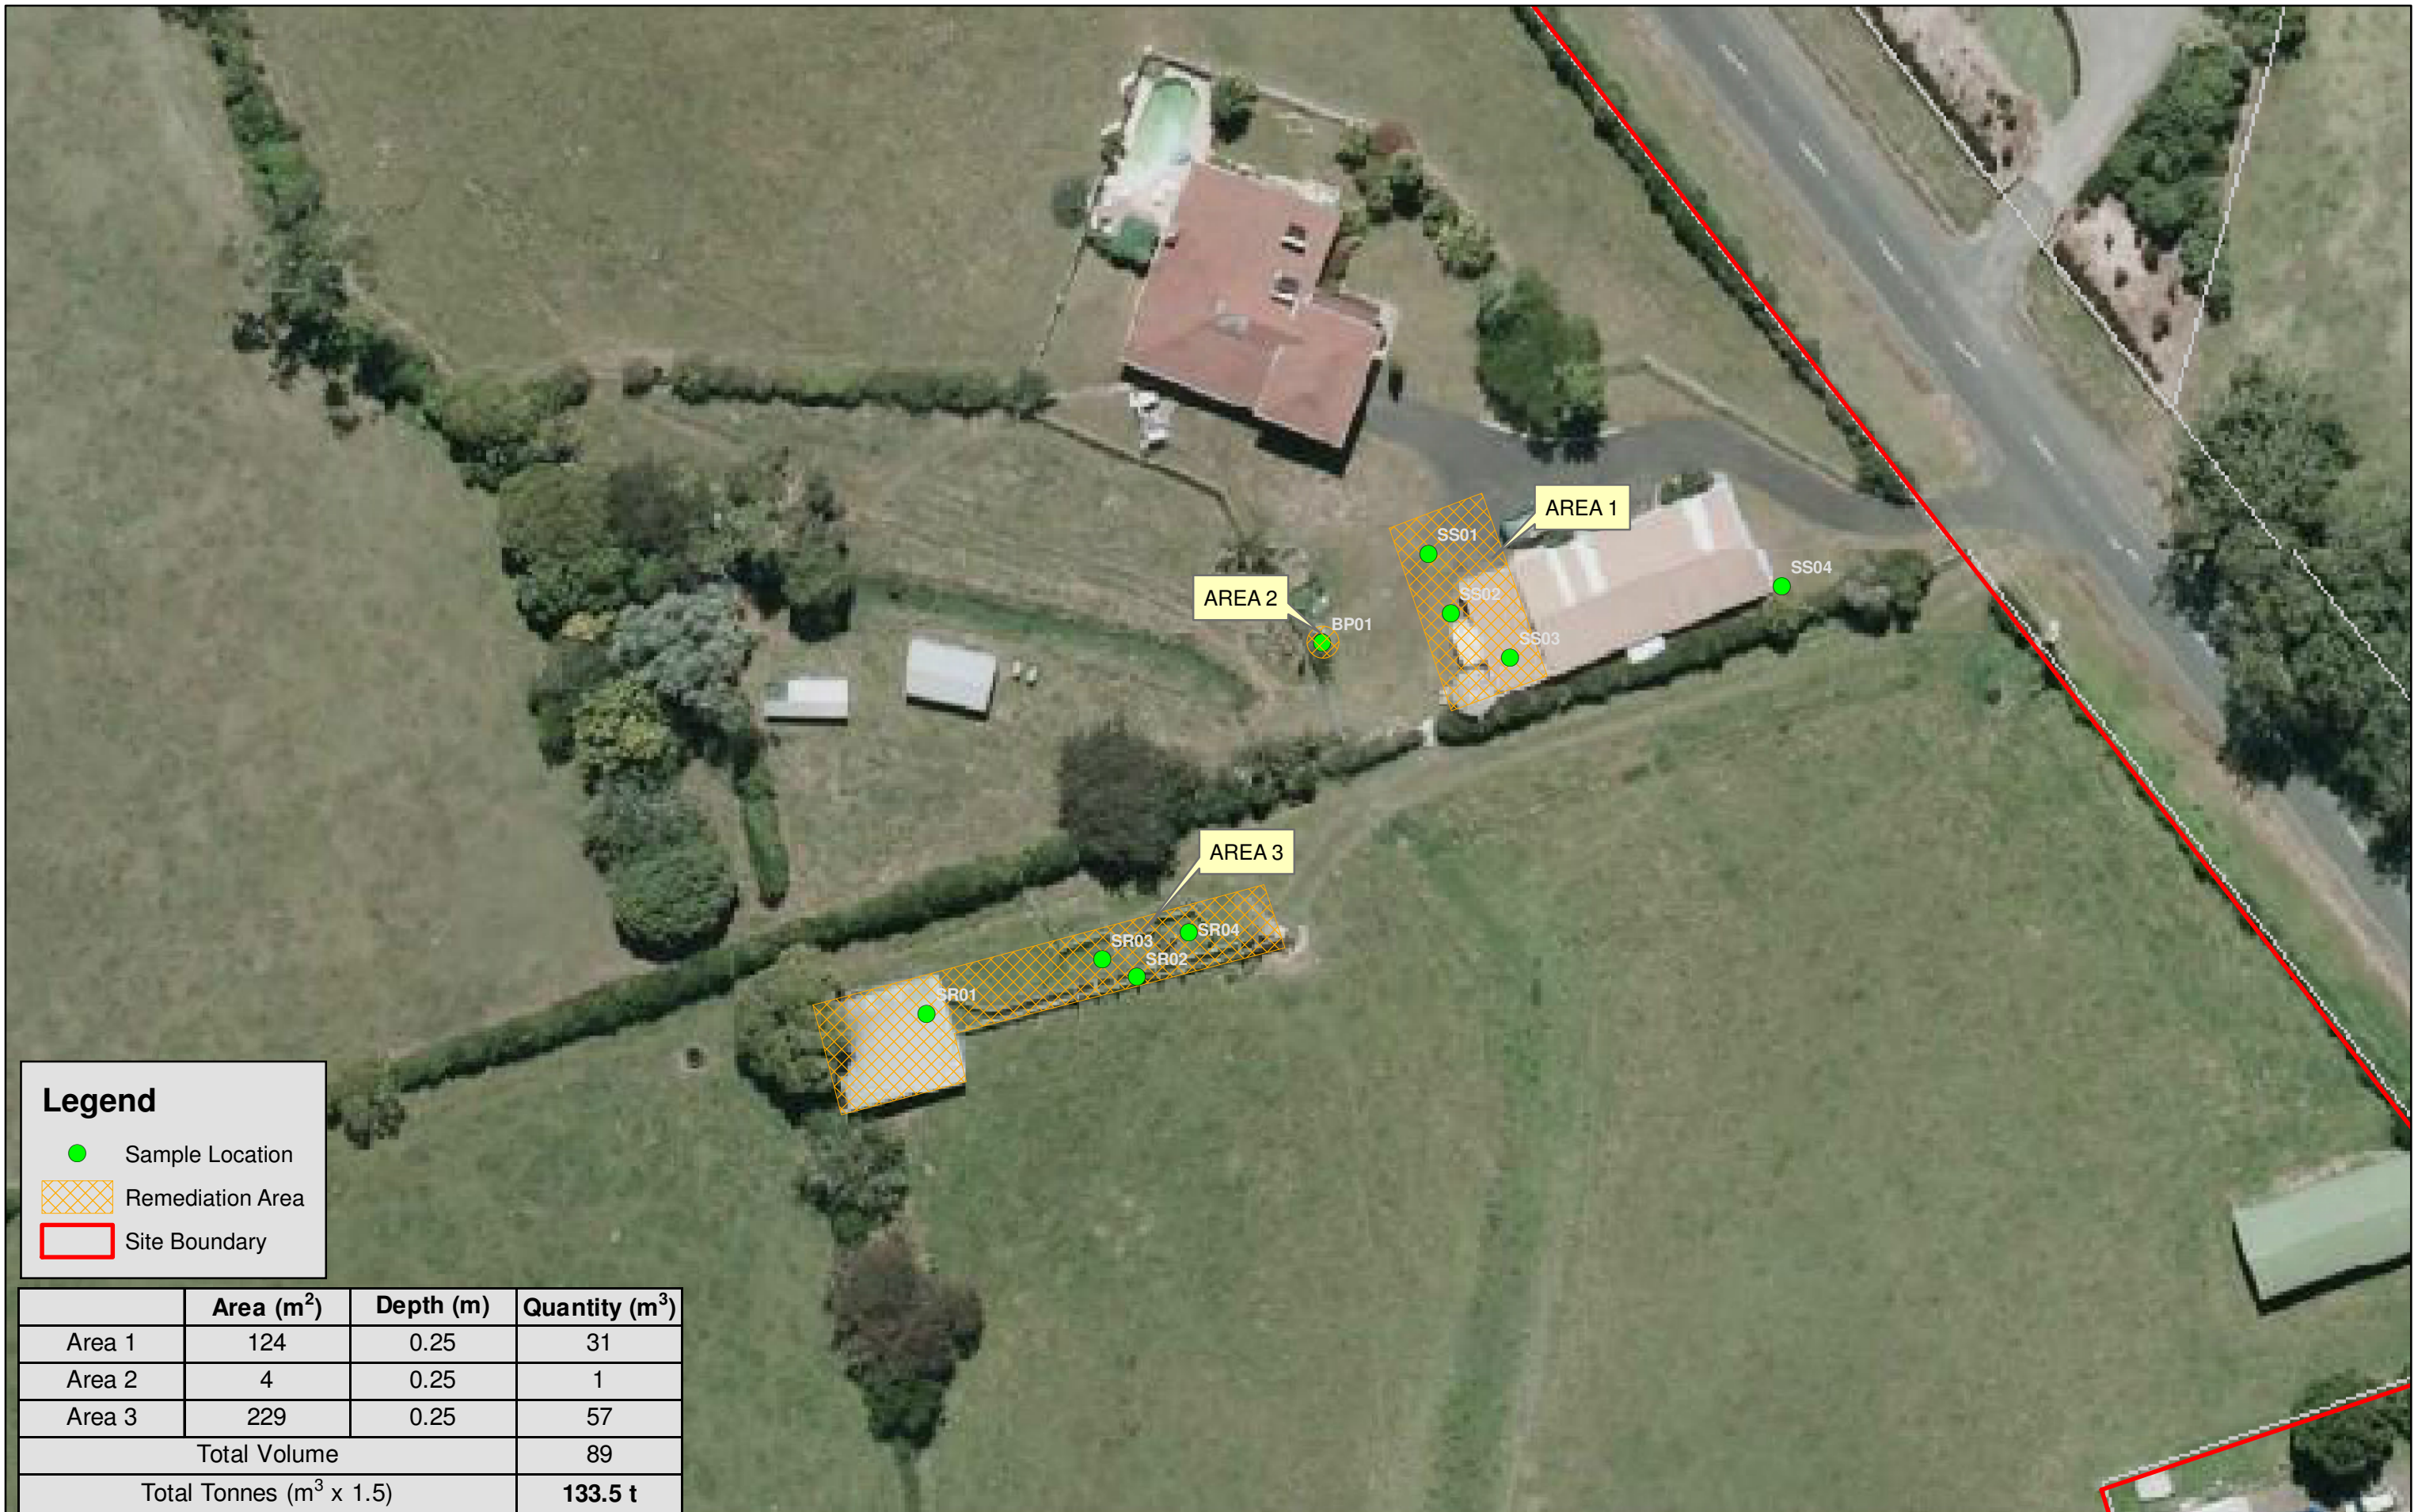
Figure 3 - Inferred Area and Depth of Contamination

The inferred extent of the contaminated soils at the site is presented in Figure 3. This estimate is based on the sampling and results available following the site investigation and it should be noted that the volume may increase or decrease following inspection, XRF screening and validation sampling.

The site at 160 Bremner Road, Drury will require remediation of the affected soils prior to being redeveloped. It will be necessary to cut up to a depth of 0.25 m below the existing ground level to complete the required remedial works. The estimated volume of heavy metal contaminated soil requiring remediation is 89 m³, it should be noted that these volumes may change during the remedial process.
