## The Tree Consultancy Company

**To:** Maureen Glassey – Principal Advisor, Auckland Council  
**From:** Andrew Benson – Urban tree ecophysiologicalist, The Tree Consultancy Company  
**cc:**  
**Date:** 13<sup>th</sup> October 2020  
**Re:** PRELIMINARY summary of findings – Western Springs Pines

The following information pertains to assessments of 198 standing pine trees (*Pinus radiata*) in Western Springs, Auckland, carried out between 21<sup>st</sup> September and 9<sup>th</sup> October 2020. It is a concise summary of our methods and findings and is provided as **PRELIMINARY** only. We expressly indicate at this stage that the data have not been fully checked and it may be that some of the numbers presented will change by the end of the week pending full data analysis and review.

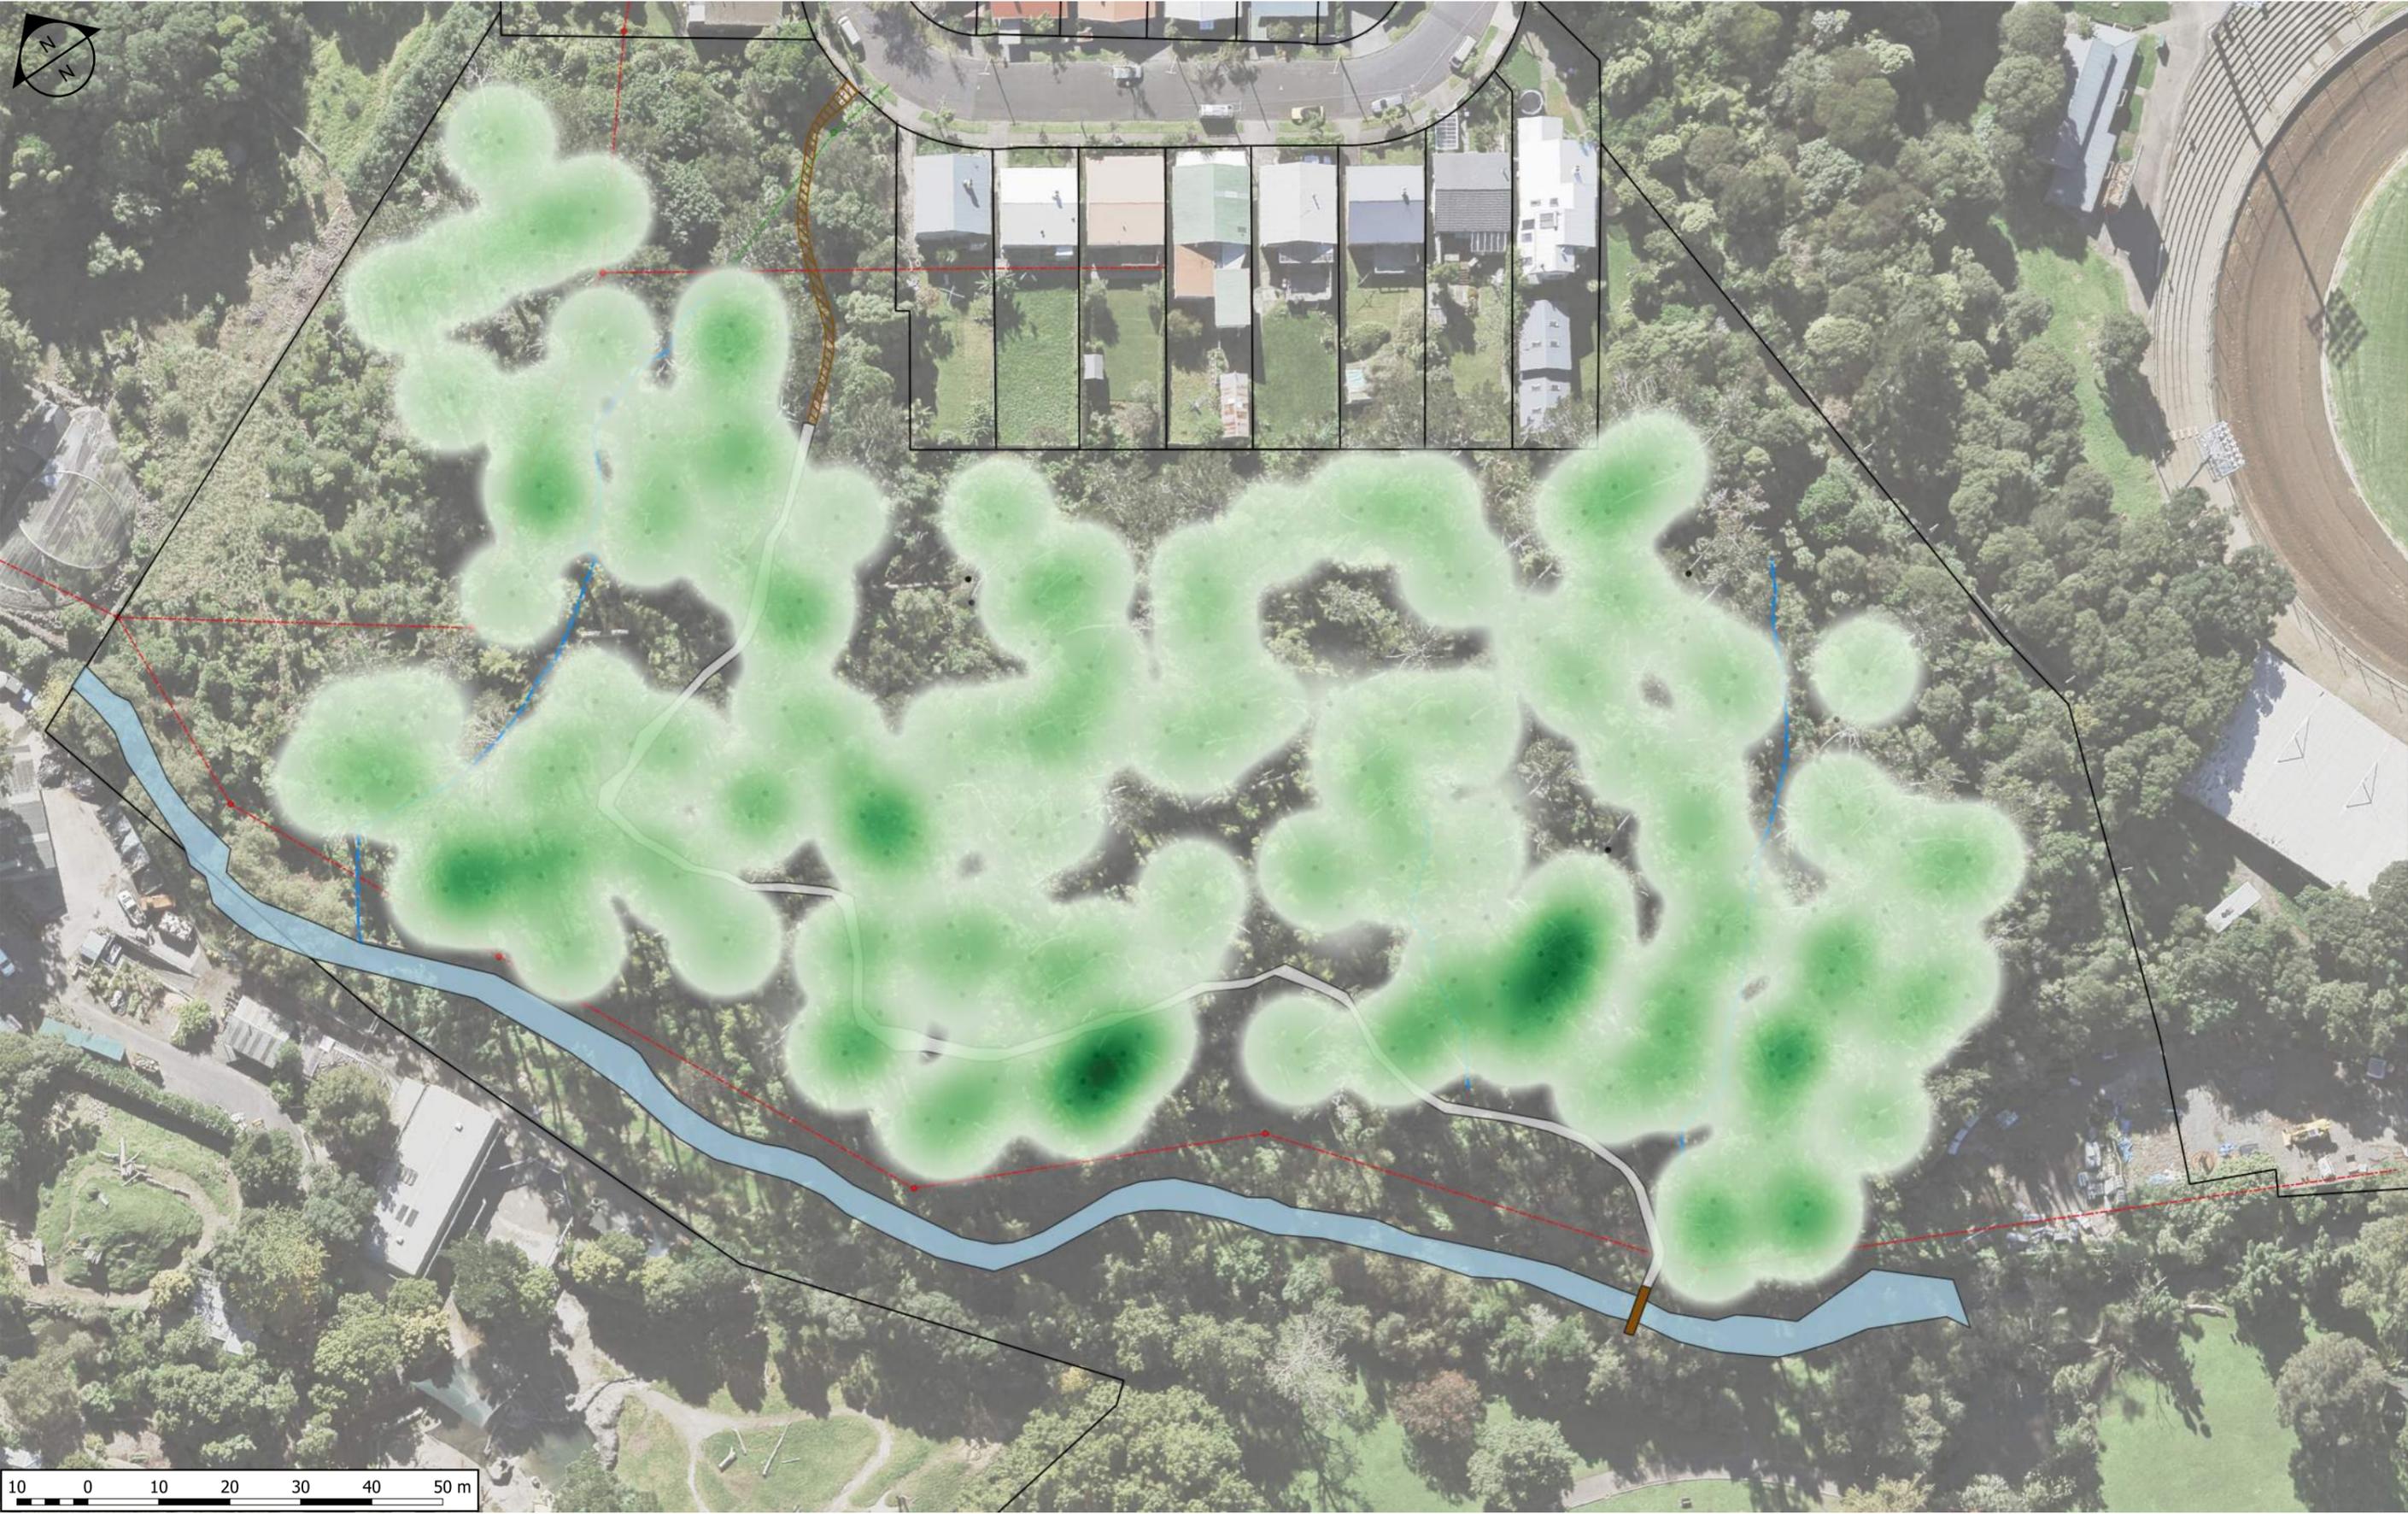
Western Springs Pine Forest  
Tree condition plan  
PRELIMINARY

- The stand of trees has been in decline since 1988 (Langston. P. W, 1988; Collett, 2018) and because of the above, will continue to decline.
- There are currently 31 standing dead trees (16%).

- There are currently 57 trees with < 50% live crown volume (29%).
- There are currently 83 trees with > 70% live crown volume (42%).
- Tree safety factors ranged from 0.44 to 1.26 (mean = 0.87) based on H:D ratios. The safety factor is computed using a known wind speed ( $22.5 \text{ ms}^{-1}$ ) and defines an order of magnitude at which stem breakage could be expected to occur. In essence, it is a measure of the tree's reliability to resist wind loading (Niklas, 2002). Most trees have a safety factor of at least 4.5 (Mattheck and Breloer, 1994), meaning they can withstand wind loads 4.5 times greater than the normal wind load.

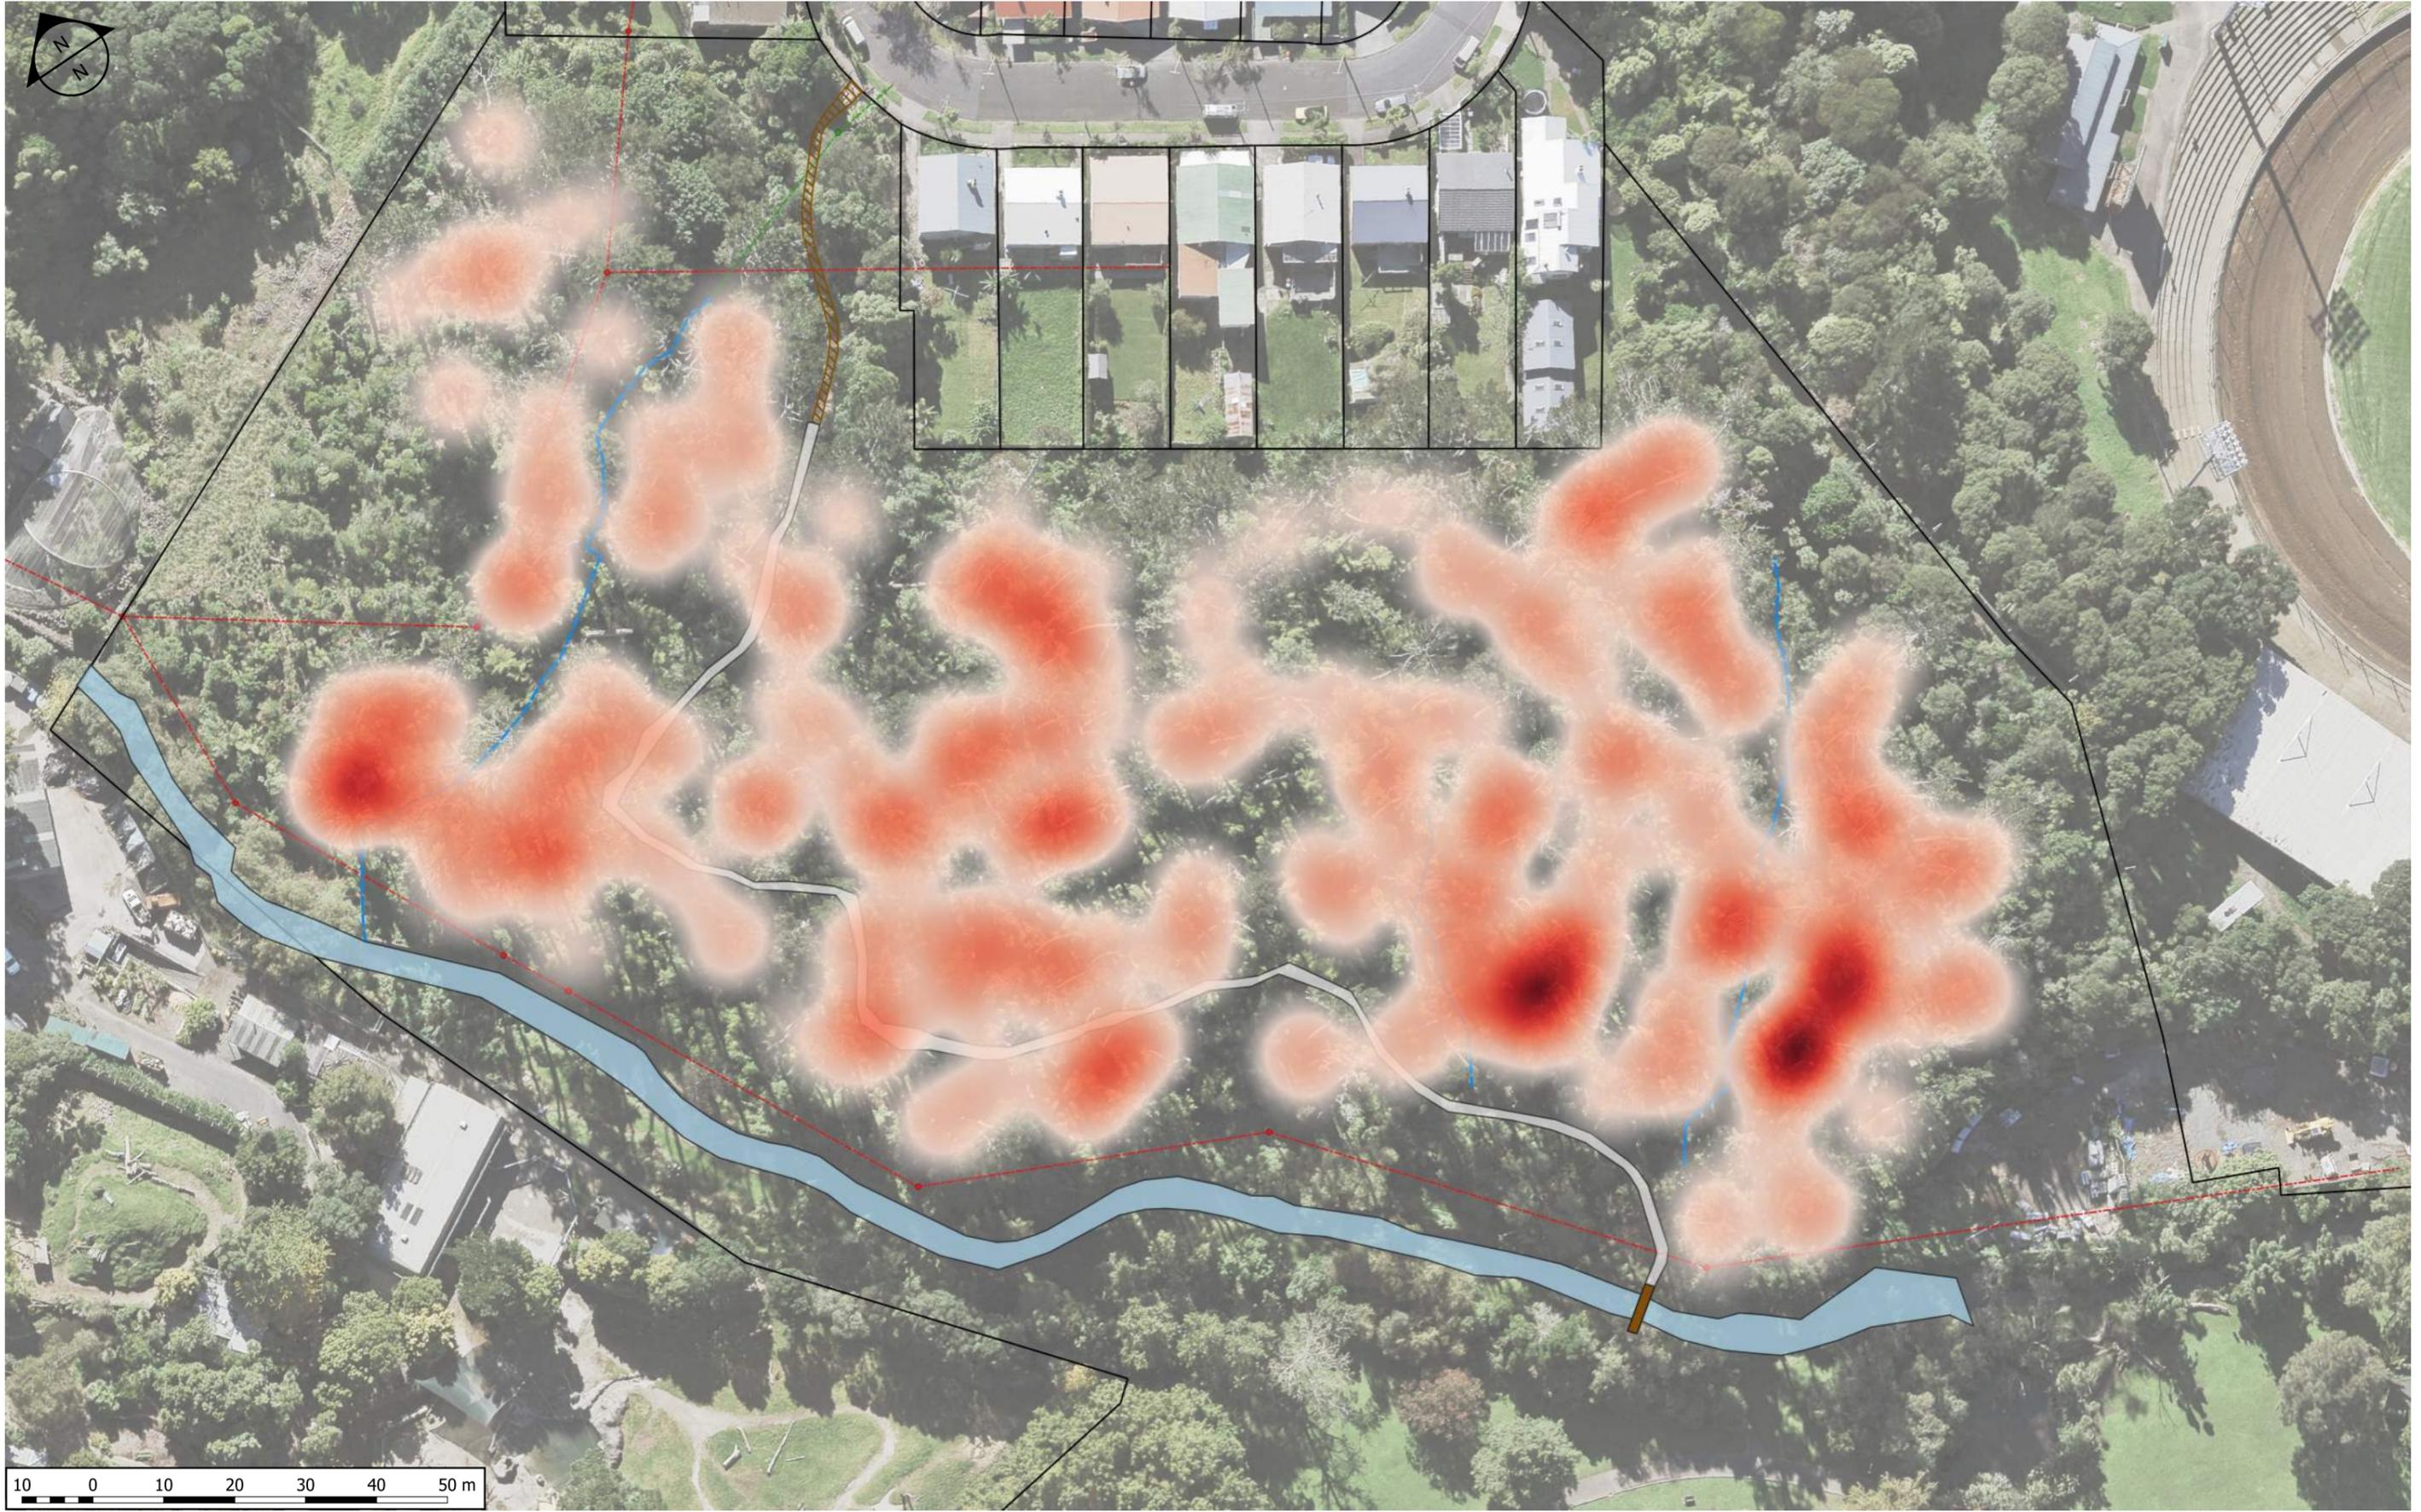
Western Springs Pine Forest  
 Height : Diameter ratio plan  
 PRELIMINARY

- Trees in the pine forest could be expected to experience stem breakage when wind speeds exceed  $9.9 \text{ ms}^{-1}$  ( $35.6 \text{ kmh}^{-1}$ ).
- Stem breakage is the most common mode of failure in the forest (Collett, 2018).

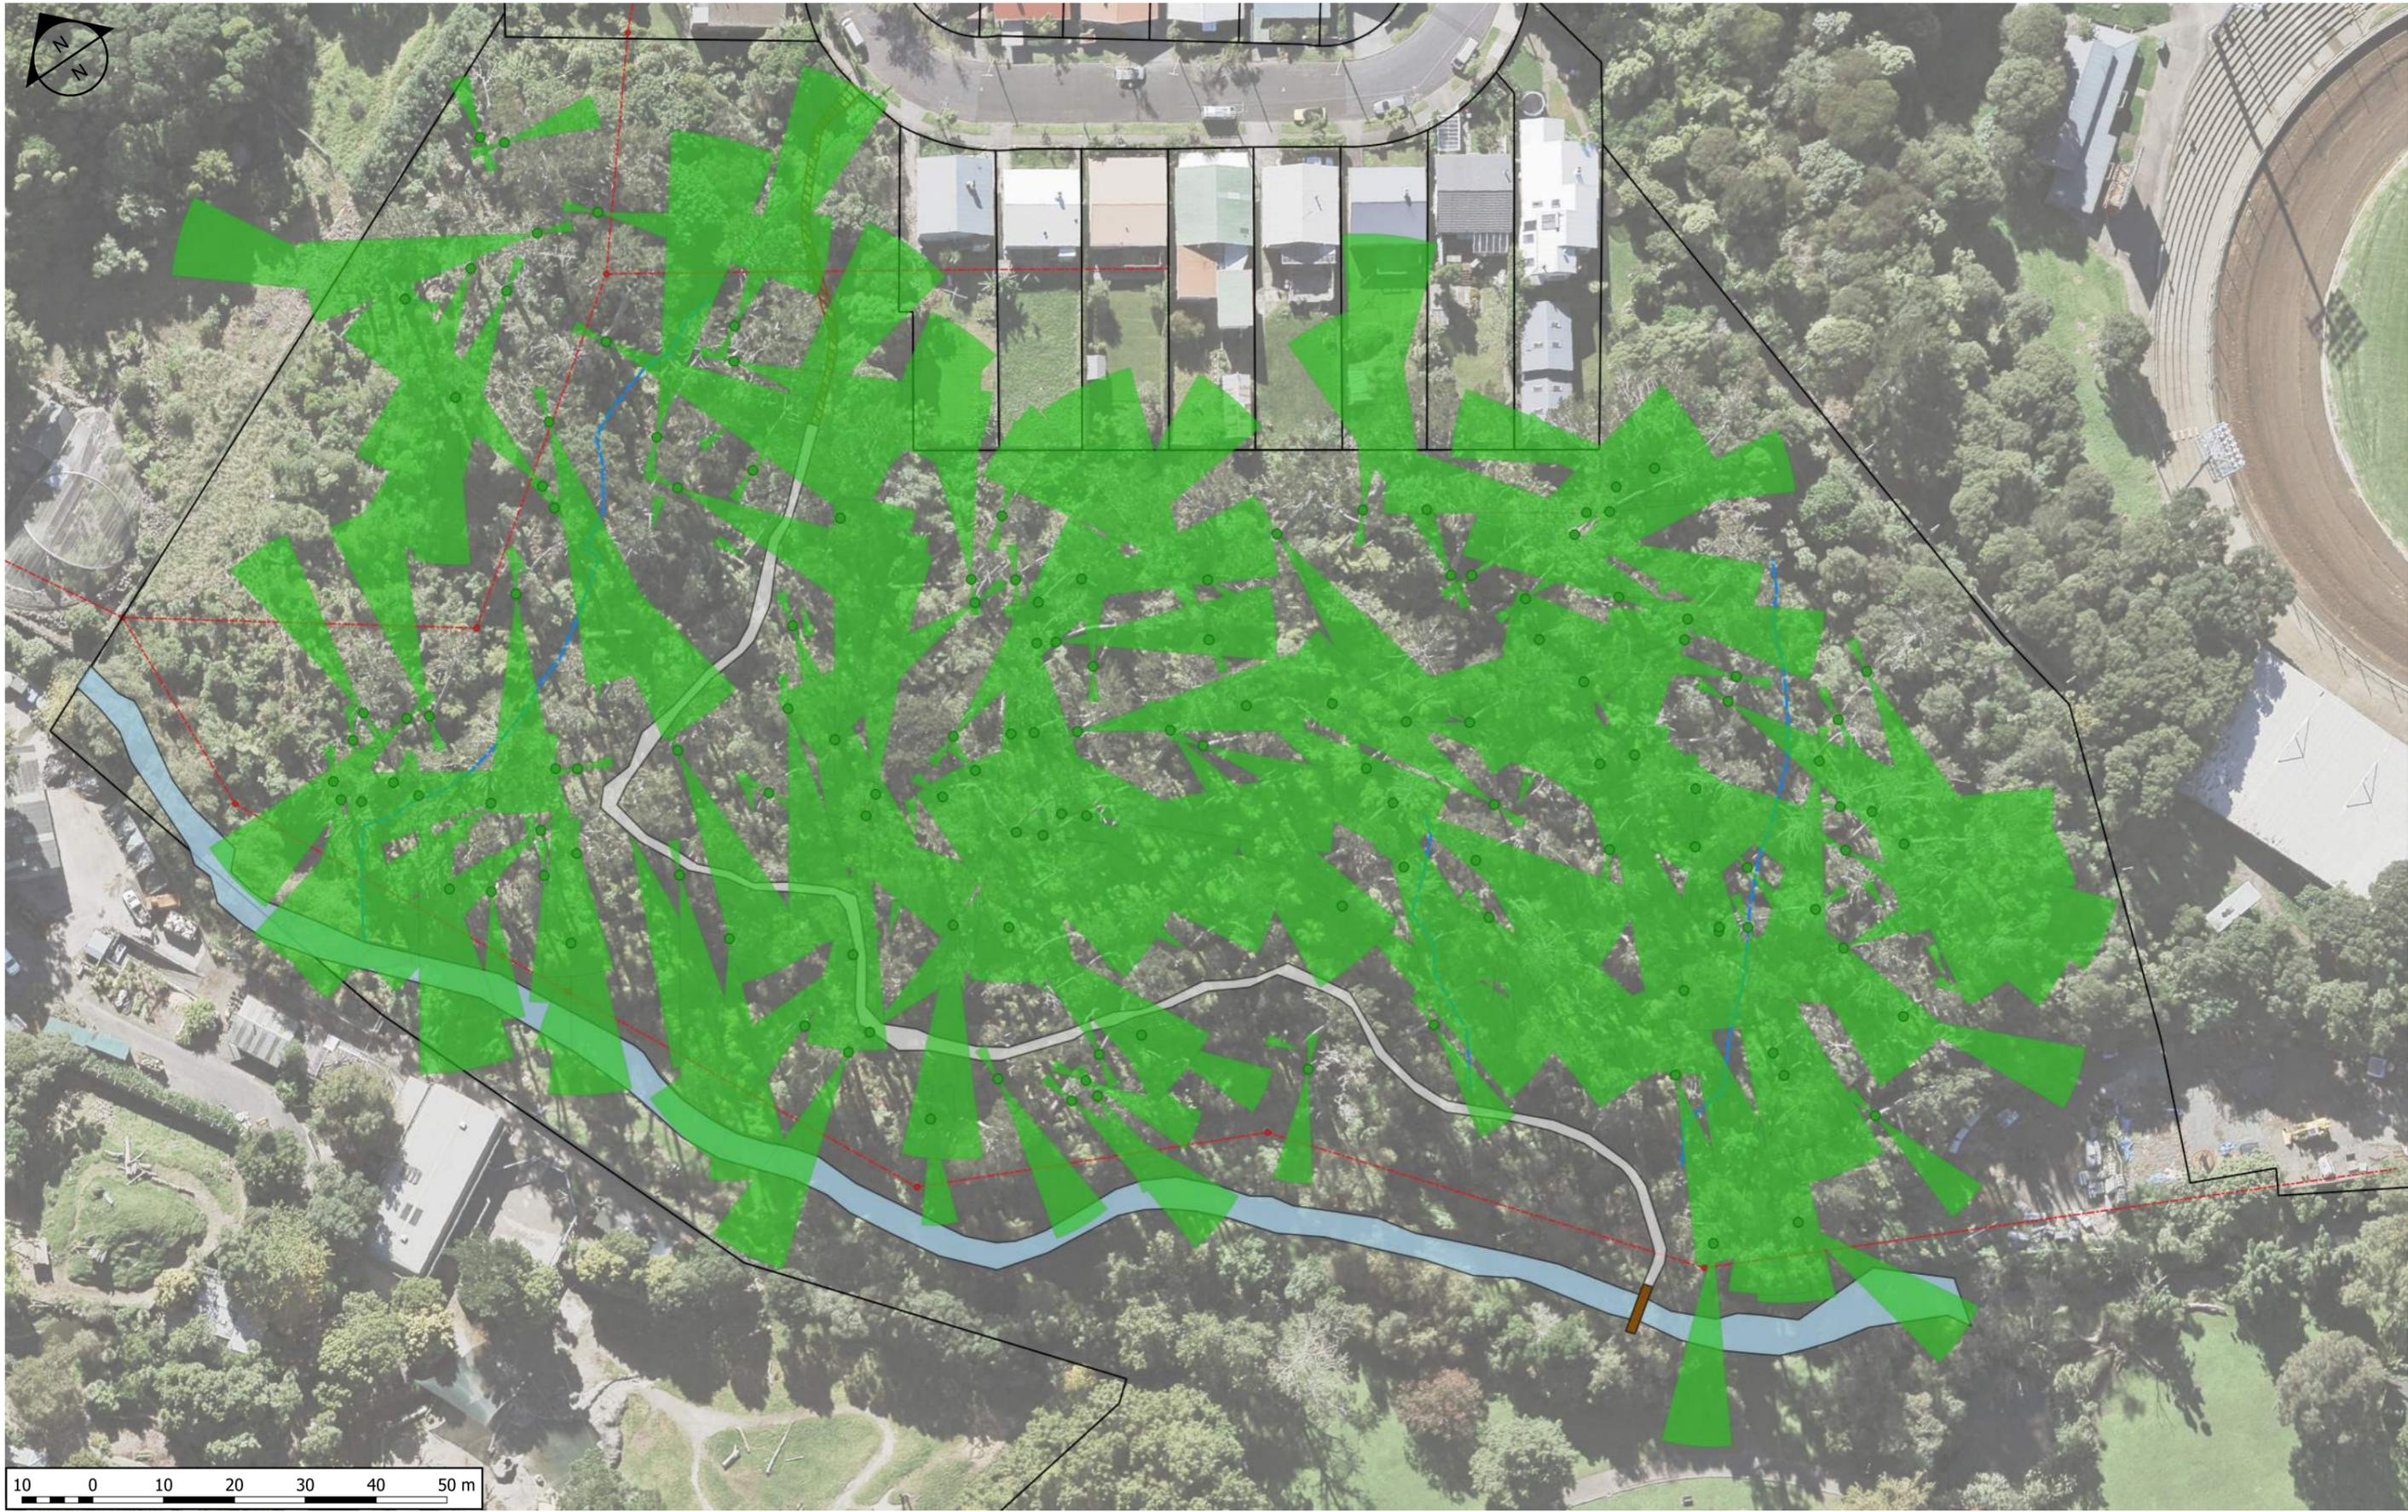
Western Springs Pine Forest  
Acceptable risks plan  
PRELIMINARY

- Based on the most likely mode of tree failure (stem breakage) and the recorded trunk azimuths, there are:
  - 139 'Acceptable' risks (70%)
  - 7 'Tolerable' risks (4%)
  - 50 'Not tolerable' risks (25%)
  - 2 'Not acceptable' risks (1%)
- The overall risk to pedestrians using the path during normal operation is 'Unacceptable'.
