Jubilee Bridge Structural Condition Assessment Report (Post Auckland Extreme Weather Events)

Panmure Basin, Lagoon Drive,
Panmure

Job No. 21785

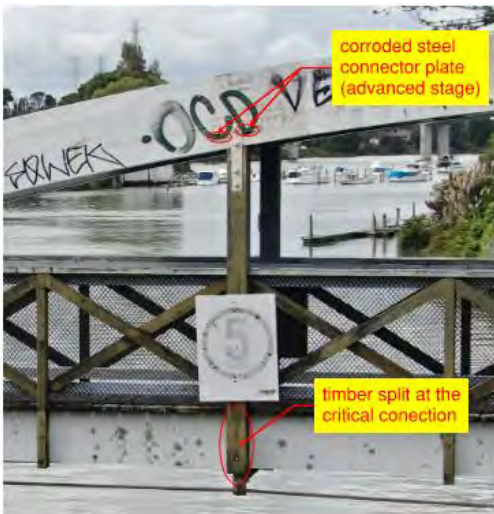
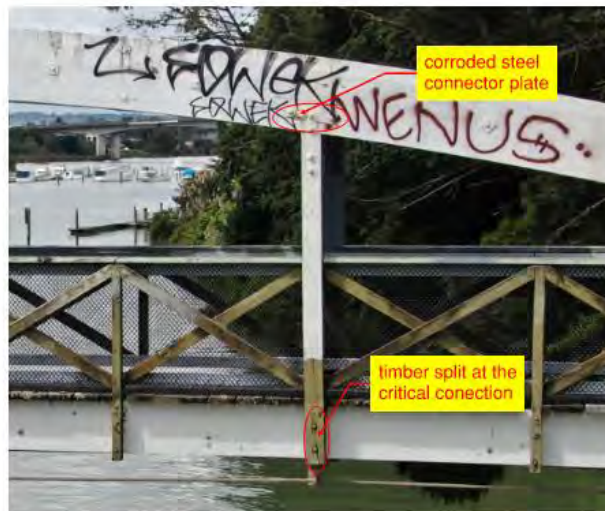
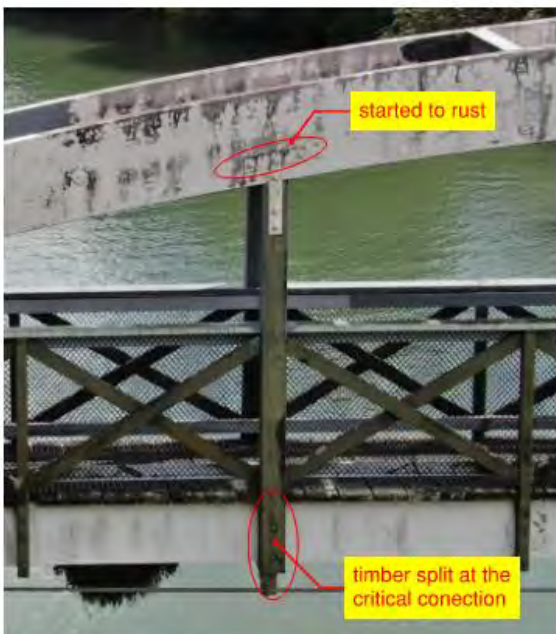
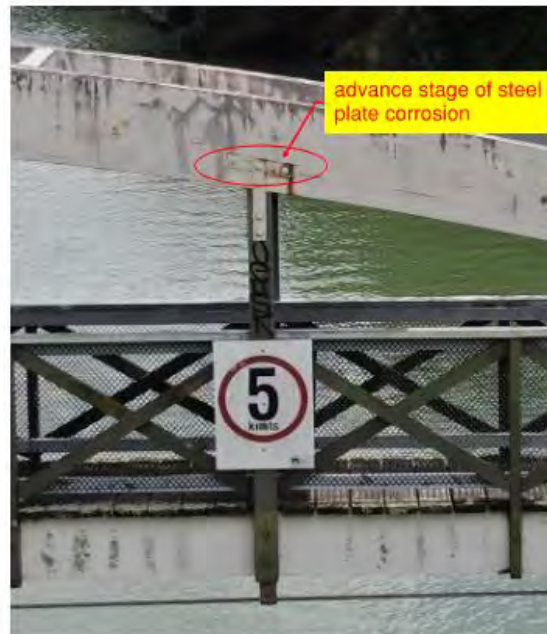
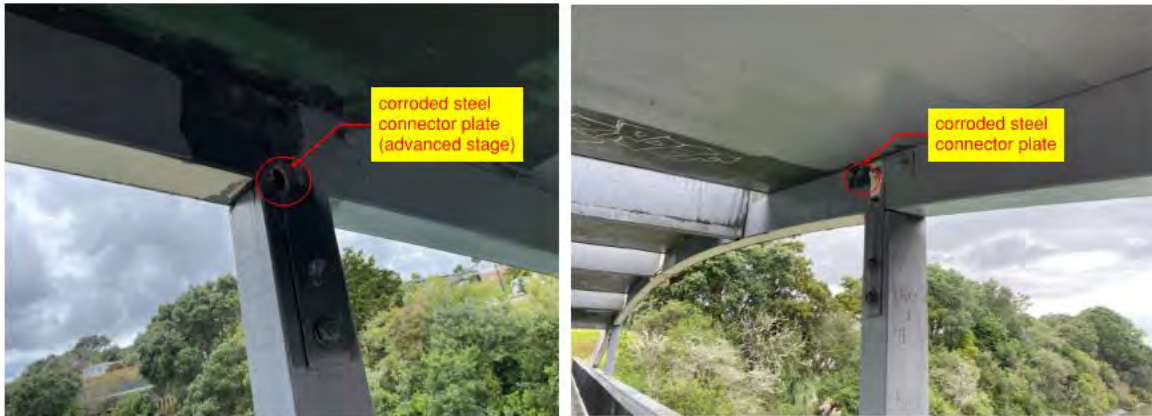
- Splitting of timber has occurred at the bolted connections between the hangers and the main horizontal beams. These bolted connections are critical connections by which the main horizontal beams are supported by the top laminated arches, and the timber splits here can significantly reduce the capacities of these structural connections.
- The T-shaped structural steel plates at the top of the hangers have mild to advanced corrosion. Similar to the bolted connections at the bottoms of the hangers, these T-shaped steel plates are also critical to the overall structural performance of the bridge. The bridge deck would be at an increased risk of collapse if any of these steel plates were to fail.
- One of the timber hangers on the northern side of the bridge is showing signs of decay; see Figure 2b

Figure 2a: Timber splits and corrosions at the hangers

1. Replace the split timber hangers, including the T-Shaped steel plates where mild to advanced corrosions have been observed (refer to section 3.1 of this report). If visually acceptable, we suggest adding the new hanger adjacent to (or a certain distance away from) the existing split hanger without removing the existing one. This will provide structural redundancy to the bridge. This work should be done as soon as reasonably practicable (within one month from the date of this report). The bridge must be closed off for public use when this work is in progress.

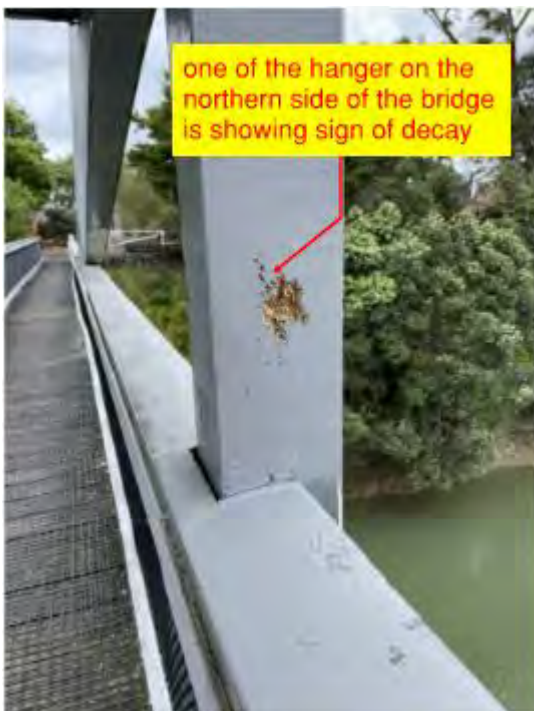
Figure 2b: Condition of one of the hangers on the Northern side.

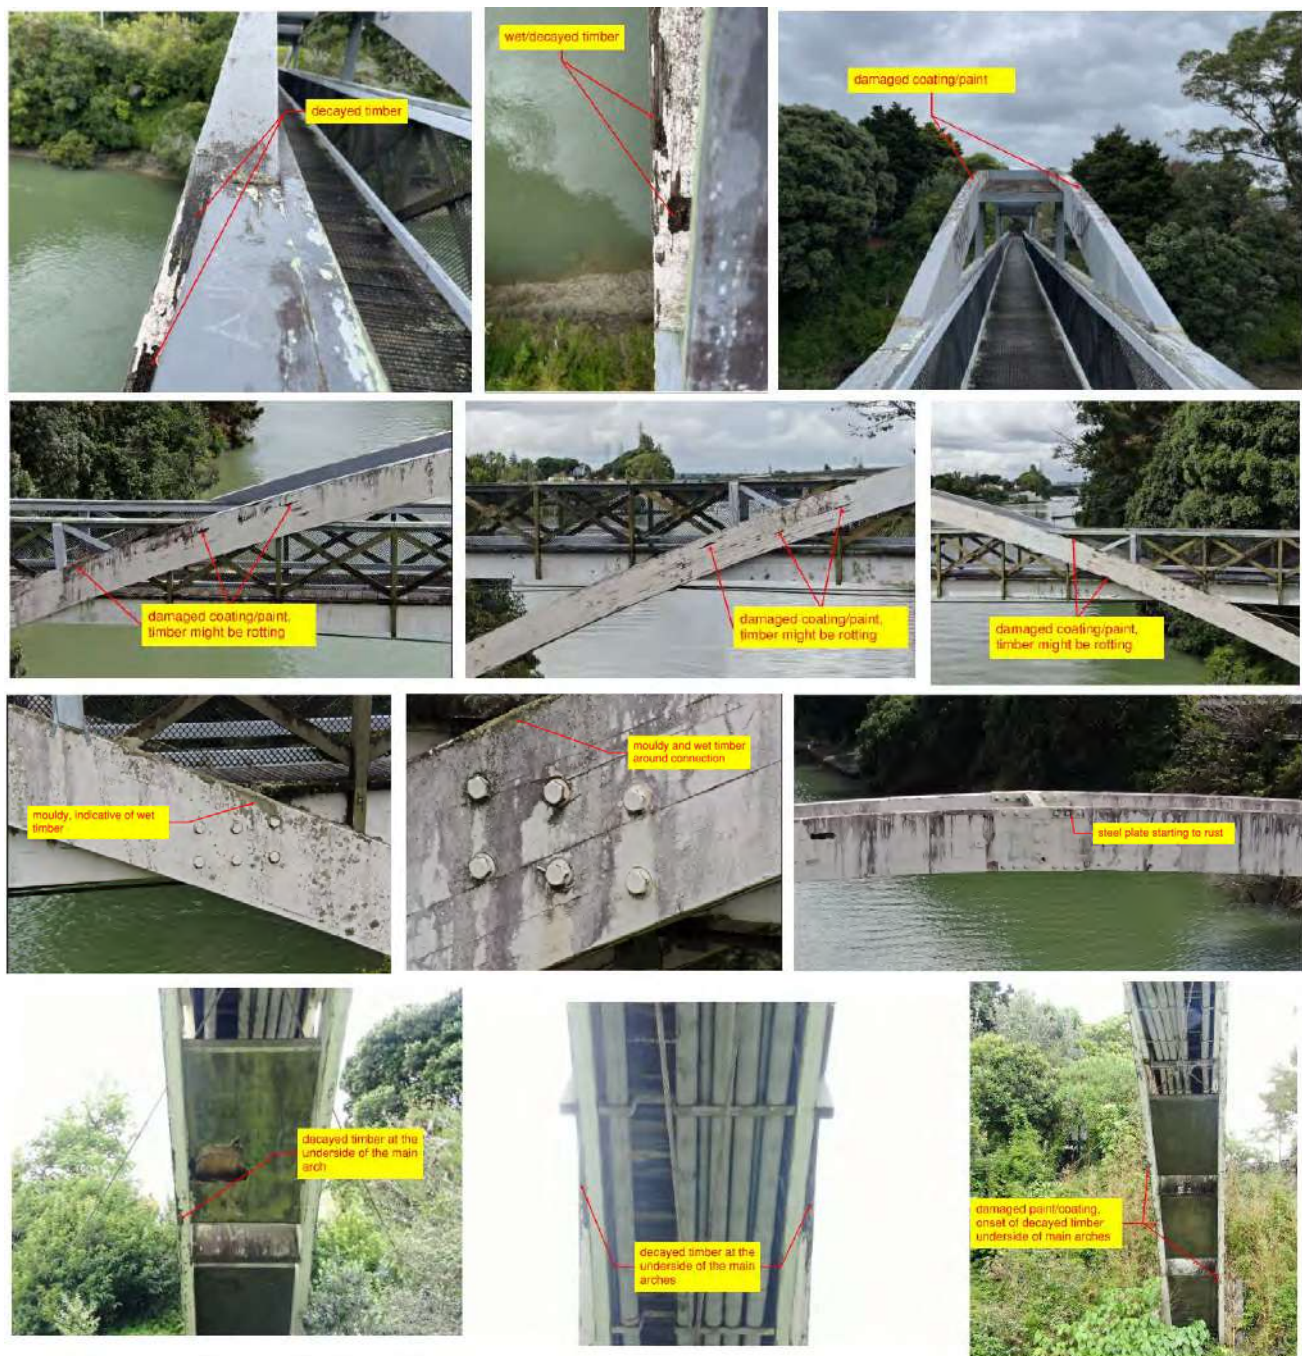
The paint/ protective coating system of the main timber arches was observed as being in poor condition; the paint was flaky and stained. Areas of moulds are visible across most parts of the arch beams. Decayed and rotting timbers are also observed along the lengths of the arches. Without extensive invasive investigation and laboratory testing, the severity of the decayed timber impact is difficult to determine from inspection alone. See Figure 3a for the conditions of the main arches.

Figure 3a: Conditions of the laminated timber arches

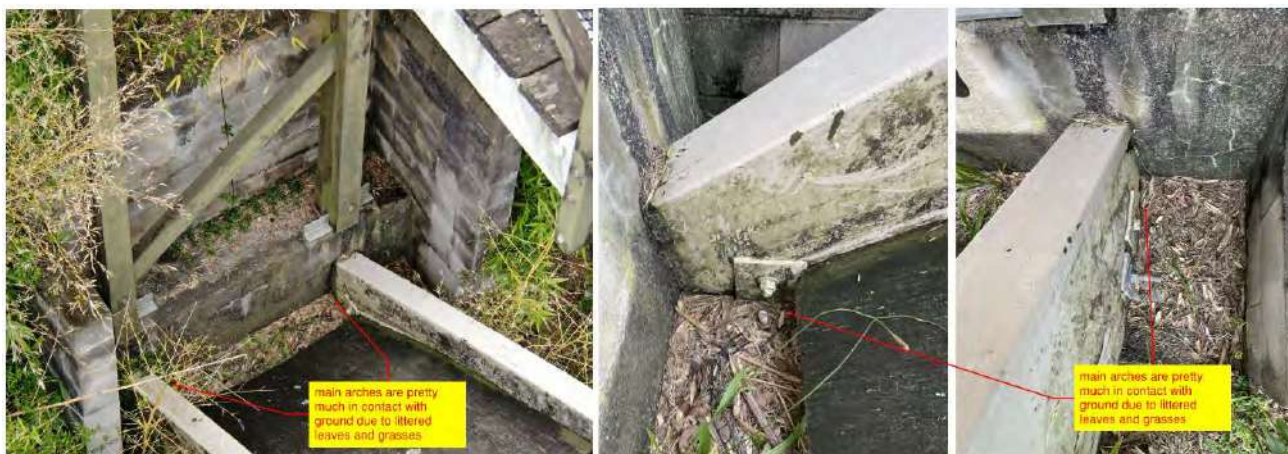
The main timber arches are supported at each end by concrete abutments. It can be seen from Figure 3b that the bottom supports of these main arches are affected by water, which has been held at these locations due to the build-up of trapped debris comprising leaf litter and vegetation, causing the timber ends to be essentially in contact with the ground. From the information provided by the previous Opus report, the main timber arches are known to be treated to H3.2, which is not adequate when the bottoms of the main arches are in contact with the ground. The main timber arches should be treated to a min of H4 to meet the durability requirements. In lieu of treating the timber, the base areas need to be reconstructed such that entrapment of leaf litter and vegetation is prevented. Further in-depth investigation and laboratory testing of the leg areas of the arches is required to assess the degree/ extent of any decayed timbers.

Figure 3b: Support conditions of the main timber arches

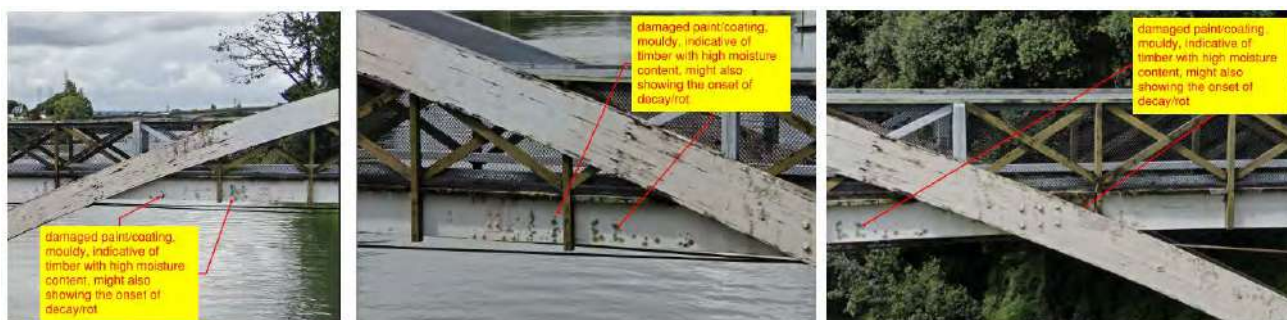
The main laminated horizontal beams were found to be in better condition compared to the timber arches. However, the paint/ coating system is showing signs of ageing; mouldy, discoloured areas are visible on areas of the beams (more apparent towards the west bank). Small areas of timber decay/ rot are also present.

Figure 4: Conditions of the laminated timber main beams

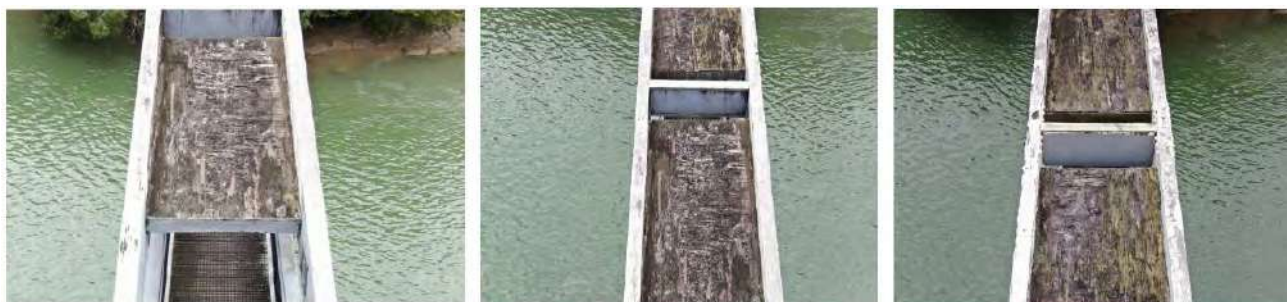
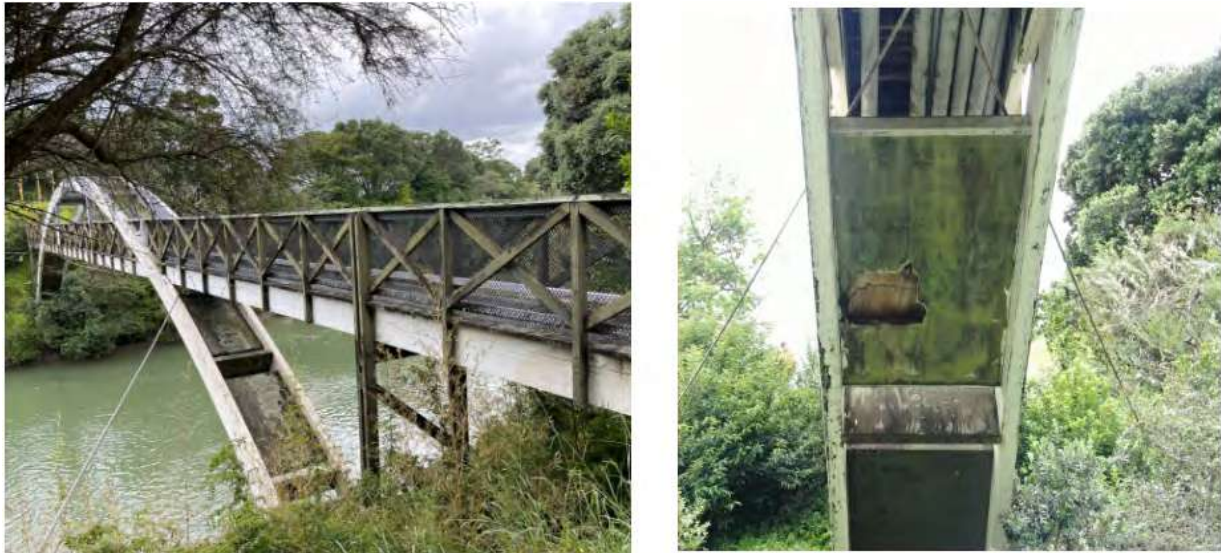
There are plywood diaphragms and box beams which make up each bracing unit, and these connect and provide lateral restraints between the two arches. All of these were seen to be in very poor condition. The external faces of the tanalised plywood panels were observed as in an advanced stage of decay, with numerous edges partially or fully detached from the supporting timber members. One of the bottom plywood diaphragms on the eastern end of the bridge was observed with a large hole in it. There was no longer any detectable protective paint coating visible.

Figure 5: Conditions of the plywood diaphragms and box beams

2. Expose areas of timber members that are within the plywood diaphragms and box beams; these areas of the timber are the most susceptible to water and where moisture can become trapped and cause the most damage or decay to the timber. Additional probing with Resistograph may be required should the timber inside the plywood diaphragms & box beams display signs of deterioration. This work can only be carried out when the wind is calm under the supervision of a suitably qualified structural engineer. The bridge must remain closed for public use until the new plywood diaphragms & box beams (like for like, including their connections) are installed. (Note that the new plywood diaphragms & box beams will only be installed if the decision is made that the bridge is still feasible to be kept for a certain period of time until the new bridge is built. Before installing the new plywood diaphragm and box beams, areas of the main arches that are to be covered within the box beams are to be prepped and repainted). This work should be done as soon as reasonably practicable, ideally one month from the date of this report and will need to be carried out in stages; one bracing element at a time is to be removed and repaired before moving to the next.

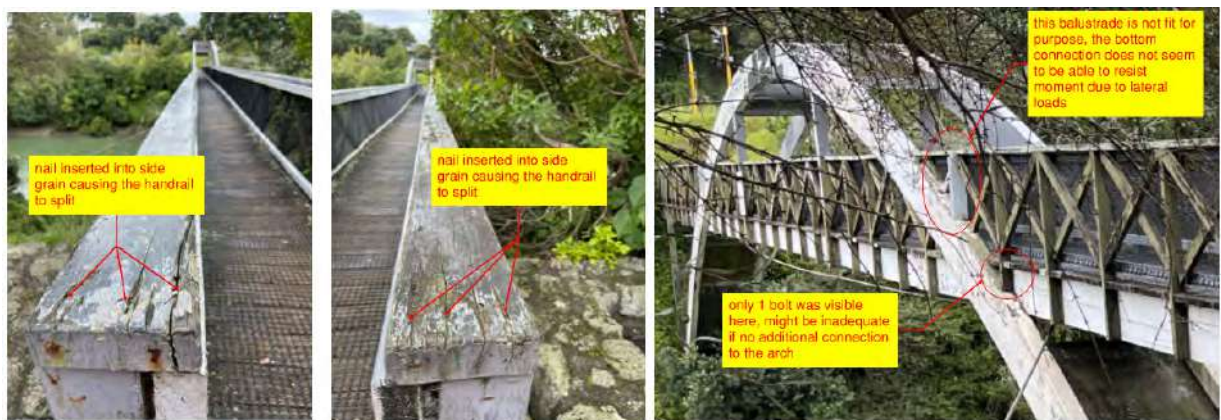
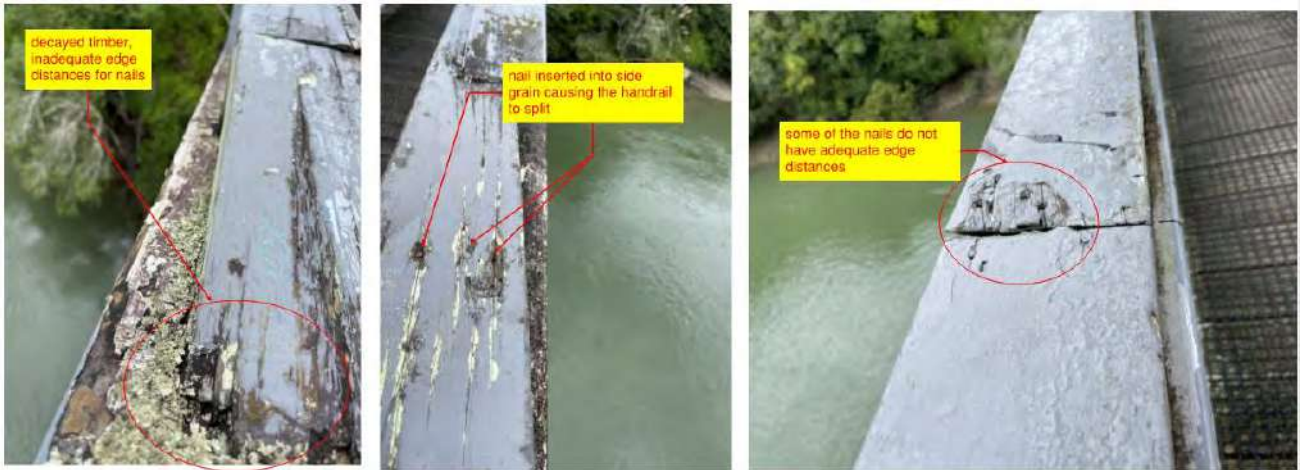
In general, the handrails are seen to be in poor to very poor condition. The paint/ coating system is damaged and no longer provides adequate protection. Rather than using pre-drilled screws to connect the handrails to the uprights, nails have been used instead. Some nails, positioned too close to the edge of the members & inserted into the side grains of the timbers, have caused the handrails to split. These splits, together with inadequate edge distances for some of the nails, compromise the structural integrity of the handrails to transfer loads to the uprights.

The 100x75 balusters are spaced at approximately 1.5 m crs; by inspection, the existing balusters are not adequate to resist the minimum barrier loads described in Table 3.3 AS/NZS 1170.1:2002. The structural capacities of the shorter balustrades closest to the main arches are also further compromised due to their inadequate bottom connections, see Figure 6.

The cross timber infills are found to be in fair/poor condition. We cannot verify their connections to the balustrades from the existing drawings.

Figure 6: Conditions of the timber handrails and balustrades

4. Replace the entire balustrade. The current handrails and their nailed connections are in very poor condition; the cross timber infills are in fair to poor condition with unverifiable connections to the balustrades. By inspection, the uprights @ 1.5 m crs do not appear to be structurally adequate. (see Section 3.5). We recommend this work be done within six months from the date of this report.

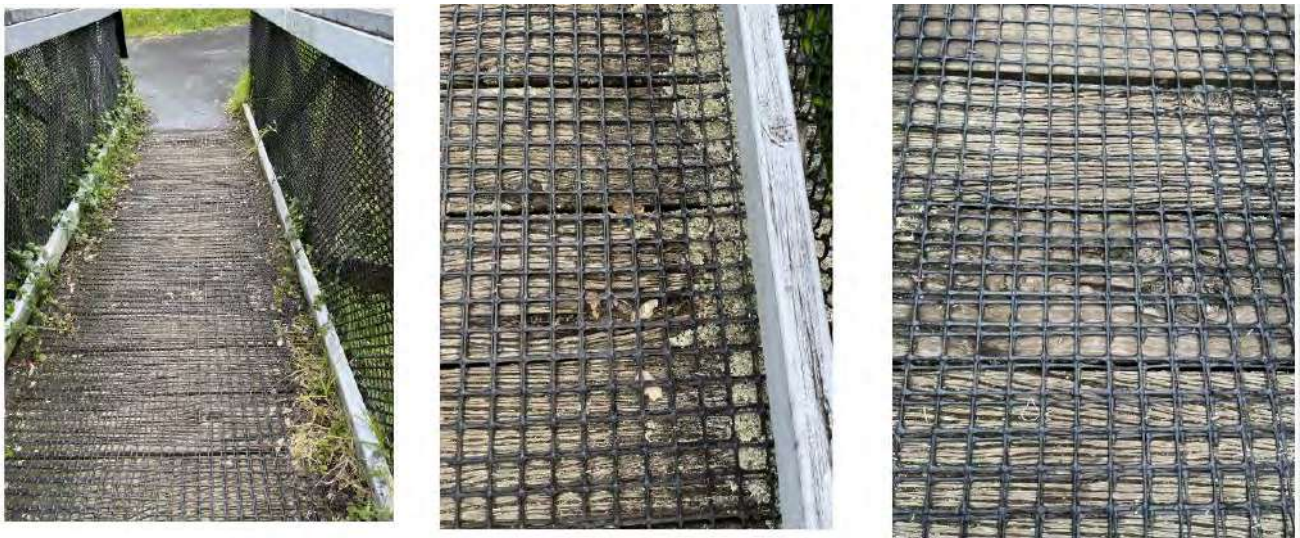
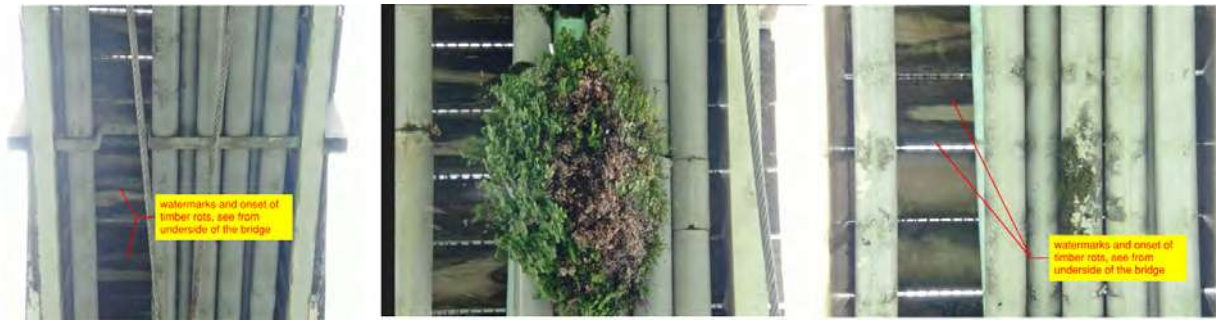
The timber decking boards were found to be in poor condition overall. The timber fibres at the surface of the boards were failing as the result of prolonged exposure to environmental conditions, ultraviolet and water damage. In some areas, it appeared that the inner layers of the boards were starting to be affected. On the underside of the boards, watermarks and mouldy conditions starting from the edges (gaps between the boards) were observed. This wet condition encourages fungi to grow and exacerbates the decay of the deck boards.

Figure 7: Conditions of the timber deck boards

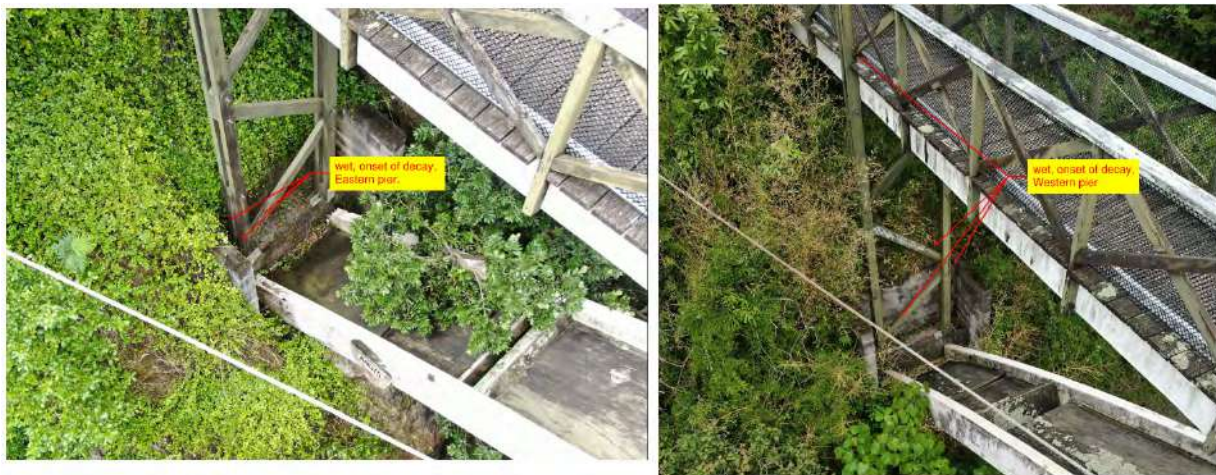
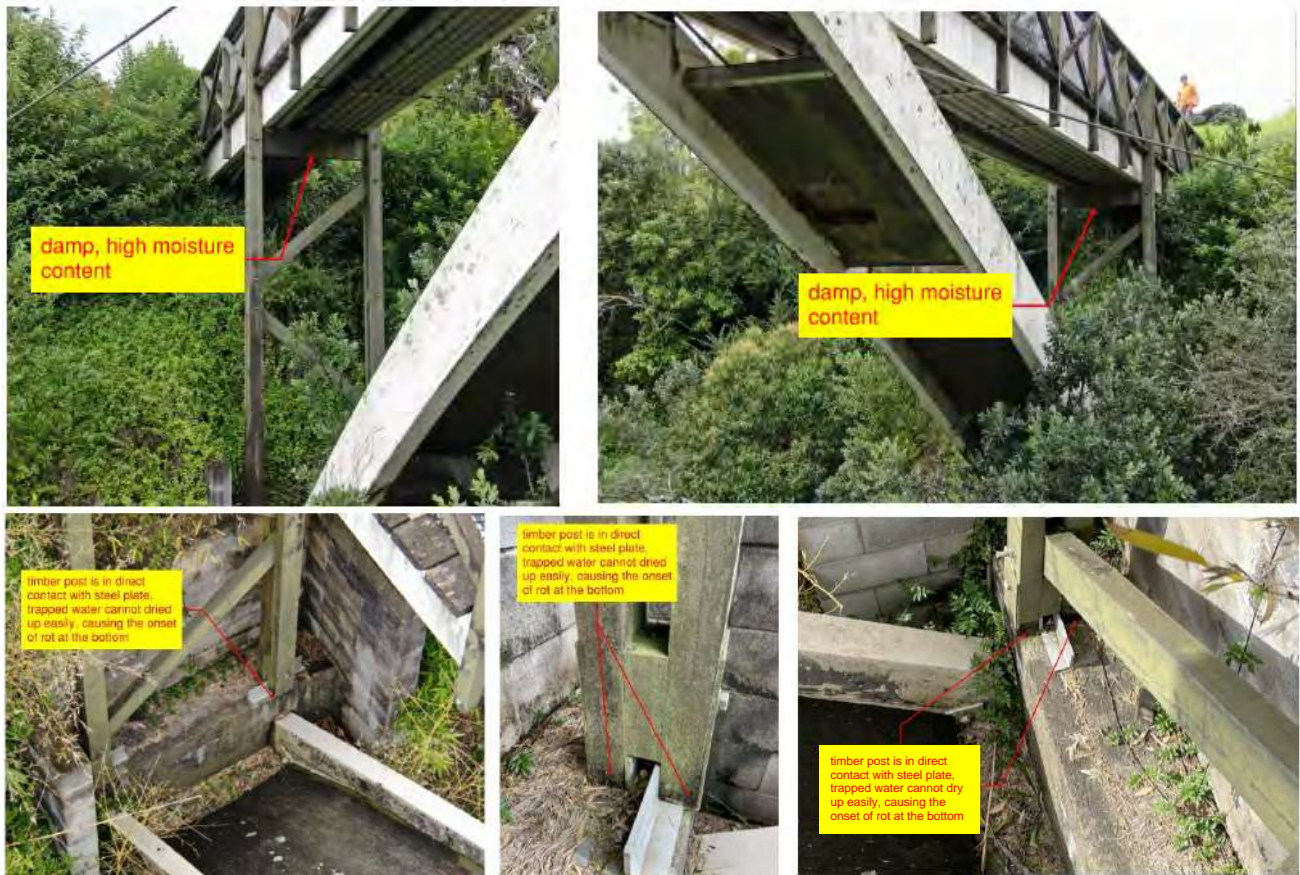
Visually, it appears that there is an onset of timber decay, especially at the lower parts of the piers and diagonal braces, see Figure 8. Of particular concern is the detail of the bottom connection of the piers; the piers are not elevated off the steel plate to create a gap for the water to escape fast enough and keep the bottom of the piers dry. Due to this constant wetness, the bottom of the piers is starting to rot. Further, in-depth investigation and laboratory testing of the leg areas of the piers is required to assess the degree/ extent of any decayed timbers.

Figure 8: Conditions of the timber piers

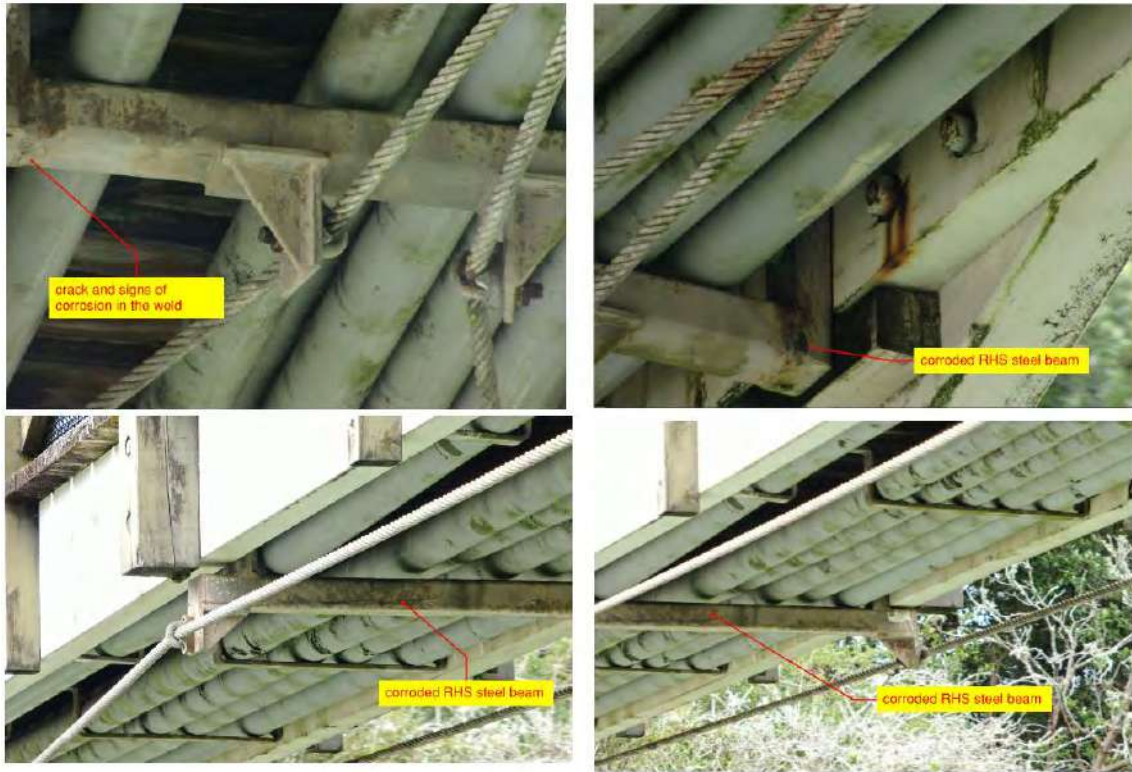
- Some of the galvanised RHS steel beams to which the 26dia cables are anchored are in poor condition and showing signs of severe corrosion.

Figure 9: Conditions of RHS steel beams under the bridge

3. Remove the rust stain/surface corrosion on the sway cables and recoat the cables with a zinc-rich compound. The remaining cable sway system needs to be examined (i.e., the corroded bolts, nuts, cleats & RHS beams). All the corroded bolts & nuts are to be replaced with HDG bolts, and all the corroded RHS beams and steel cleats are to be cleaned and prepared for repainting with zinc-rich paints. Replace the corroded turn buckles and apply the correct tensioning to the sway cables (at their current state, the sway cables are loose, they won't provide efficient lateral restraints to the bridge). We recommend this work be done within three months from the date of this report.

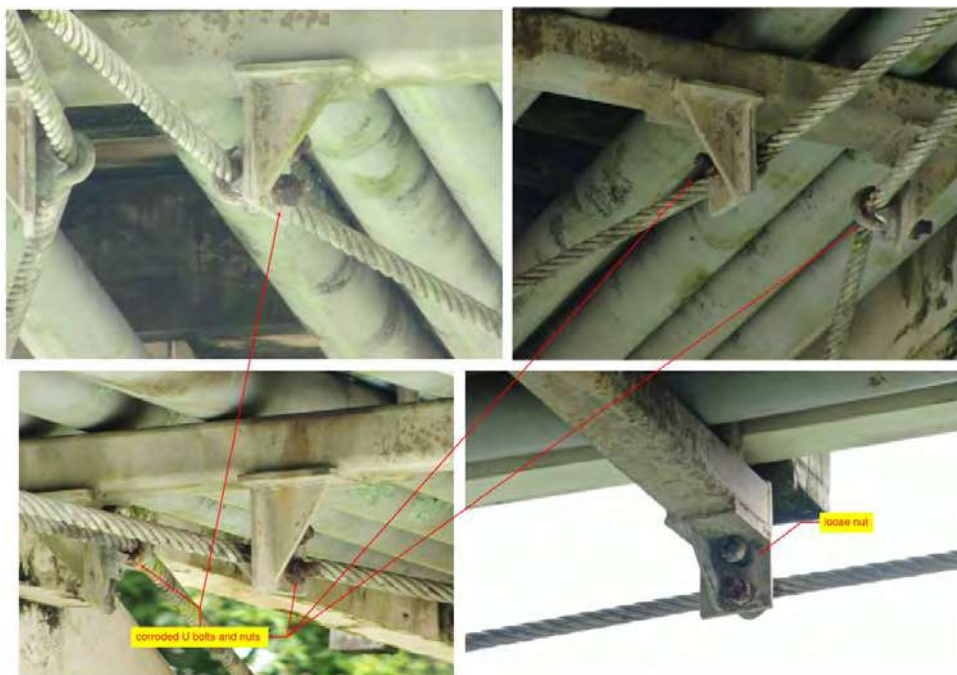
- Most of the U-shaped bolts and nuts of the sway cable system are severely corroded; one of the nuts could also be seen as almost completely detached.
- The cable themselves appeared to be very loose, bringing their ability to be engaged to restrain the bridge from lateral swaying in question, see Figure 11.
- Surface corrosion has started on the sway cable; see Figures 9 & 11.

Figure 10: Conditions U bolts and nuts

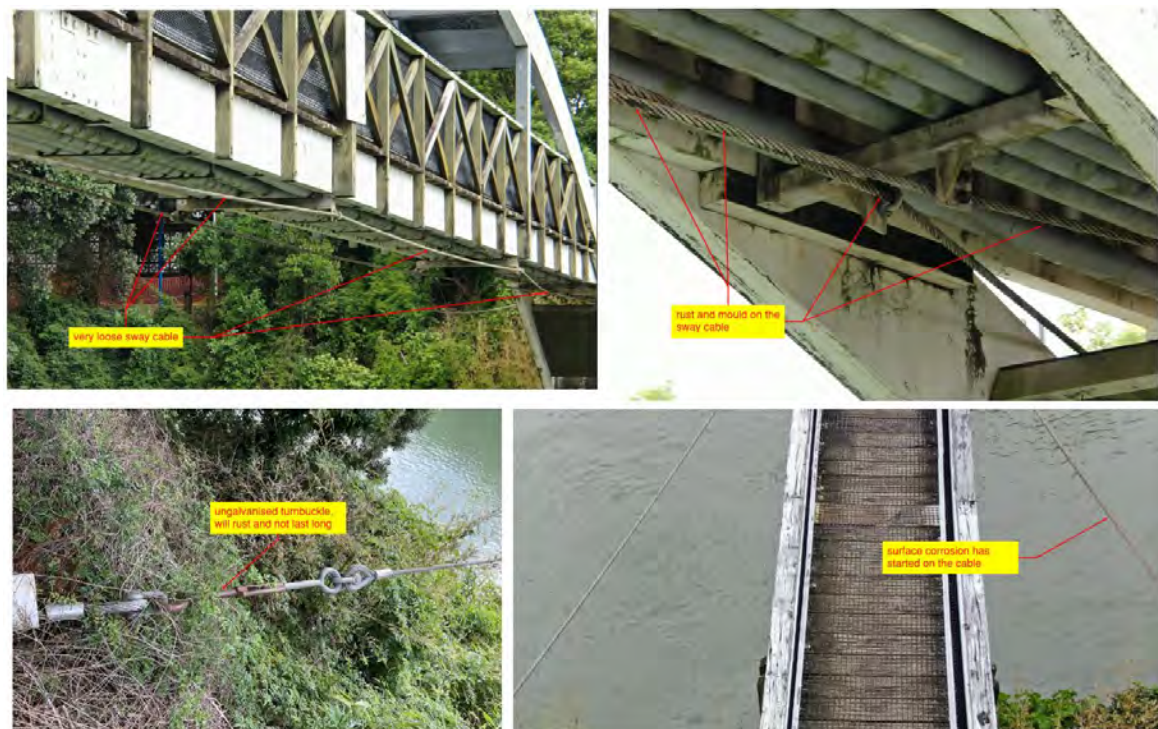
Figure 11: Conditions sway cables

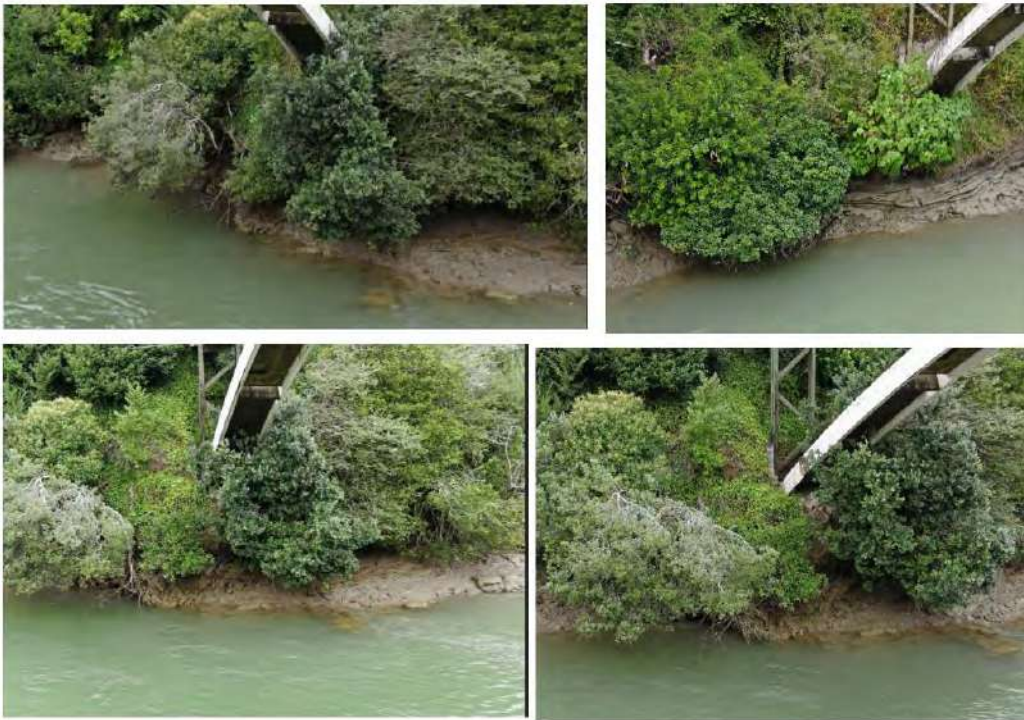
There was no visible movement of the concrete abutments or ground directly supporting the abutments following the Auckland flood events in the last week of January 2023. There was a small landslip observed, which was off to the southern side of the western abutment. However, this was noted as being sufficiently detached from the abutment to have not raised any concern.

Figure 12: Conditions of the eastern bank of the bridge – Post Auckland flood event

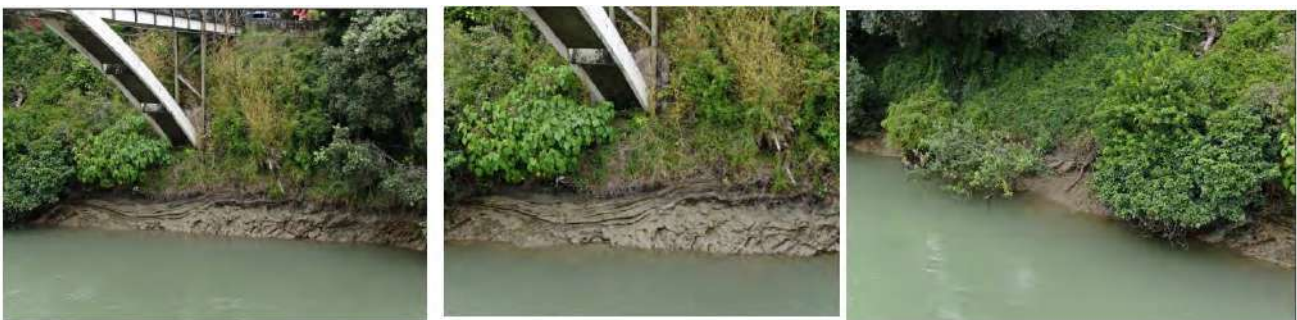
Figure 13: Conditions of the western bank of the bridge – Post Auckland flood event

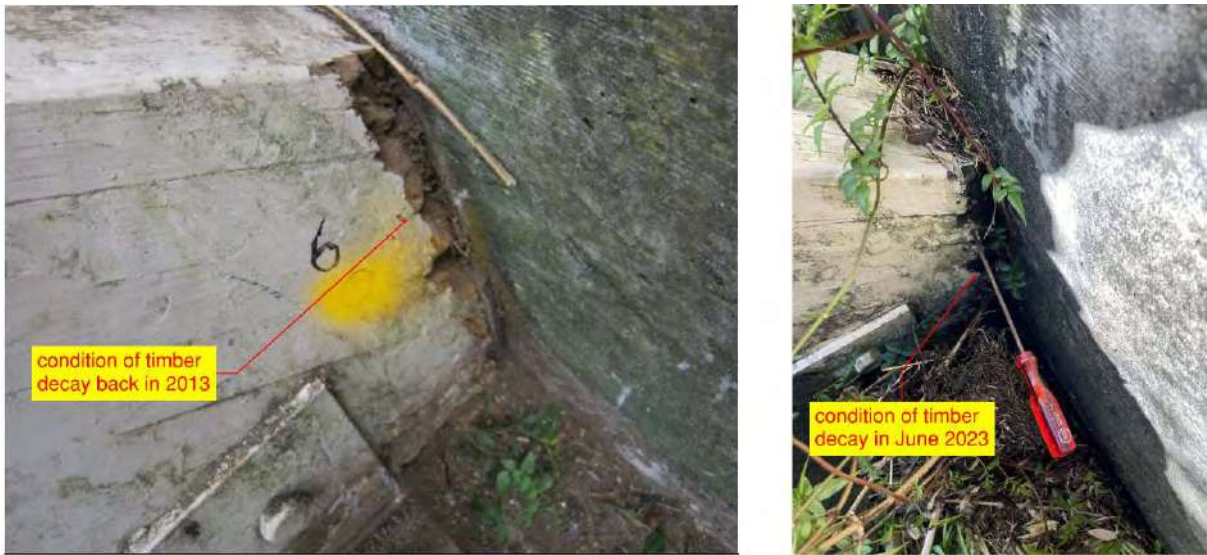
Comparing the conditions of the base of the main timber arches that were observed during the recent site investigation and the previous site investigation back in 2013, it's apparent that the bottom of the main arches has deteriorated further, and decay is noticeably in a more advanced stage (see the comparisons in Figures 14-

Figure 14: Side-by-side comparison of the base of the main timber arches on the Watene Rd side – Southern arches.

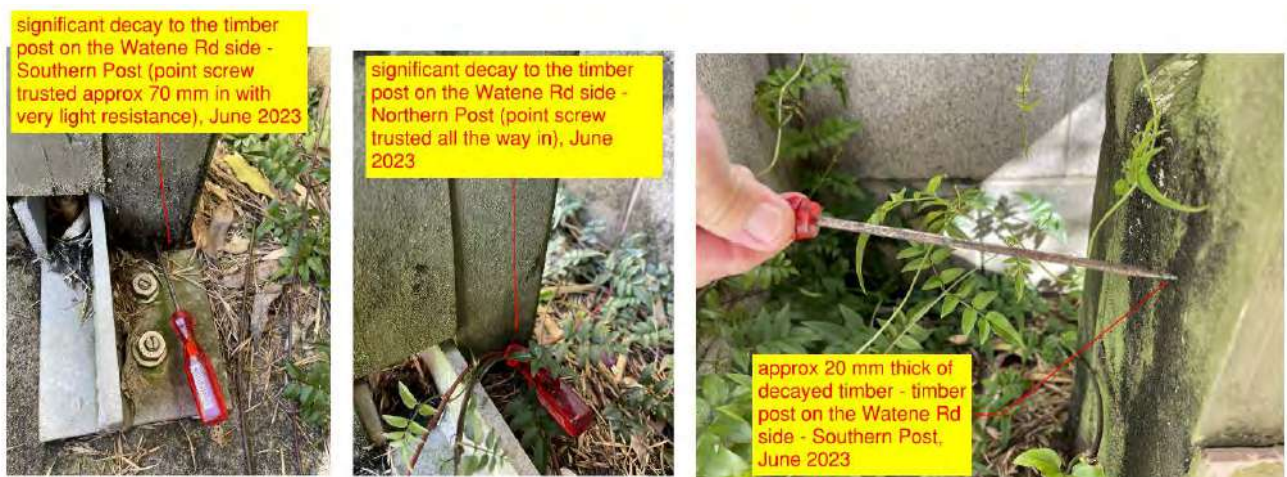
15). We also observed that the timber piers supporting the main horizontal beams were at an advanced deterioration at the ends (refer to Figure 16).

Figure 16: Conditions of timber posts supporting the main horizontal beam – Watene Road end.

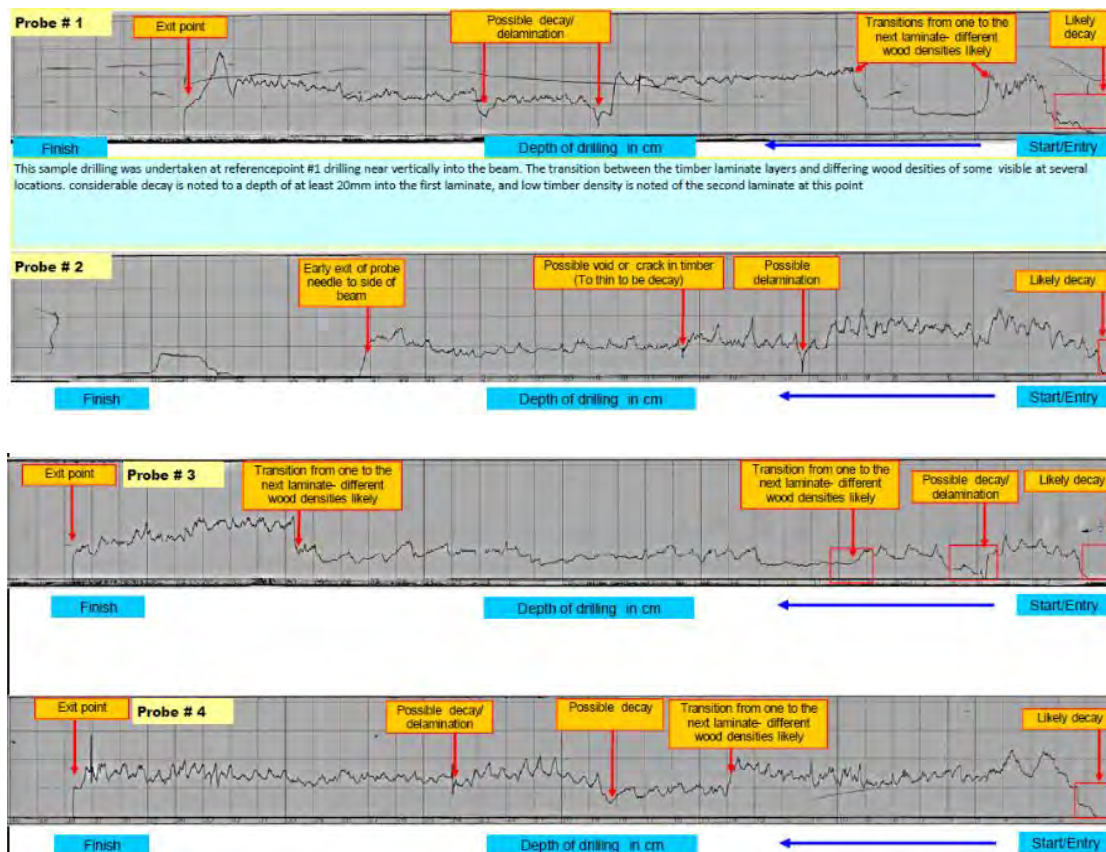
Figure 18: Resistograph test results and their interpretations.

As can be seen from Figure 18, the Resistograph test results were far from conclusive. Without taking cored samples of the timbers for proper laboratory tests, it is just too difficult to tell whether the less resistant parts of the timber were caused by decay, delamination, varying timber densities between the laminated timbers, imperfections or voids which were incumbent at the time of fabrication.

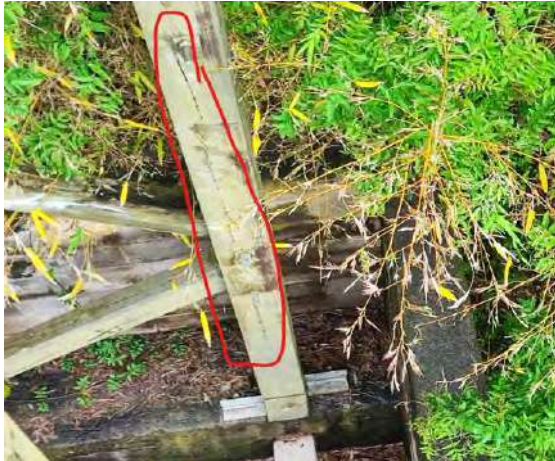
1. Timber piles show splitting

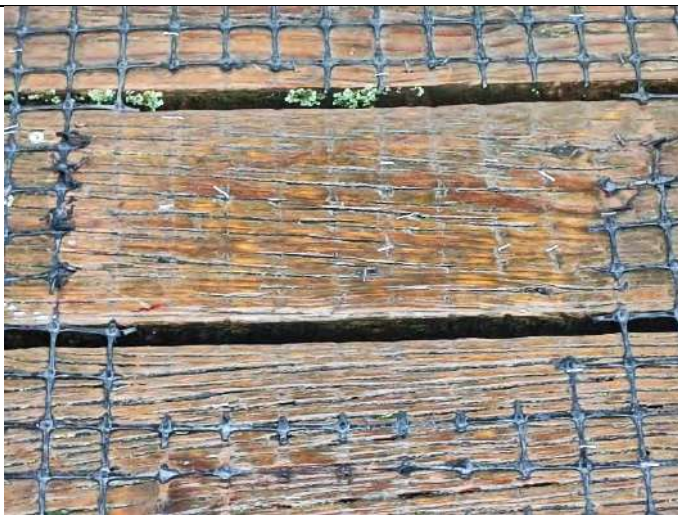
3. Typical: Damage to non-slip mesh

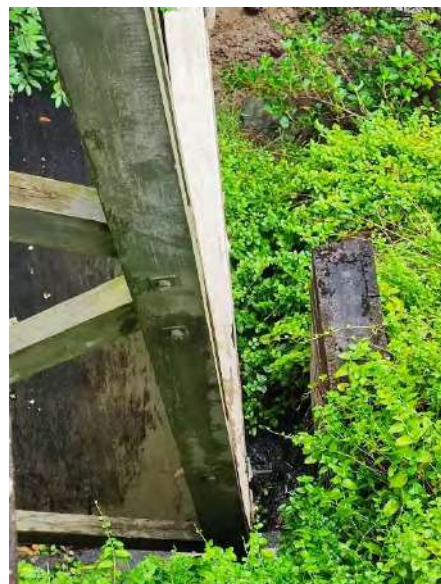
4. No erosion to the concrete footing

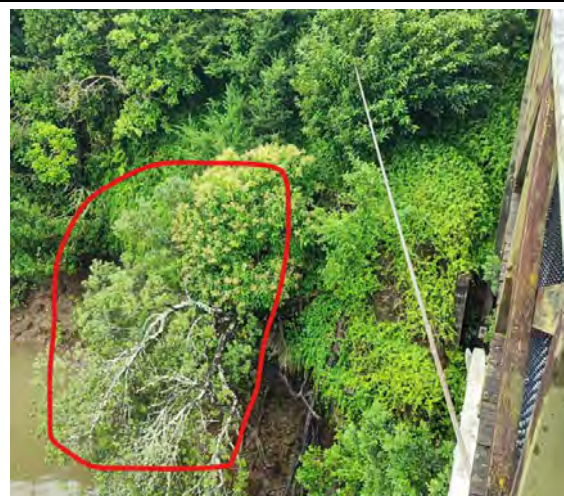
6. New slips beside the bridge on the east end

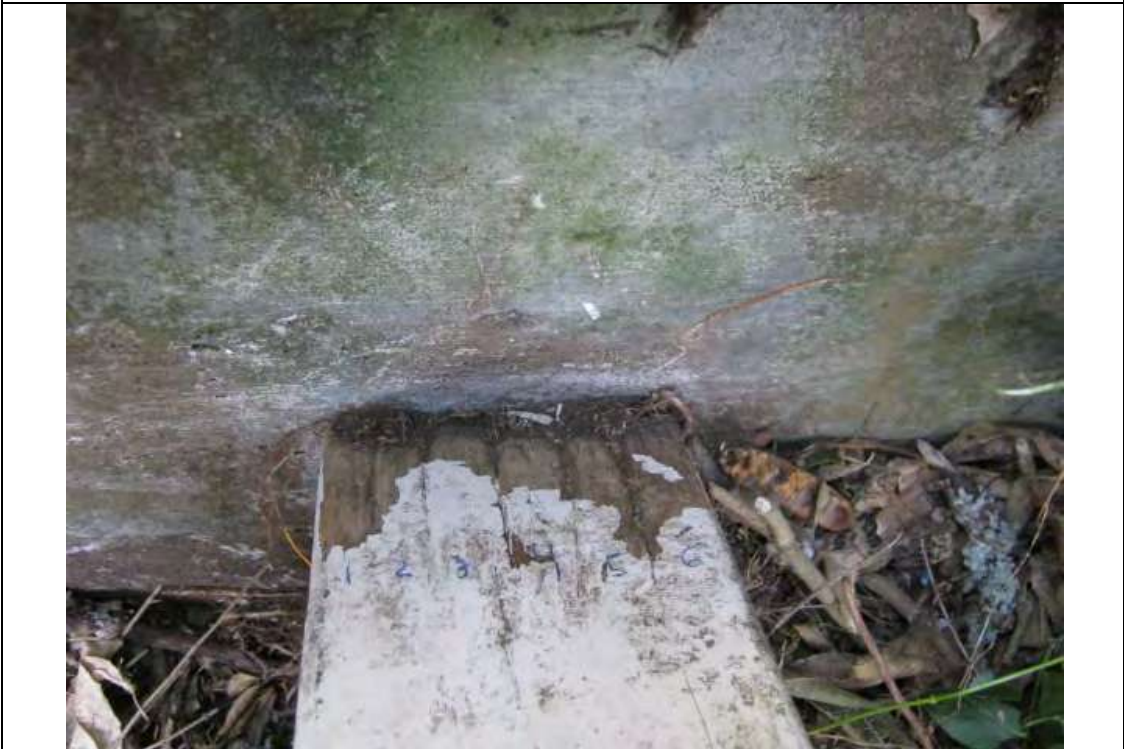
Photo showing the end of Beam "B" showing end decay and lateral de-lamination.

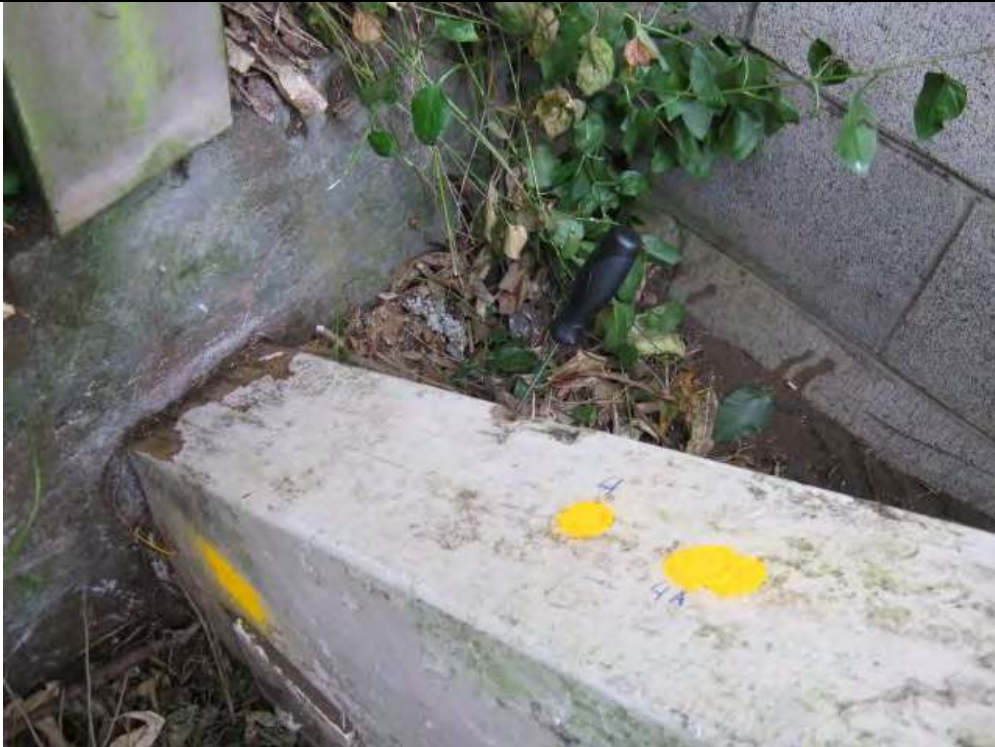
Photo showing Beam "B" with manual probe pushed into decayed wood.

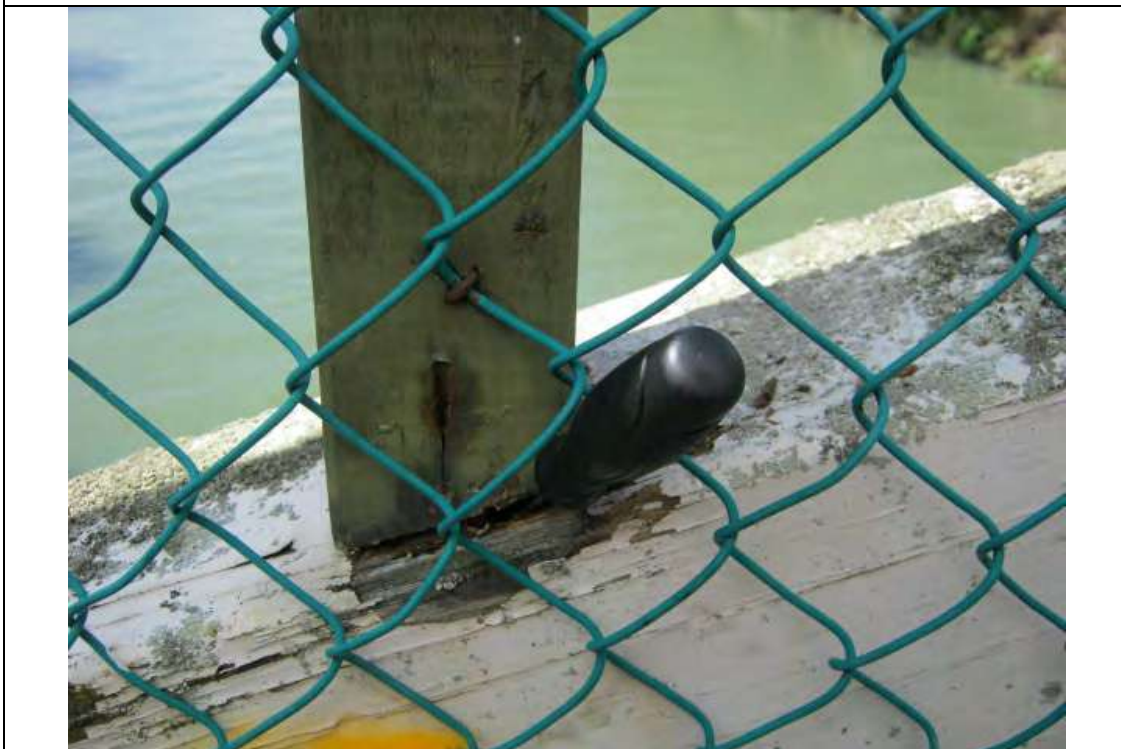
Severely decayed wood below handrail support (Beam "B"). 150mm manual probe completely inserted
