Jubilee Bridge Structural Condition Assessment Report (Post Auckland Extreme Weather Events)

Panmure Basin, Lagoon Drive,
Panmure

Job No. 21785

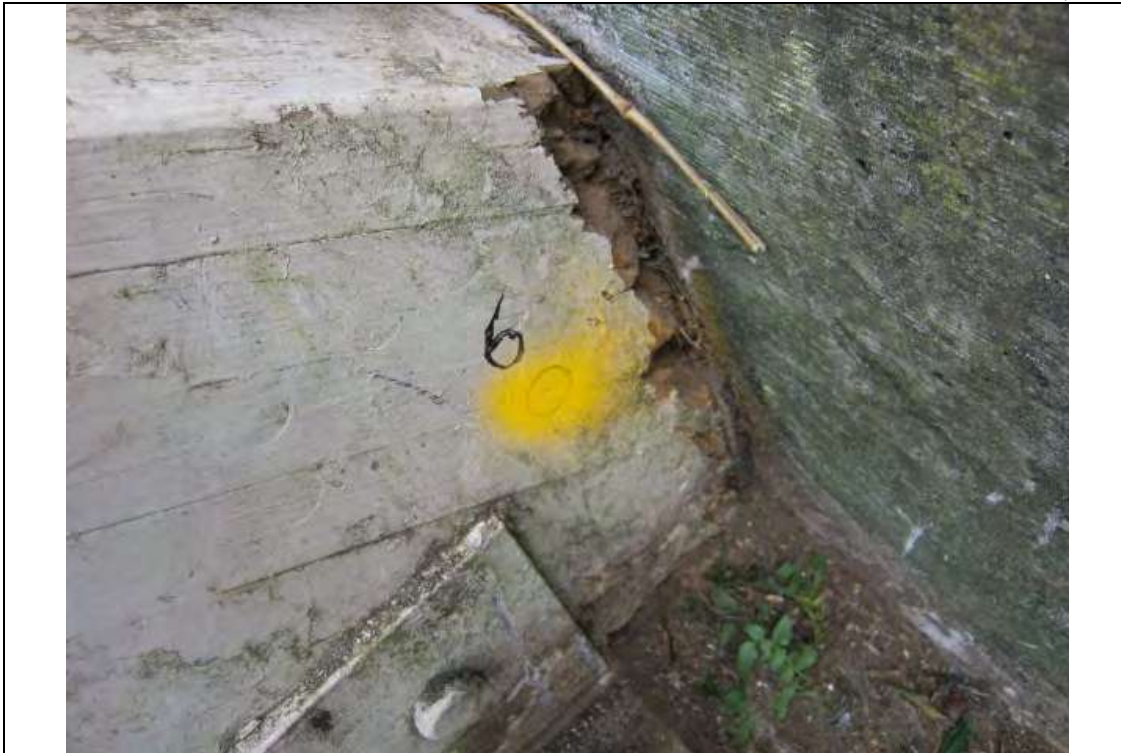
Photo showing beam "C", probe #6 and decay at beam end.

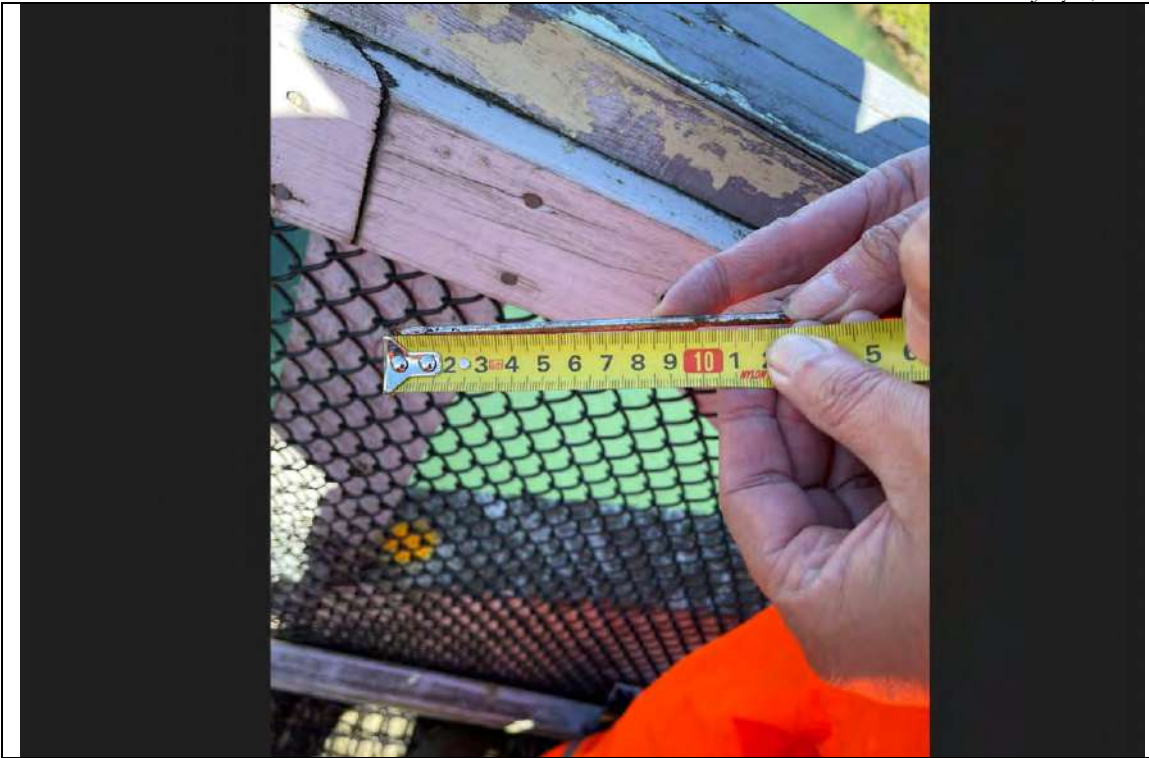
#2 severe decay detected under handrail post
