Waitakere Coastal Communities Landslide Risk Assessment

**Appendix B – Muriwai Engineering
Geological Report**

Auckland Council

15 May 2024

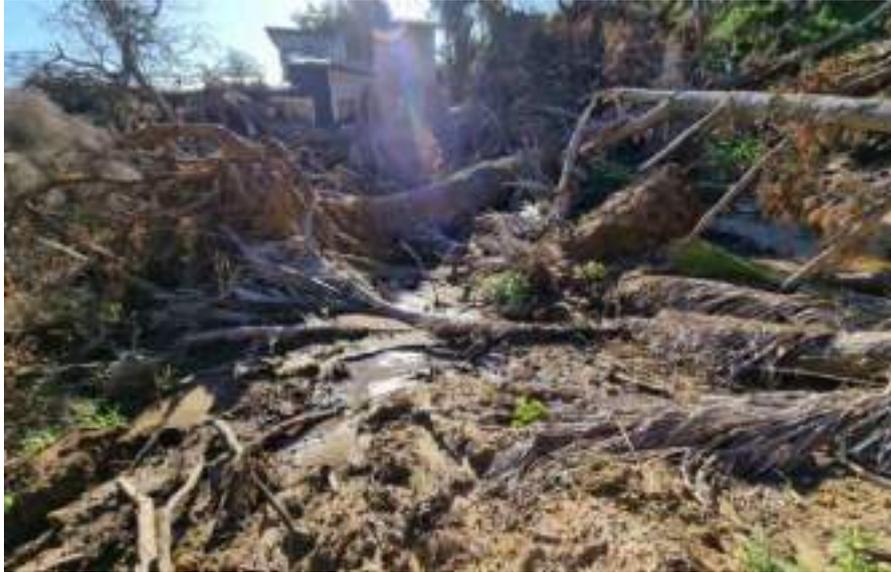
Figure B7 *Entrained vegetation and sand/silt comprising the overall 'colluvial debris', GHD 2023. Debris resulting from Landslides M-LS07,08,09.*

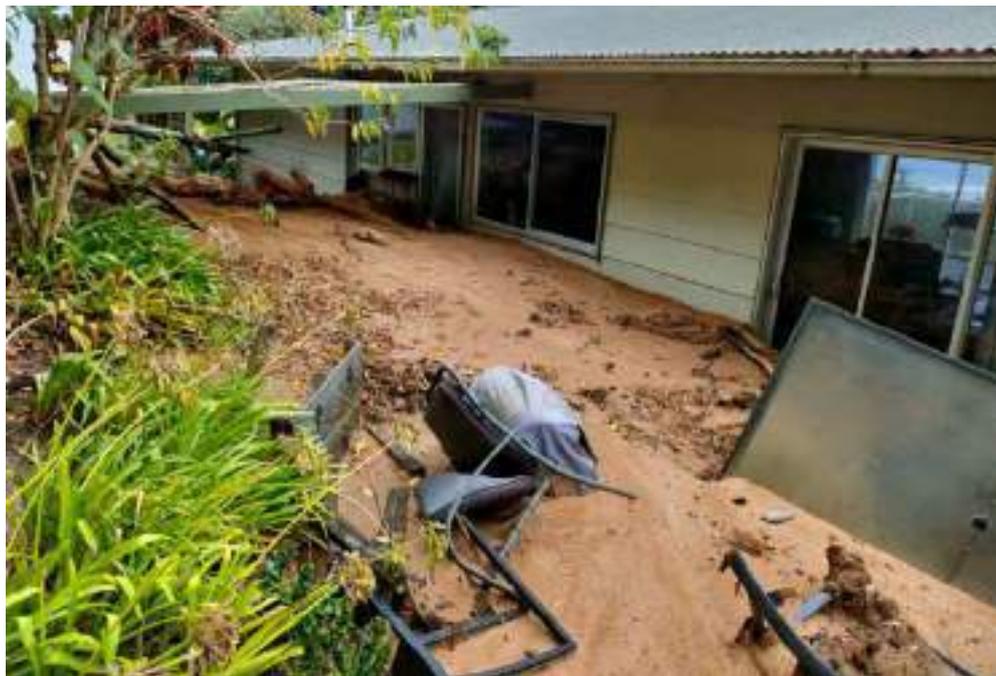
Figure B9 *Example of engineering geological unit '2023 Recent Colluvium'. Medium grained sand, unconsolidated, spread out thinly across existing surfaces.*

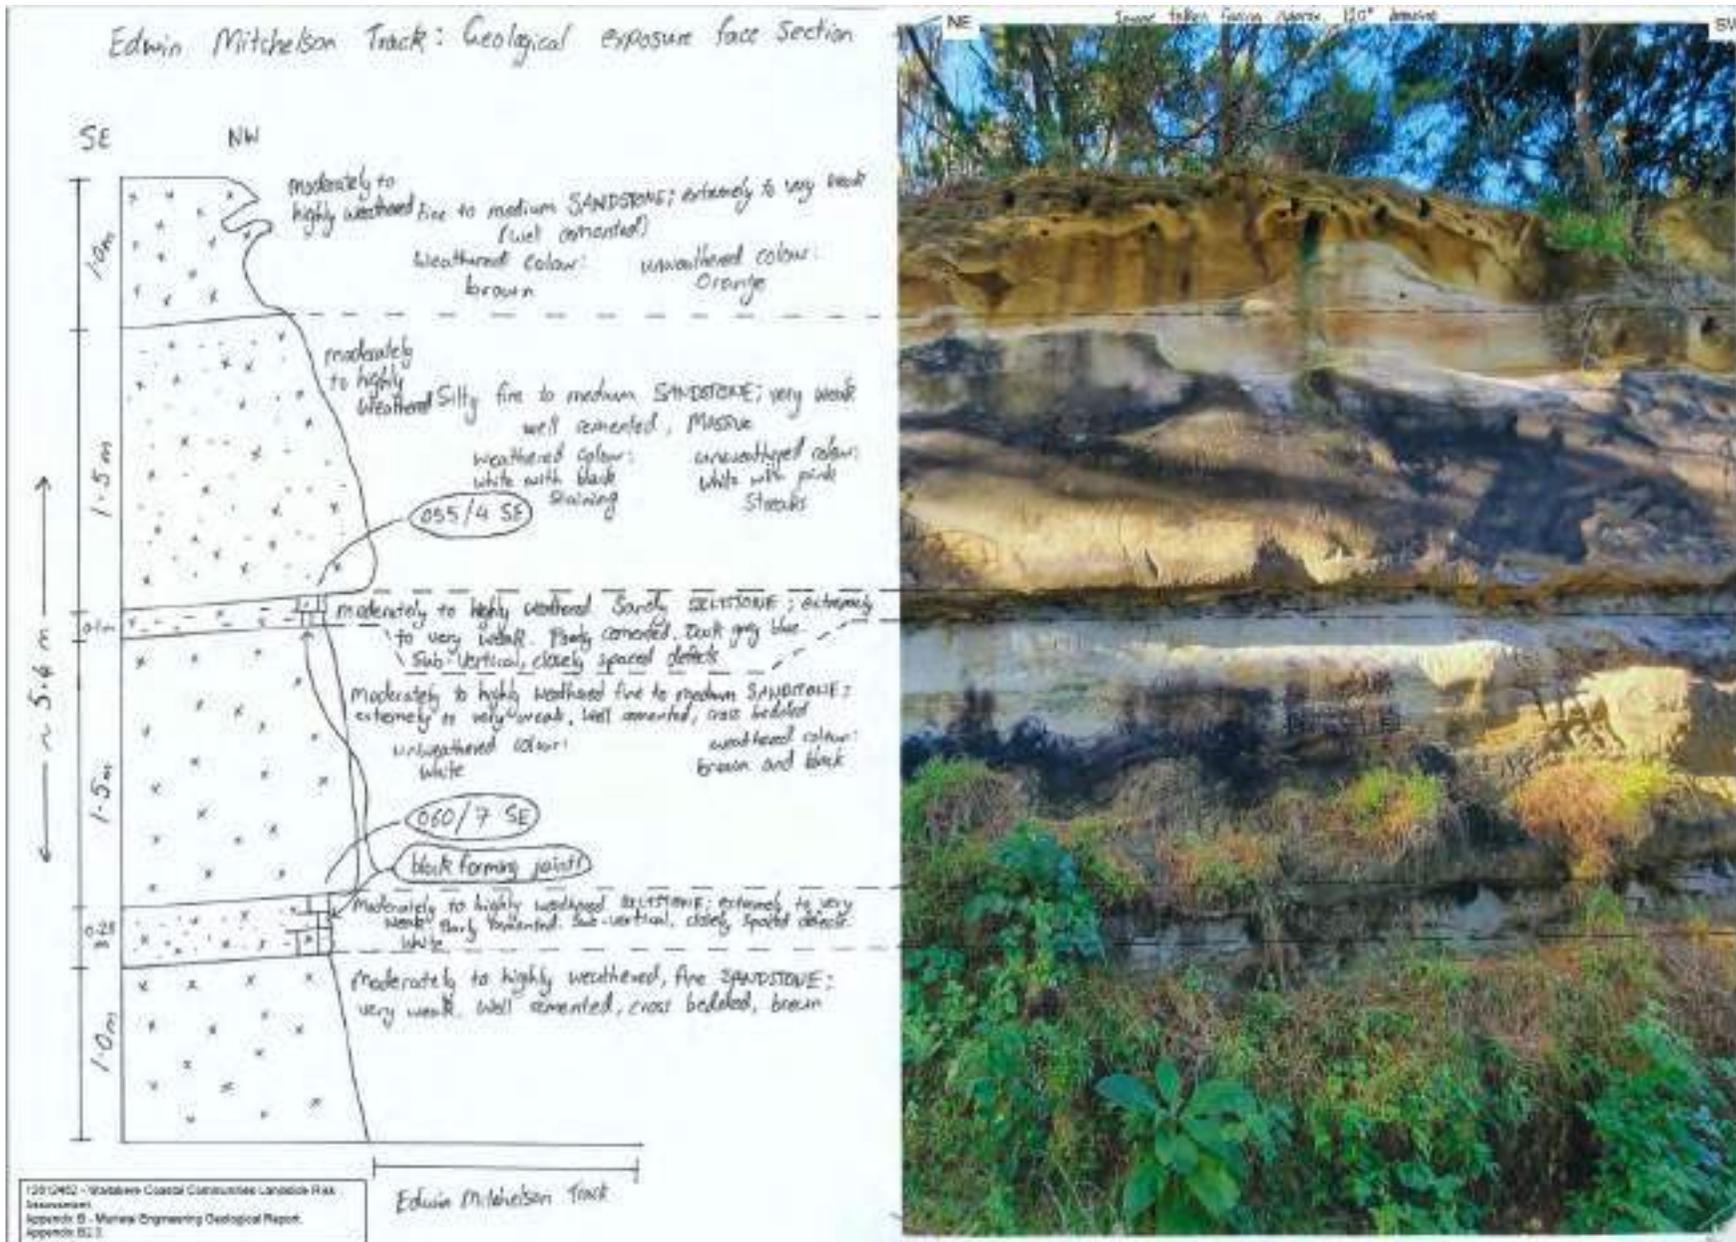
Figure B15 Face log of Awhitu Formation Less Cemented Sands preserving rock fabric and structure, Edwin Mitchelson Track cut slope. Refer Figure A116 for specific location (marked).

Recently exposed sands (landslide slip surfaces) often retain near-vertical bluffs and rock mass fabric (block jointing and bedding, Figure B15); however, it is easily disrupted when physically agitated or when water is passed through it, as observed by sections of shallow core having disaggregated upon recovery. This is not observed with core at depth.

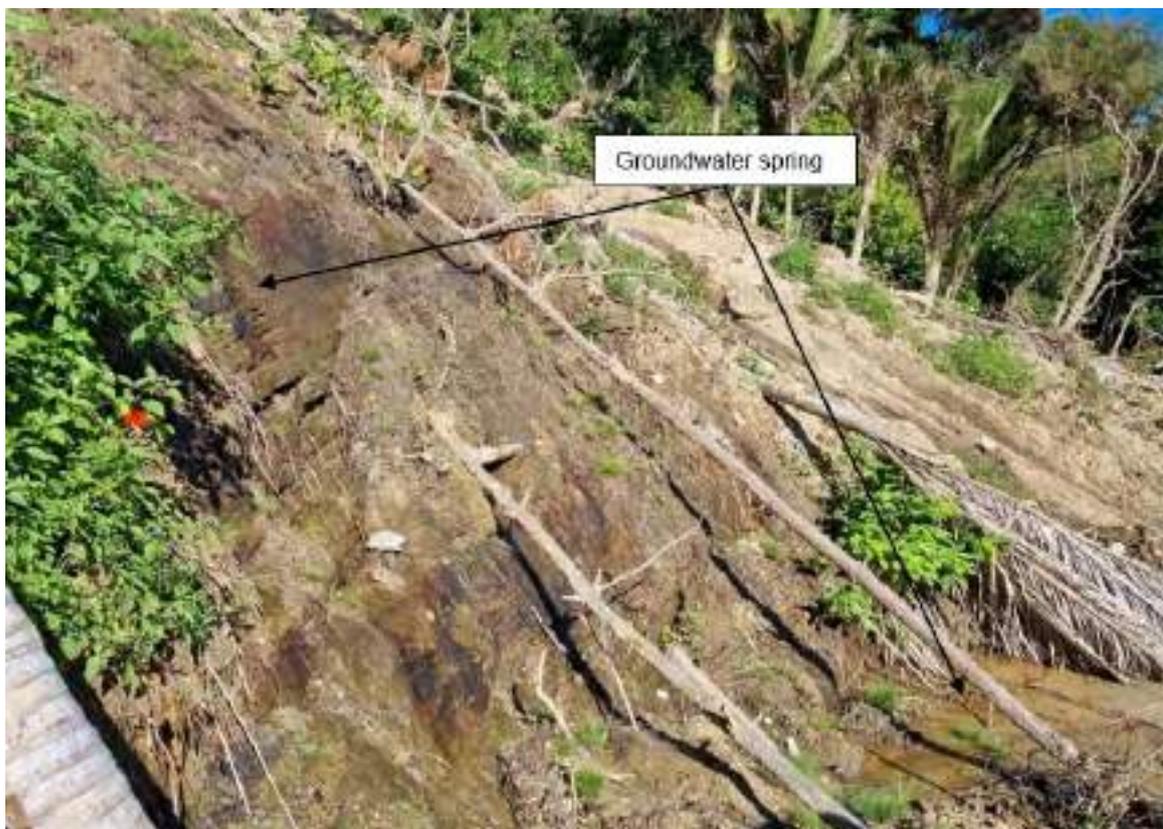
Figure B20 Groundwater seepage above highly oxidised (limonite) layer within Awhitu Formation ‘less cemented’ sand

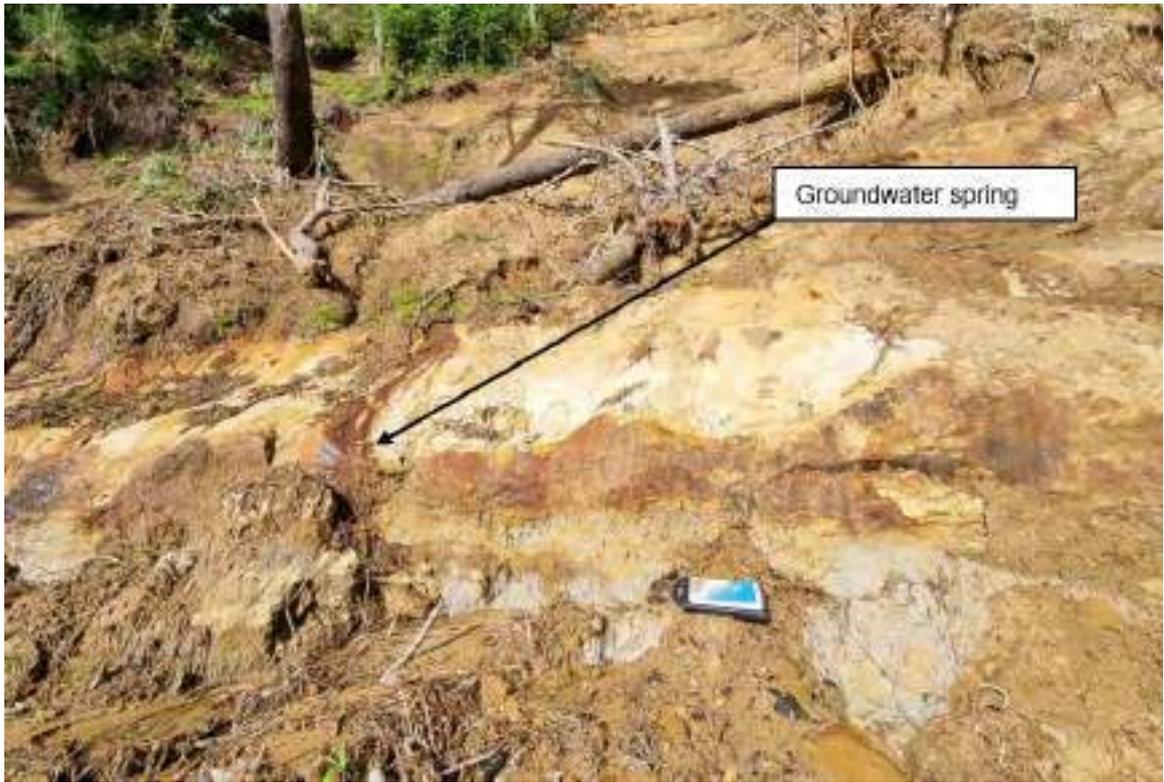
Figure B21 Groundwater spring emitting above silt/clay bed within Awhitu Formation 'less cemented' sand.

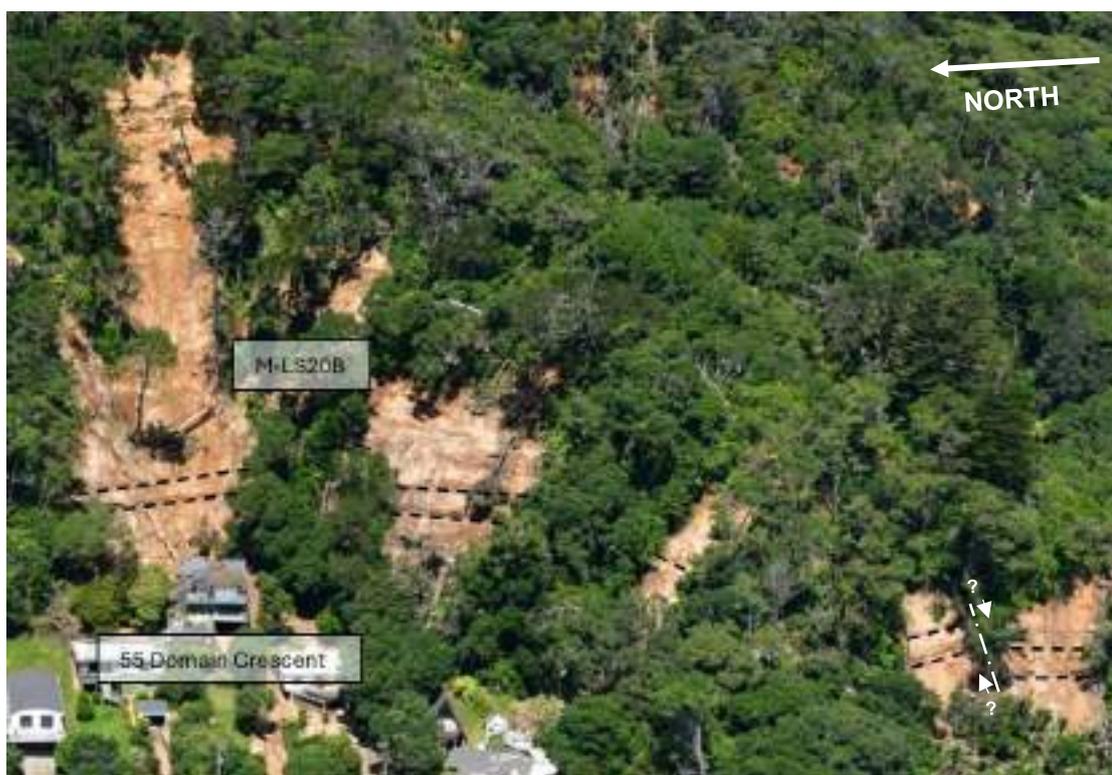
Figure B23 Example of lateral extent of near horizontal silt/clay beds within Awhitu Group, indicated by dashed line. Domain Crescent, M-LS20B for reference. Gentle dip due north – northeast.

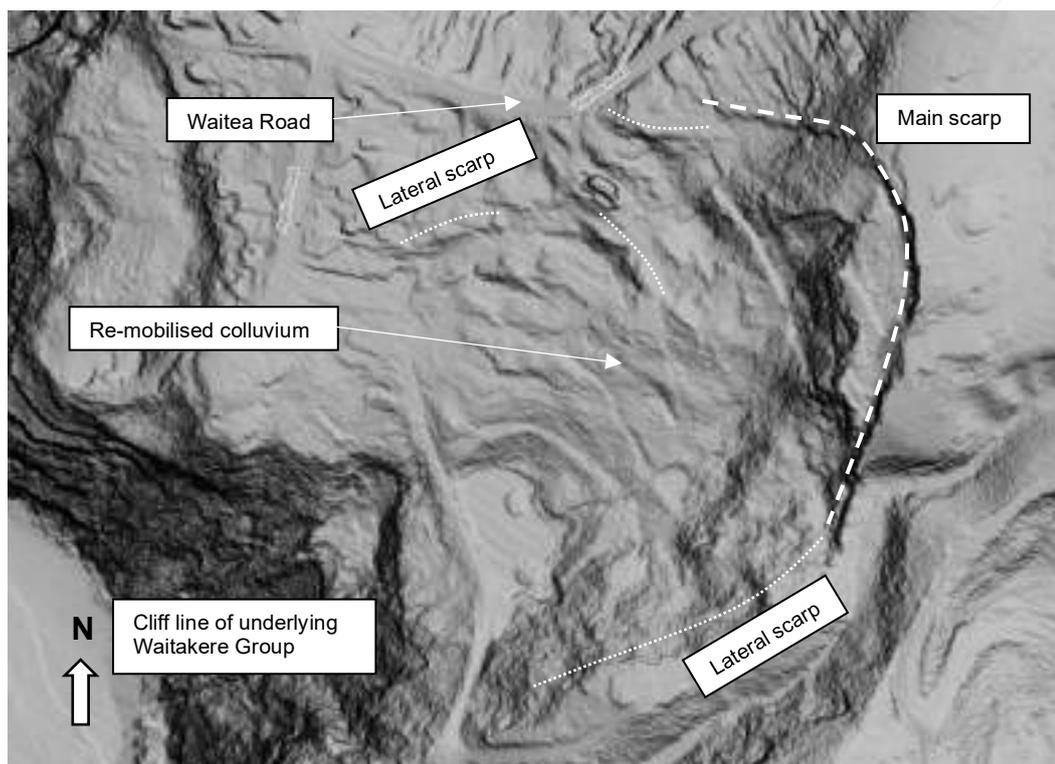
Figure B31 Deep seated landslide (earthflow) within Awhitu Sand Formation, underlying contact with Waitakere Formation daylighting in toe area (cliffs). Background surface model has a 'hill shade' applied to highlight the geomorphology.

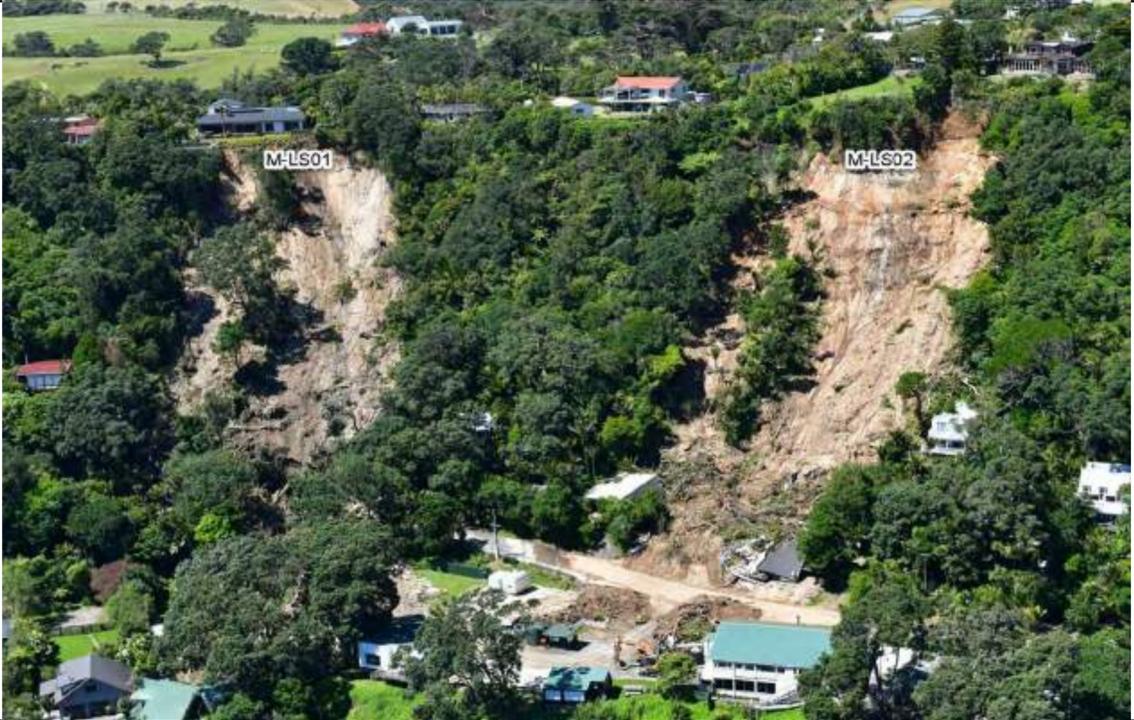
M-LS02	Translational, Debris flow	1728523.55	5923935.03	52	0.5	127	31	Large landslide has damaged or destroyed multiple structures on multiple properties. Landslide debris comprises Awhitu Sand. Patch of Insitu palm trees present within the centre of the landslide

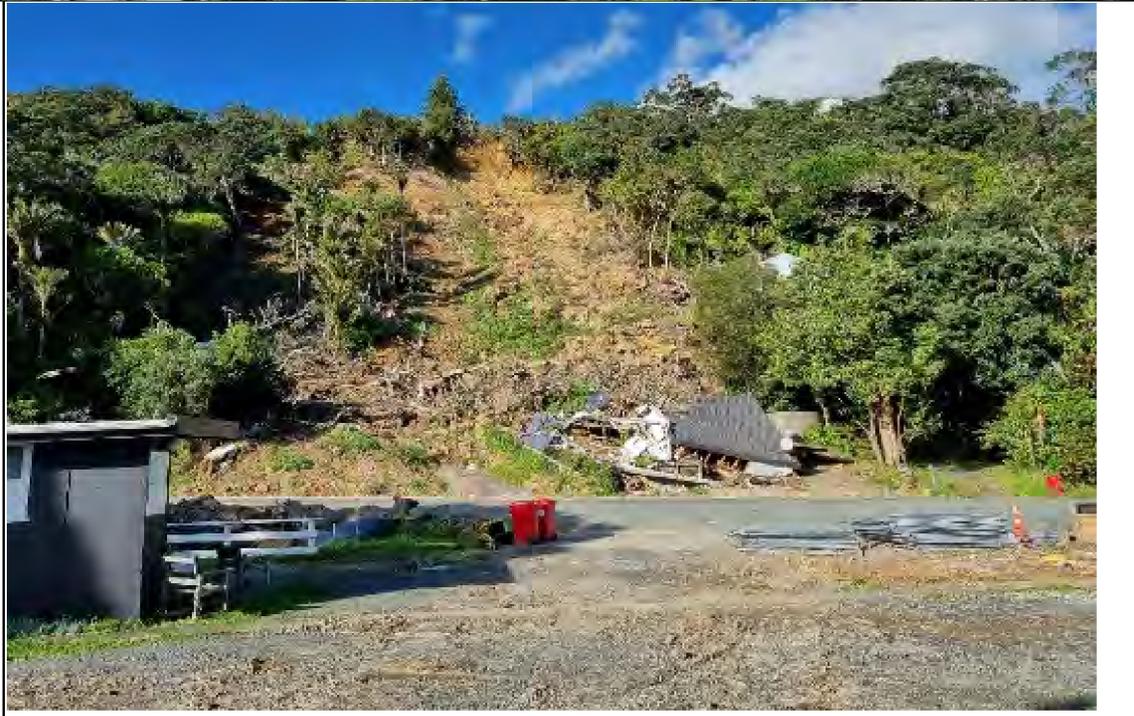
Geomorphology Zone	Landslide ID	Landslide Mechanism, Type	Coordinates (NZTM)		Landslide Dimensional Data				General Landslide Information	Photographs
			Easting (m)	Northing (m)	Approx. Main Scarp Width (m)	Approx. Average Depletion Zone Depth (m)	Approx. Debris Runnout Length (m)	Approx. Local Slope Angle (Degrees)		
Zone 2	M-LS03	Translational, Debris flow	1728528.85	5923806.37	33	0.25	91	42	Large landslide above Watercare's water treatment plant on Motutara Road

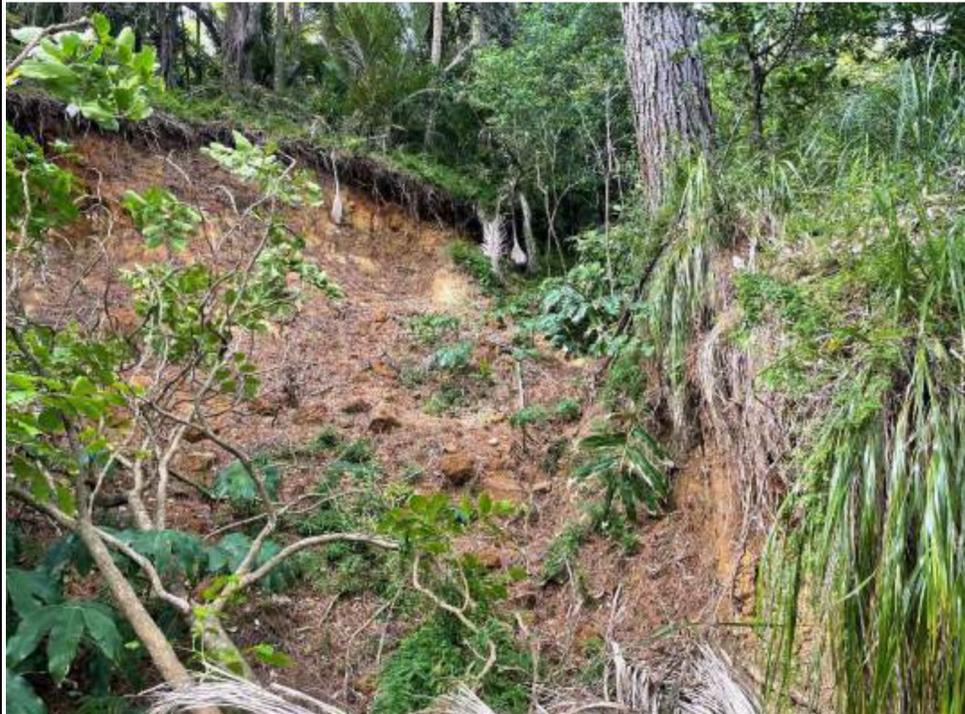
Geomorphology Zone	Landslide ID	Landslide Mechanism, Type	Coordinates (NZTM)		Landslide Dimensional Data				General Landslide Information	Photographs
			Easting (m)	Northing (m)	Approx. Main Scarp Width (m)	Approx. Average Depletion Zone Depth (m)	Approx. Debris Runnout Length (m)	Approx. Local Slope Angle (Degrees)		
Zone 3	M-LS11	Translational, Debris flow	1728087.884	5923389.317	15	0.5	47	25	Landslide has occurred within the cut slope above the driveway.

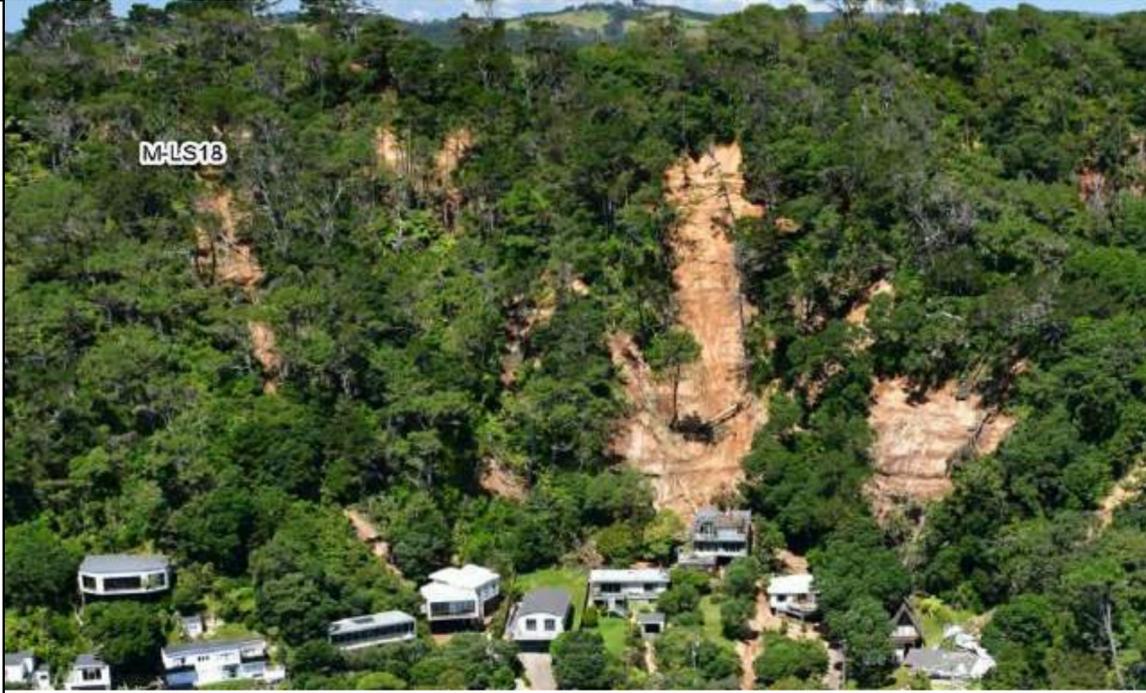
Geomorphology Zone	Landslide ID	Landslide Mechanism, Type	Coordinates (NZTM)		Landslide Dimensional Data				General Landslide Information	Photographs
			Easting (m)	Northing (m)	Approx. Main Scarp Width (m)	Approx. Average Depletion Zone Depth (m)	Approx. Debris Runnout Length (m)	Approx. Local Slope Angle (Degrees)		
Zone 3	M-LS18B	Translational, Debris flow	1727906.46	5923033.905	38	0.5	132	37	Landslide has occurred as an underslip below the Edwin Mitchelson Track, along walking track.

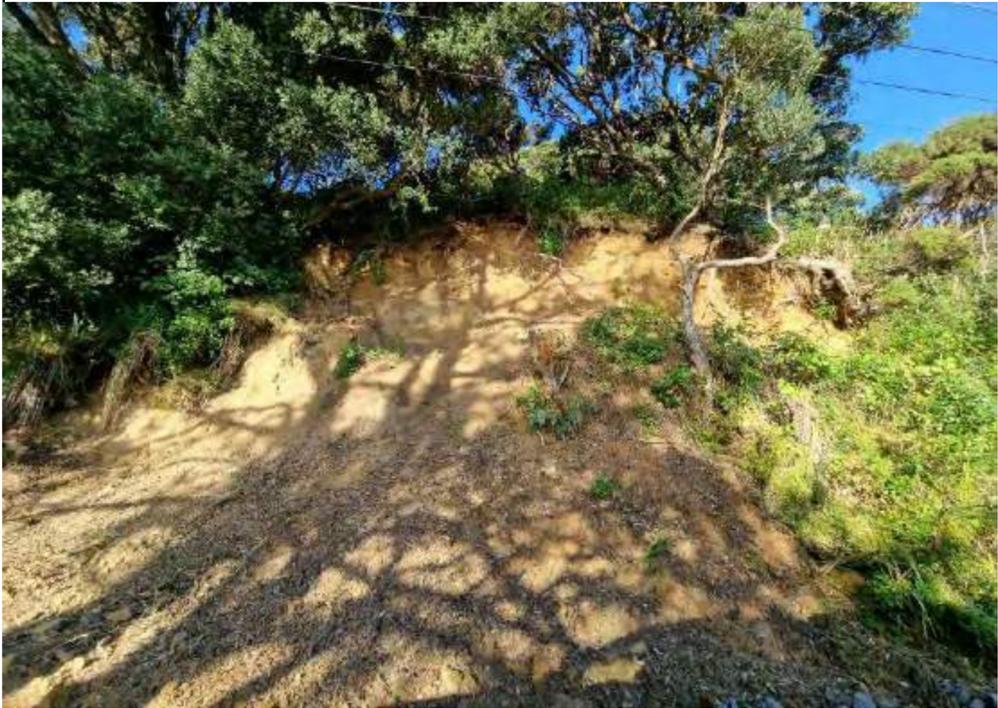
Geomorphology Zone	Landslide ID	Landslide Mechanism, Type	Coordinates (NZTM)		Landslide Dimensional Data				General Landslide Information	Photographs
			Easting (m)	Northing (m)	Approx. Main Scarp Width (m)	Approx. Average Depletion Zone Depth (m)	Approx. Debris Runnout Length (m)	Approx. Local Slope Angle (Degrees)		
Zone 3	M-LS42	Translational, Debris flow	1727907.628	5923229.037	4	1	25	40	A landslide has occurred behind and upslope of the dwelling. The landslide has occurred on the slopes toward the lower base of the escarpment.

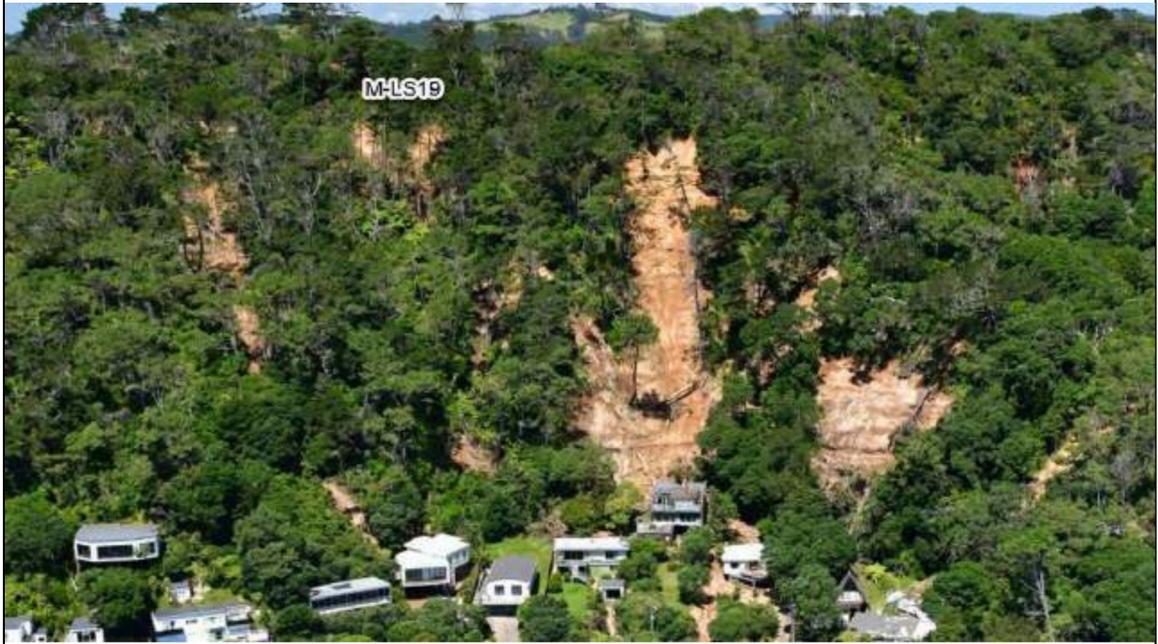
Geomorphology Zone	Landslide ID	Landslide Mechanism, Type	Coordinates (NZTM)		Landslide Dimensional Data				General Landslide Information	Photographs
			Easting (m)	Northing (m)	Approx. Main Scarp Width (m)	Approx. Average Depletion Zone Depth (m)	Approx. Debris Runnout Length (m)	Approx. Local Slope Angle (Degrees)		
Zone 4	M-LS19B	Translational, Debris flow	1727875.58	5922999.209	38	0.25	115	27	Landslide has occurred as an underslip adjacent to the Edwin Mitchelson track cut. Seepage observed above limonite layers

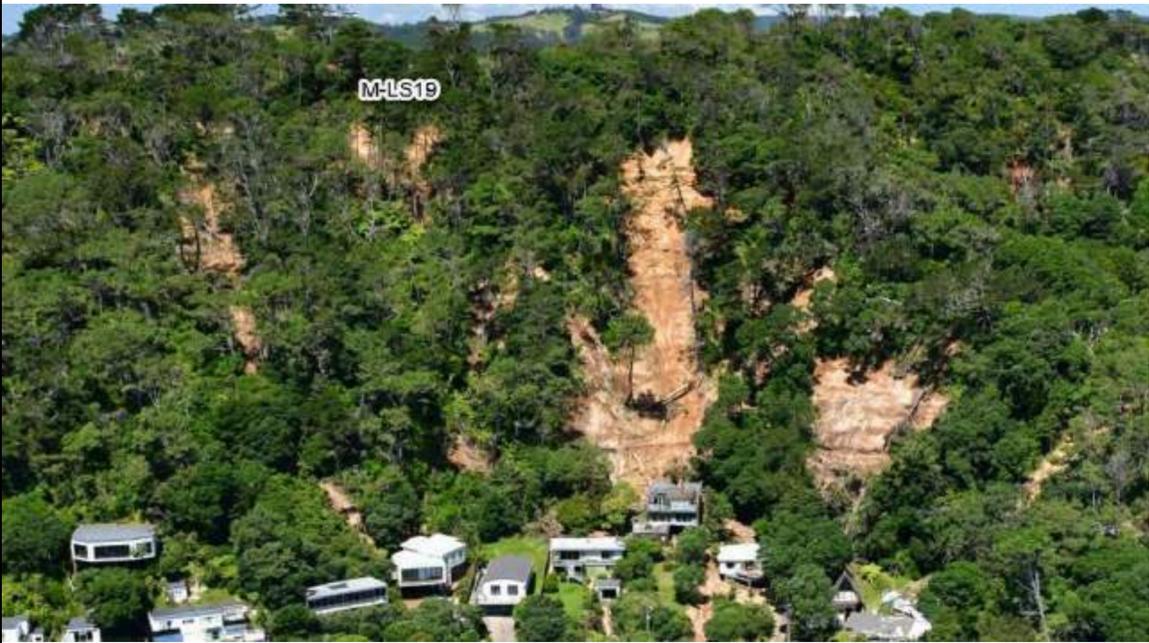
M-LS20A	Translational, Debris flow	1727848.788	5922938.305	46	0.5	13	55	Landslide has occurred within the upslope cut of the Edwin Mitchelson track (overslip). Track remains mostly intact with some debris on the track.

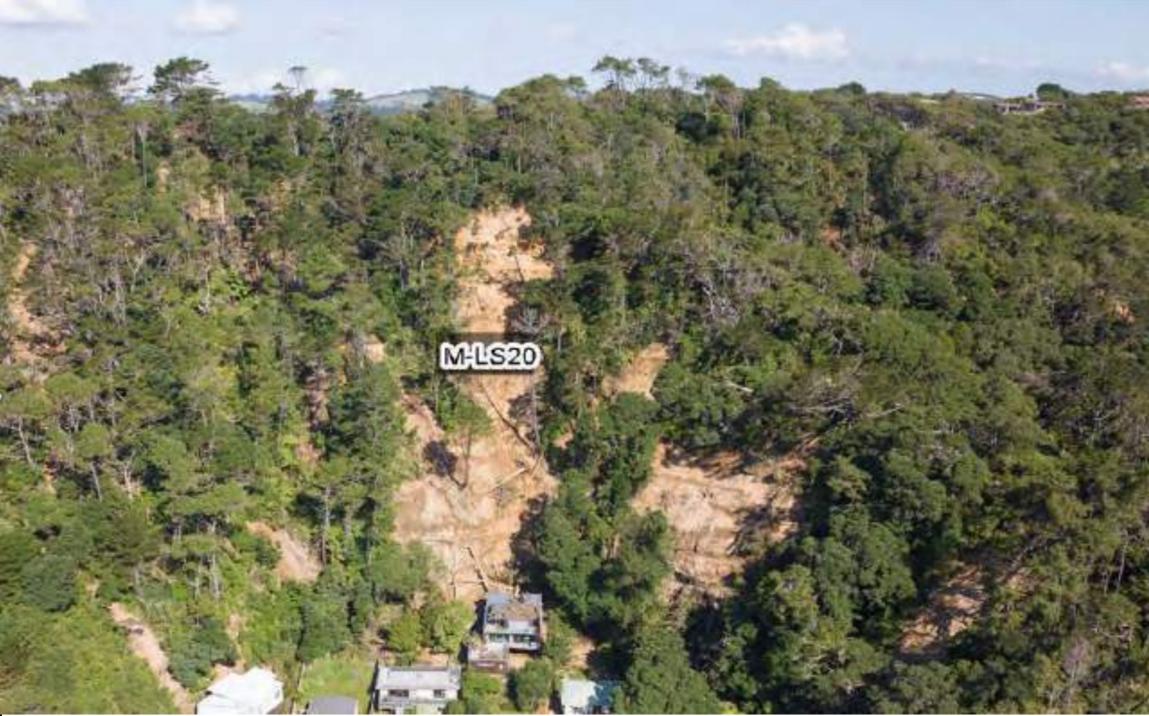
Geomorphology Zone	Landslide ID	Landslide Mechanism, Type	Coordinates (NZTM)		Landslide Dimensional Data				General Landslide Information	Photographs
			Easting (m)	Northing (m)	Approx. Main Scarp Width (m)	Approx. Average Depletion Zone Depth (m)	Approx. Debris Runnout Length (m)	Approx. Local Slope Angle (Degrees)		
Zone 4	M-LS20B	Translational, Debris flow	1727820.128	5922964.941	96	0.75	137	42	Landslide has occurred as an underslip adjacent to the Edwin Mitchelson track cut. Seepage observed above limonite layers
