Title: Preliminary Site Investigation					
Date	Version	Description	Prepared by:	Reviewed by:	Authorised by:
October 2024	1	Preliminary Site Investigation Report	C. Thornton	L. Phuah	C. Bauld
October 2024	2	Updated for Resource Consent	C. Thornton	L. Phuah	C. Bauld

The Tennessee Bridge project involves removing the current embankment which carries the existing Eastern Interceptor (EI), an approximately 2.6 m diameter reinforced concrete wastewater pipe. The replacement will comprise a new pipe and pipe bridge in the coastal marine area (CMA) to open up the waterway capacity to allow increased flood conveyance. Diversion chambers are required at either end of the new pipe, connecting it to the existing pipe to facilitate the change over from the old pipe to the new pipe bridge diversion.

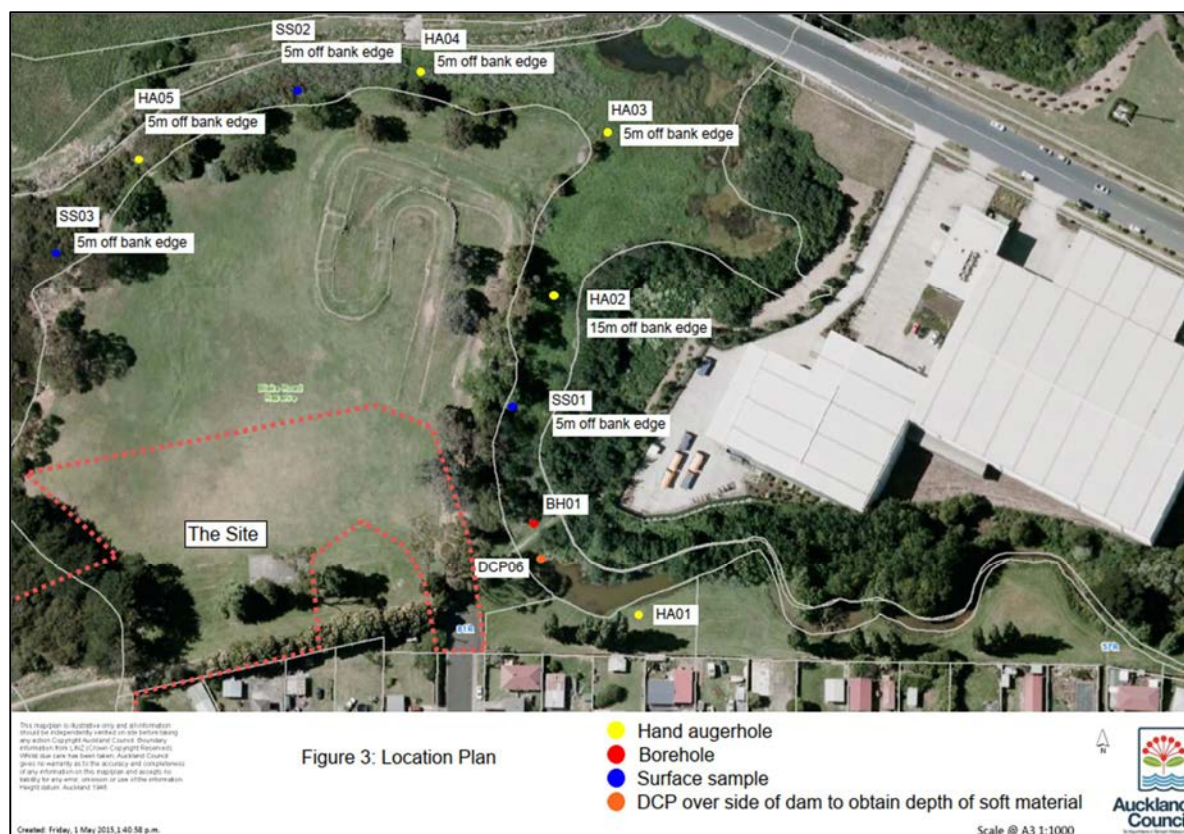
Figure 3.1: Locations of previous investigations. (Source: AECOM Geotechnical and Contaminated Land Assessment)

In June 2015, AECOM New Zealand Limited (AECOM) undertook a combined geotechnical and contaminated land assessment at Blake Road Reserve to support the upgrade of the Blake Road Stormwater improvements Project. The location of the previous investigation in relation to the site is shown on Figure 3.1. Soil sampling was carried out at one hand auger locations (HA01), the results of the testing indicated:

- Concentrations of heavy metals were detected within the published non-volcanic background levels for Auckland.
- Total petroleum hydrocarbons and polycyclic aromatic hydrocarbon (PAH) compounds were not recorded above the laboratory limit of reporting.
- The assessment indicates that the soil quality does not pose an immediate risk to a commercial/industrial outdoor worker (unpaved).

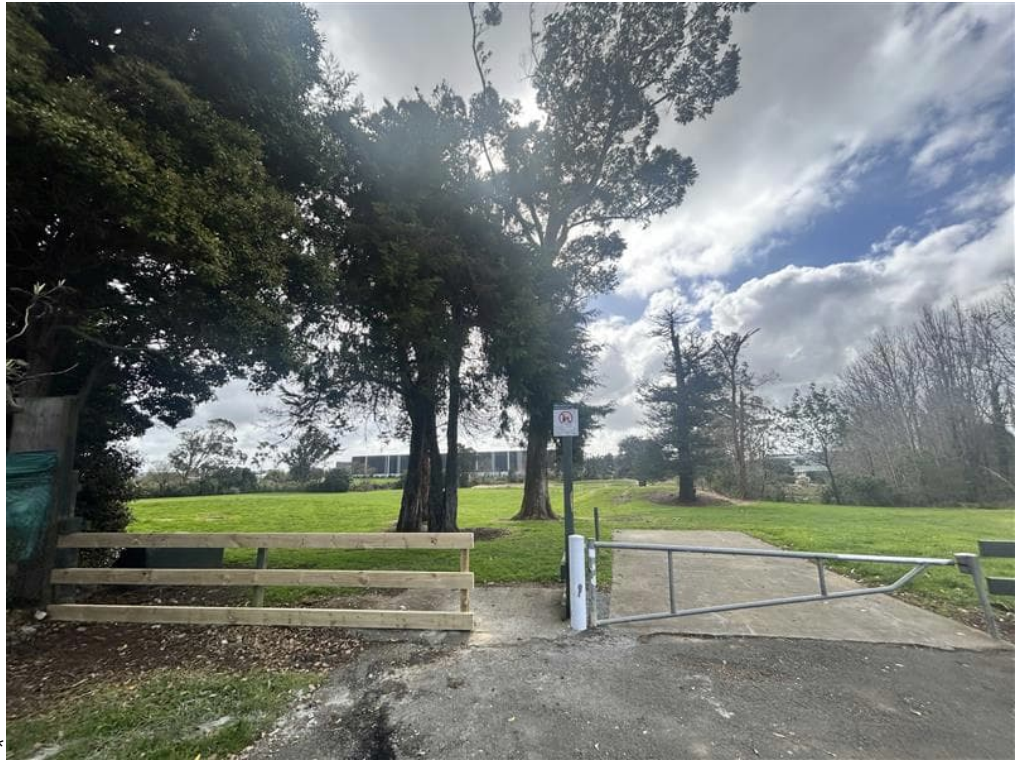
*Photograph Appendix C.1: View northeast towards the eastern compound area from the Blake Road entrance.*

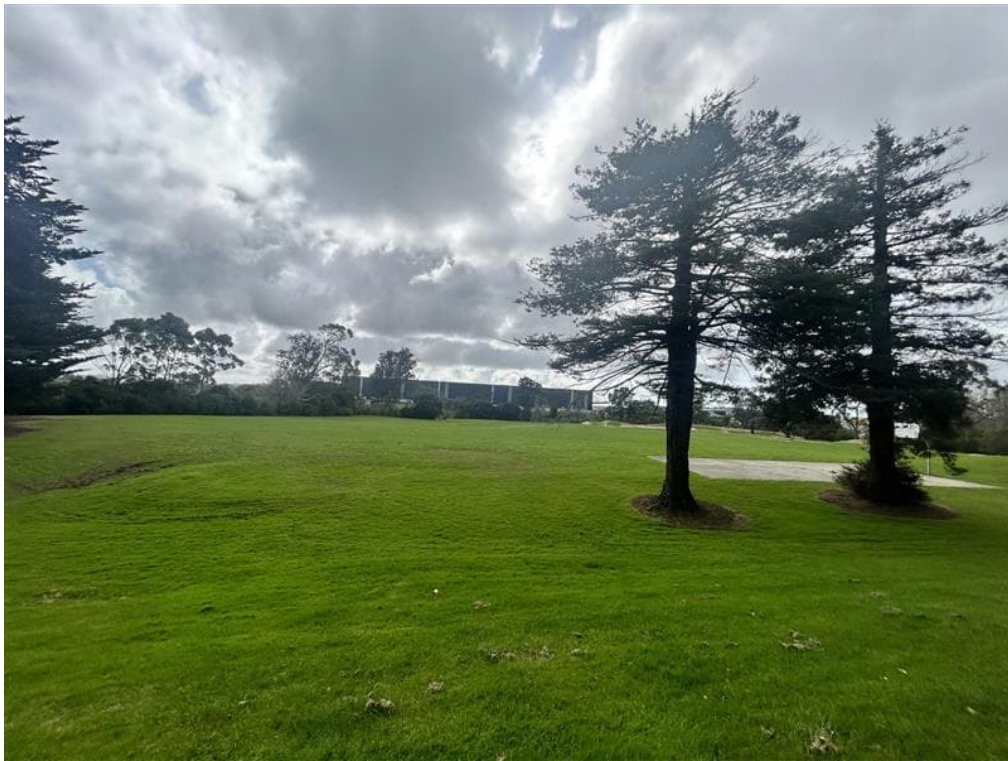
*Photograph Appendix C.2: View north towards the eastern compound area.*

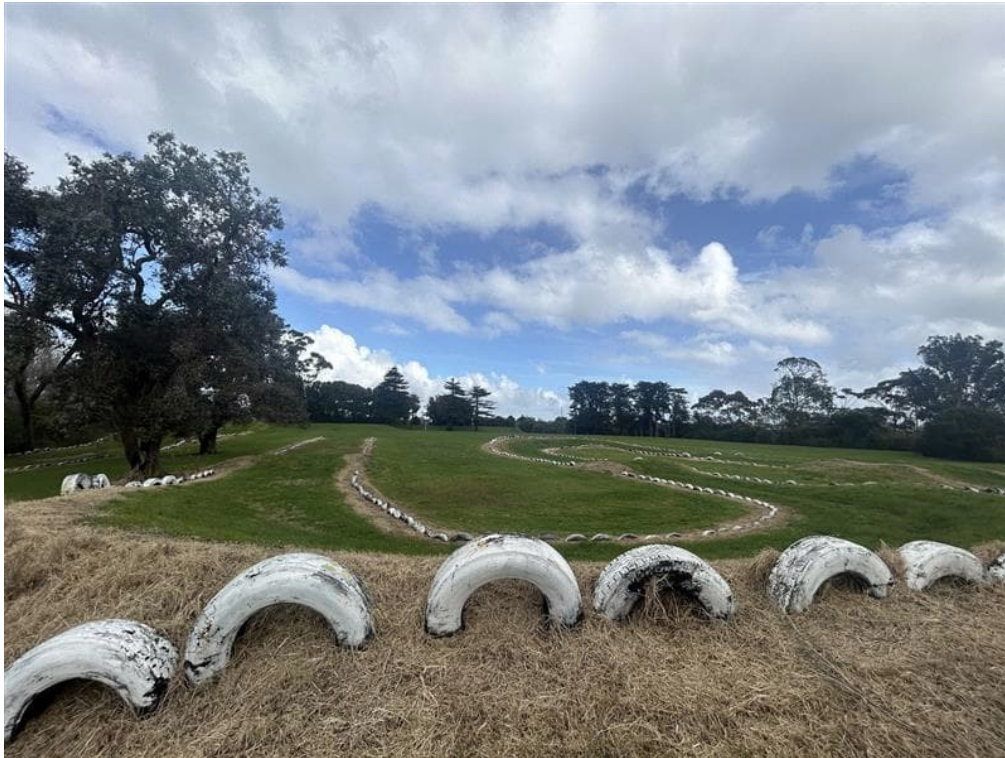
*Photograph Appendix C.3: View south towards the bike track, tyres north of the eastern compound area*

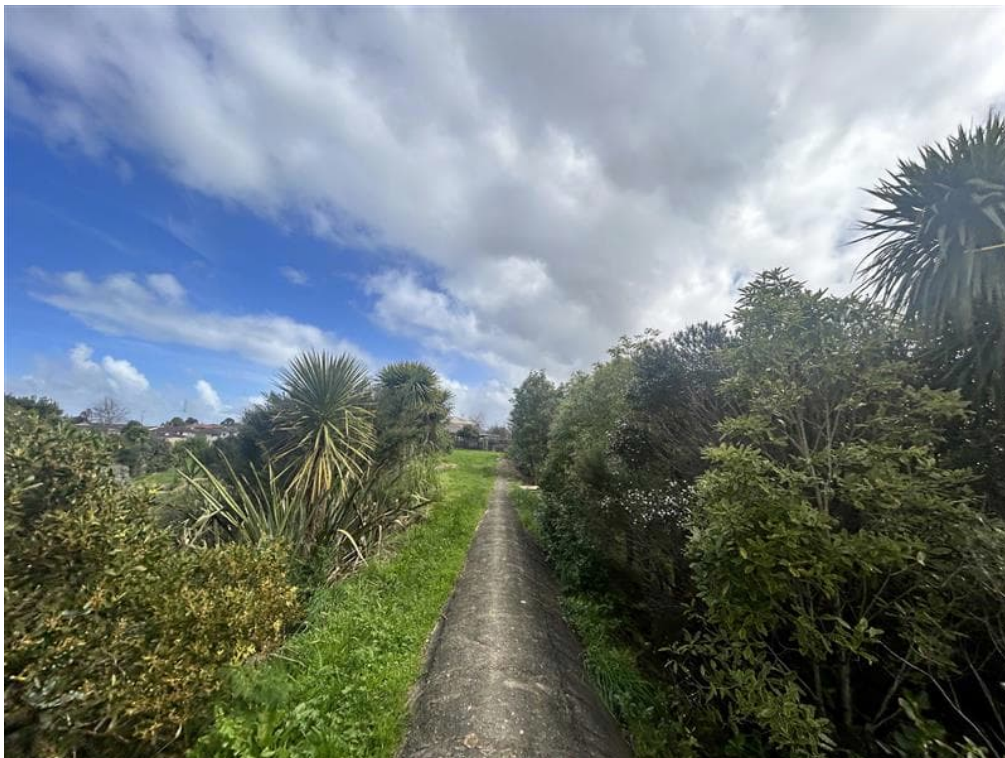
*Photograph Appendix C.4: View facing west towards the current embankment.*

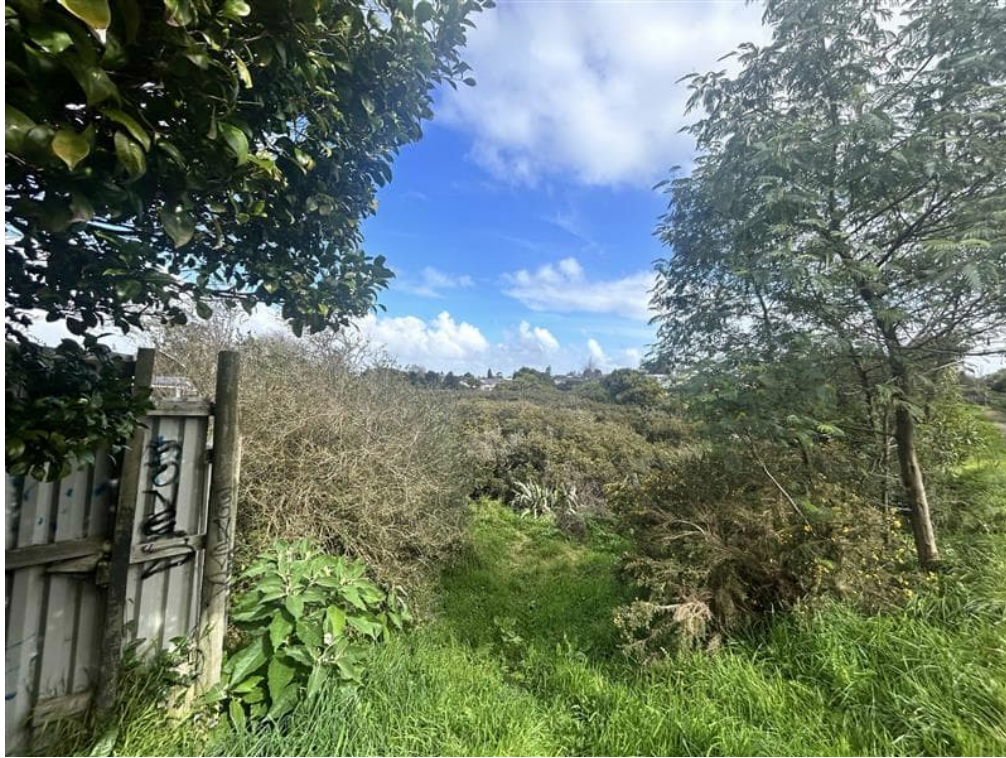
*Photograph Appendix C.5: Vegetation and mangrove area to the east of the current embankment.*

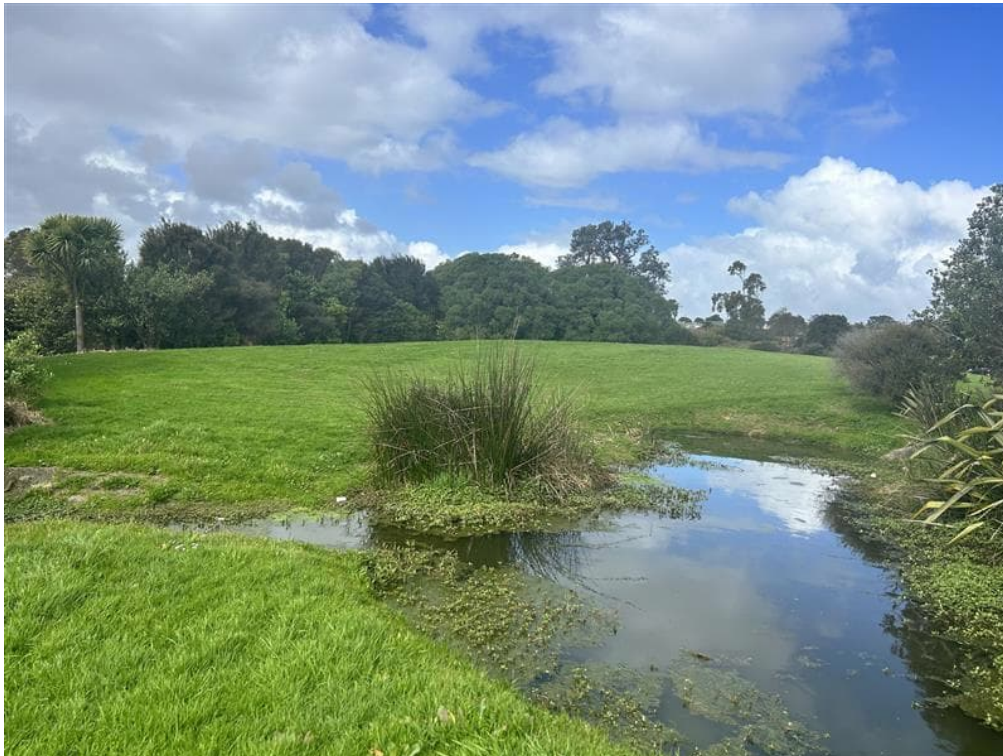
*Photograph Appendix C.6: View northeast of small stream and ponded water in the western compound area.*

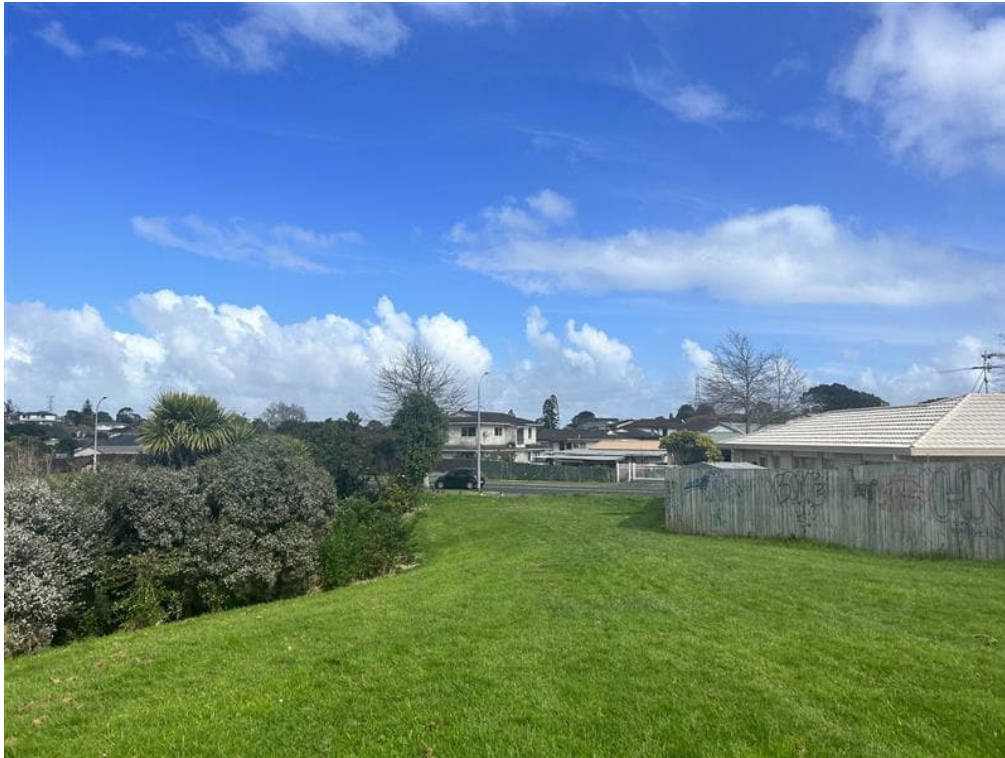
*Photograph Appendix C.7: View south in the western compound area, showing residential dwellings and the mangroves.*

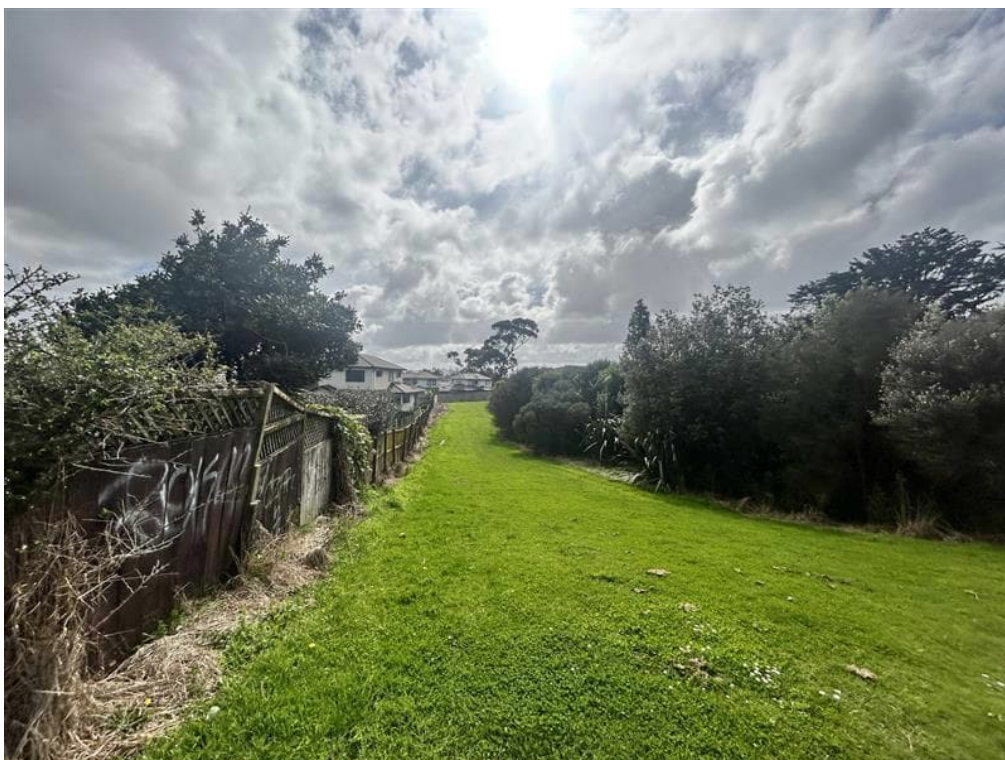
*Photograph Appendix C.8: View northwest in the western compound area, showing the small well-maintained grass walkway, which continues northwest of the western compound.*

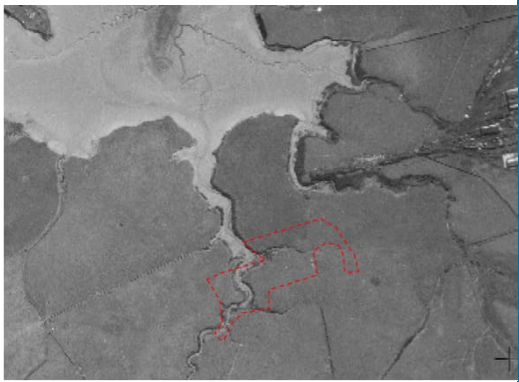
Year and source	Site observations	Surrounding land use	Imagery
1940 - Retrolens	The site is vacant pastoral land. Tarata Creek runs through the centre of the site.	The area surrounding the site is also vacant pastoral . Further north, there is mangroves and Mangere Inlet.

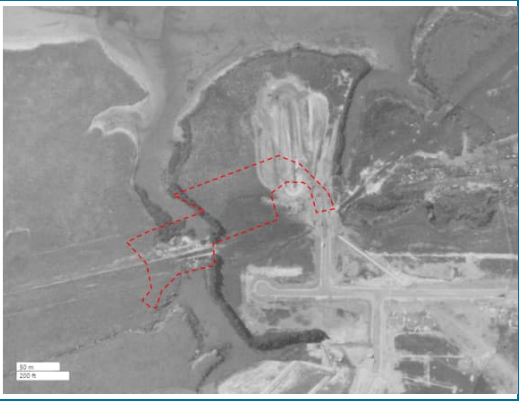
1959 Retrolens	The site remains vacant, soil disturbance is visible in the northeastern and southwestern portion of the site along Tarata Creek.	Soil disturbance is visible to the north of the site and residential development is occurring to the south and southeast. Blake road has been constructed to the south of the site.

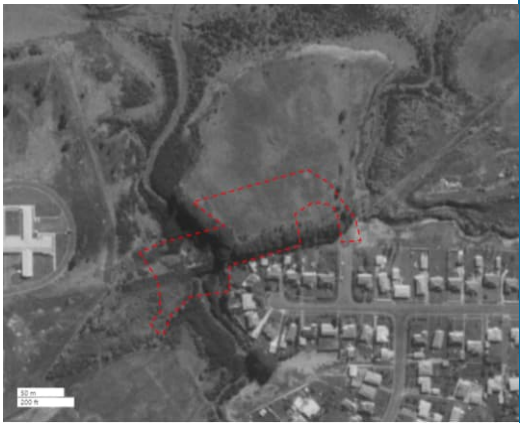
Year and source	Site observations	Surrounding land use	Imagery
1975 Auckland Council Geomaps	The site remains vacant. It appears the embankment has been constructed, with a linear area of soil disturbance is visible	Residential properties are visible to the southeast, a commercial property to the west. Blake Road reserve is visible to the north of the site.

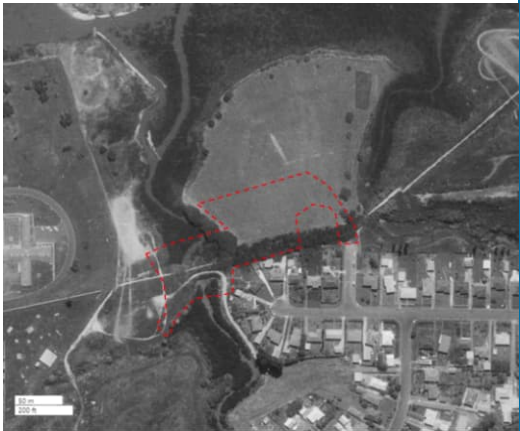
1980 Auckland Council Geomaps	Soil disturbance is visible in the northwestern portion of the site included the construction of new pathways.	Further residential development has occurred in the wider surrounding. Soil disturbance and clear tracks are visible to the west of the site.

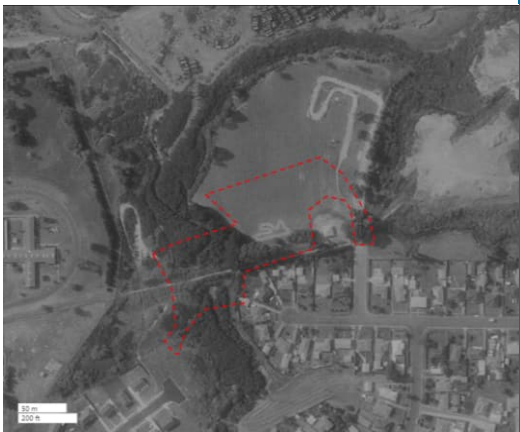
1987 Auckland Council Geomaps	A small area of soil disturbance is visible in the centre and northeast areas of the site.	A dwelling structure is visible directly south of the site. Soil disturbance activities are visible to the east of the site associated with the BMX cycle track.

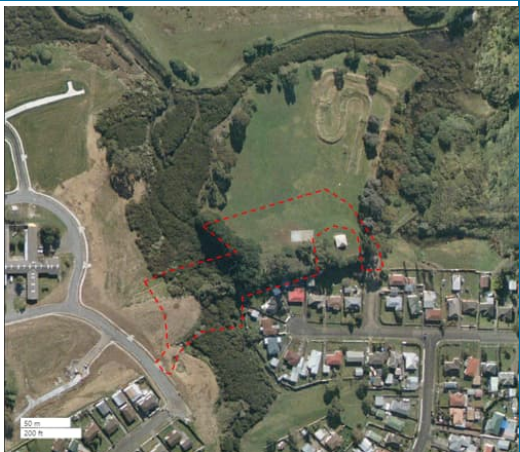
2001 Auckland Council Geomaps	A concrete basketball court is visible onsite. No significant changes visible onsite.	A BMX cycle track has been developed to the north of the site. To the west, extensive vegetation now covers previous areas of exposed soil. Further residential development is visible to the southwest.

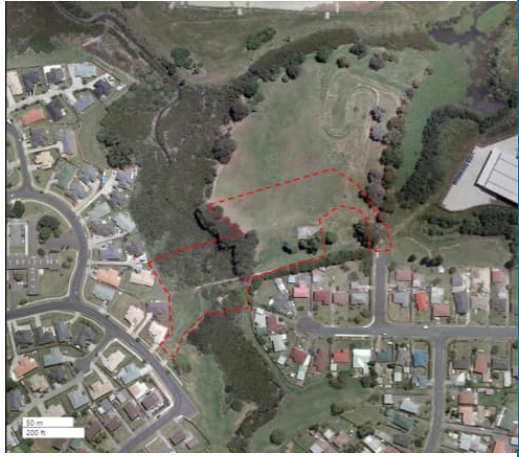
Year and source	Site observations	Surrounding land use	Imagery
2008 Auckland Council Geomaps	No significant changes to the site.	A commercial/industrial building has been constructed to the east and further residential development to the west.

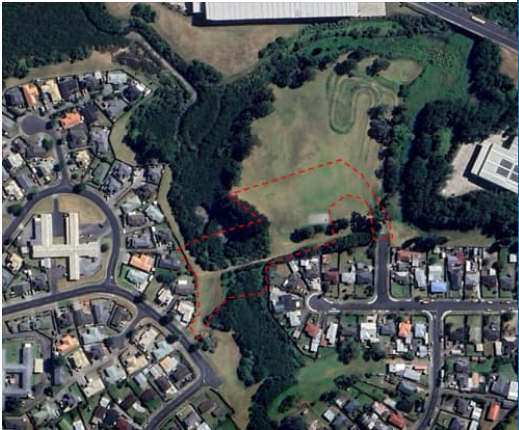
2024 Auckland Council Geomaps	No significant changes to the site.	No significant change to the surrounding area.
