12 October 2021

David Moore  
Director  
Golf Strategy Group Ltd  
60 Clearwater Avenue  
**CHRISTCHURCH 8051**

## **MURIWAI DOWNS GOLF PROJECT: UPDATED PRELIMINARY SITE INVESTIGATION**

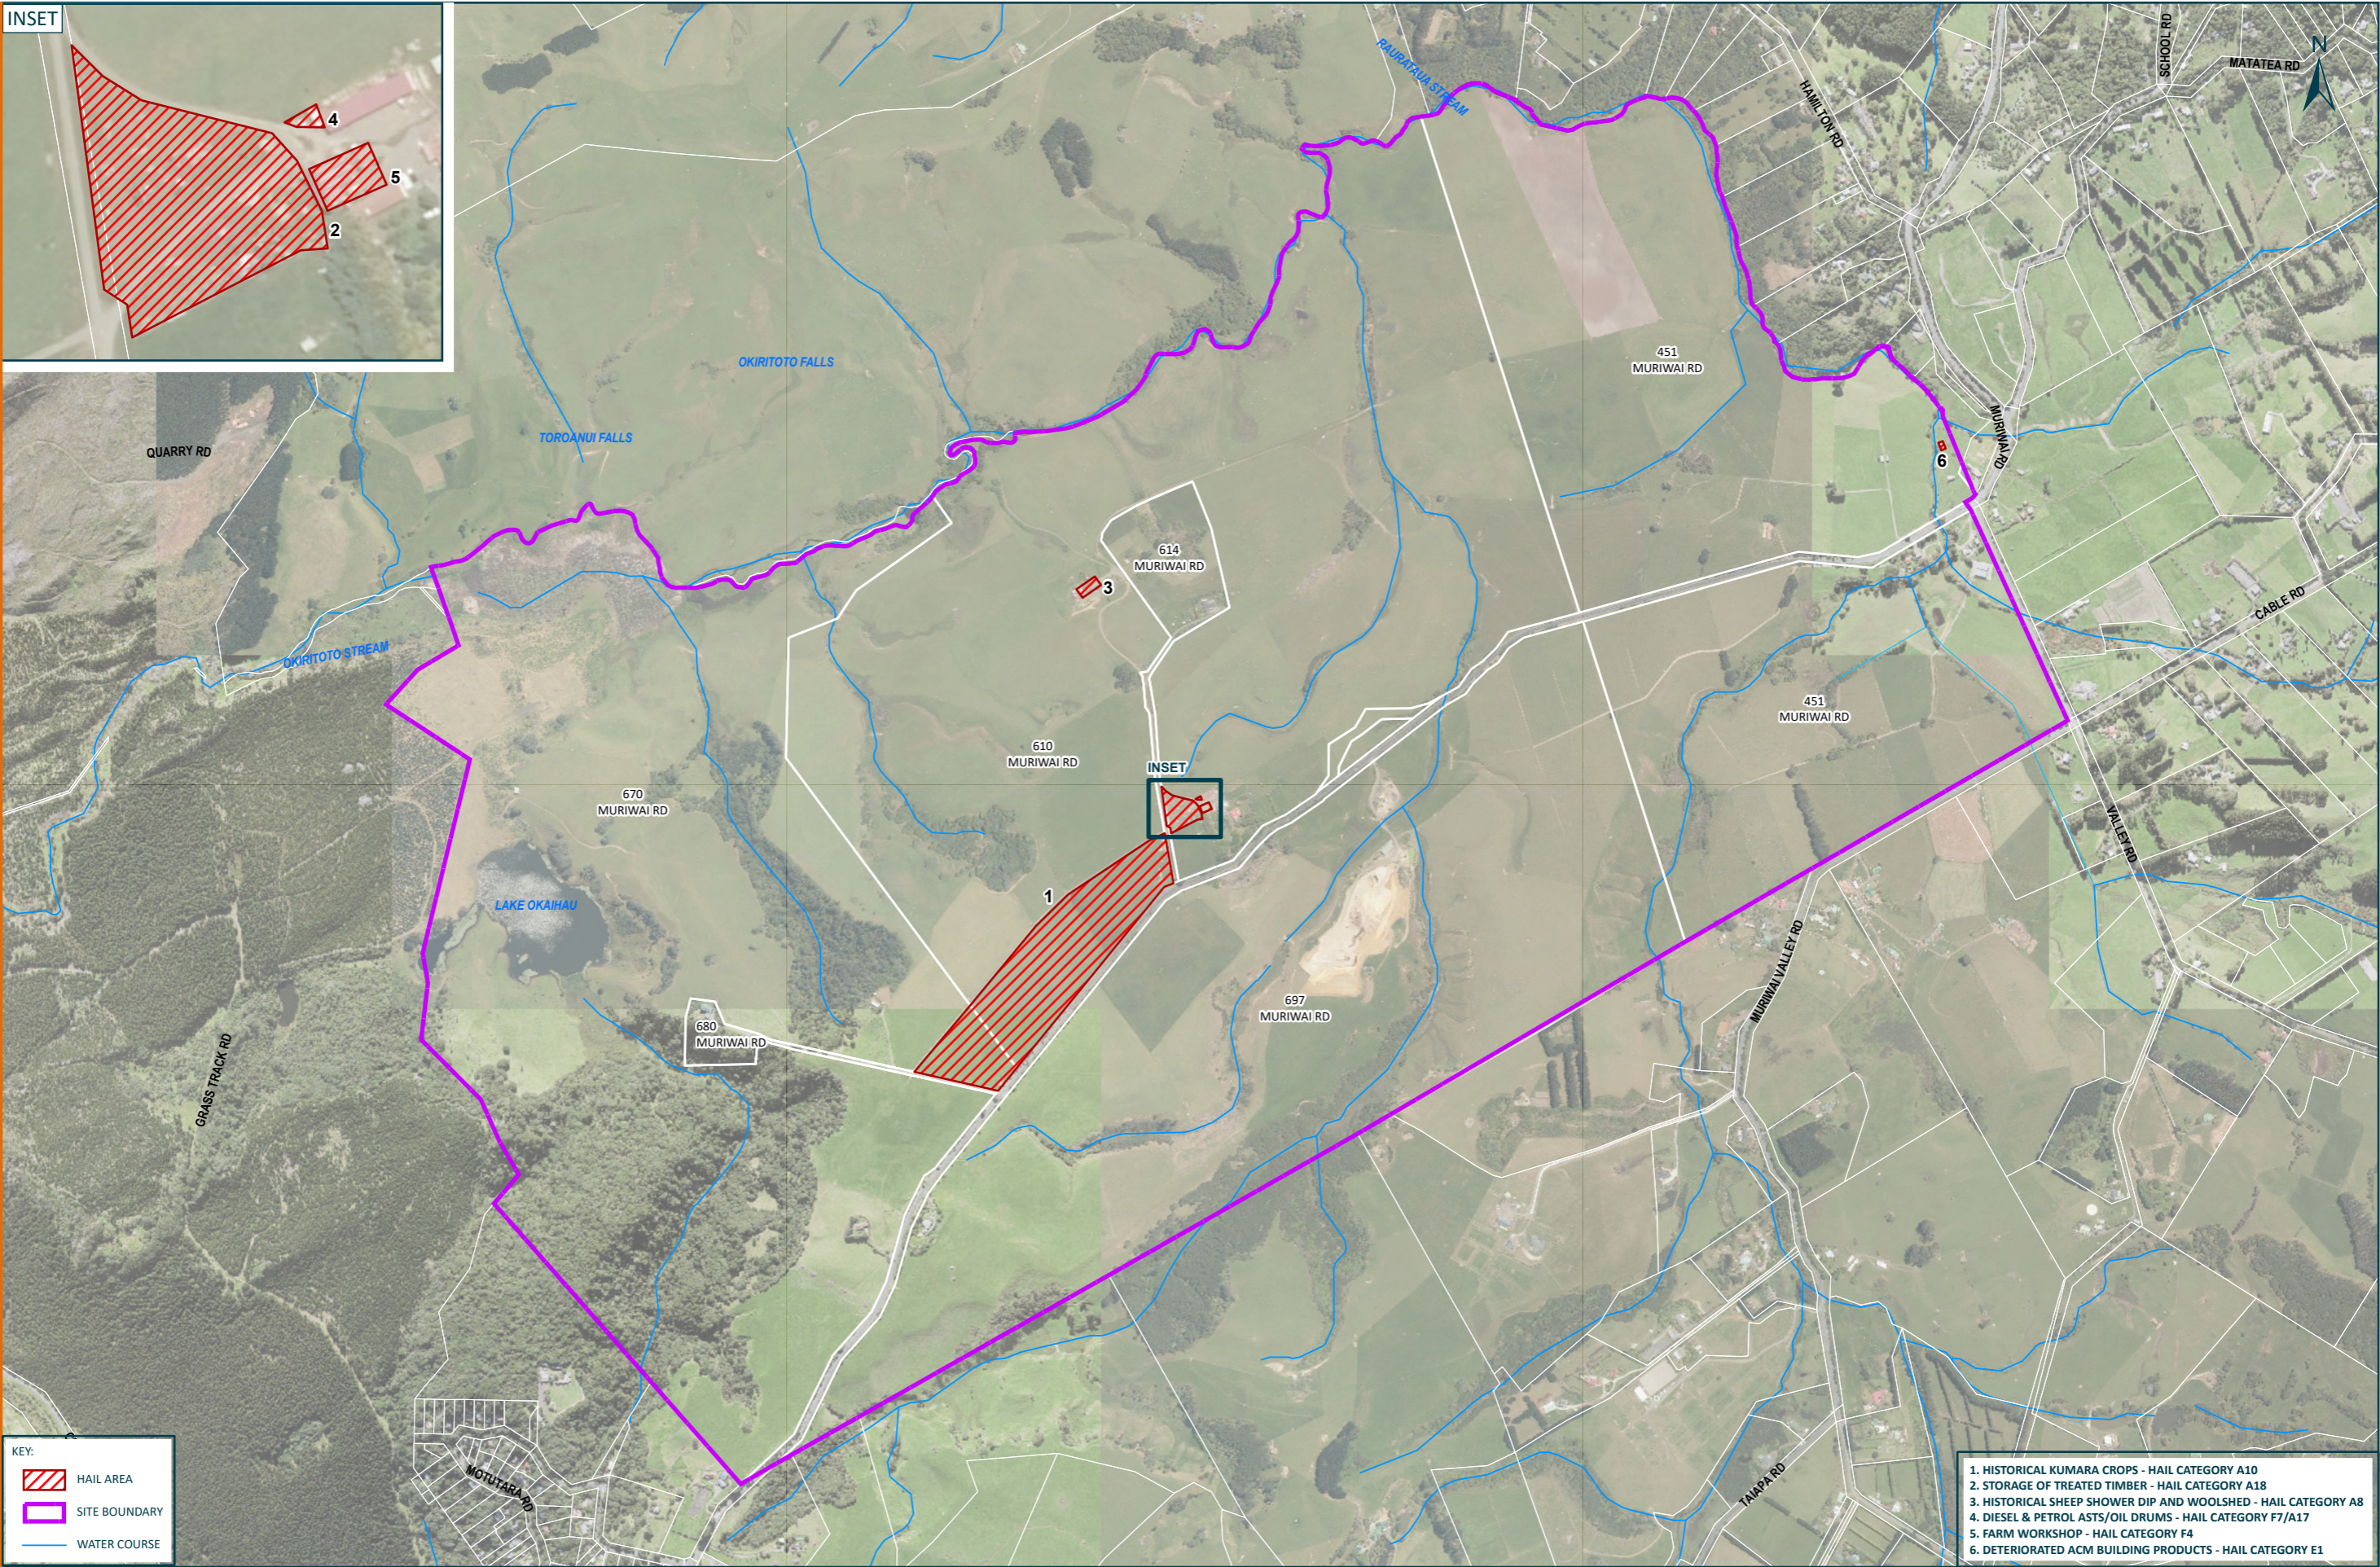
1. HISTORICAL KUMARA CROPS - HAIL CATEGORY A10
2. STORAGE OF TREATED TIMBER - HAIL CATEGORY A18
3. HISTORICAL SHEEP SHOWER DIP AND WOOLSHED - HAIL CATEGORY A8
4. DIESEL & PETROL ASTS/OIL DRUMS - HAIL CATEGORY F7/A17
5. FARM WORKSHOP - HAIL CATEGORY F4
6. DETERIORATED ACM BUILDING PRODUCTS - HAIL CATEGORY E1

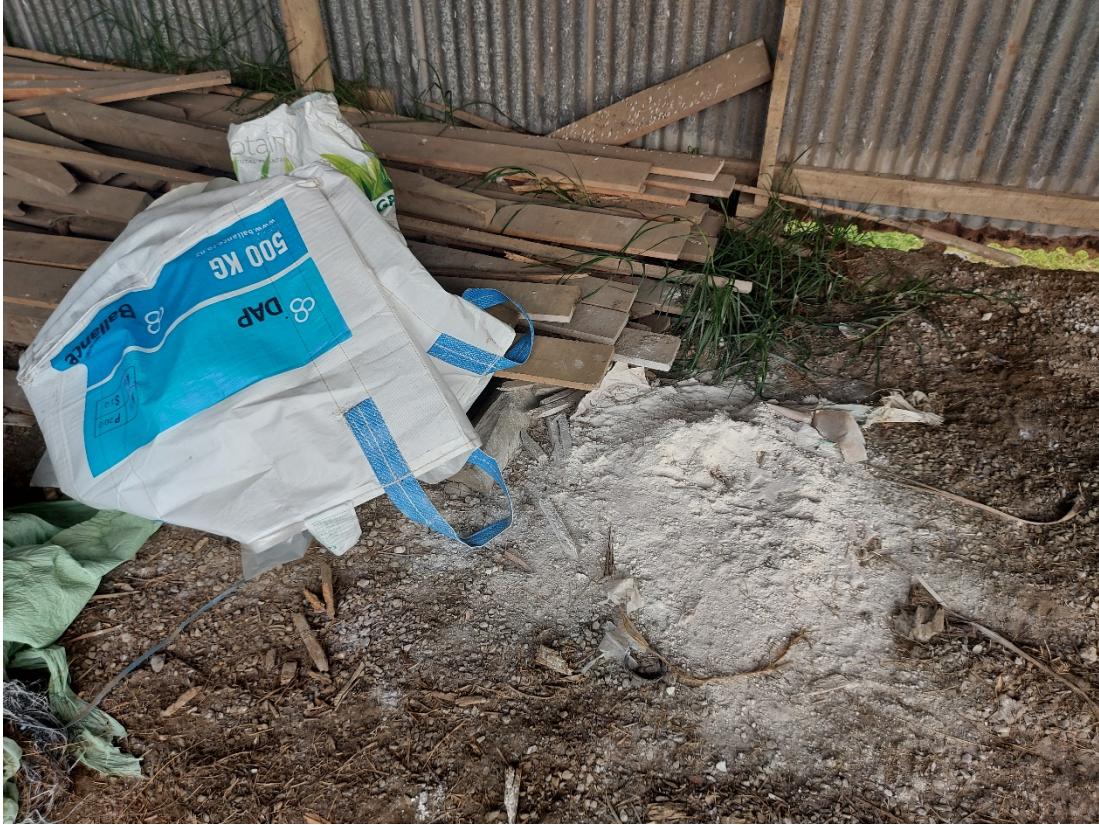
**Photograph 1: White powder on ground in northern building of the workshop area.**

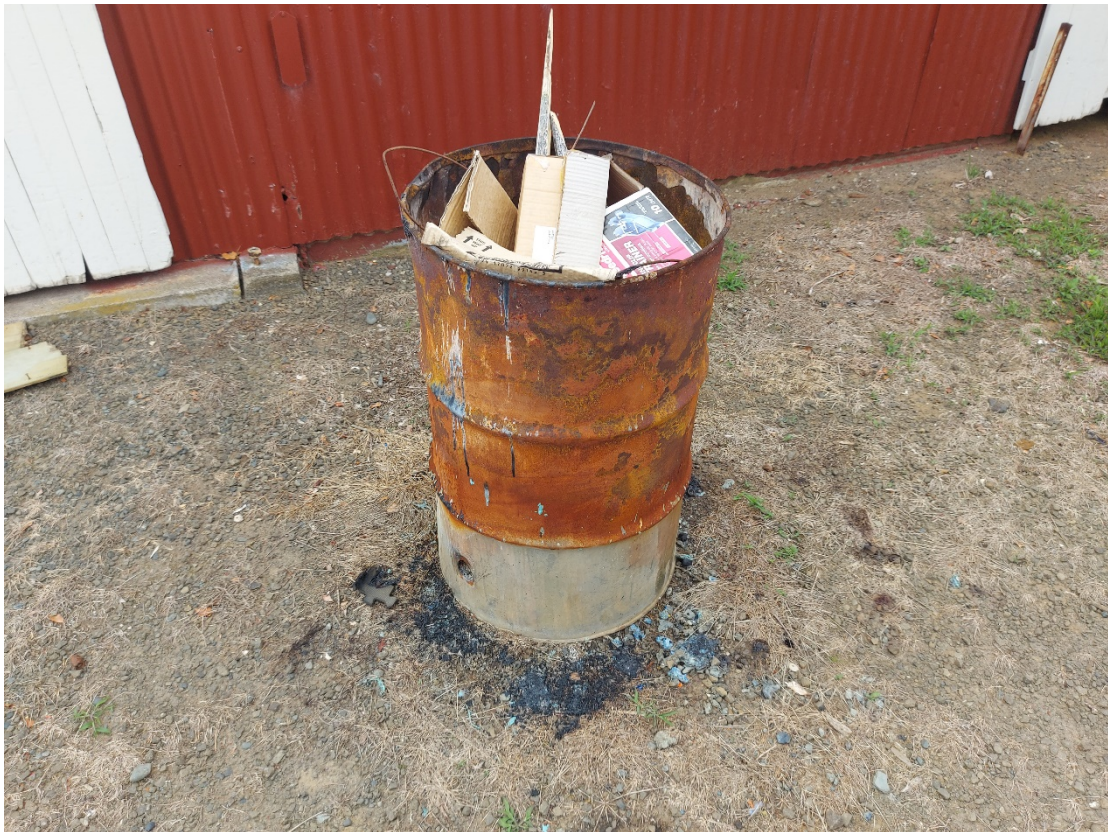
**Photograph 2: Steel drum in the workshop area used for burning material.**

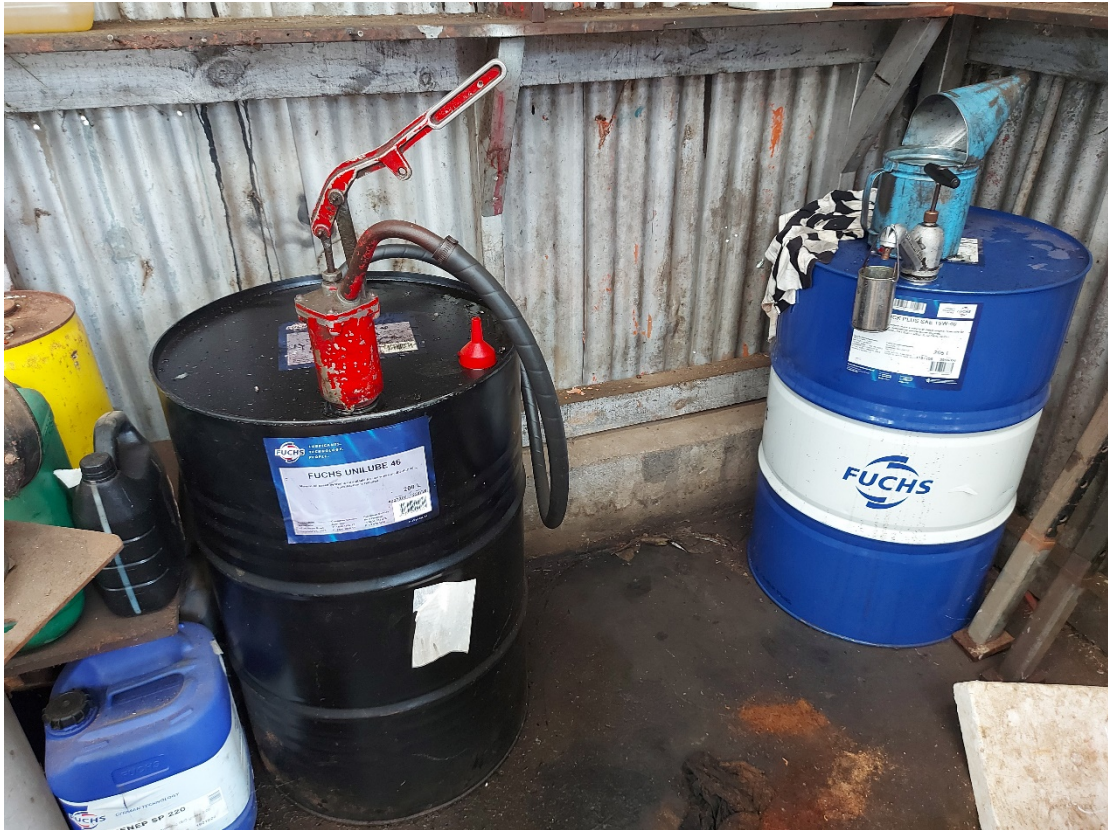
The main workshop had a concrete floor and is used for the general service of farm vehicles and machinery (HAIL Category F4). There is general storage of fuels, oils, lubricants, and agrichemicals (used, in use and waiting to be used). Staining on the concrete was noted surrounding the drums of fuel and oil. In front of the workshop was a small area of stained ground with associated scrap metals, as well as an old drum which has been used for the burning of rubbish. This drum appeared to have cardboard in it at the time of the December 2020 site visit. Some staining was noted on the ground surrounding the drum.

Photograph 3: Example of fuel/oil drums in the main workshop building. Note the staining on the ground surrounding the drums.

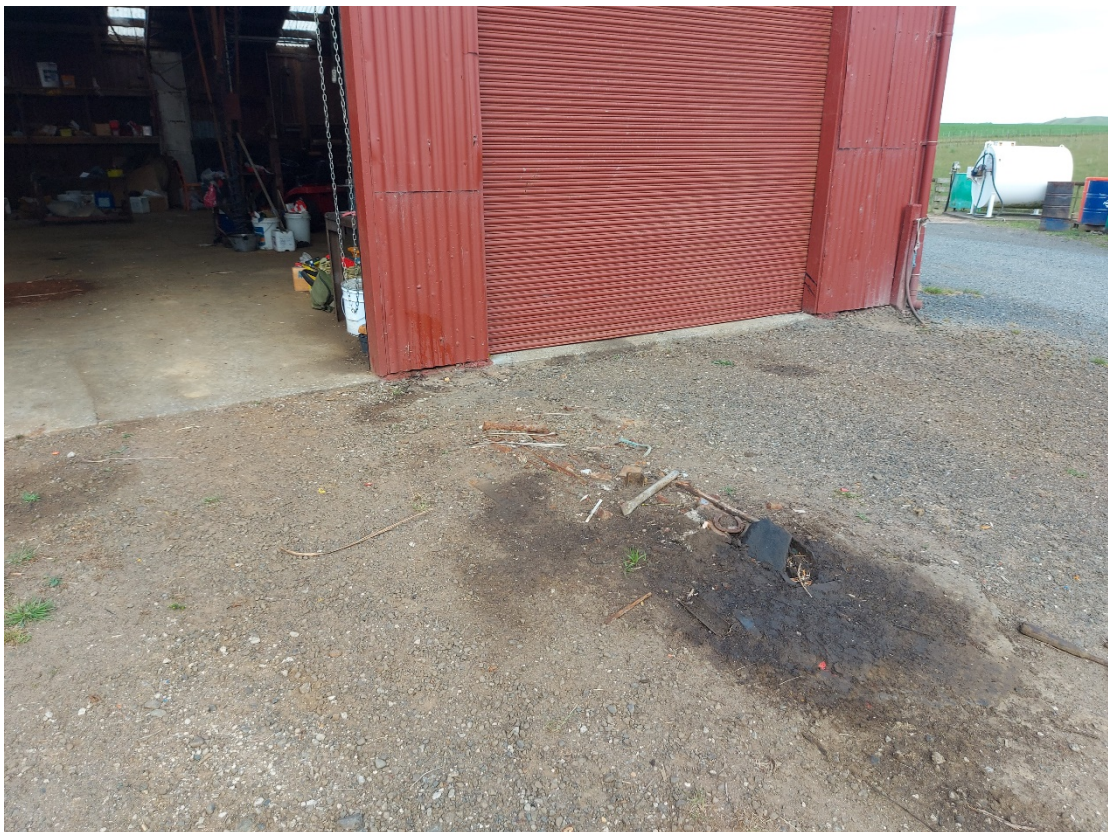
Photograph 4: Staining on ground in front of main workshop building.

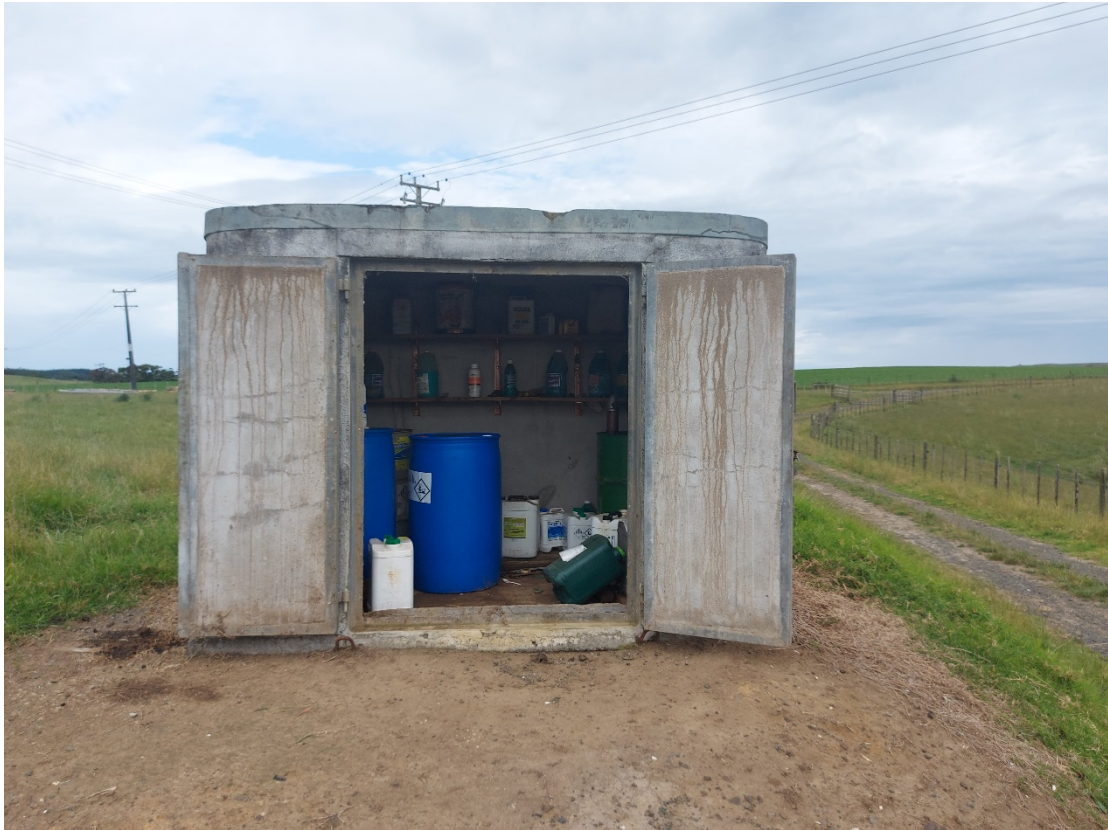
To the west of the ASTs was a concrete, bunded hazardous chemical storage shed used for general storage of agrichemicals (herbicides, pesticides, insecticides and marking dye/foam) and a steel drum marked as “poison” (HAIL Category A17).

**Photograph 5: Photograph showing the bunded concrete hazardous chemicals storage shed.**

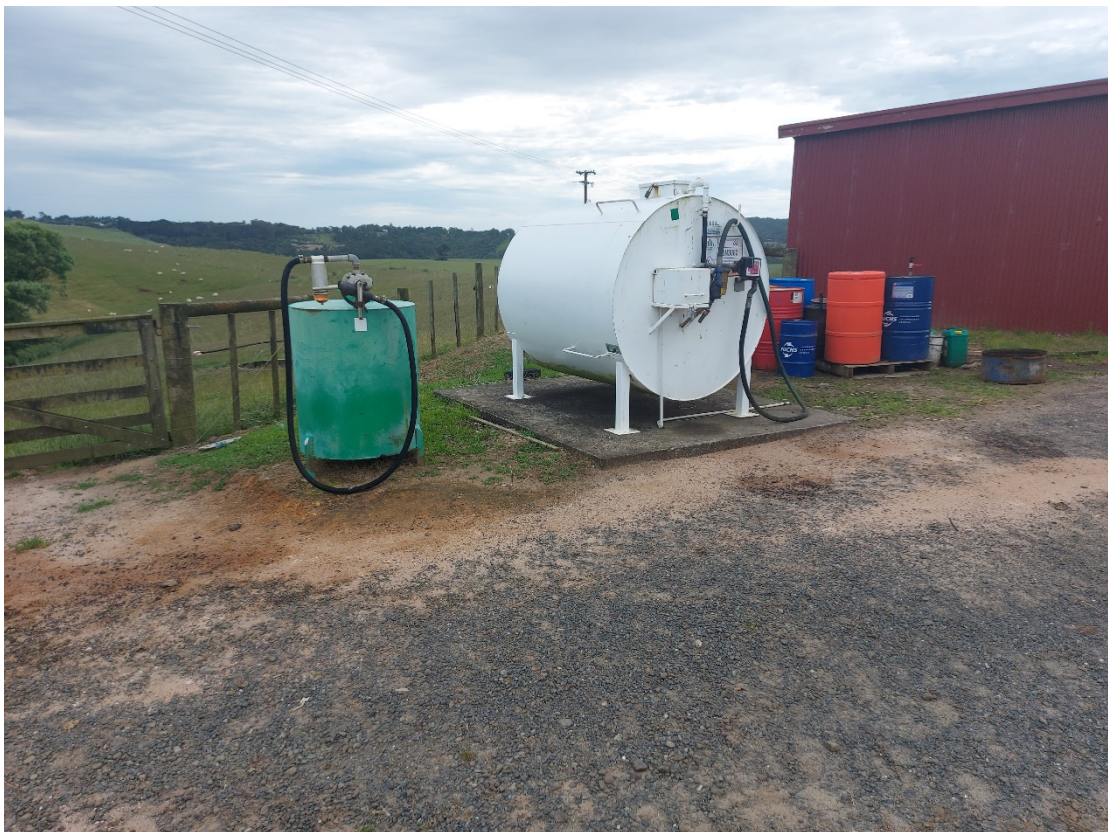
- ⋆ Petrol and diesel ASTs: Both un-bunded (Photograph 6). The petrol AST is ~200 L<sup>5</sup> and diesel AST is ~1500 L (personal communication with Mr Paul Mackie and Mr Ryan Brandeburg). There was evidence of staining on the ground and dead grass from a recent spill of diesel AST (Photograph 7) – as observed in December 2020. There were old 44-gallon steel and plastic drums of fuel and oil stored adjacent to the ASTs. This area was not bunded and some staining was evident on the ground surrounding these drums (Photograph 8).

Two un-bunded ASTs (one petrol and one diesel [HAIL Category F7]) and old (empty) fuel and oil drums were located immediately adjacent to the west of the workshop area (HAIL Category A17). Some staining of the ground was noted surrounding these drums. Personal communication with Mr Paul Mackie indicated a spill had occurred from the diesel AST approximately three months prior to the December 2020 site visit and staining of the ground and dead grass surrounding and downgradient of the AST could be seen at that time.

**Photograph 6: Un-bunded petrol (left) and diesel (right) ASTs in the workshop area. Un-bunded storage of fuel drums to the right of diesel AST (shown closer in Photograph 7).**

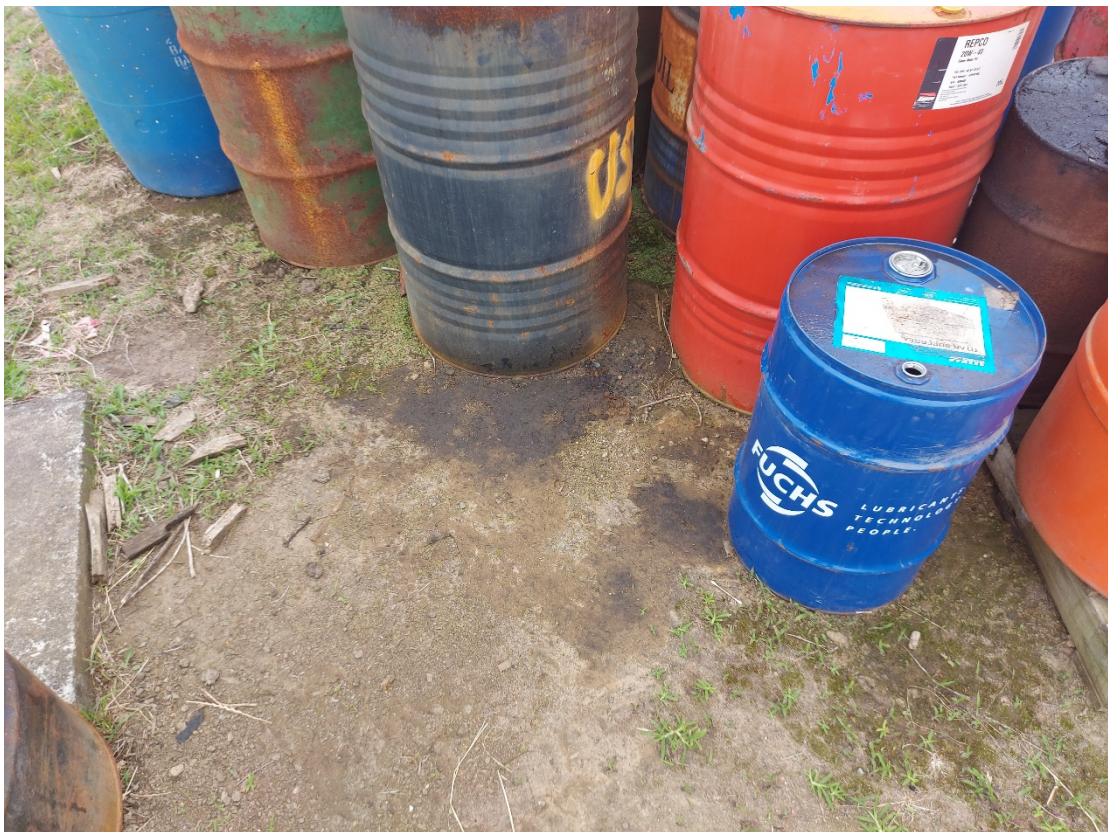
**Photograph 8: Staining on ground surrounding un-bunded storage of fuel/oil drums next to ASTs.**

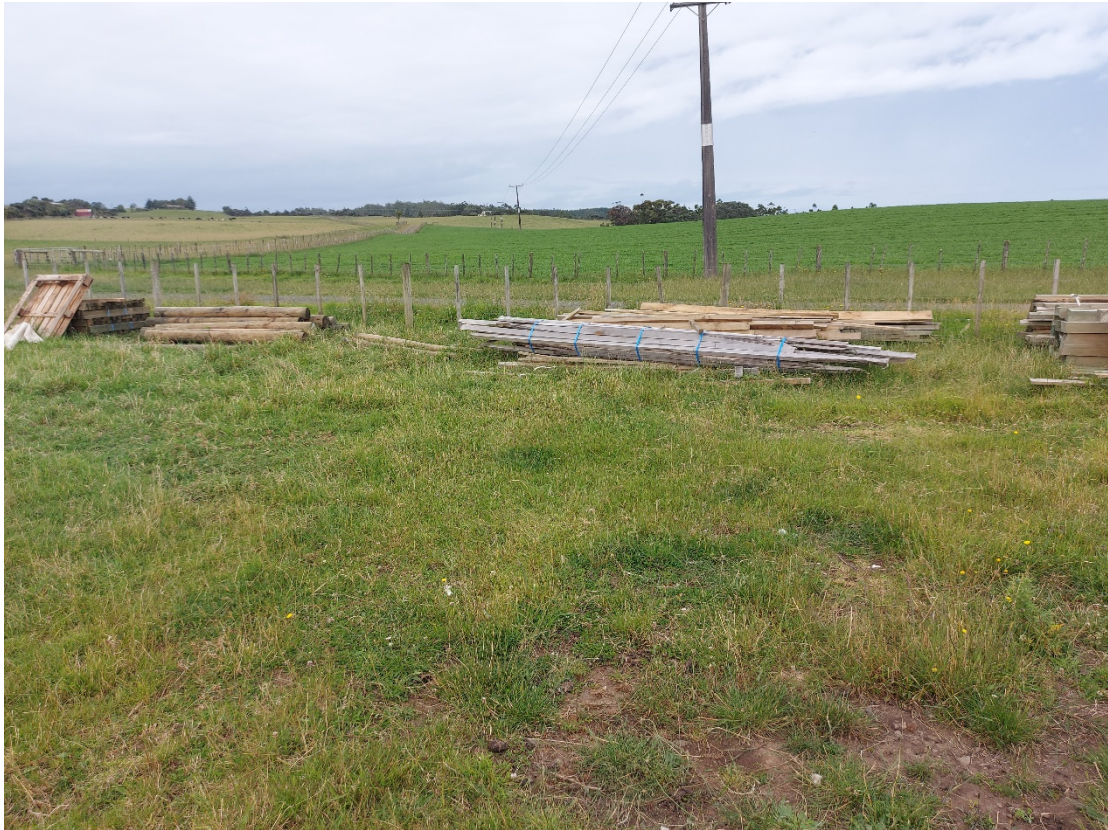
- ⋆ Storage of treated timber was observed in the paddocks to the west of the workshop area (Photograph 9).

There were piles of treated timber stored in the paddocks to the west of the workshop area observed during the December 2020 site visit. Email communication with Mr Ryan Brandeburg suggests the timber has been there since the land was purchased in early 2020. Historical aeriels suggest that these paddocks have been used for storage purposes since ~1980; however, what items have been present there is unknown. The current storage of timber and the storage of unknown items (which could have comprised treated timber) on these paddocks since the 1980s potentially means this area could conservatively be classified under HAIL Category A18 on the proviso that treated timber has been stored on unsealed ground at the same location for about 40 years.

**Photograph 9: Some of the piles of treated timber stored on the paddock to the west of the workshop area.**

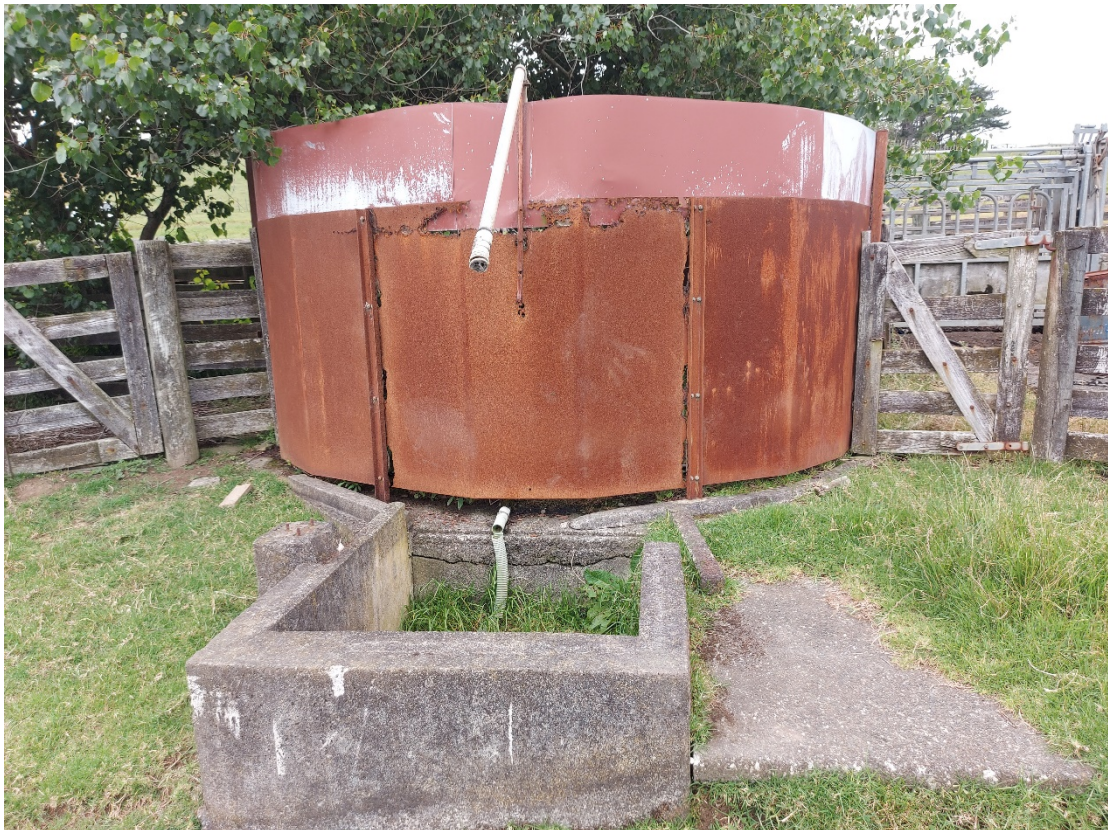
To the east of the woolshed was an old, disused shower sheep dip (HAIL Category A8) which was identified in the Contaminated Site Enquiry, confirmed in communication with Mr Paul Mackie and then observed during the December 2020 site visit. Due to the age and possibility of old sheep spray/dip chemicals being stored in the woolshed, the woolshed building itself should conservatively be classified under HAIL Category A8 along with the area surrounding the shower sheep dip.

**Photograph 10: Old shower sheep dip in yard area next to woolshed.**

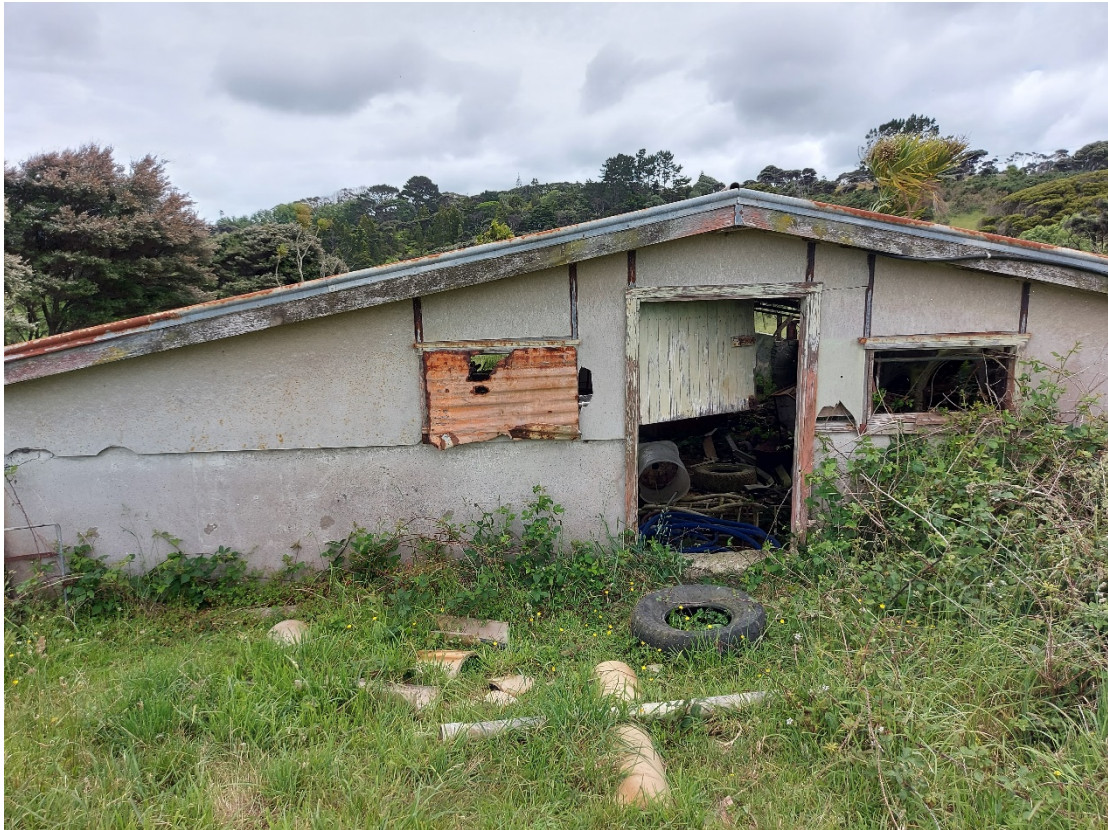
It is expected that, given the age of these buildings/structures (including the former boarding house), they could have (and/or do) contain ACMs in their building products (potential HAIL Category E1 if the asbestos is in a deteriorated condition) and may also be/have been painted with lead-based paint products (potential HAIL Category I) – especially prevalent in buildings constructed prior to the mid-1970s. During the site walkover, the only structure that was observed to have visibly deteriorated ACM was the shed in the far eastern part of the site (Feature 6 on Figure 2).

**Photograph 11: Shed in the eastern section of the site. Note the fibre cement cladding (likely ACM).**

In addition, as noted Under the Health and Safety at Work (Asbestos) Regulations, buildings constructed before 1 January 2000 have the potential to contain asbestos building products (i.e. ACMs) and, as such, require surveys to identify the presence and location of any ACMs before refurbishment or demolition.

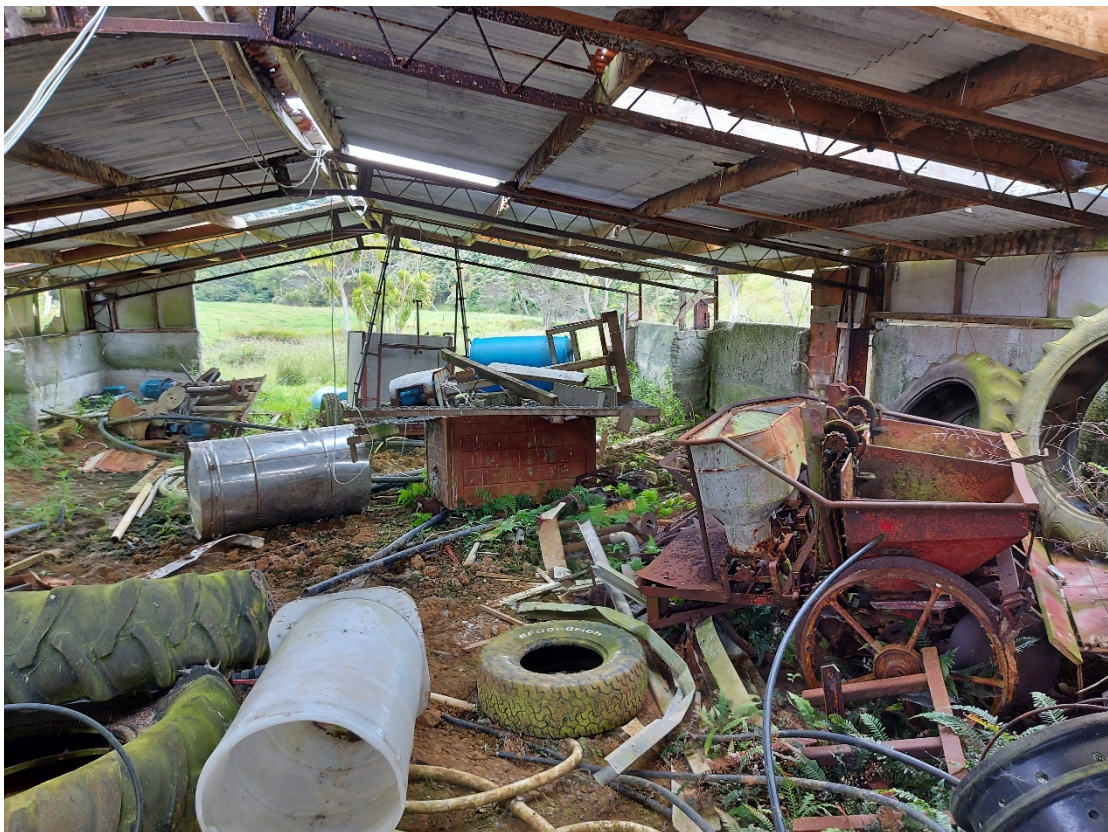
**Photograph 12: View from inside the above shed showing storage of old, disused farm equipment and machinery.**
