| | Project : <b>Site Investigations</b> | Cone no. : <b>C10CFIP.C13184</b> | |
| | Location: <b>John Rymer PI - Kohimarama</b> | Project no. : <b>01TT05</b> | |

**Appendix D: Geological setting, subsurface ground  
and groundwater conditions**

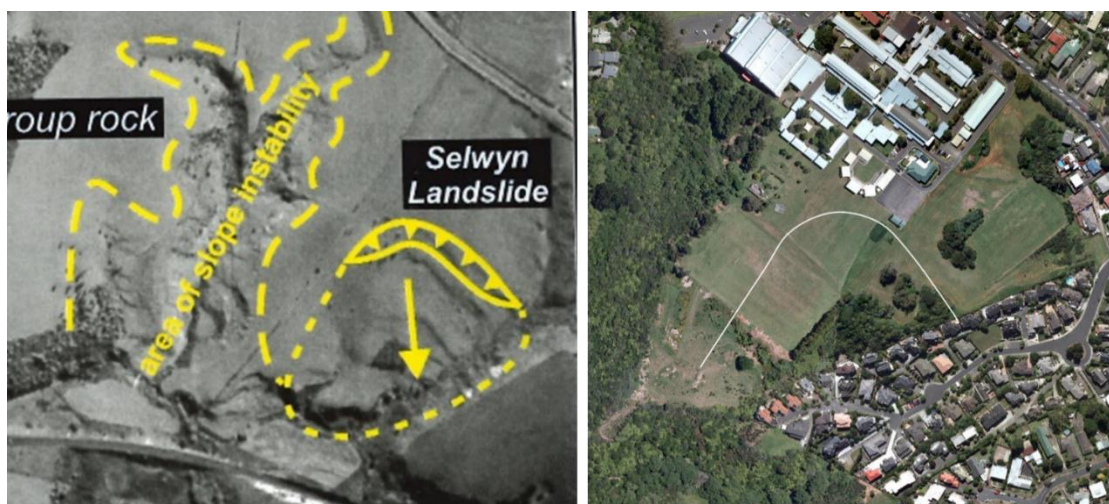
- Slope instability affected the lower playing fields at Selwyn College in 1979 and was remediated by the installation of counterfort drains.
- Large scale slope movement is visible in the 1951 aerial photographs, as indicated by hummocky ground extend back to the current school buildings.
- Slope movement north of the lower hockey field in the 1972 photographs and 1975 photographs.
- The Babbage report references a thesis on the Geology of the Orakei Basin area<sup>10</sup>. The thesis identified the Selwyn landslide in the location of the Selwyn College playing fields and bush at the southern part of the property (in Appendix Figure B). Note the topic of the thesis is another landslide some distance from the Site and it does not appear to discuss this feature within the text.

Appendix Figure B: Mapped extent of the Selwyn Landslide, shown on left from 1999 thesis<sup>8</sup> and overlain on 2017 aerial on image on right, the back scarp is shown by the white line.

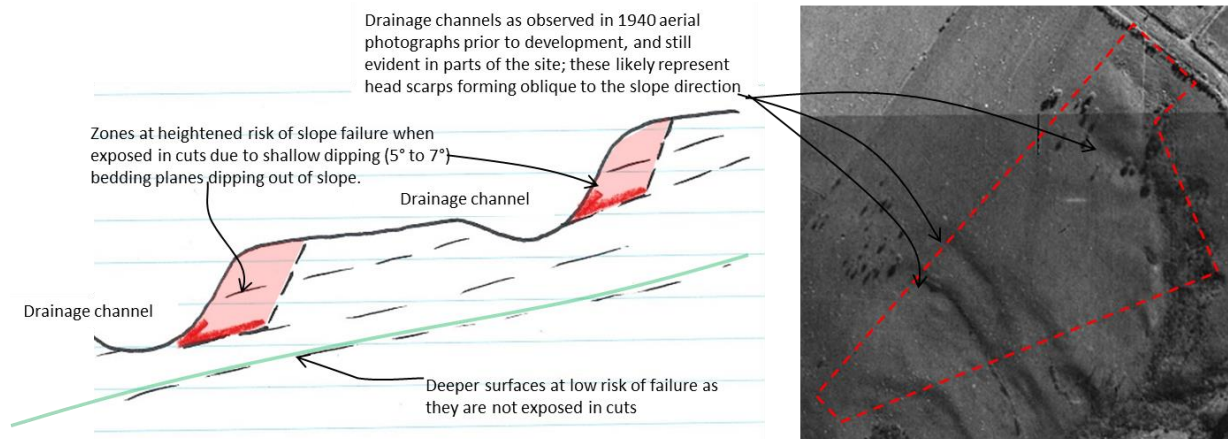
The shallow slope failures are considered to form as the potential bedding plane shear surfaces are exposed at the toe by drainage channels (refer to Appendix Figure C) or by a previous failure. The slope failure may then 'unzip' upslope as the potential failure surfaces are exposed at the toe as the result of the preceding failure.

The depth of the drainage channels probably represent the potential depth of instability. The existing site geomorphology and aerial photographs indicate that the scale of the channels and thereby depth of the potential failure surface is in the order of 5 to 9 m.

*Appendix Figure C: Sketch indicating potential slope movement mechanism and 1940 aerial photograph with drainage channels*

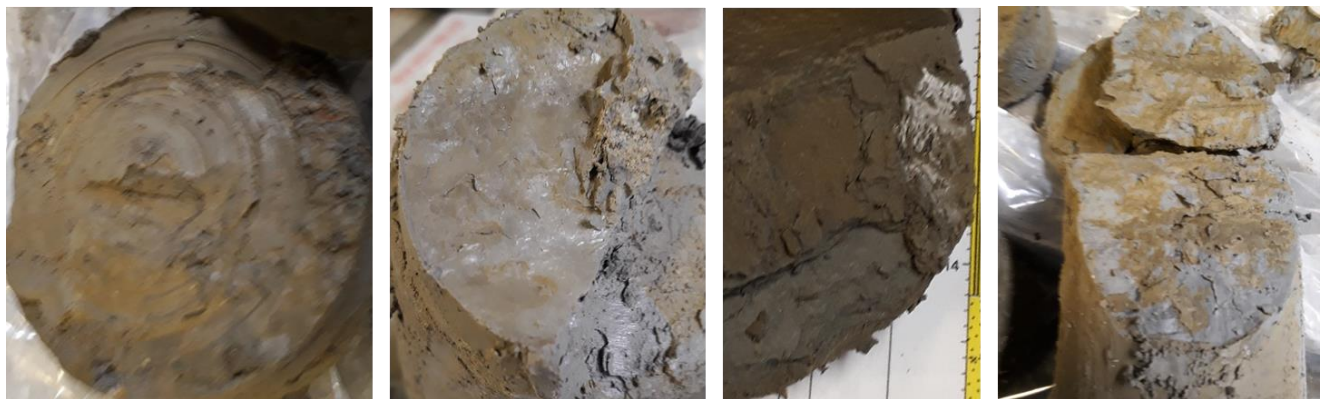
The recent borehole and re-assessment of the previous boreholes described in Appendix D identified potential shear surfaces at depths ranging from 5.0 to 9.0 m, and up to 13.0 m beneath the fill in the middle of the playing field (BH04). Identified surfaces are typically polished surfaces and drilling breaks which occur along bedding. These surfaces indicate an increased risk of a series of lateral translational failures along softened mudstone beds dipping oblique to the slope at around  $5^{\circ}$ , this is described in further detail in Section E2. The location and depth of identified surfaces are presented in Appendix Table H and examples shown in Appendix Figure D. Note these surfaces do not necessarily indicate the occurrence of previous failures, but rather are surfaces along which failure could occur should they be exposed in a cut slope or by natural erosion.

*Appendix Figure D: Examples of potential shear surfaces encountered in investigations: polished planar drill break BH02 at 7.1 m, polished surface in BH05 at 5.25 m and in BH04 at 12.95 m, inclined defect in BH04 at 13.1 m.*

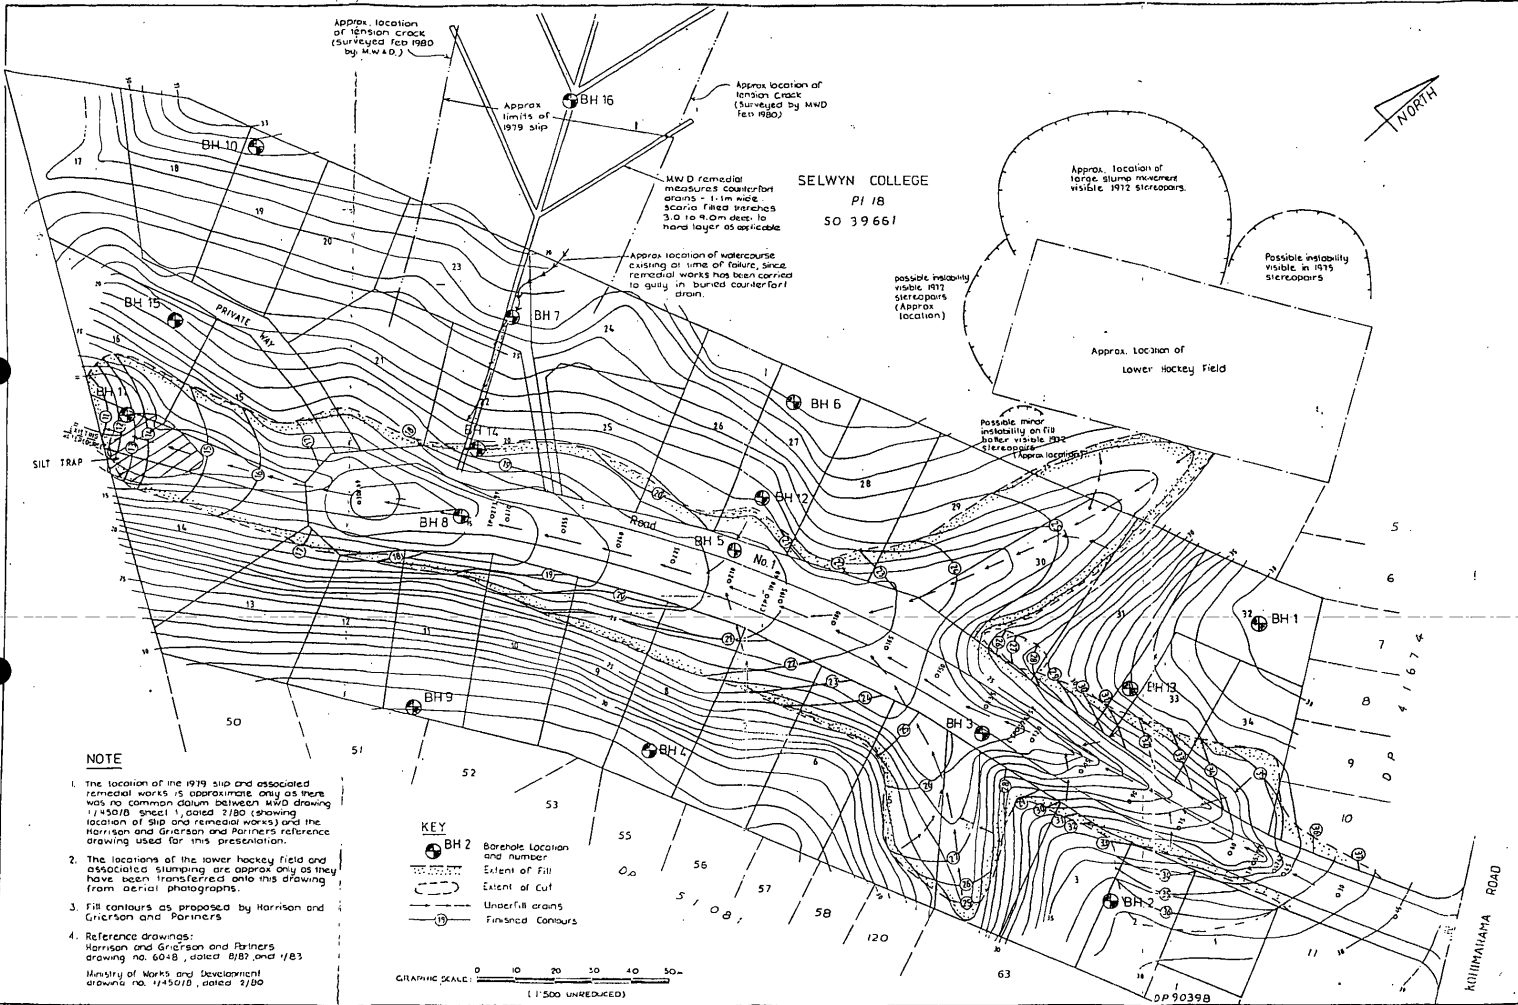
Approx. location of tension crack (surveyed Feb 1980 by MWD A.D.)

Approx. limits of 1979 slip

Approx. location of watercourse existing at time of failure, since remedial works has been carried to gully in buried counterfort drain.
