#### Former Caltex Pakuranga - Conceptual Site Model

# Former Caltex Pakuranga

Site Validation Report

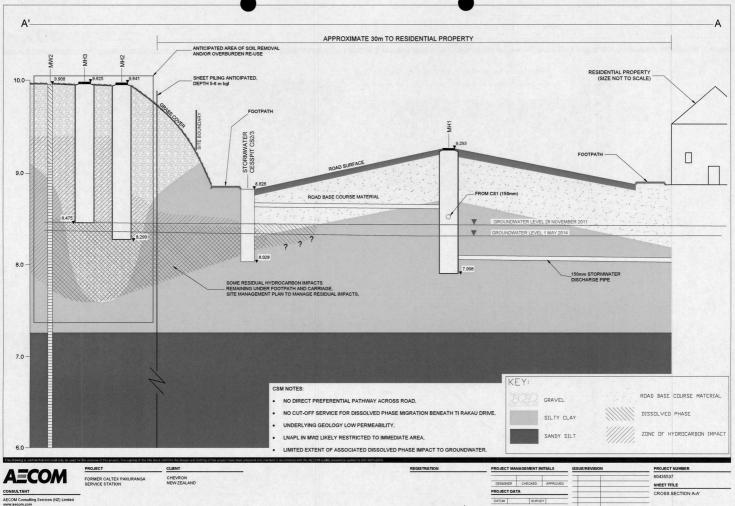
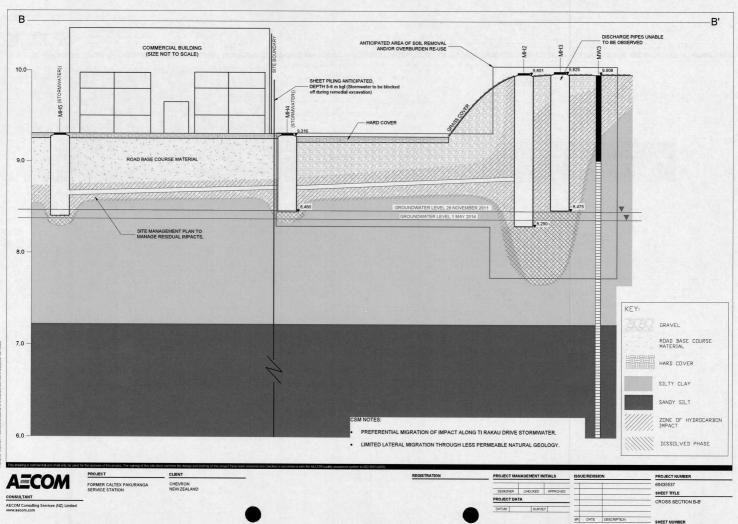
Attachment 1 – Cross sections A-A' and B-B'

The A–A' cross section shows the expected distribution of hydrocarbons in the sub-surface along the north western boundary of the site.

The cross section also shows groundwater present within the underlying natural silty clay geology which is expected to partially inhibit vertical migration of hydrocarbons owing to its low permeability properties.

Soil sampling from the various phases of investigation at the site indicate that hydrocarbon impacts are present between 1.2 to 2.4 mbgl along the site frontage with Ti Rakau Drive. These soil samples were taken in areas immediately associated with a former stormwater interceptor system. It is inferred that hydrocarbon impact has preferentially migrated and settled along the more permeable bedding material associated with the interceptor pipe-work and sub-surface structures. The impacts are expected to have settled in close proximity to the infrastructure rather than having penetrated significantly into the underlying silty clay geology.

The principles affecting the distribution of hydrocarbon impacts in cross section A–A' are also reflected in cross section B–B'. Hydrocarbon impacts associated with the stormwater system are inferred to have migrated preferentially along the bedding material surrounding the stormwater pipework, towards Manhole 4 at the corner of the site and then towards Manhole 5, located off-site. This distribution of impact is also evidenced by low level readings for volatile organics of between 1 and 5 ppm on a photo-ionisation detector (PID) within the stormwater chamber of Manhole 4. Readings in Manhole 5 were <1ppm.

Residual impacts around the stormwater system with the site will be removed during the planned remedial excavation, with the remaining impact present in soils immediately surrounding the stormwater infrastructure between Manhole 4 and Manhole 5 beneath the Ti Rakau Drive foot-path.

It is noted that this impacted material within the site will be largely removed during the planned remedial excavation works and residual impacts beyond site boundary are expected to be minimal due to the low permeability of the surrounding of natural silty clay geology.
