# Detailed Site Investigation (Contamination), MoE Drury Due Diligence, 281 Jesmond Road

Prepared for Ministry of Education (Client)

Prepared by Beca Limited (Beca)

5 September 2018

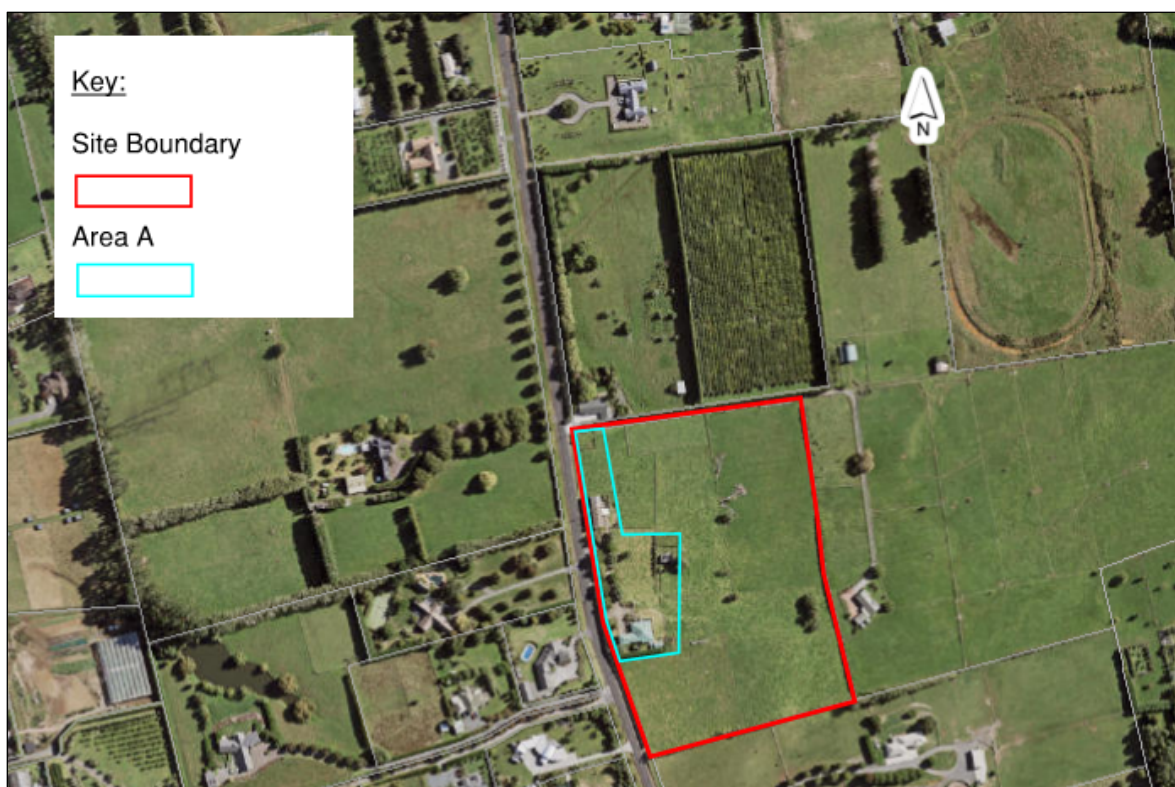
Figure 4. Area within the site identified for possible contamination. Source: Auckland Council GeoMaps.

The area of potential contamination identified in the PSI includes: the stock holding pen in the north-west of the site, the small residential dwelling connected to the shed on the site’s western boundary toward the north of the site, the shed located near the centre of the site, the filled domestic lawn in front of the large residential dwelling, and the old incinerator to the east of the house. This area of concern (Area A) is displayed in **Figure 4** below.

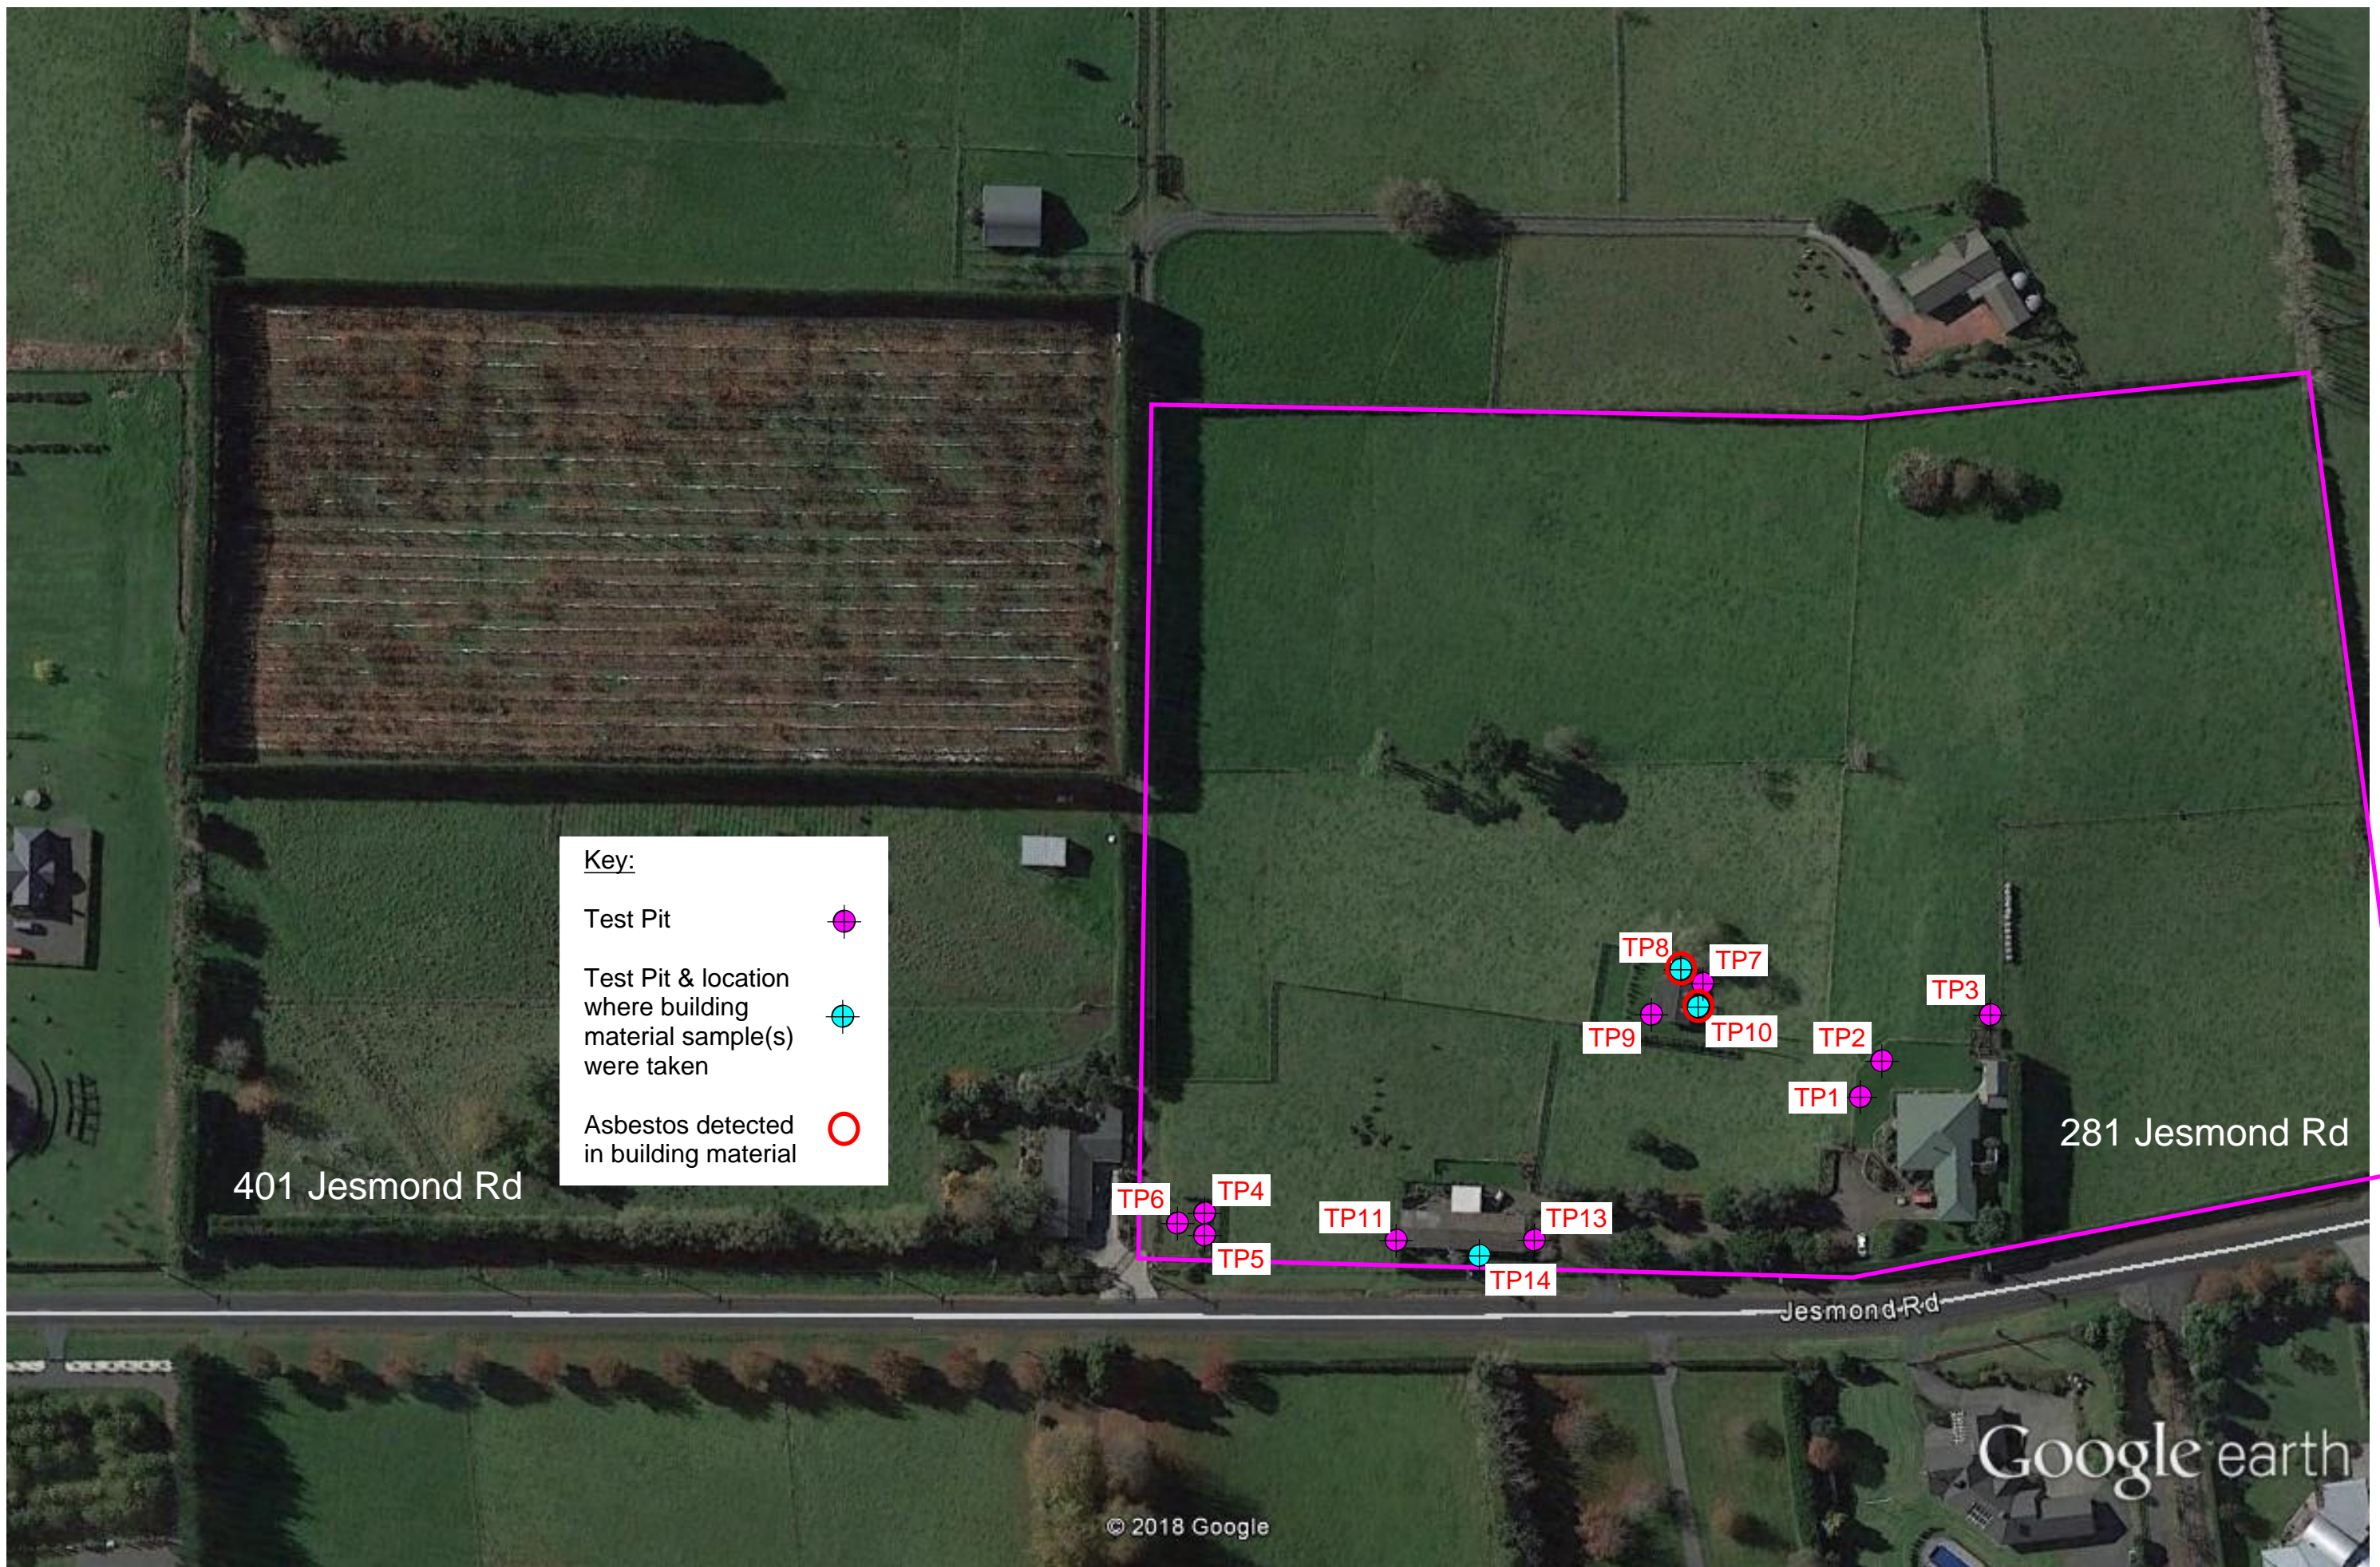
Soil Sample Location Plan - Contamination Assessment (27th July 2018)

- Orange-brown clayey silt was observed in most of the soil samples.
- Soil samples taken in the vicinity of the retaining wall appeared to be fill.
- Broken fibre cement sheet fragments were observed around the stables in the centre of the site, and under the west side of the old shed connected to the residential dwelling near Jesmond Road.
- No samples were taken at TP12 due to a concrete foundation being present at the surface. Only one shallow sample was able to be collected at TP4 due to the inability to penetrate further.

- Four of the six soil samples had loose, white (chrysotile) asbestos fibres detected.
  - The shallow soil sample from TP9 taken from a depth of 0.1-0.2cm from soil nearby the central stables area returned a concentration of 0.00232% w/w which is greater than 0.001% w/w threshold for the Tier 1 risk assessment criteria for human health protection.

Asbestos was identified as potentially present in the building materials within the PSI, samples were taken of broken cladding materials and asbestos detected in the cladding of the stables and nearby soil. The broken material observed by the old shed connected to the small dwelling did not have asbestos detected. One soil sample in the vicinity of this small dwelling showed a detectable concentration of white asbestos, however below human health risk guidelines. A building materials assessment was outside of the scope of this soil investigation. The spread of asbestos within soils has not been delineated, nor assessed in terms of its potential human health impact or overall impact of site development. Further testing and assessment of asbestos is recommended.

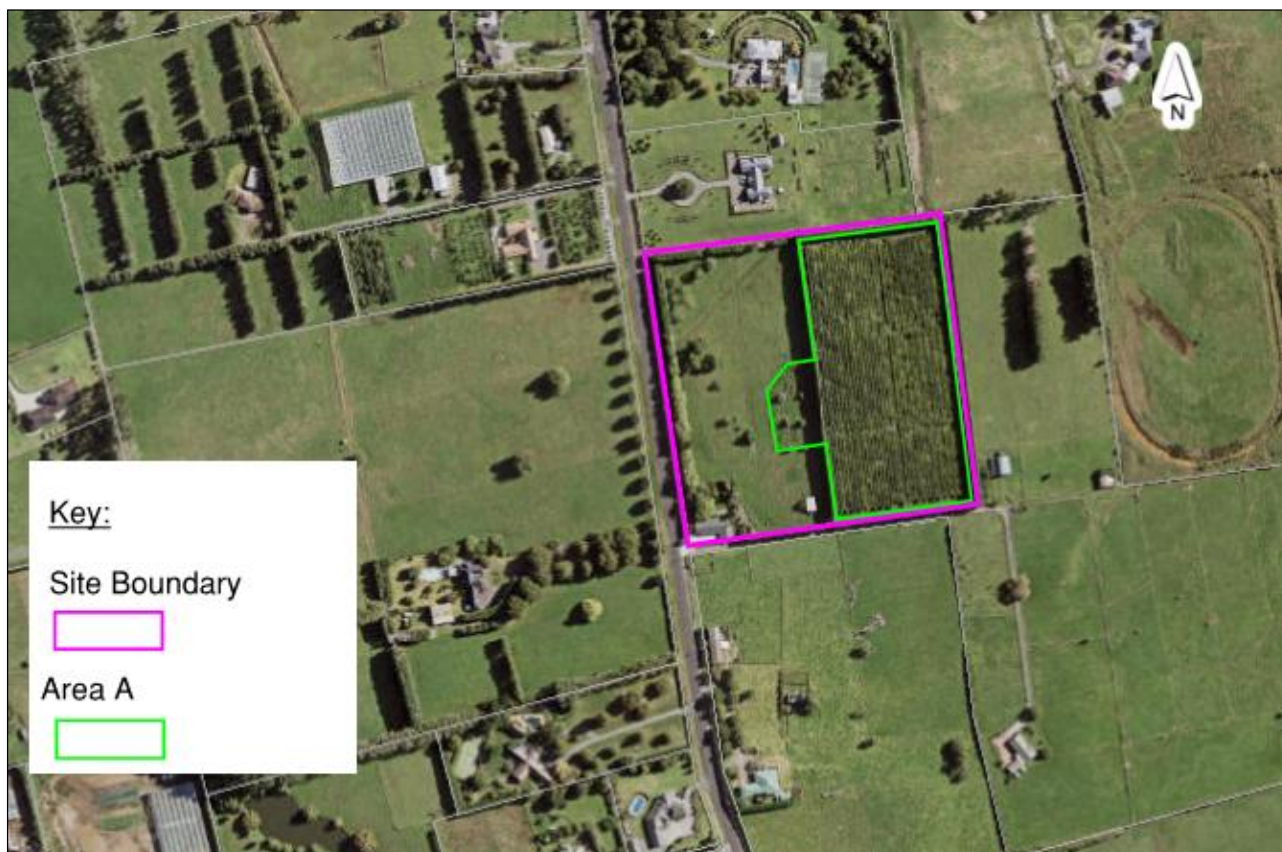
Figure 3. Area within the site identified for possible contamination. Source: Auckland Council GeoMaps.

The area of concern is the possible kiwifruit orchard in the east of the site and a potential market garden (present since 1996) near the centre of the site. These two activities may have led to the possible contamination of soils within the site. This area of further investigation (Area A) is displayed in **Figure 3** below.
