## Preliminary Site Investigation

57 & 57A Schnapper Rock Road,  
Schnapper Rock

Project Number: SCON0156

9 August 2021

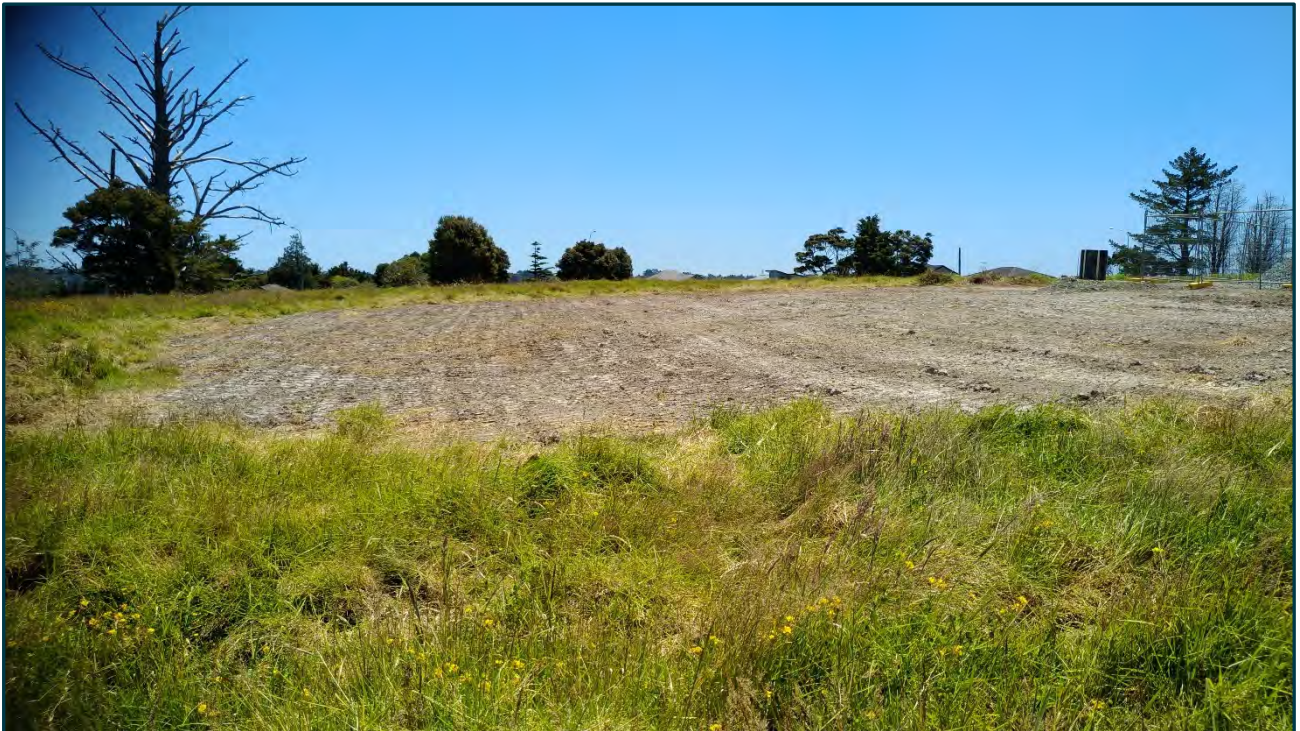
Photograph 7: View of soil disturbance area to the southwest of fenced area, facing northwest.

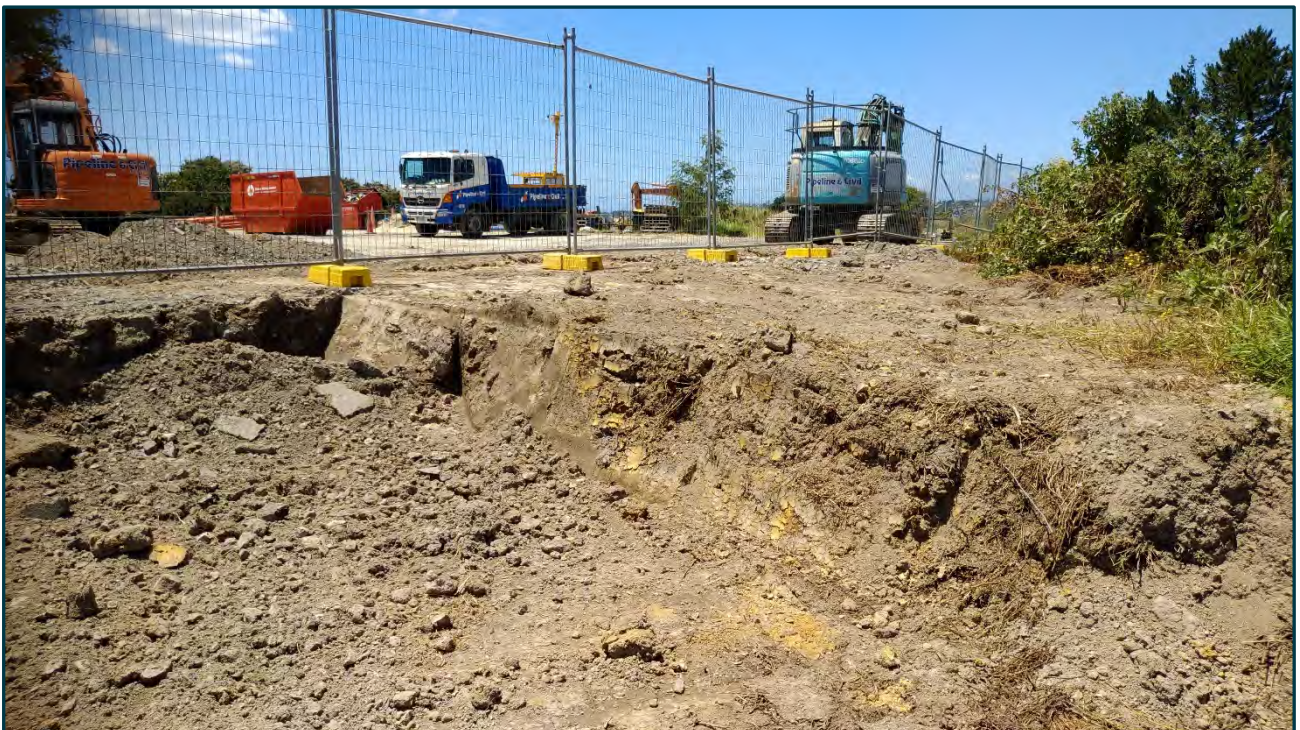
Photograph 8: View of soil disturbance area to the southwest of fenced area, facing east.

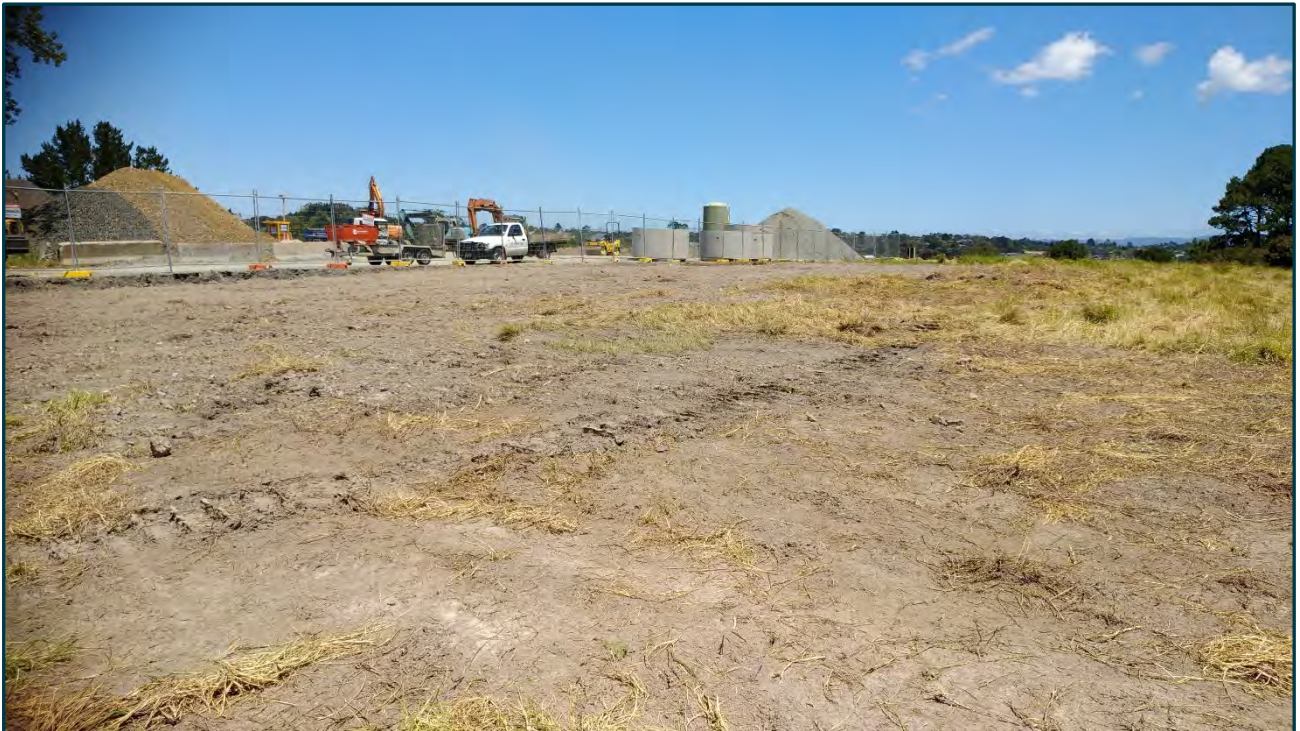
Photograph 9: View of soil disturbance area to the northwest of fenced area, facing southeast.

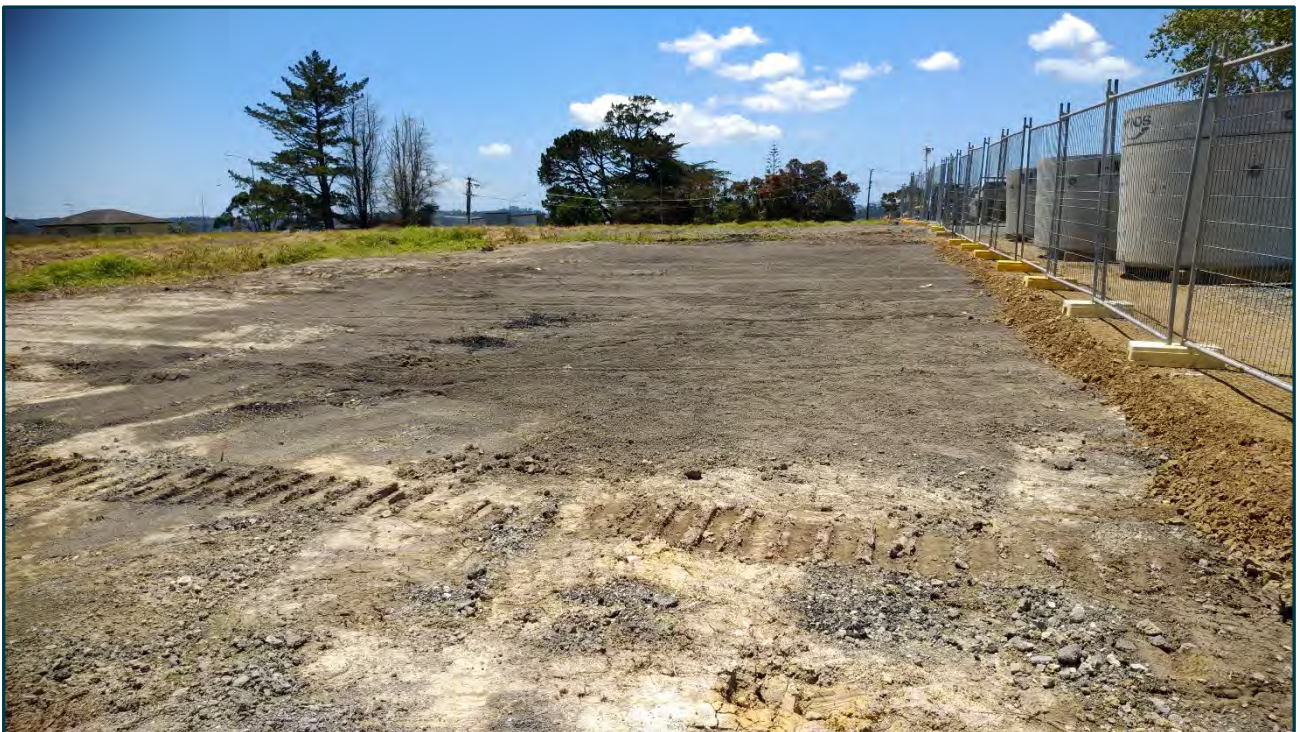
Photograph 10: View of soil disturbance area to the northwest of fenced area, facing north.

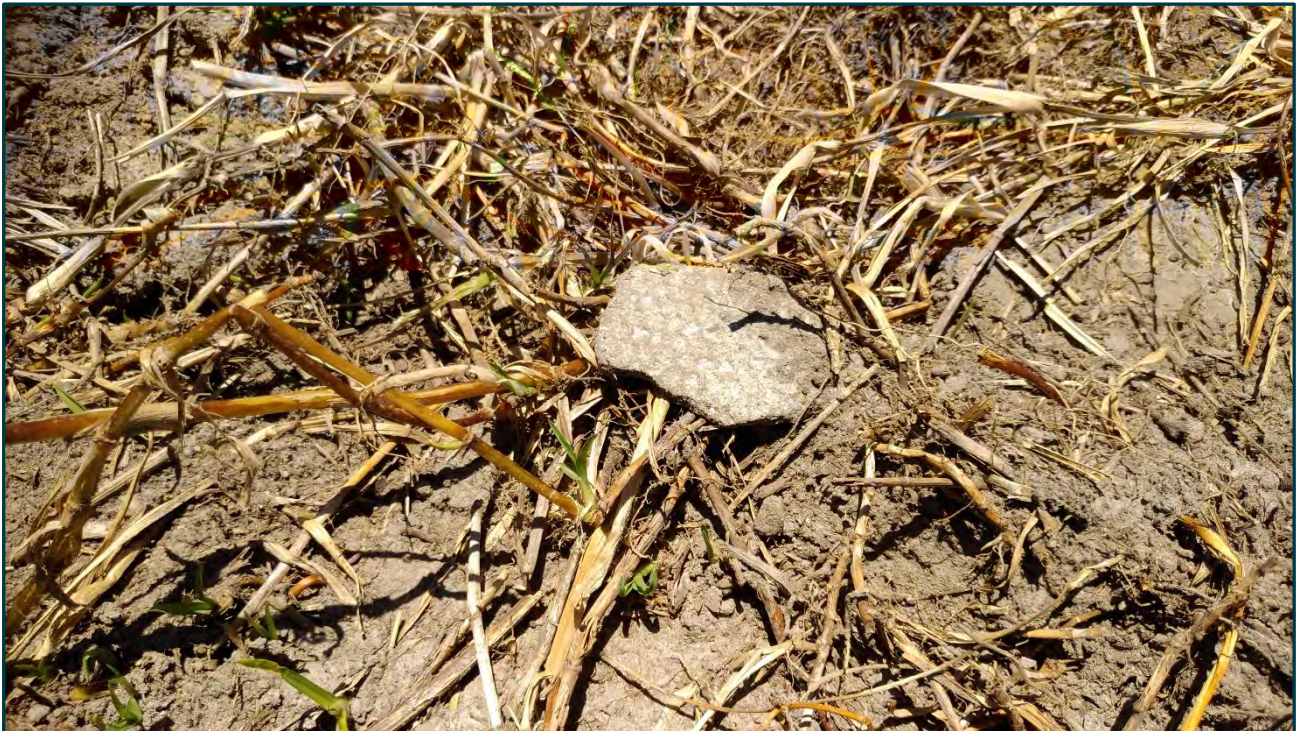
A site walkover and inspection were undertaken on 15 December 2020. During the site walkover, fragments of potential asbestos containing material (ACM) were identified in a localised area to the northwest of the Watercare site. However, based on the small number of suspected ACM fragments observed, it is considered unlikely that the underlying soils had been impacted. It is therefore recommended that the fragments of suspected ACM are hand-picked and disposed of appropriately prior to any soil disturbance in this area of the site.

- The site was accessed from the northwest via Schnapper Rock Road
- The site was grassed and vacant. The site was densely vegetated along the south-western boundary
- Two watercourses were evident. One watercourse was located in the western portion sloping towards the south-eastern boundary of site, and one in the southern portion sloping towards the south-western boundary of site
- The northeast portion of the site was fenced off leading to the Watercare site (57A Schnapper Rock Road)
- Soil disturbance was evident adjacent to the northwest and southwest of the Watercare site. The vegetation had been cleared; clay exposed and track marks evident. A small number of fragments of suspected asbestos containing material (ACM) were observed at the surface within a localised area to the northwest of the fencing.

Based on the small number of suspected ACM fragments observed, it is considered unlikely that the underlying soils had been impacted. It is therefore recommended that these fragments are hand-picked and disposed of appropriately.

Photograph 11: View of fragment of potential ACM identified within soil disturbance area to the northwest of fenced area.

However, it is recommended that the fragments of suspected ACM are hand-picked and disposed of appropriately prior to any soil disturbance in this area of the site.

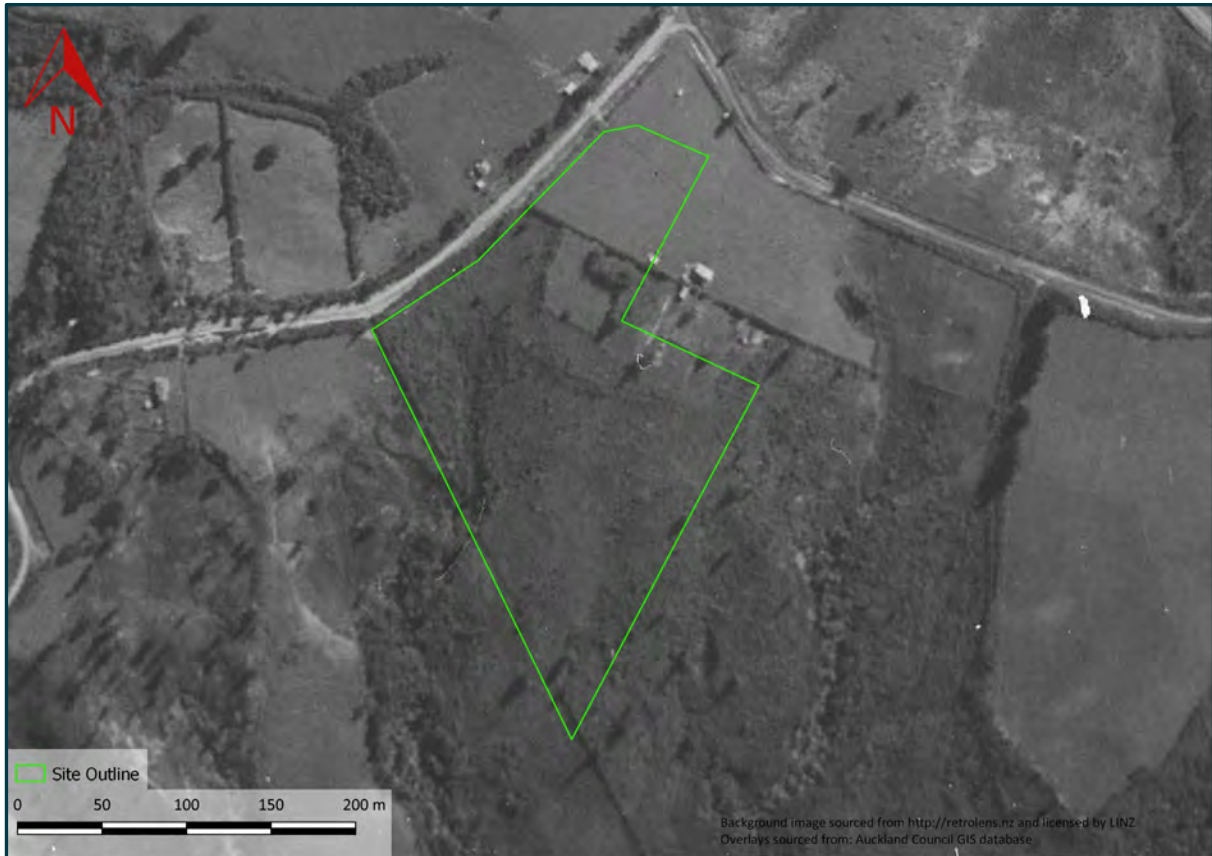
1940 Aerial Photograph

- **1940:** The site appears rural in use and forms part of a larger parent property. Shed (1) can be observed on the northeast boundary of the site. A dwelling and shed (2) is apparent to the northeast of the site within the larger parent property. The watercourses in the west and southern portion of the site are apparent and the surrounding areas appear densely vegetated. Schnapper Rock Road is evident to the northwest and northeast

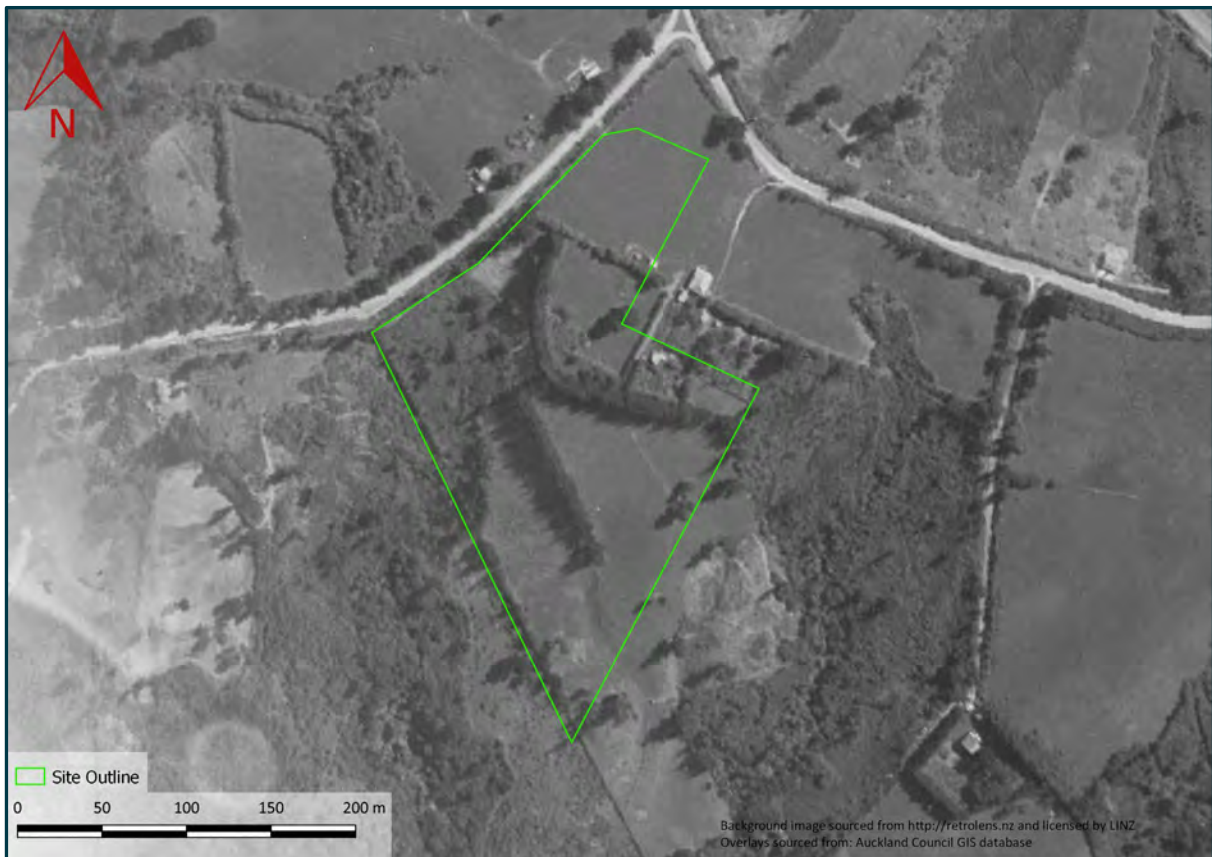
1950 Aerial Photograph

- **1950:** Shed (3) is evident near the central-northern boundary of the site. Most of the vegetation has been cleared and additional shelterbelts are evident in the southern portion of the site. An extension to the southern end of the dwelling in the parent property to the northeast is evident. Shed (4) and a small domestic orchard can be observed immediately south of the dwelling in the parent property

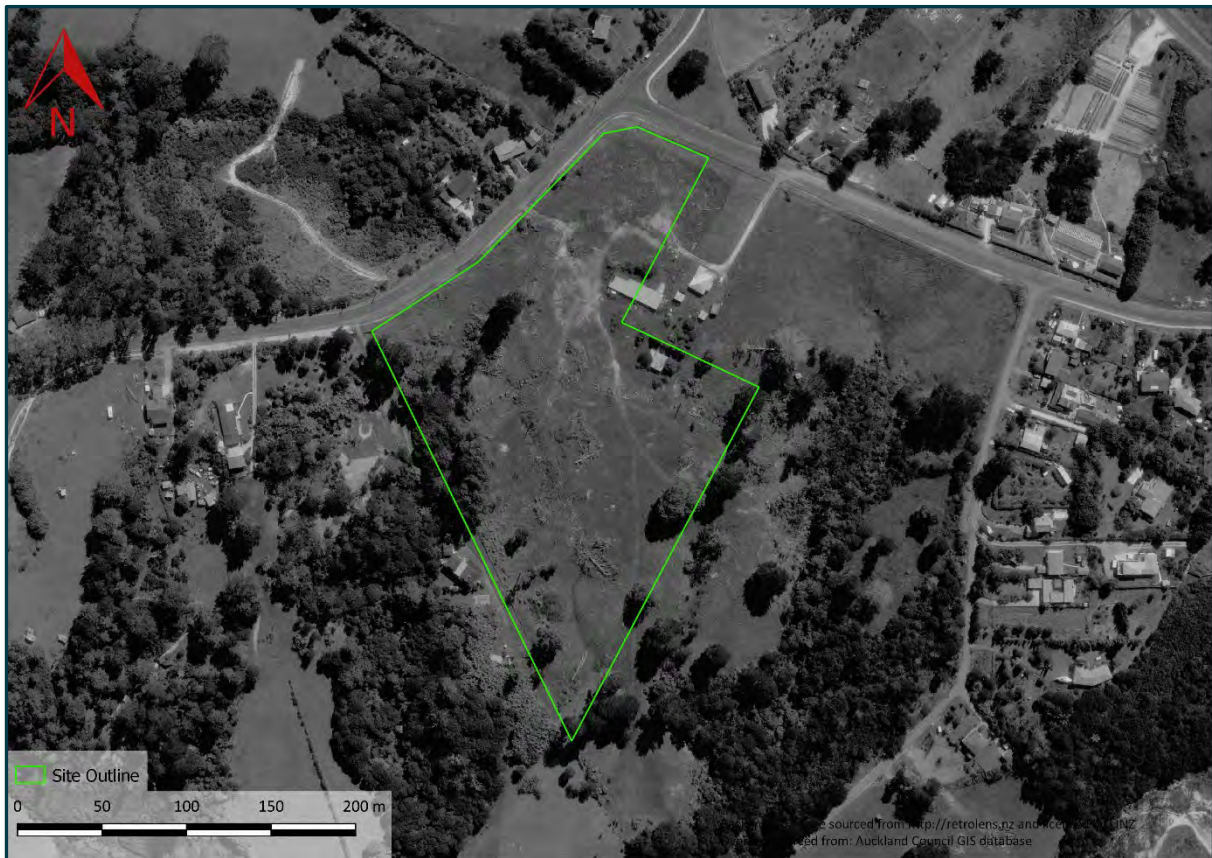
1981 Aerial Photograph

- **1981:** All shelterbelts and most vegetation has been cleared from the site. A number of smaller sheds in the parent property to the northeast are no longer evident. Schnapper Rock Road to the north of the site has been altered to its existing form. A small-scale market garden can be observed on the property further northeast beyond Schnapper Rock Road

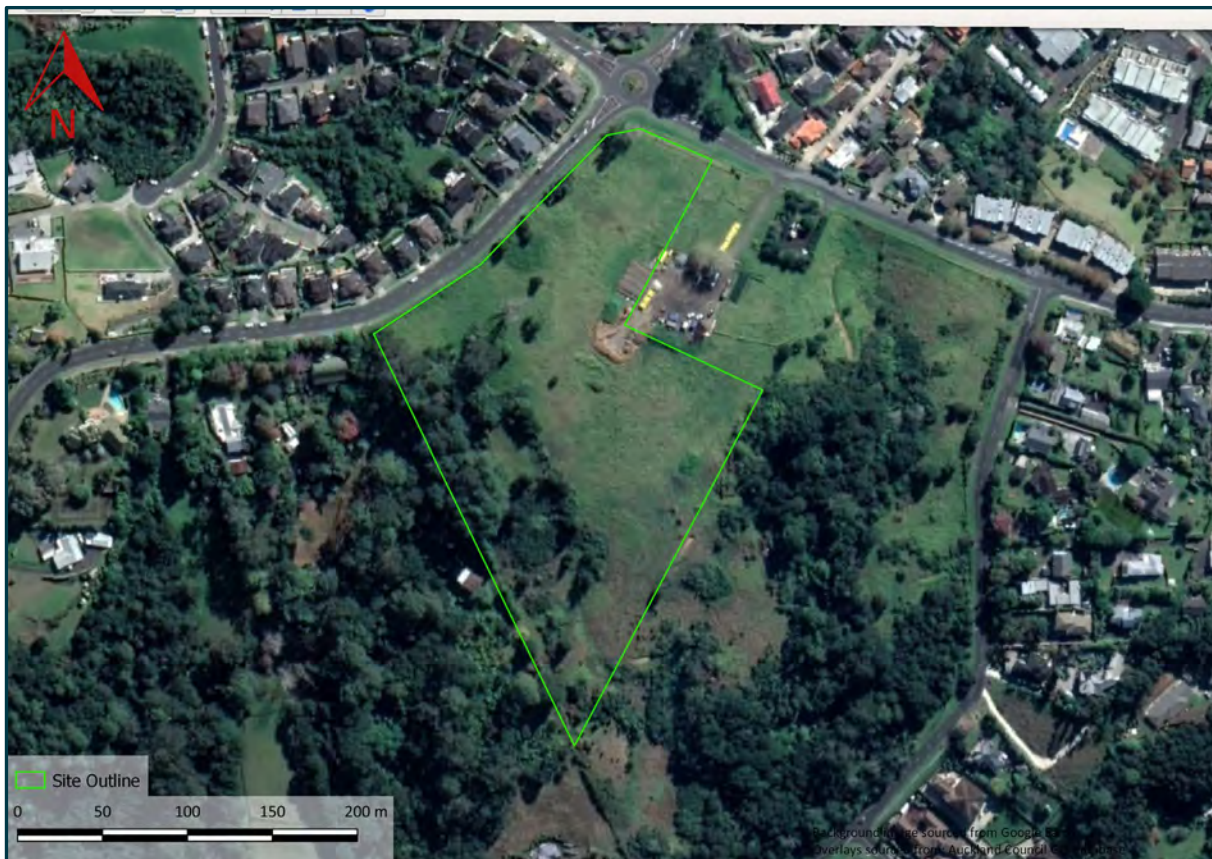
2019 Aerial Photograph

- **2019:** A yard is evident on the parent property to the northeast. As part of the yard, a garage like structure is located on the site, bordering the northwest boundary of the yard. A section of the yard also extends onto the site in the central portion of the site.
