O'HARA WAIUKU PLAN CHANGE  
45A, 92 AND 130 CONSTABLE ROAD,  
WAIUKU

# GEOTECHNICAL ASSESSMENT REPORT

Project No.	64932	Approved for Issue	
Version No.	2	Name	J P M Shorten
Status	Final	Signature	 
Authors	A G J Stuart	Date	6 July 2021
Reviewer	J P M Shorten

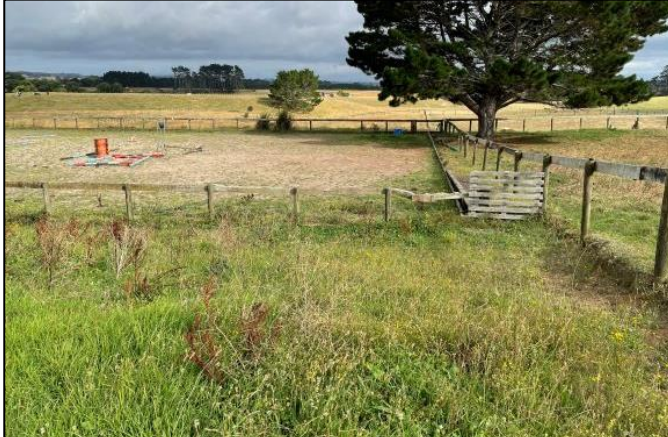
<p><b>Photograph 1.1:</b> Looking south-west across southern part of site, showing low lying area.</p>

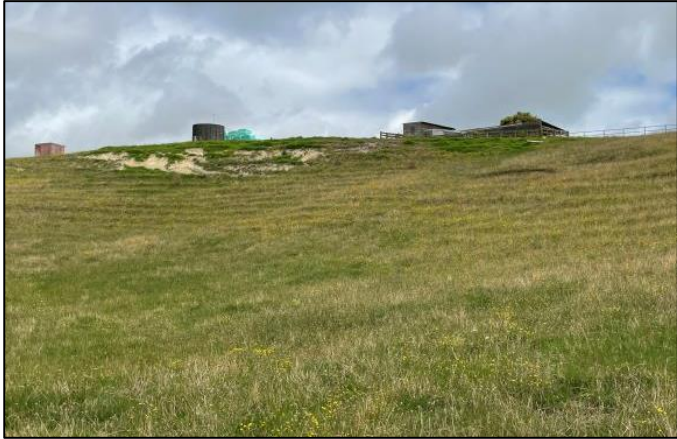
<p><b>Photograph 2.1:</b> Looking north-west across southern part of site.</p> <p>Note large, approximately 10 m high, arcuate bowl feature comprising a series of stepped benches separated by vertical scarp features up to approximately 2.5 m height.</p>

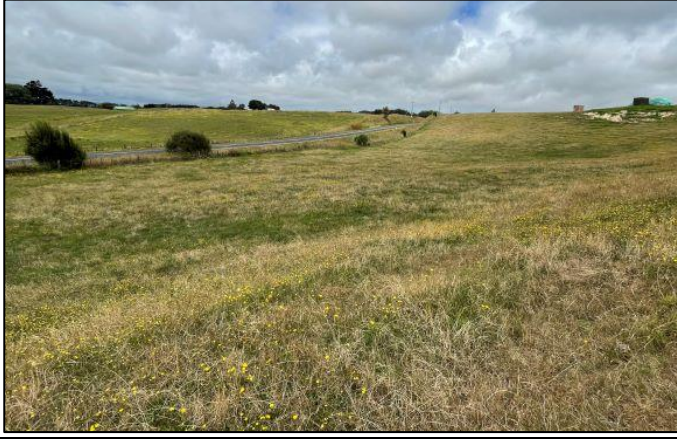
The area at the toe of the arcuate bowl feature was low-lying, showing evidence of water ponding. It was noted that Constable Road, which forms the south eastern site boundary, has been formed on a fill embankment up to 2.0 m in vertical height. The ponding area may potentially be associated with the formation of Constable Road blocking a previously existing overland flow path. [refer Photograph 2.2]

<p><b>Photograph 2.2:</b> Looking south-west at toe of bowl feature.</p> <p>Note evidence of water ponding, attributed to Constable Road, which forms the south eastern site boundary, being formed on a fill embankment up to 2.0 m in vertical height.</p>

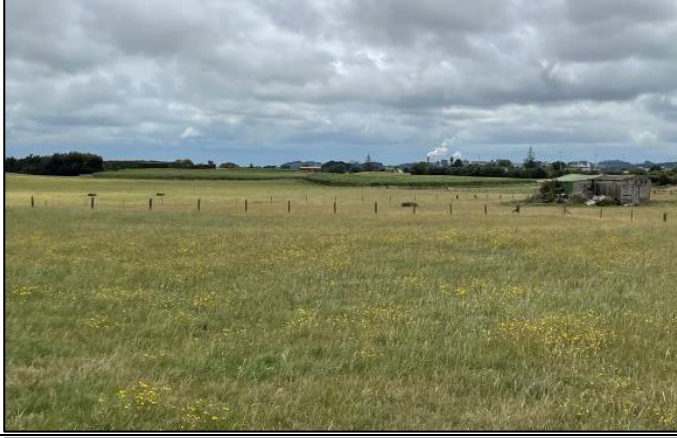
<p><b>Photograph 2.3:</b> Looking north across central part of site.</p> <p>Note gently rolling topography</p>

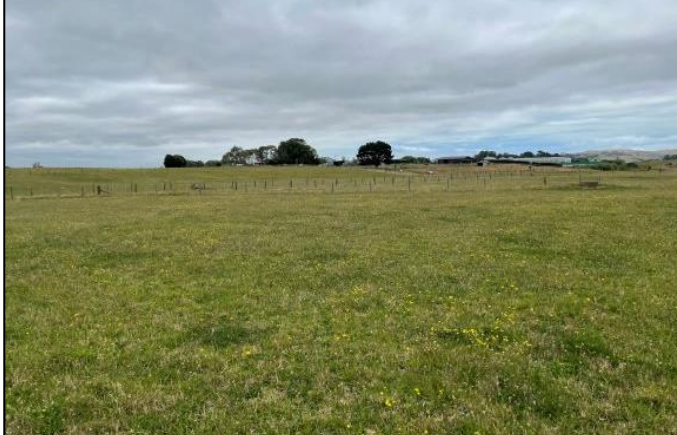
<p><b>Photograph 2.4:</b> Looking south across central part of site.</p> <p>Note gently rolling topography.</p>

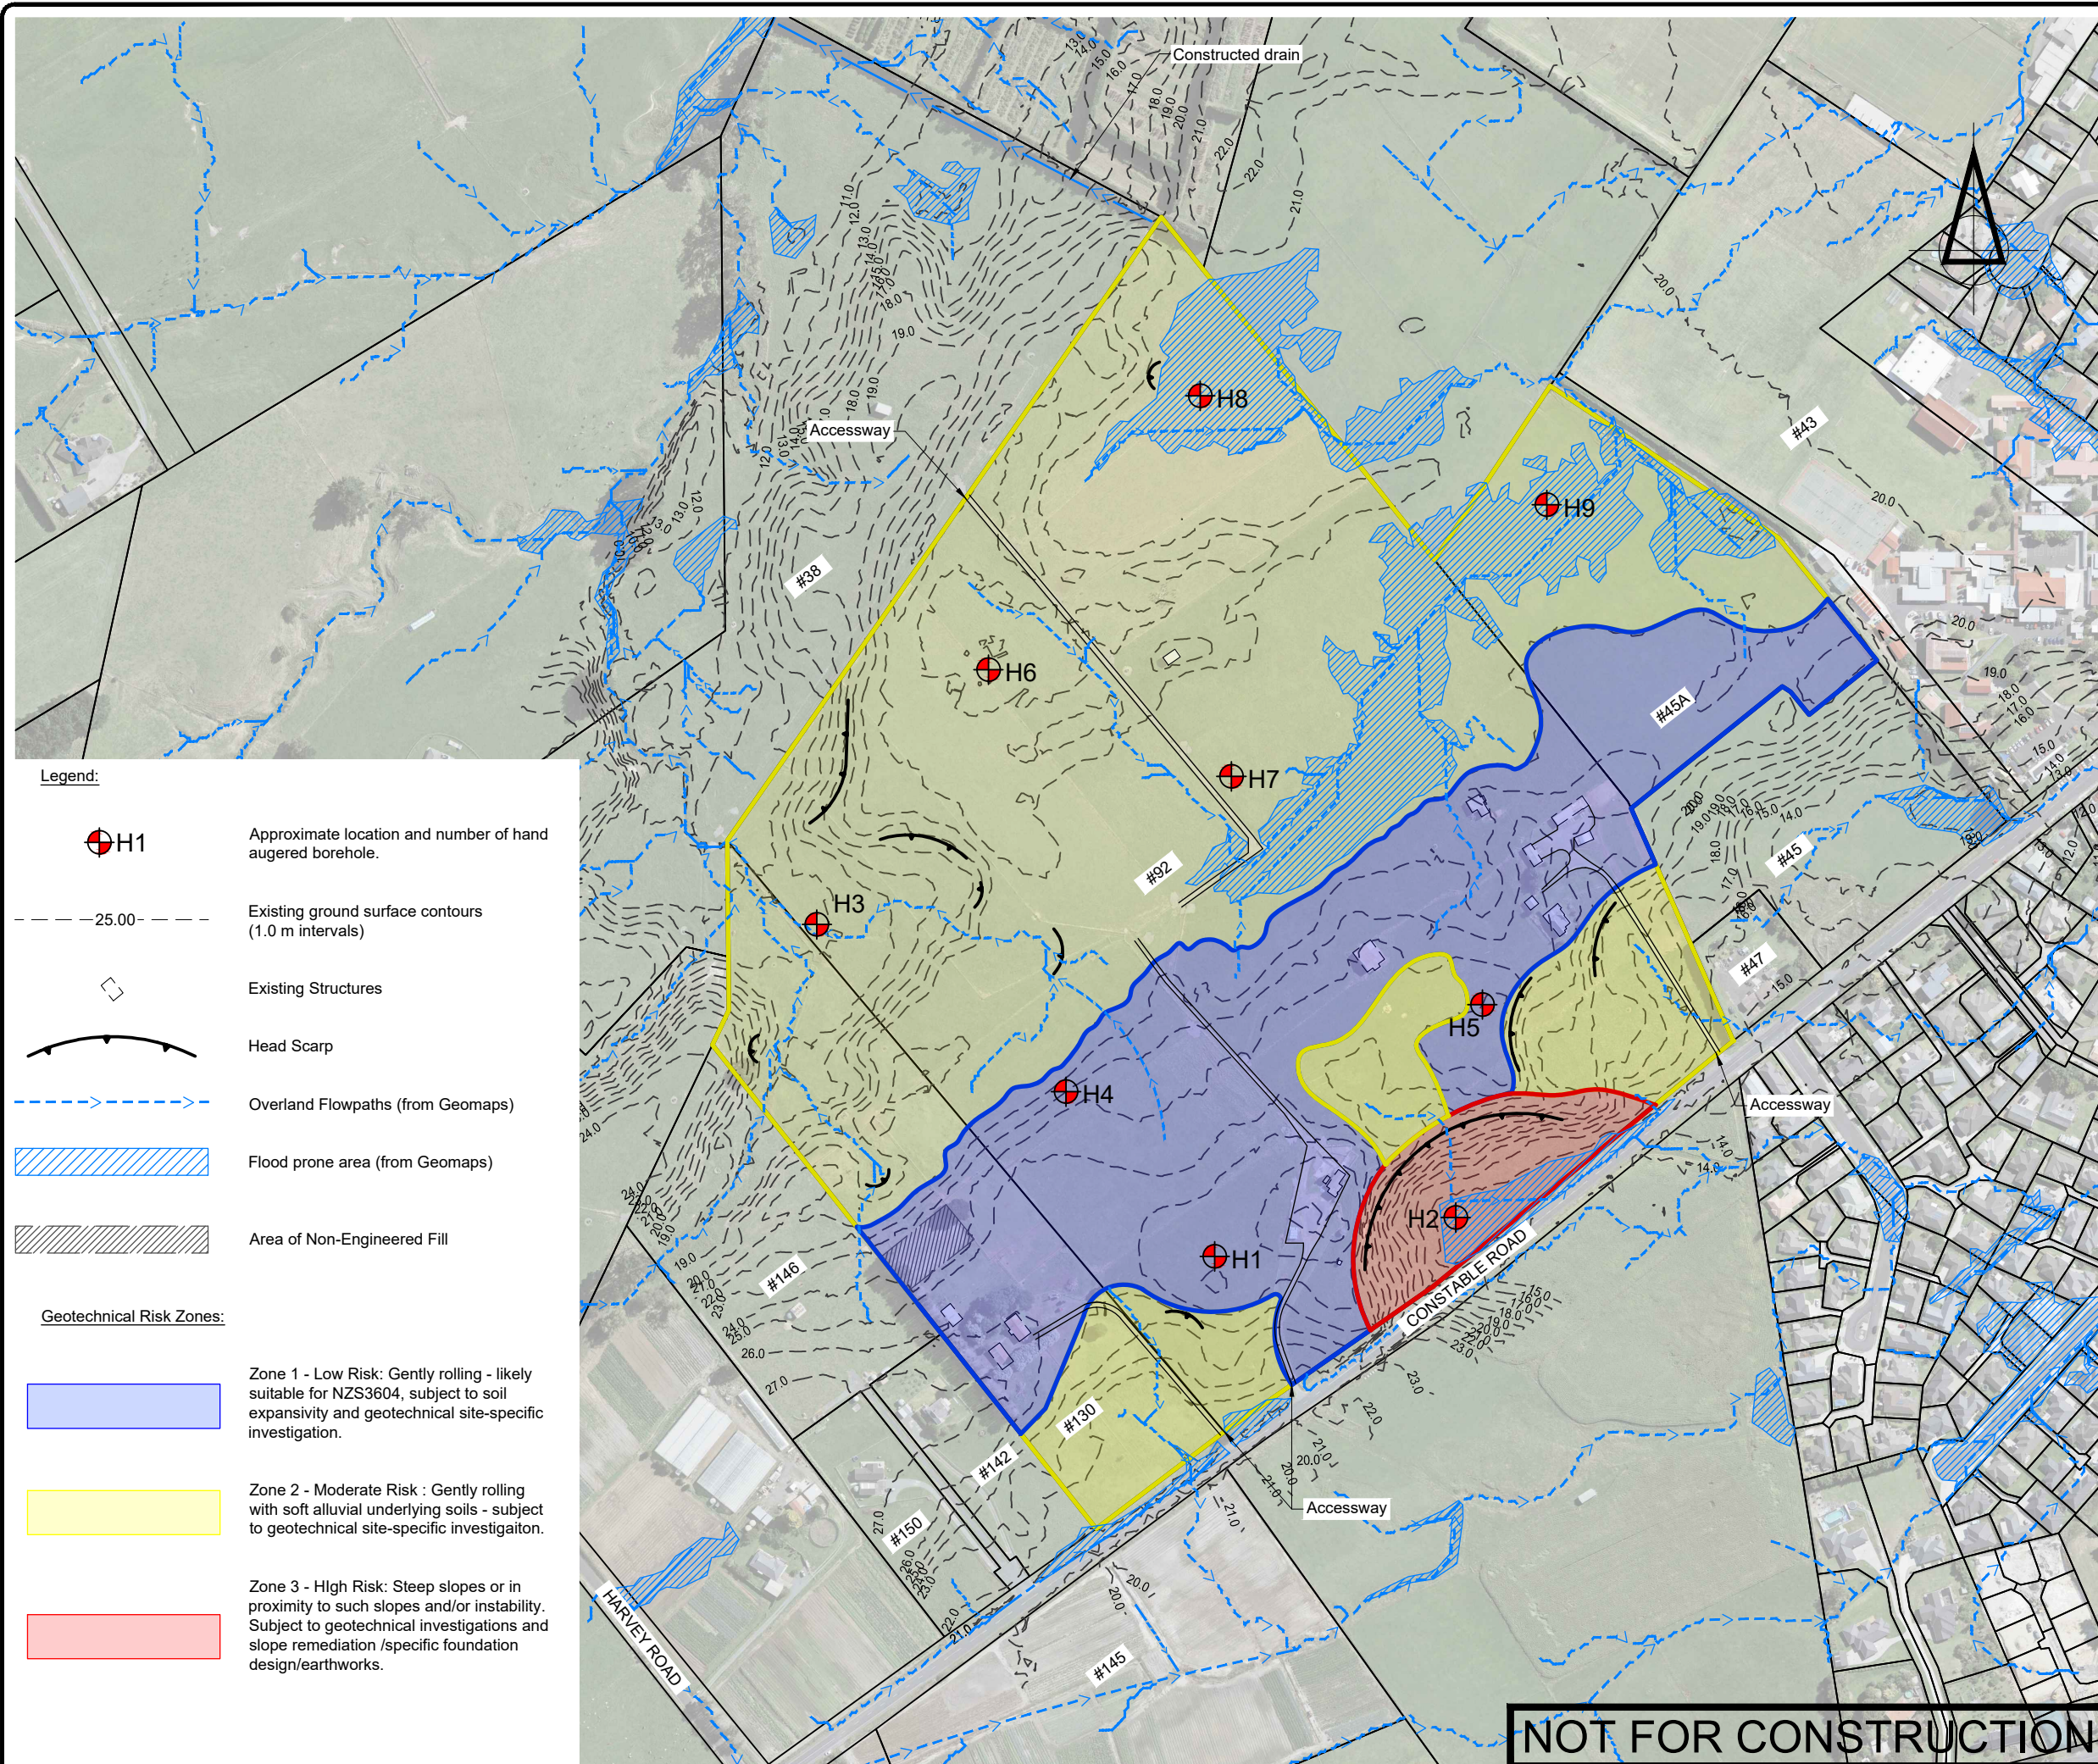
**Drawing**  
**64931-1 Plan Showing Geomorphological**  
**Features and Geotechnical Risk Zones**

Three geotechnical risk zones have been developed with regard to these hazards, as shown on the appended Fraser Thomas drawing 64932/1. The drawing provides a high-level classification of the land suitability to inform a Masterplan, with blue (Zone 1) being low risk, yellow (Zone 2) having moderate risk and red (Zone 3) high risk.

This zone generally comprises gently to slightly sloping topography, with evidence of minor slope instability and/or likely underlain by highly compressible organic and/or soft cohesive soils. Development in this zone should be subject to site-specific geotechnical investigations and specific foundation or earthworks design where deemed necessary.

This zone comprises steeply sloping (greater than 1V:4H) topography or areas in close proximity to such slopes, and/or evidence of significant slope instability features. Development in this zone should be subject to geotechnical investigations and slope remediation and/or specific foundation design and/or earthworks where deemed necessary.

It is considered that there is a moderate to high risk that slopes within these risk zones and in particular the High Risk Zone adjacent to Constable Road, could be affected by slope instability due to natural events, such as extreme transient rainfall events, or due to inappropriate land modification or development. In particular, instability could be caused by inappropriate cut or fill earthworks or inappropriate discharge of stormwater or wastewater.

Furthermore, areas within the Moderate and High Risk Zones are underlain by highly compressible organic and/or soft cohesive soils. It is possible that any proposed development fill or building foundations will impose a significant vertical stress on the underlying highly compressible organic or soft soils resulting in differential settlement which may adversely affect any proposed building or structure underlain by such soils.

It is recommended that any proposed residential development in the Low Risk Zone be subject to site-specific geotechnical investigation and appraisal at the subdivision consent application stage and a report submitted to confirm the suitability of any particular site for such building development.

It is possible that the geotechnical investigation and appraisal carried out for any proposed development will show that slope stabilisation or foundation improvement works are required in order to mitigate the risk of slope instability or foundation settlement.

Foundation improvement could include earthworks to undercut unsuitable material and replace it with engineered fill or, alternatively, piled foundations could be utilised. Further geotechnical investigation may require a machine boreholes and/or a cone penetration tests (CPTs), in order to determine the thickness and nature of any highly compressible organic or soft soil layer and pile design parameters.
