PRELIMINARY SITE INVESTIGATION (PSI)

301 BUCKLAND ROAD, PUKEKOHE

Reference Number: REP-1258/PSI/NOV18

16 NOVEMBER 2018

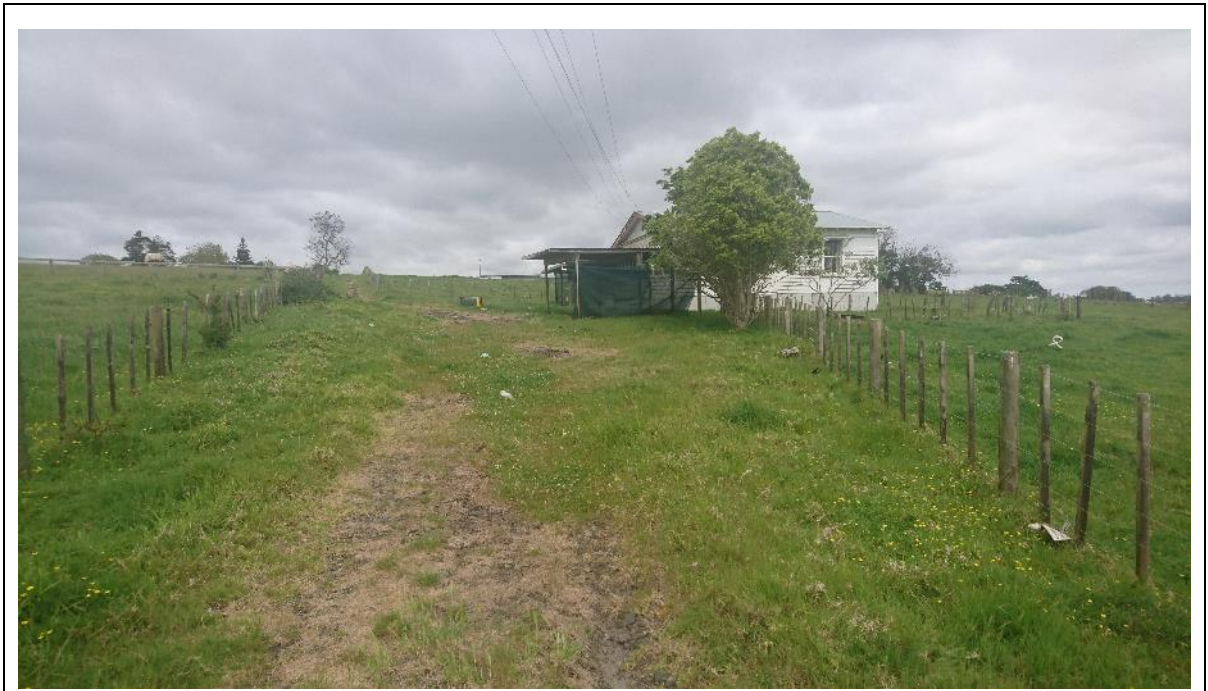
PLATE 1: DWELLING WITH STOCKPILE ALONG FENCE ON LEFT

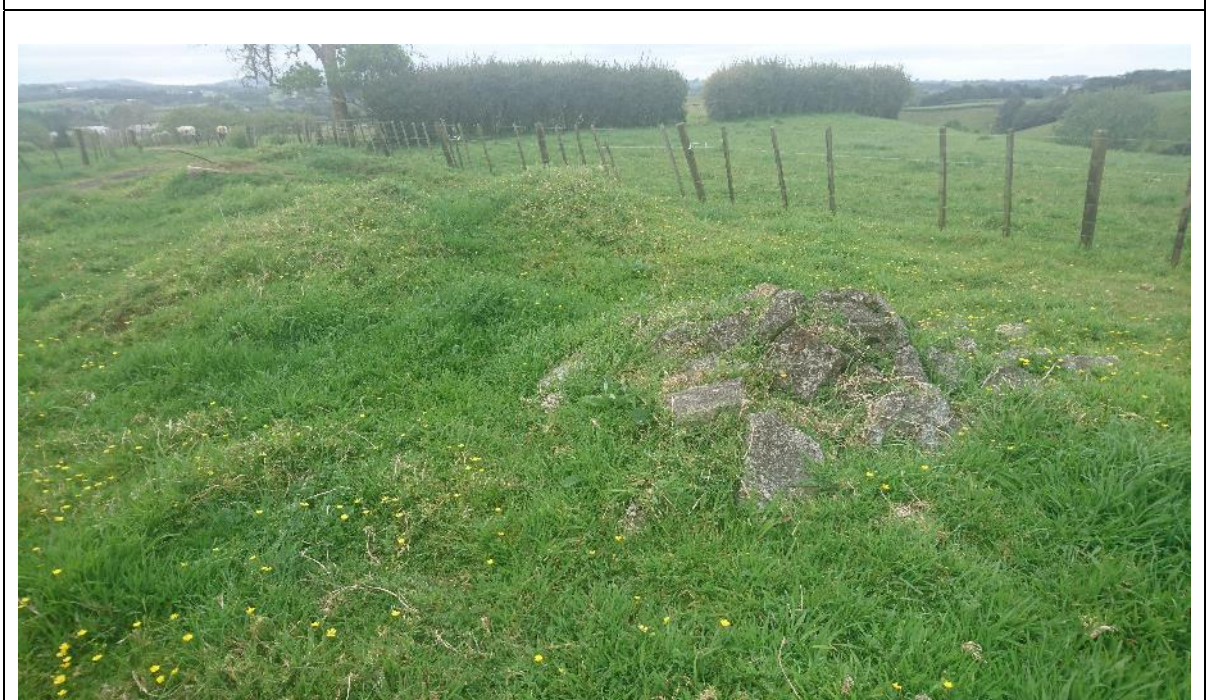
PLATE 2: PARTIALLY BURIED CONCRETE AND STONE IN SW CORNER

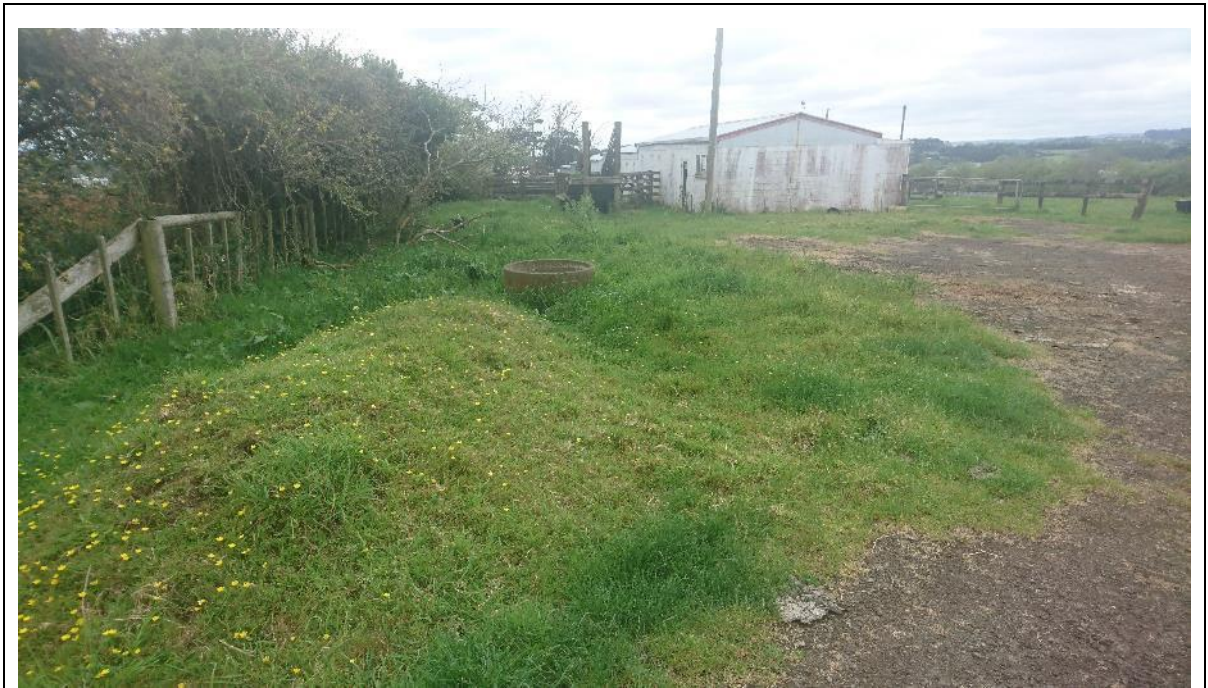
PLATE 3: PARTIALLY BURIED STOCKPILE IN SW CORNER

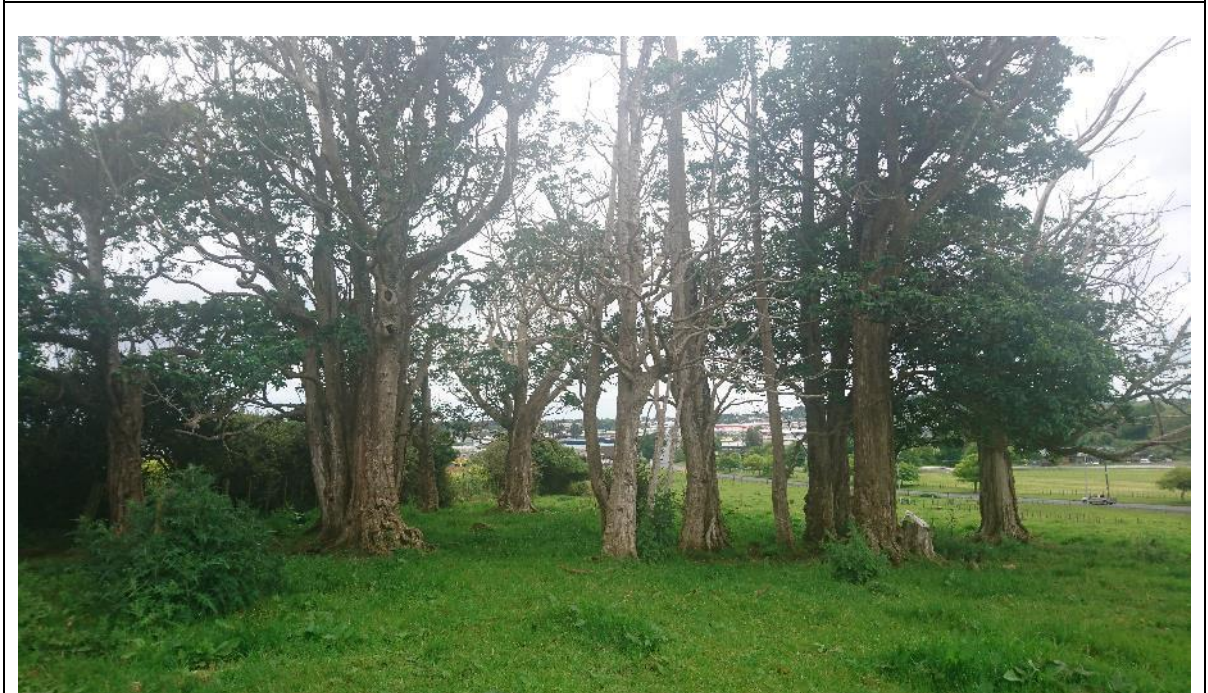
PLATE 4: TREES SURROUNDING PARTIALLY BURIED CONCRETE

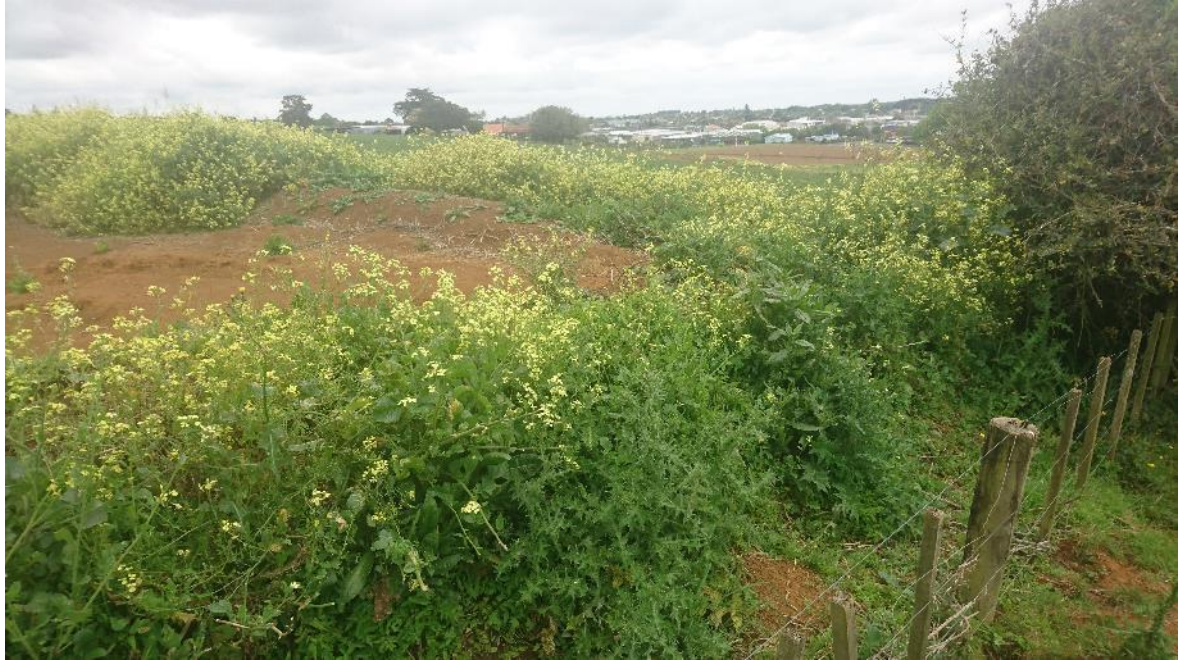
There are currently no visible signs on site of horticulture having occurred. However, it was noted that material from the neighbouring horticultural farm to the west of the site has migrated across the site along an overland flow path during heavy rain events. The horticultural field to the west is slightly elevated above the level of the site, with an earth berm running from north to south along the boundary line. It appears that this bund, and the boundary between the north and south horticultural fields forms a ‘dam’ where sediment accumulates during rainfall. The earth berm on the boundary does not appear to be structurally reinforced, so it is considered that periods of prolonged or heavy rain result in material migrating along the overland flow path as water moves from the horticultural field down gradient onto the site. This migration is visible in the 2017 aerial photograph.

PLATE 5: SOIL BUND AND SEDIMENT 'DAM' ON NEIGHBOURING PROPERTY

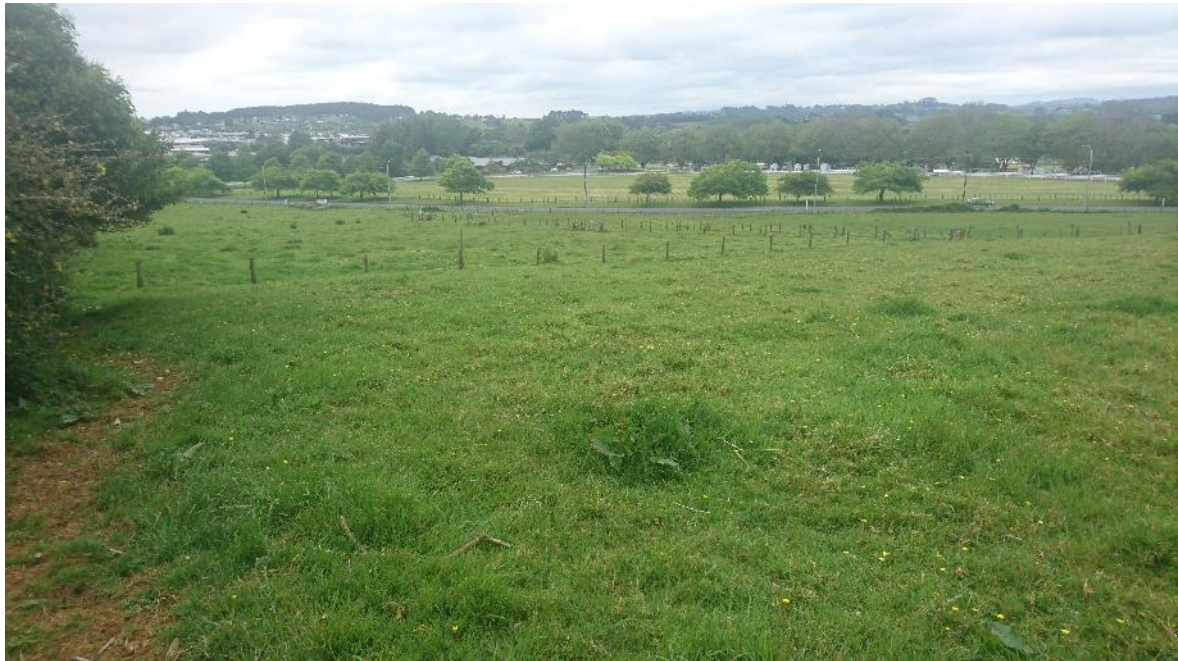
PLATE 6: LOOKING NE FROM SOIL BUND (PLATE 5) ALONG OVERLAND FLOW PATH

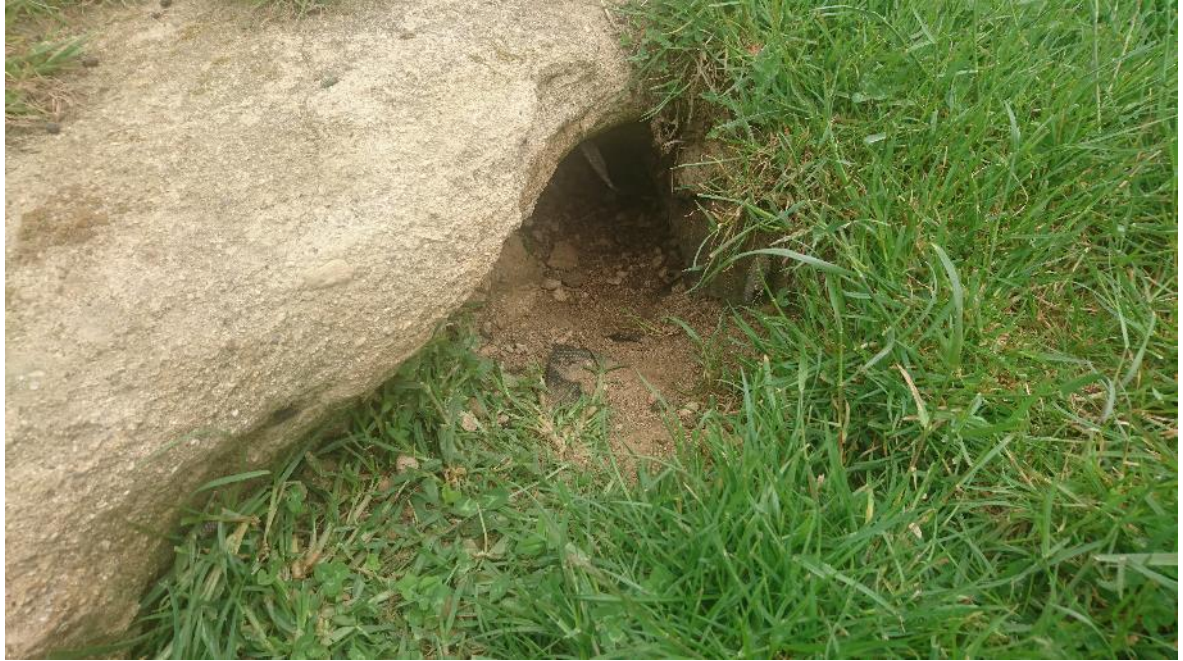
The single residential dwelling on the southern boundary of the site appeared in relatively good condition, with no noticeable damage to the exterior of the building. A gravel driveway in a state of disrepair extends along the southern boundary of the property, from Buckland Road to Webb Street. Minor surficial rubbish around the house was noted, but no signs of significant dumping or buried rubbish were identified. A small grassed stockpile of soil lies along the southern boundary opposite the timber-frame car port, and is most likely locally derived material stockpiled during the construction of the house. The remnants of a horse training circle is located in front of the stables, with shallow coarse sand overlying geotextile material present beneath the current layer of grass.

PLATE 7: FILL IN EX HORSE TRAINING CIRCLE WITH UNDERLYING GEOTEXTILE MATERIAL

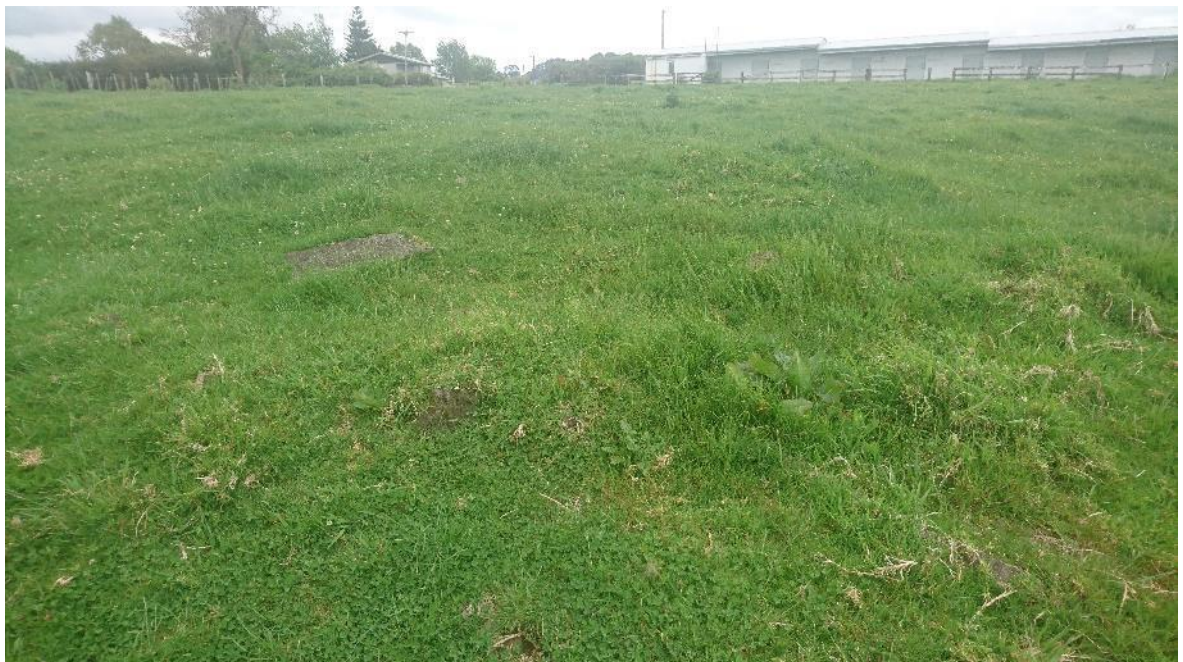
PLATE 8: PARTIALLY BURIED RUBBLE FROM PREVIOUSLY REMOVED BUILDING WEST OF HOUSE

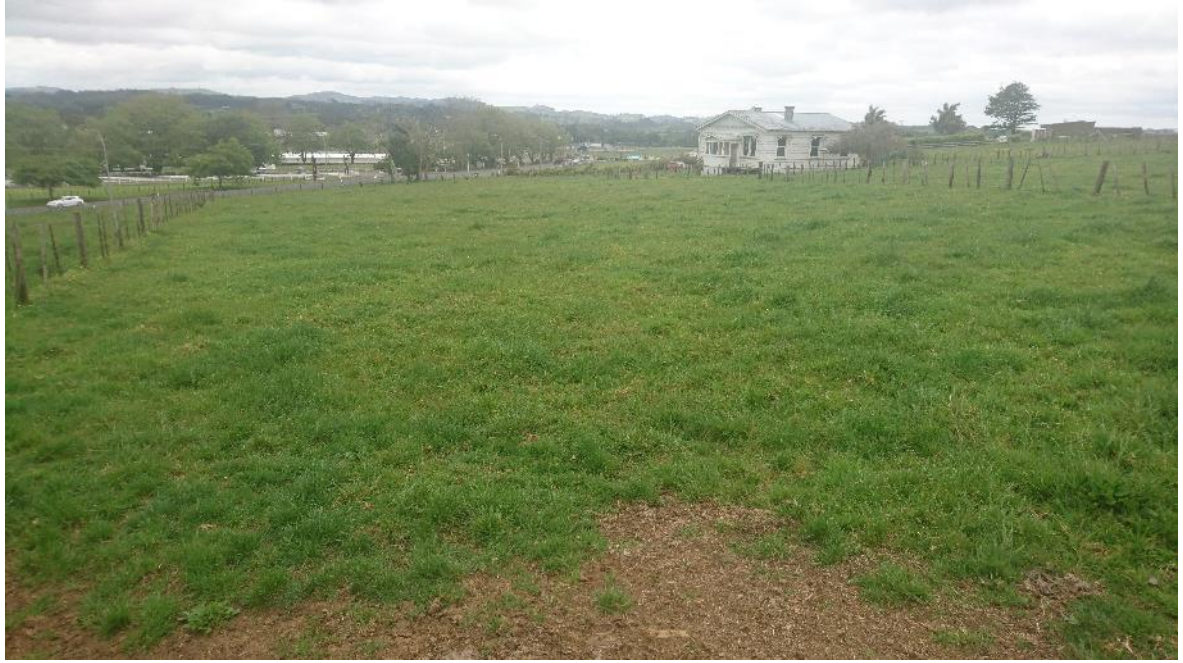
PLATE 9: POSSIBLE HISTORIC HORTICULTURAL FIELD

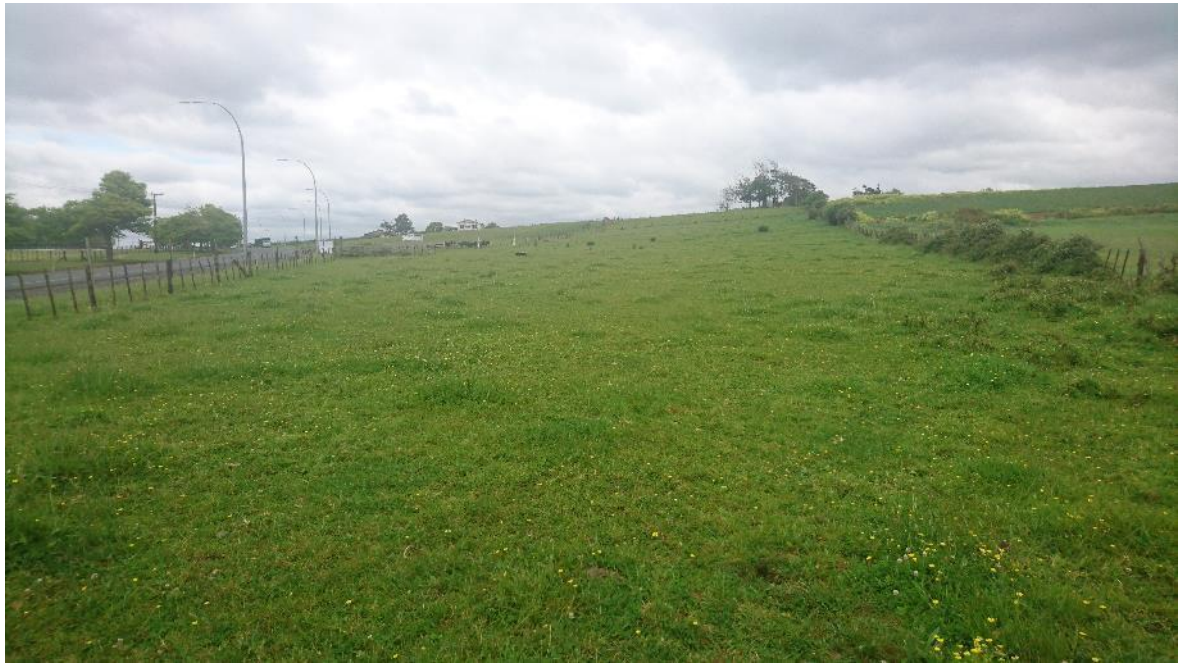
PLATE 10: LOOKING SOUTH UP-GRADIENT FROM NORTHERN CORNER OF PROPERTY
