Hingaia Stream Catchment Watercourse Assessment Report Draft

[July 2018]

Hingaia Stream Catchment Watercourse Assessment Report

4Sight Consulting¹

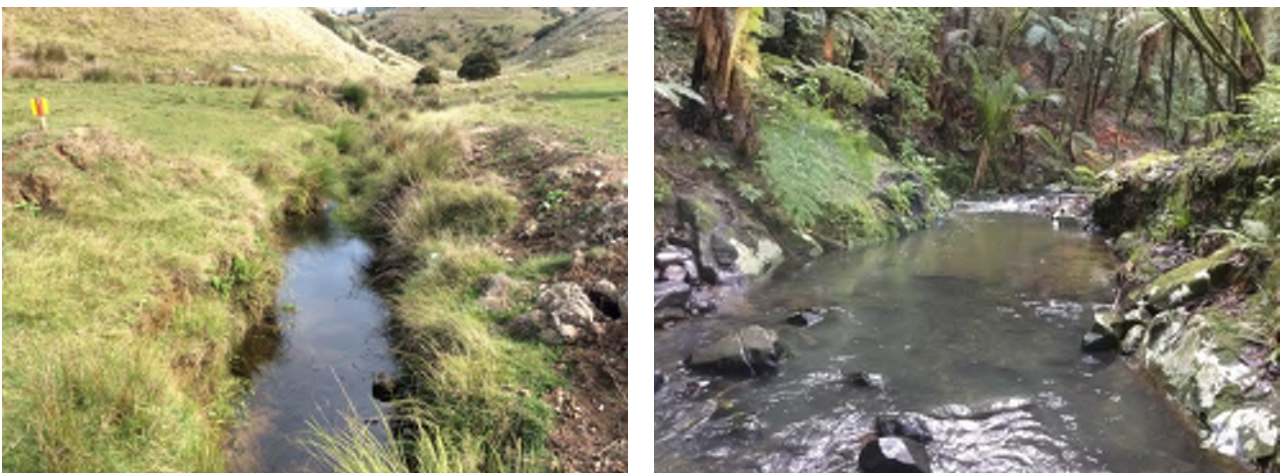
Figure 2: Representative stream photos, A) poorly vegetated soft-bottomed stream channel through agricultural land and B) well vegetated hard-bottomed stream channel through steep gully.

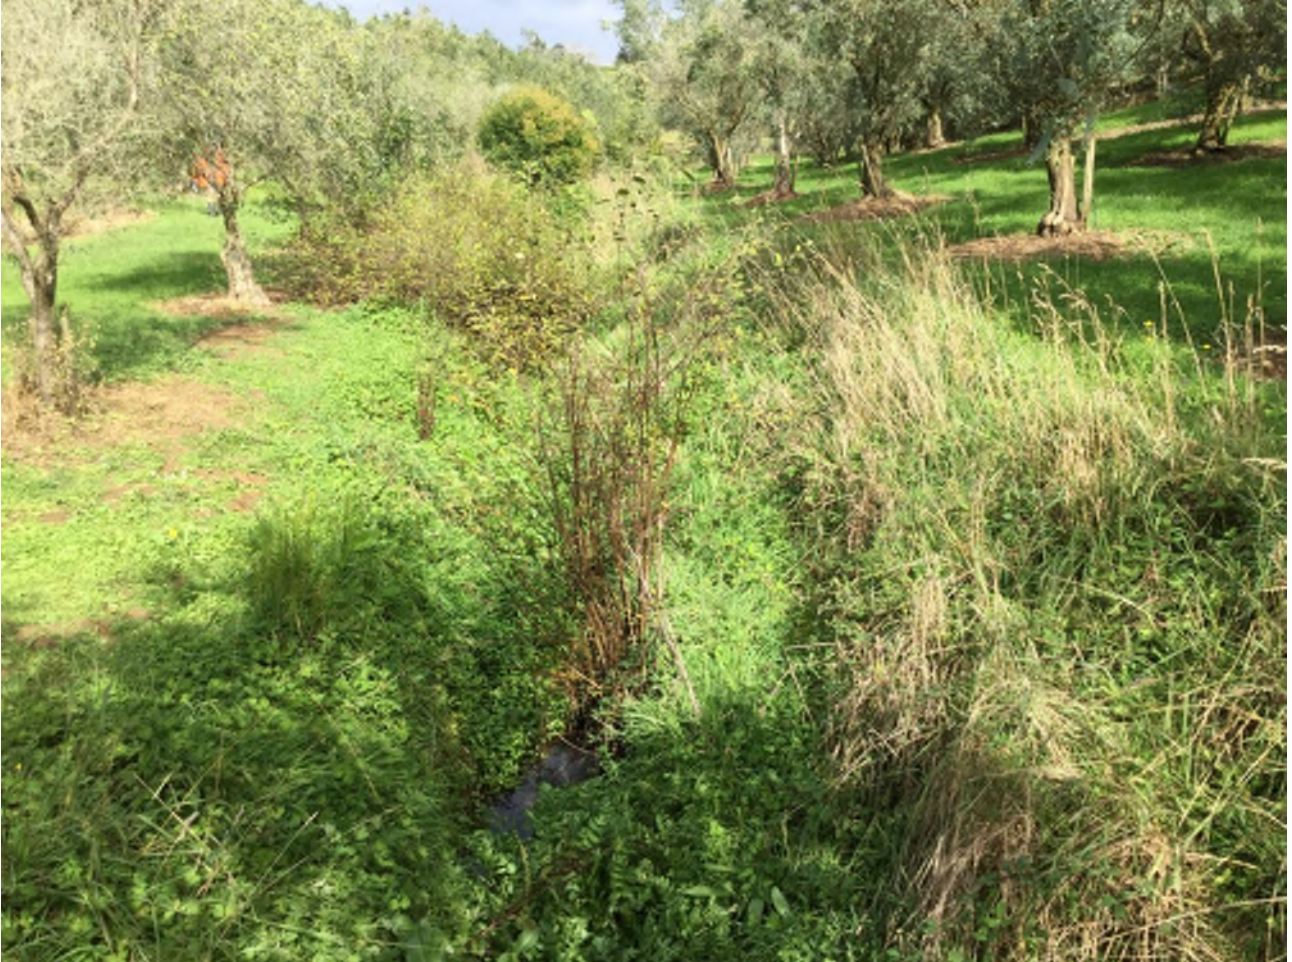
A lack of stream shade, in conjunction with nutrient laden runoff, can result in waterways developing excessive growth of macrophytes (aquatic plants) and/or periphyton (Table 9; Figure 3). Emergent macrophytes were commonly observed during the stream survey, with 60,289 m of stream, 37% of the total surveyed length, having emergent macrophyte growth in excess of 20% of the water surface area. Submerged macrophyte beds, while

Figure 3: Excessive macrophyte growth along poorly shaded section of stream.

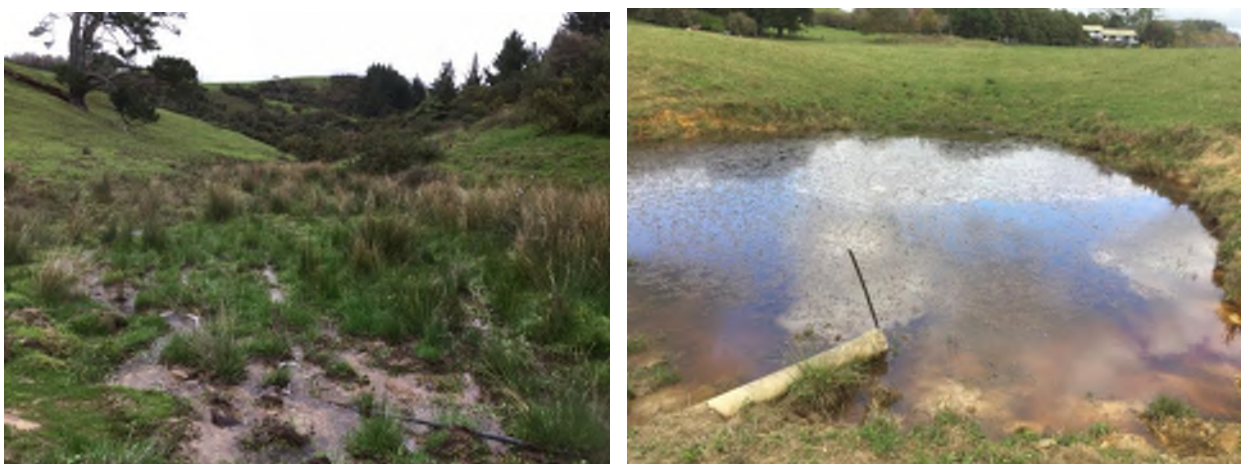
Figure 8: Wetlands within the catchment. A) stock damaged natural wetland and B) farm pond

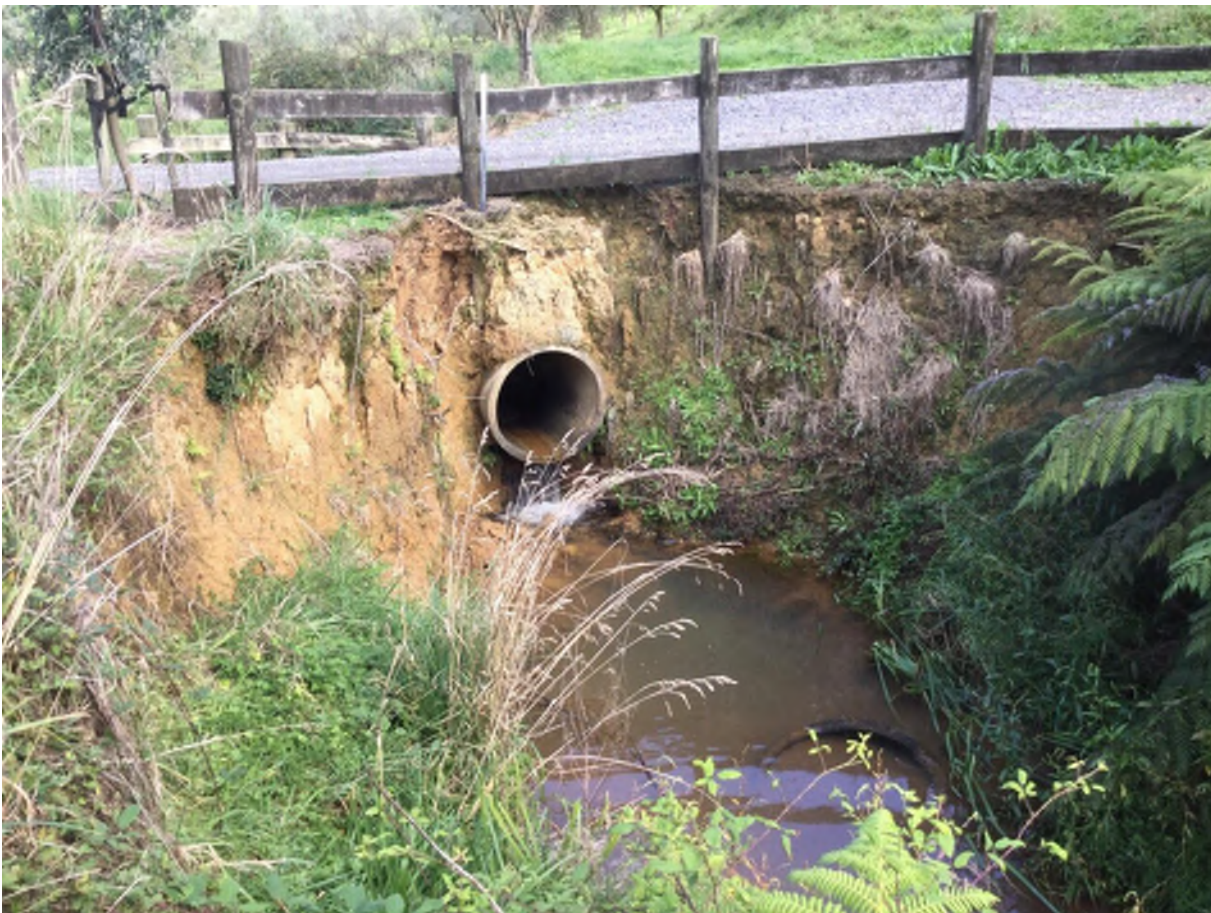
Figure 9: Significant erosion, and a fish barrier, associated with a rural, private asset.

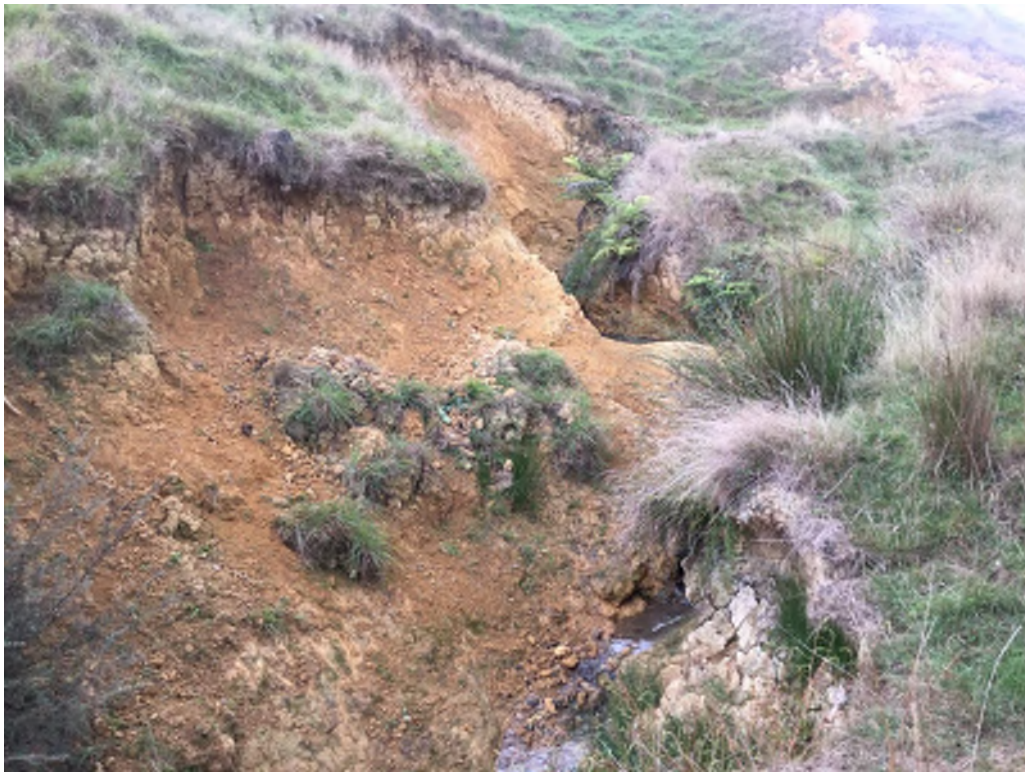
In total 134 erosion hotspots were recorded within the catchment (Table 18; Appendix A, Map 4; Figure 10). The majority of hotspots (122) had formed as a direct response to increased water flow during flood events while the remaining 16 were in areas where severe stock damage was likely to create ongoing bank erosion issues during high flow periods. The average size of an erosion hotspot was 13 m in length and 37 m² in area (Table 18). The four largest erosion hotspots were all approximately 200 m² in area and were scattered through the catchment. These were large scale eroded areas contributing significant amounts of sediment to the stream, however the majority of hotspots were smaller, isolated patches of active erosion that was considerably more severe than observed on the surrounding banks.

Figure 10: Erosion hotspot alongside a stream channel edge.

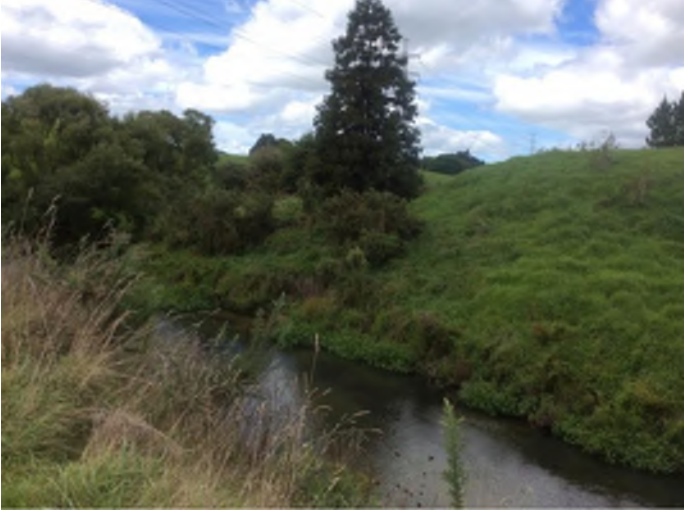
<p data-bbox="169 842 839 931">Poorly vegetated riparian margins, with erosion evident in the background.</p>

<p data-bbox="911 842 1517 931">Further evidence of degradation to riparian margins.</p>	
<p data-bbox="456 954 552 987" style="text-align: center;">Notes</p>		<p data-bbox="1062 954 1366 987" style="text-align: center;">Benefits to Council</p>	
<ul data-bbox="201 1021 847 2022" style="list-style-type: none"> • Stream through EO2 is within land zoned for future urban development. • Currently farmland, but anticipated for development from 2028 onwards, with stream size large enough to trigger esplanade reserve requirements. • Riparian margins are degraded. • Improving riparian planting offers an opportunity to improve amenity, ecological and conveyance values of the lower Hingaia Stream. • Walkway/cycleway could be incorporated into any plans for enhancement. • Provides important link between existing esplanade reserves in urban areas upstream (Drury Township) and downstream (Drury South). • Potential for establishment of 10 km riparian corridor along Hingaia Stream, if this section is planted and linked with enhancement upstream/downstream. 		<ul data-bbox="919 1021 1557 1395" style="list-style-type: none"> • Leverage off developer lead initiatives for restoration. • Helps to address flooding issues within Hingaia Stream catchment . • Good opportunity, once development occurs, for and community involvement. • Contributes to and extends the Local Board Greenways Plan.

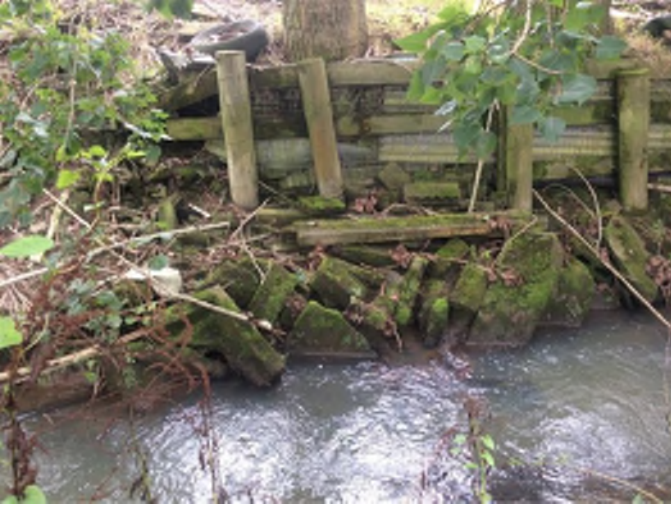
<p data-bbox="177 835 829 925">Limited riparian vegetation, low TLB providing some potential fish spawning habitat</p>

<p data-bbox="922 835 1493 925">Bank lining designed to protect property against elevated stream levels</p>	Notes	Benefits to Council
<ul style="list-style-type: none"> • Stream through EO3 is within land zoned for future urban development. • Current mixed land use including urban and rural activities. • Flood prone area under investigation by AC. • Riparian margins are degraded. • Elevated <i>E.coli</i> and heavy metals. • Good connectivity to lower Hingaia Stream mainstem and has some value for potential fish (galaxiid) spawning habitat. • Stream naturalisation (bank recontouring) and riparian improvements could address ecological and some conveyance issues • Structures such as wetlands may also alleviate some flooding issues. 	<ul style="list-style-type: none"> • Leverage off developer lead initiatives for stream enhancement. • Helps to address flooding issues within Hingaia Stream catchment.

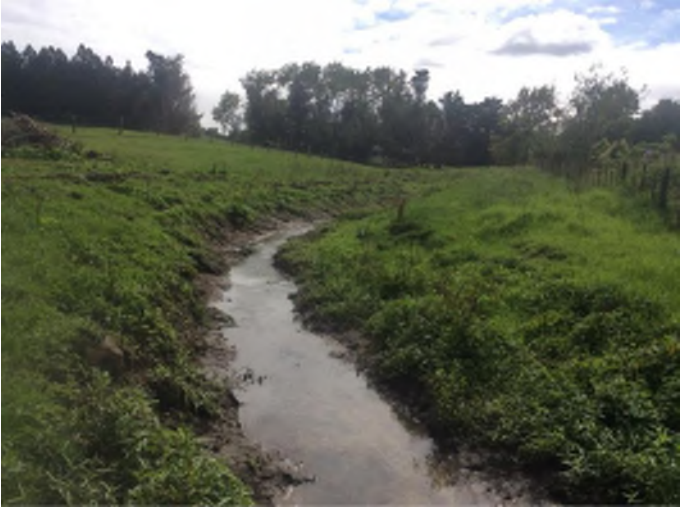
<p data-bbox="172 840 829 925">Modified stream channel within EO. Degraded riparian vegetation</p>

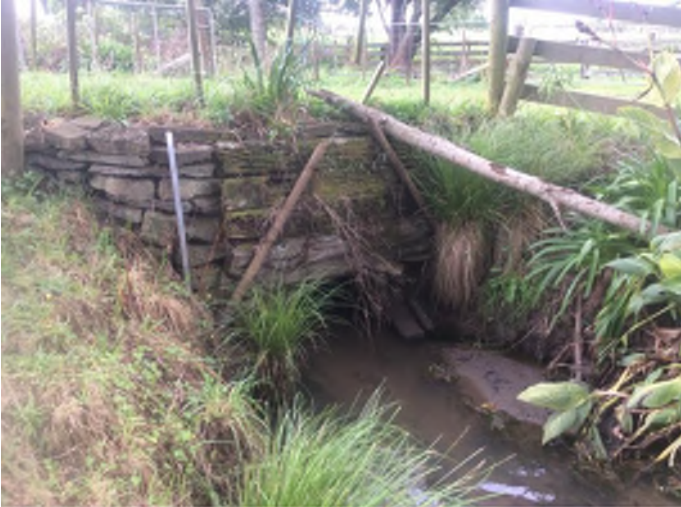
<p data-bbox="949 840 1468 875">Failing structure with erosion issues.</p>	
<p data-bbox="454 952 545 987" style="text-align: center;">Notes</p>		<p data-bbox="1061 952 1356 987" style="text-align: center;">Benefits to Council</p>	
<ul style="list-style-type: none"> • Stream through EO4 is within land zoned for future urban development. • Current mixed land use including large lot urban and rural activities. • Flood prone area. • Riparian margins are degraded. • Good connectivity to lower Hingaia Stream and has some value for fish galaxiid habitat. • Stream naturalisation and riparian improvements could address ecological and some conveyance issues 		<ul style="list-style-type: none"> • Leverage off developer lead initiatives for stream enhancement. • Helps to address flooding issues within Hingaia Stream catchment. • Enhancements could be staged, including short-term (conveyance) and longer term (riparian) enhancement opportunities.

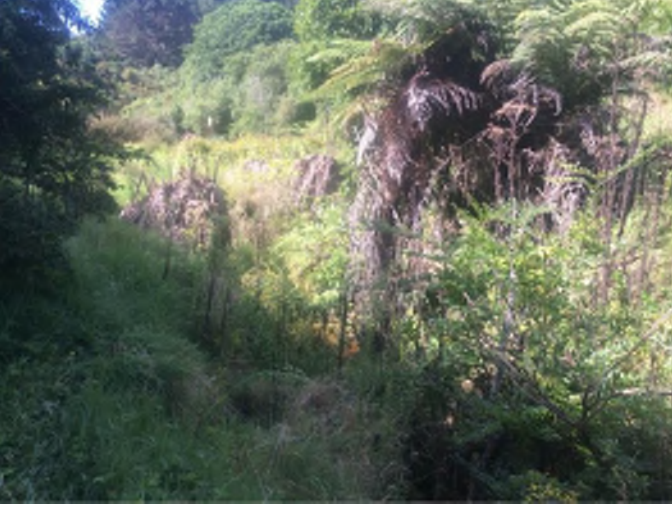
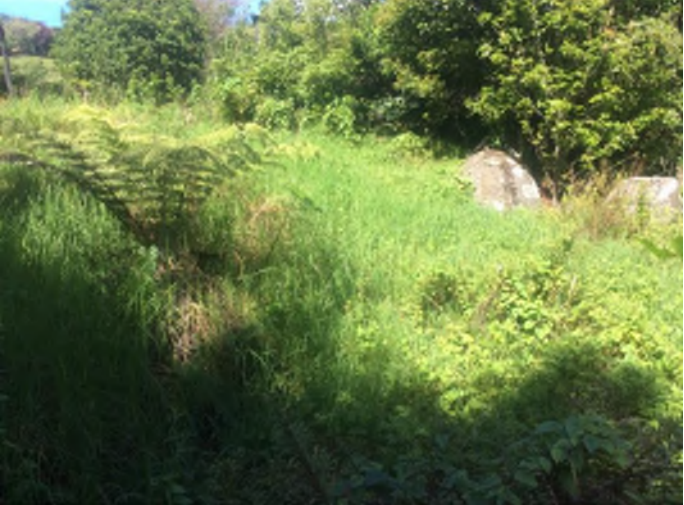
<p>Degradation of riparian zone within MacWhinney Reserve</p>	<p>Weed infestations within MacWhinney Reserve..</p>
<p>Notes</p>		<p>Benefits to Council</p>	
<ul style="list-style-type: none"> • Stream through MacWhinney Reserve. • Listed as Public Space – Conservation Zone. • Riparian vegetation compromised by weeds and exotic species. • Community involvement in weeding and planting projects would improve amenity values. • Options for formal walkway or improved dog recreation area should be considered. • Good linkage with downstream DSBP ‘Northern Diversion’ channel and enhancements. 		<ul style="list-style-type: none"> • Immediately actionable as it is on public land • Good opportunity to involve the community in a restoration project.

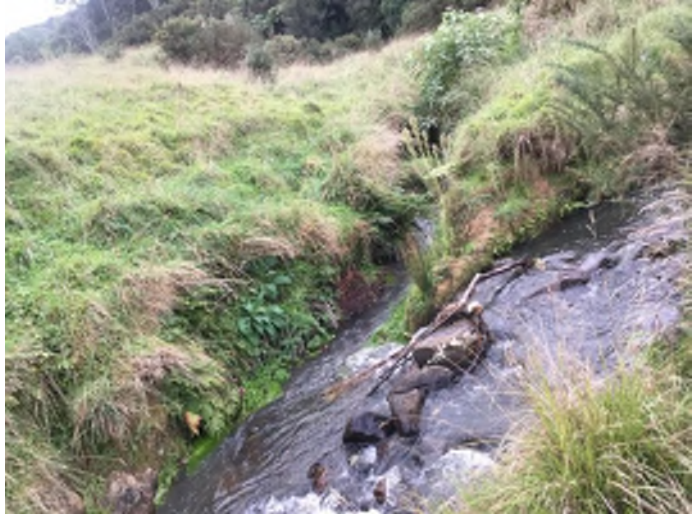
<p data-bbox="849 846 1453 927">Poorly vegetated stream channel between SEAs.</p>	<p data-bbox="151 958 240 992">Notes</p> <ul data-bbox="199 1025 831 1352" style="list-style-type: none"> • Maketu Stream tributary north of Peach Hill Road. • Link existing SEAs via approximately 350 m of riparian planting. • Additional planting through SEA_T_1178 and stock exclusion would further benefit ecological values. 	<p data-bbox="849 958 1145 992">Benefits to Council</p> <ul data-bbox="896 1025 1522 1352" style="list-style-type: none"> • Relatively small amount of stream planting required to link a significant amount of watercourse and high value vegetation. • Potential stream effects offset compensation site, with agreement from landowners.

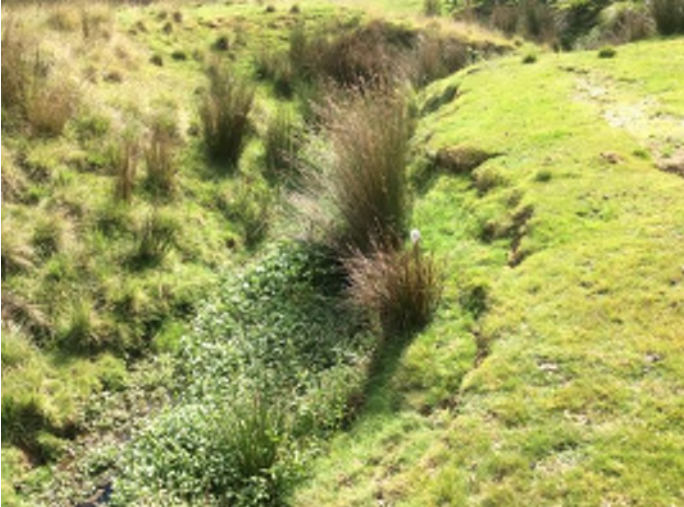
<p data-bbox="151 837 807 920">Poorly placed and possibly undersized culvert with significant erosion issues.</p>

<p data-bbox="858 837 1533 920">Unfenced and poorly vegetated stream channel positioned between SEAs.</p>		
<p data-bbox="151 954 240 987">Notes</p> <ul data-bbox="199 1021 839 1872" style="list-style-type: none"> • Maketu Stream and tributaries south of Peach Hill Road. • Link significant stands of native bush, including three SEAs with riparian planting. • Riparain planting can be used to address erosion issues and provide flood management benefits for lower catchment. • Poorly constructed and undersized stormwater assets should be replaced to address erosion issues. • A number of tributaries have been replanted by residents, while other residents have expressed interest in replanting the riparian margins of streams on their properties. • Linkage with EO6 is possible. 	<p data-bbox="858 954 1150 987">Benefits to Council</p> <ul data-bbox="906 1021 1544 1447" style="list-style-type: none"> • Reduction in erosion/sediment generating potential within catchment. • Good opportunity to engage with landowners in a positive manner. • Large enough area to provide tangible benefits for downstream flood management. • Potential environmental compensation offset sites.

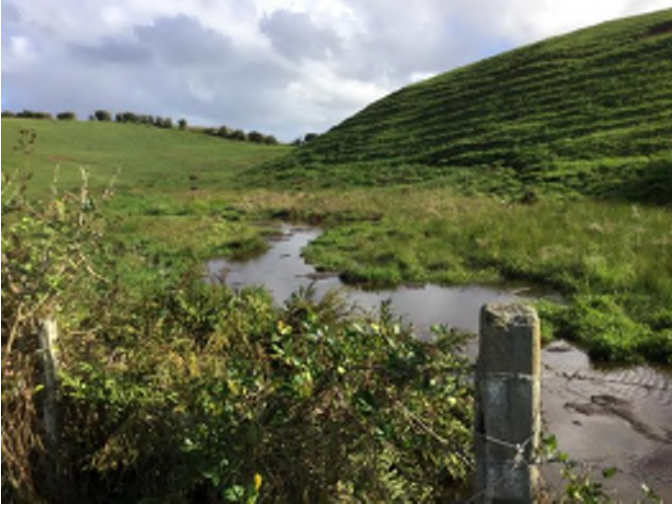
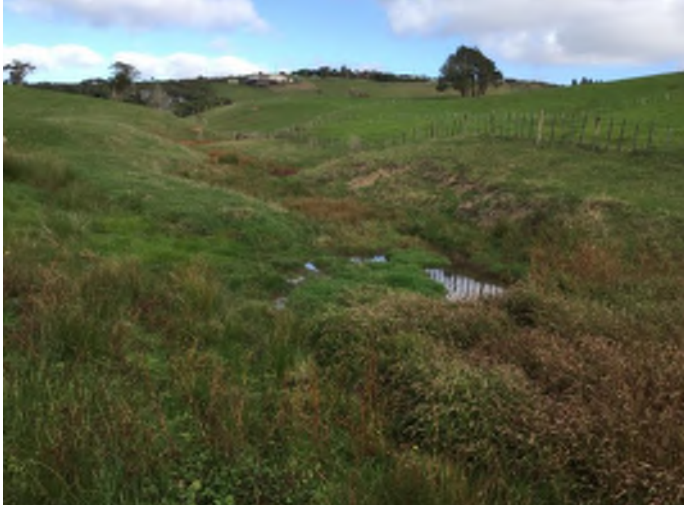
Degraded headwater stream.		Degraded headwater stream.	
Notes		Benefits to Council	
<ul style="list-style-type: none"> • Collection of numerous headwater streams in southern catchment • Minimal riparian vegetation. • Moderate to severe stock damage is common and fencing of waterways is rare. • Poorly placed and/or undersized culverts have resulted in multiple erosion issues. • Large scale project aiming to improve local and wider catchment issues. 		<ul style="list-style-type: none"> • Input from multiple Council units. • Could become a flagship project for stream restoration within the Auckland Region. • Good opportunity to work with multiple community stakeholders.
