Watercourse Assessment Report

Ngakoroa Catchment

Prepared for Auckland Council by Morphum Environmental Ltd

Client Name:	Auckland Council
Project Name:	Ngakoroa Catchment
Project Number:	P01644
Document:	Ngakoroa Watercourse Assessment Report

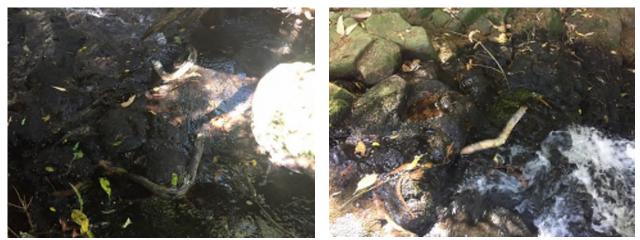
Figure 8: Dead eels found in TRIB11_5

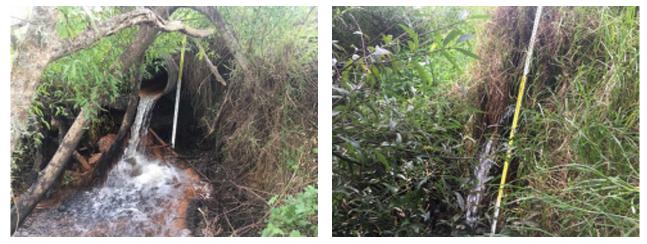
Two of the most significant barriers to fish passage within the Ngakoroa catchment are the perched culverts located on NGAWEST_7. These two structures (Asset IDs: NGAF_137 & NGAF_142) are outlets for the dam that has created a large 1.1 ha online pond immediately upstream on NGAWEST_62 (Figure 15). These culverts are perched by 0.8 and 1.5 m respectively, presenting a complete barrier to for all fish species. The effect of these culverts is to restrict fish from accessing a large proportion of the NGAWEST tributary, particularly to the high-quality fish habitat located in headwater native forest reaches on NGAWEST_24 and NGAWEST_27 (see Section 3.1.9).

Figure 15: Perched culverts forming significant fish barriers on NGAWEST tributary. Asset ID NGAF_137 (left) and NGAF_142 (right).

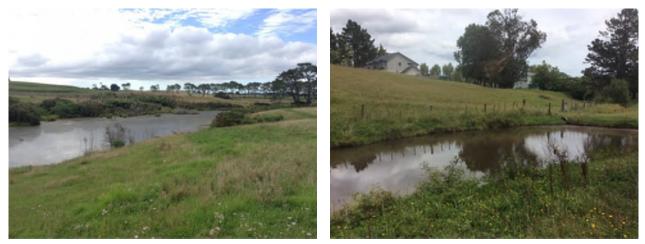
Figure 19: Large online dam at NGAWEST_6 (left) and typical farm pond, NGA_TRIB6_1 (right)

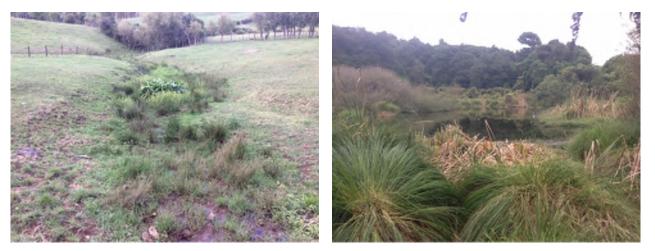
Figure 20: Riverine wetland created by severe cattle pugging on TRIB14_6 (left). Large pond surrounded by willows, raupo and sedges on TRIB17_41 (right).

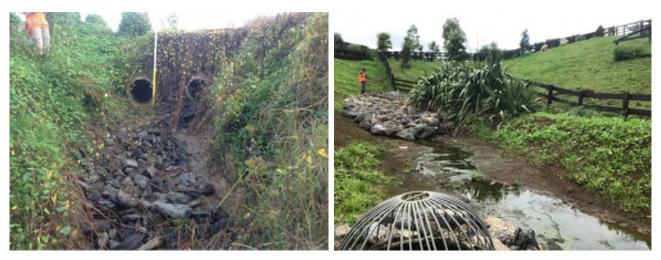
Figure 21: Left - Bombay Rd (ID 3000039153). Right - Christa Place (ID 2000322225)

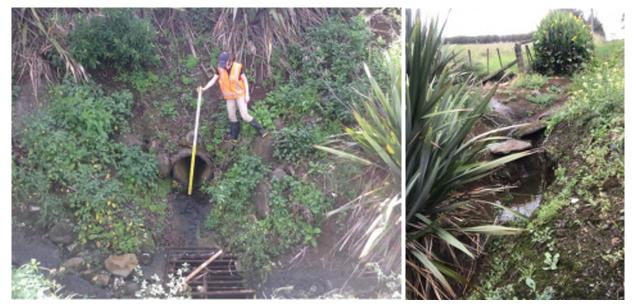
Figure 22: Left – Middle of roadside infrastructure showing pipe NGAPR_052 draining towards broken catchpit grill with inlet to Council pipe 2000200812 under this grill. Concrete reinforcing for additional outlets to the left and right. Right – facing upstream showing broken concrete dissipation.

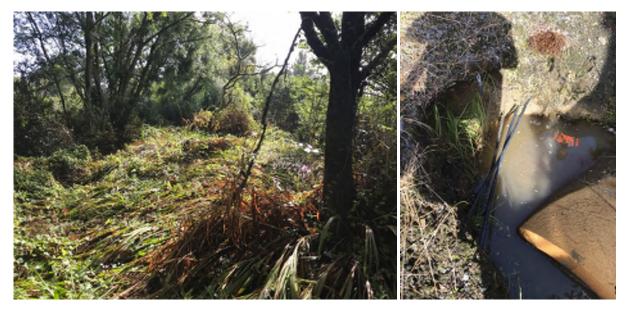
Figure 23: Left – Evidence of flooding in road corridor at Burtt Rd McPherson Rd intersection. Right – Moderate erosion at outlet NGAR_074 at McPherson Rd resulting in exposed underground services

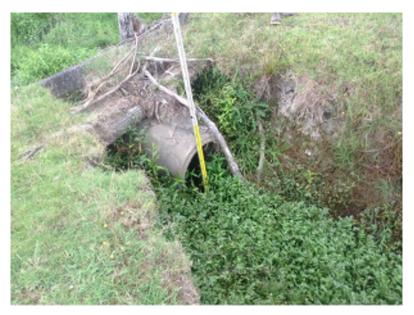
Figure 25: Erosion at outlet NGA_064 with partial collapse of retaining beams for crossing

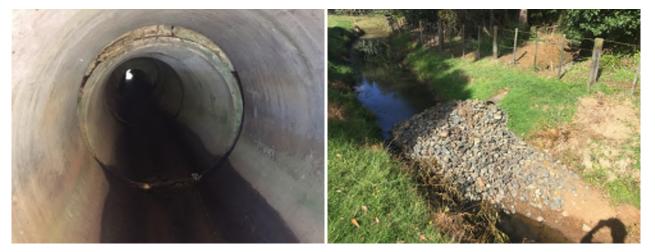
Figure 26: Left - Culvert NGAPR_044 at Great South Rd; Right - discharge of rock rip rap at Trib11_23 (NGA_155)

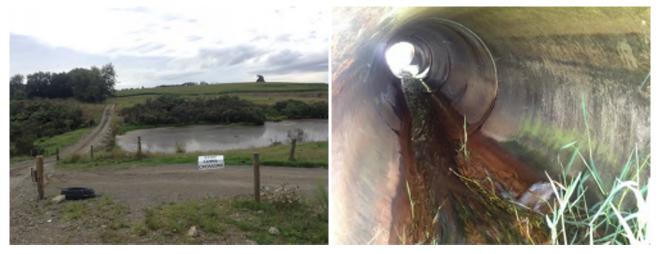
Figure 27: Culvert at online dam (NGAF_114)

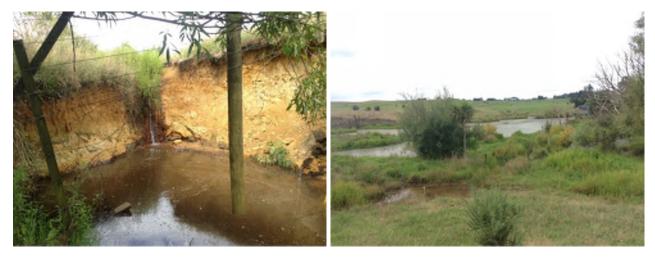
Figure 28: Dam wall breach

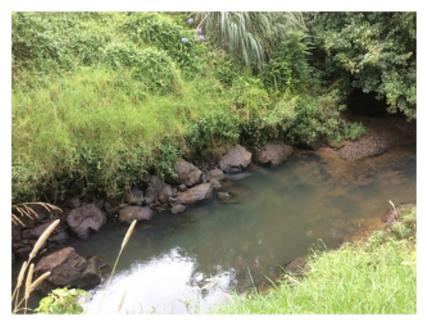
Figure 29: Rock bank lining along NGA_MAIN_2, which appeared safe and had easy access.

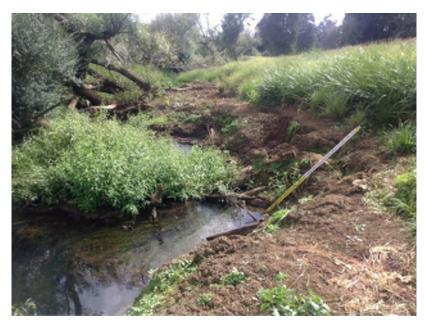
Figure 30: Erosion hotspot on NGA_MAIN_22, where slumping on the TLB has occurred as a result of poor bank vegetation and disturbance.

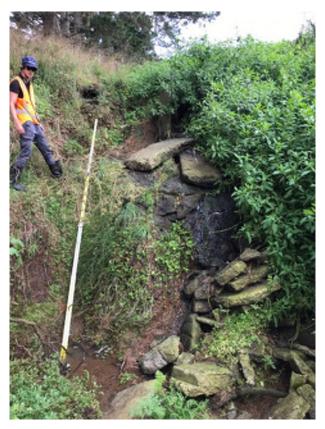
Figure 31: Culvert failure at TRIB24_6 and the associated erosion hotspot along the banks.

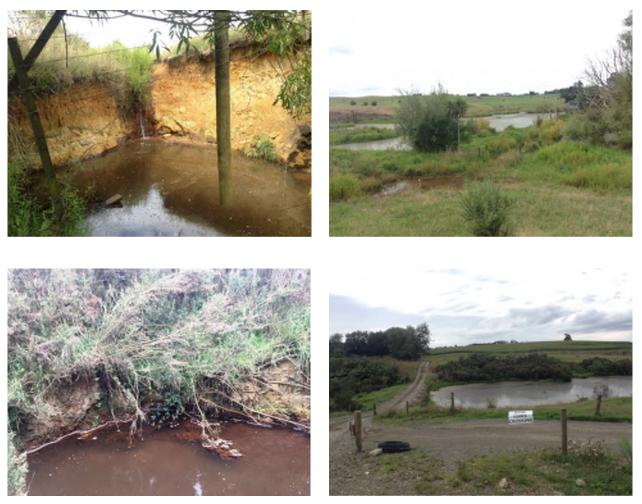
In the northern part of the catchment, the erosion hotpots are more scattered. Of note are two hotspots on NGAWEST_7 and NGAWEST_5, which are located immediately downstream of the outlets from two large online dams (Figure 32).

Figure 32: Erosion hotspots on NGAWEST_7 (top) and NGAWEST_5 (bottom) associated with large online dams in the Ngakoroa West sub-catchment.

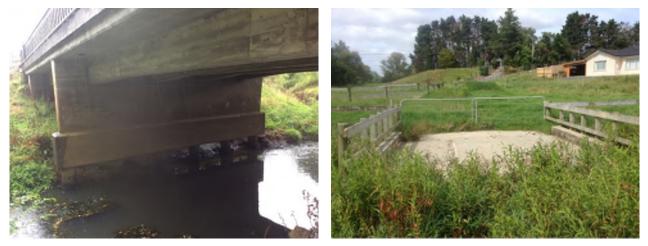
Figure 33: Bridge on Runciman Rd (TRIB9_1) with exposed piles due to scour (left). Bridge on TRIB8b_1 that poses a flooding risk (right).
