# **Milldale Development Infrastructure Project 1 - Argent Lane Extension**

Geotechnical Interpretive Report

30 September 2020

**Document reference:** 402828-MMD-XX-XX-RP-GE-006

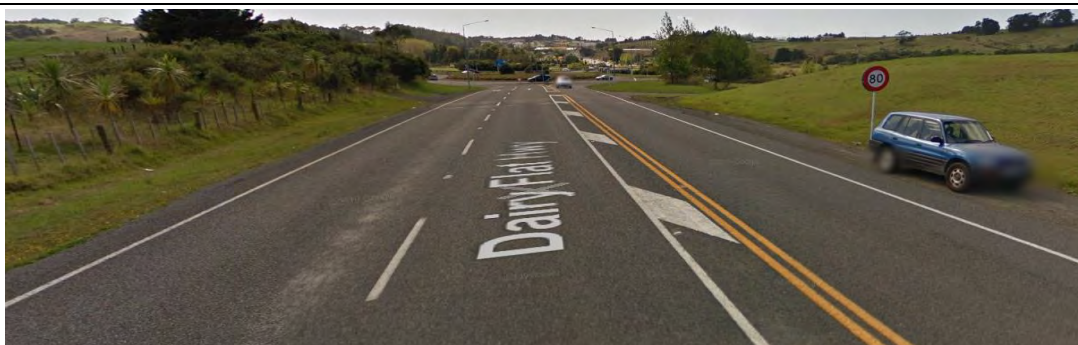
Image 1. DFH widening works looking east

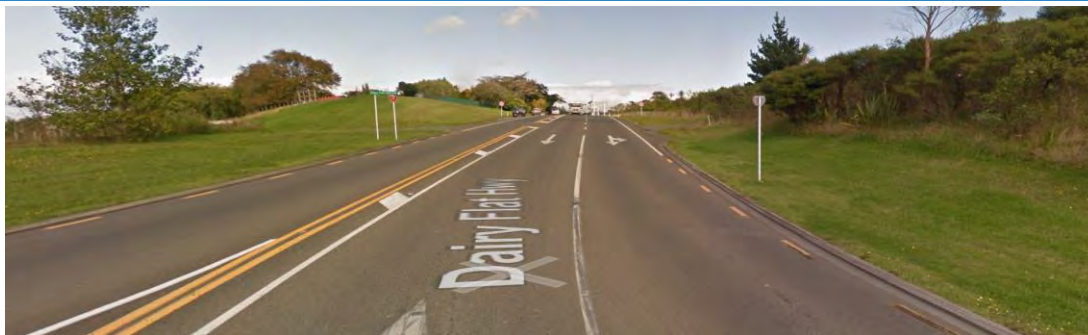
Image 2. DFH widening works looking west

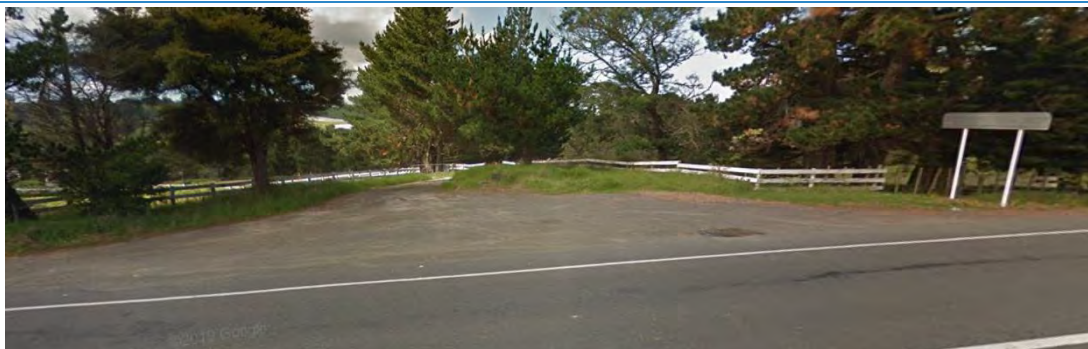
Image 3. Parking bay along side of Dairy Flat Highway.

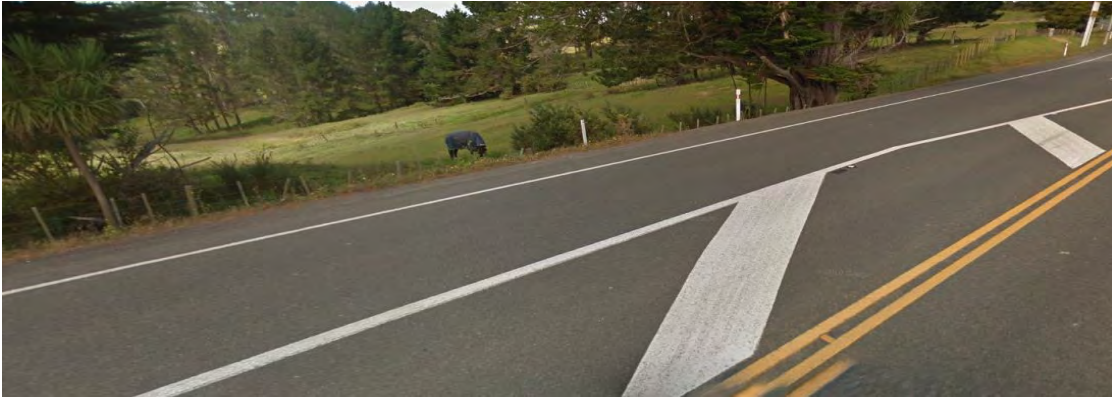
Image 4. Slope beyond the shoulder is 1V:3H into neighbouring property  
Source: Google Earth Street View

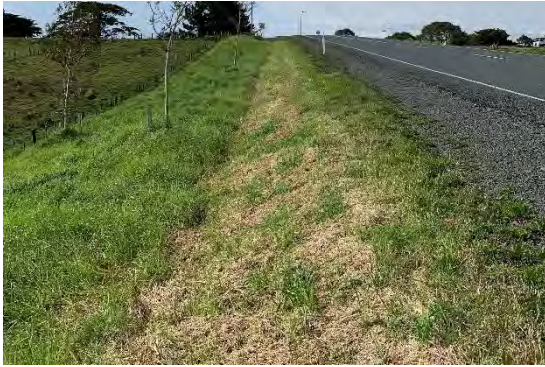
- Western shoulder of PVR, looking south
- General slope gradient of 1V:10H from
- Pavement constructed over fill ground

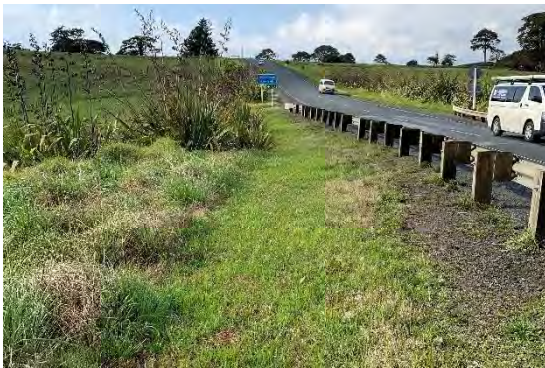
- Slopes up to 1V:2H below the existing pavement were observed near the Dairy Flat Intersection
- 1V:5H slope in most places along either side of the existing road

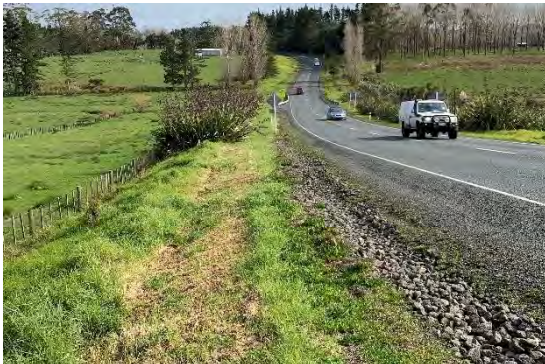
- Eastern shoulder of PVR, looking north
- Pavement constructed over fill ground

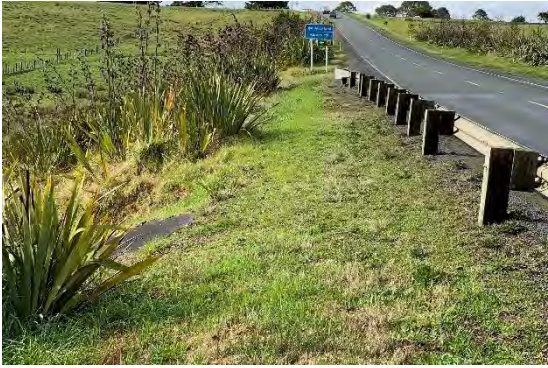
• Eastern shoulder of Pine Valley Road above the culvert

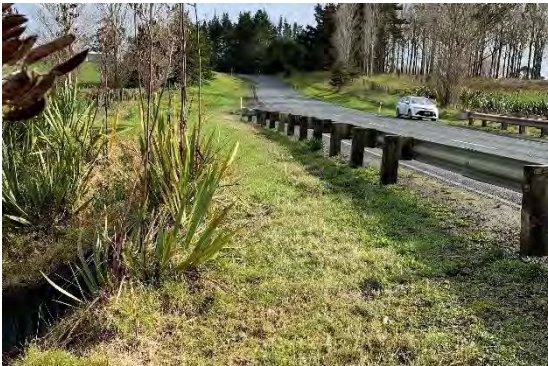
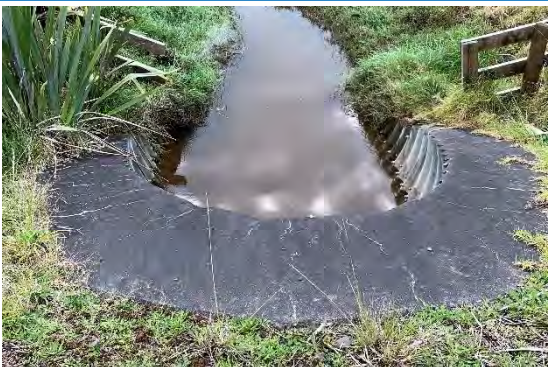
• Western shoulder of Pine Valley Road above the culvert

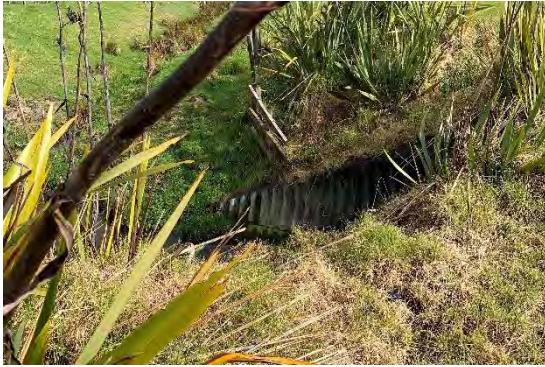
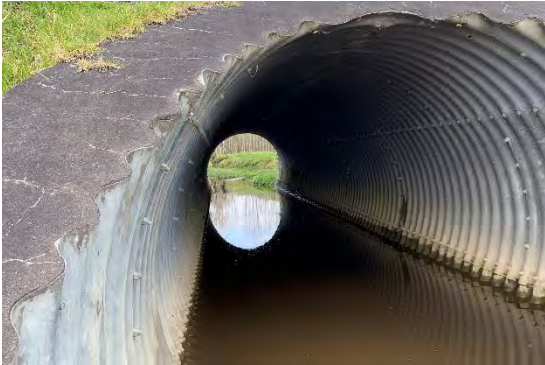
• Culvert internal

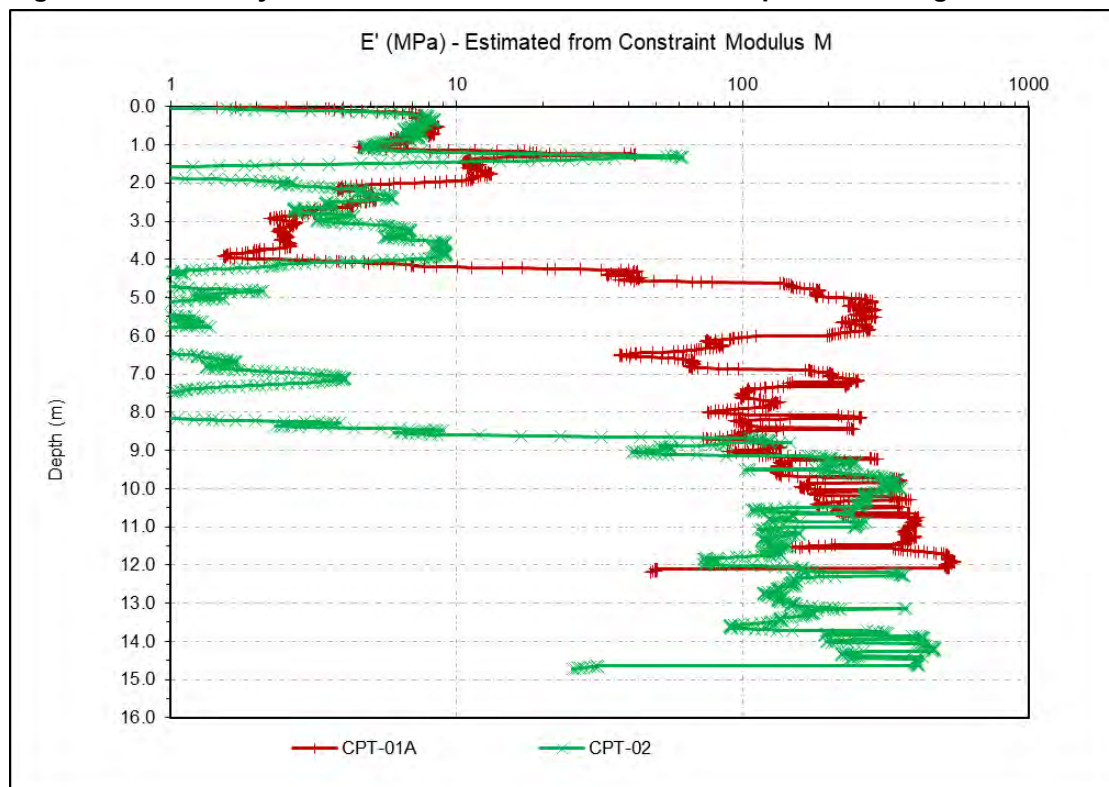
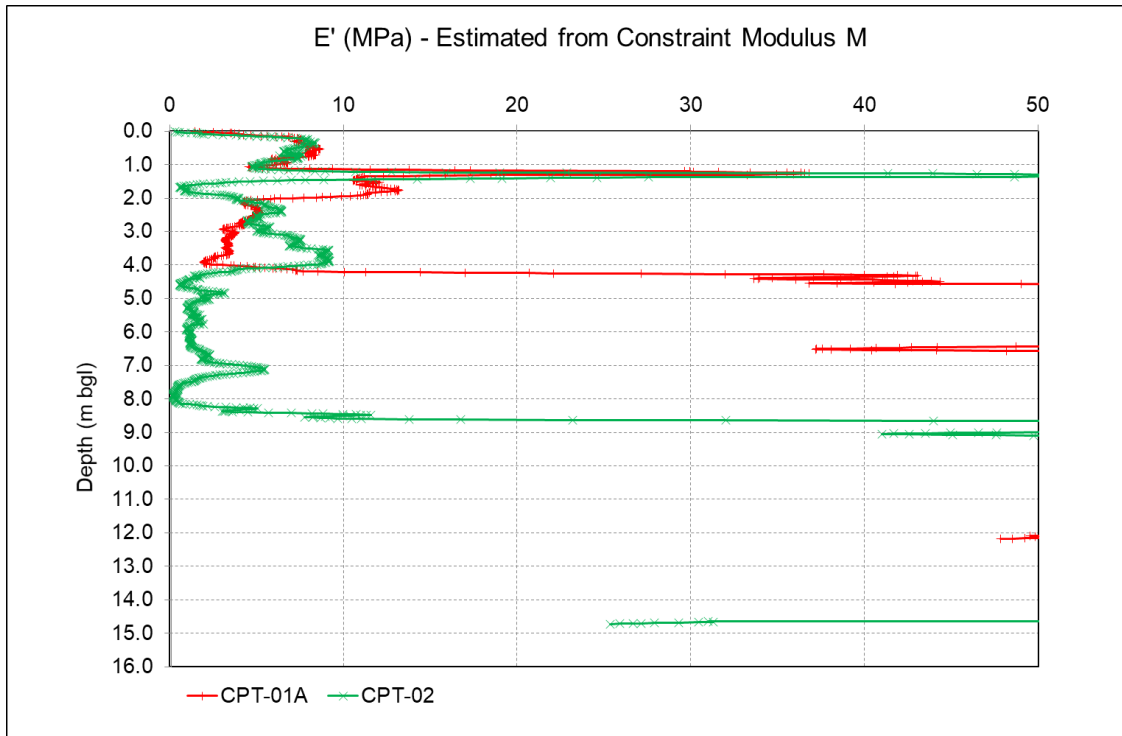
At areas adjacent to the culvert, the CPT data as shown in Figure 6.1 and Figure 6.2 indicates a desiccated crust approximately 1m thick over lower strength alluvial and colluvial soils to between 4 – 8m bgl. The estimated soil modulus values vary between 1.5MPa and 9MPa from 2m bgl to 4m bgl. Larger variance is observed between <1MPa and 290MPa in Young's modulus values within 4m to 8.5m bgl before increasing to between typically 100MPa and 550MPa below 8.5m, which is interpreted to be the surface of the residual soil over the Hukerenui Mudstone.

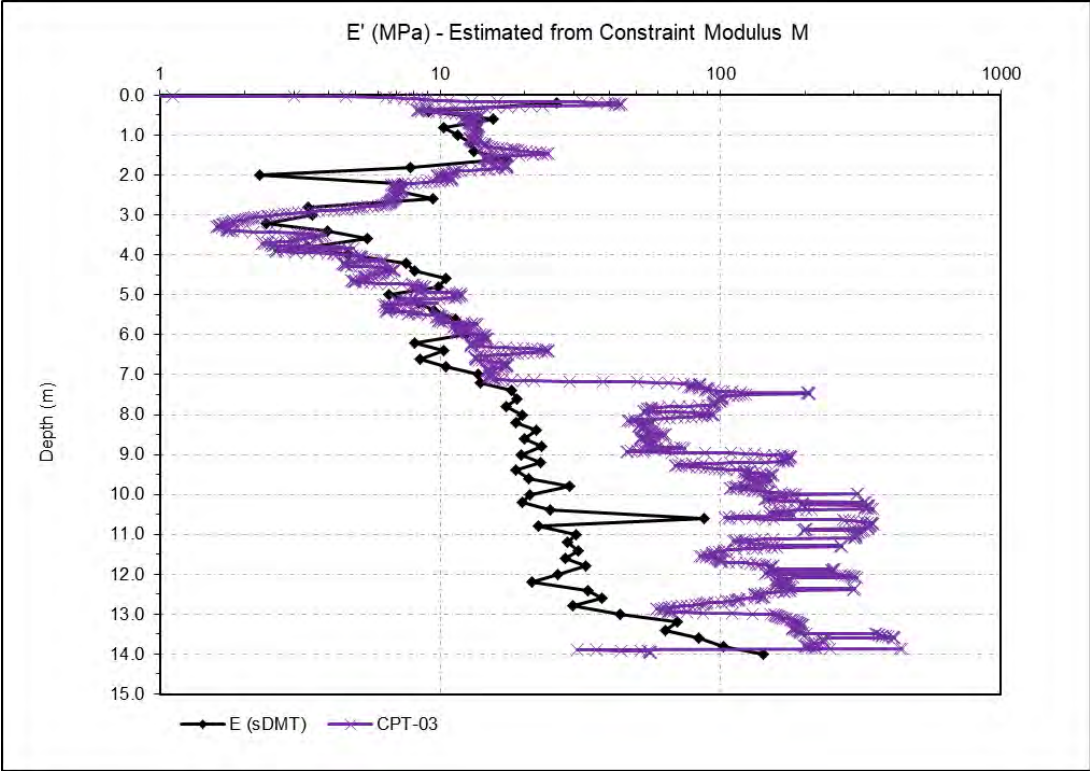
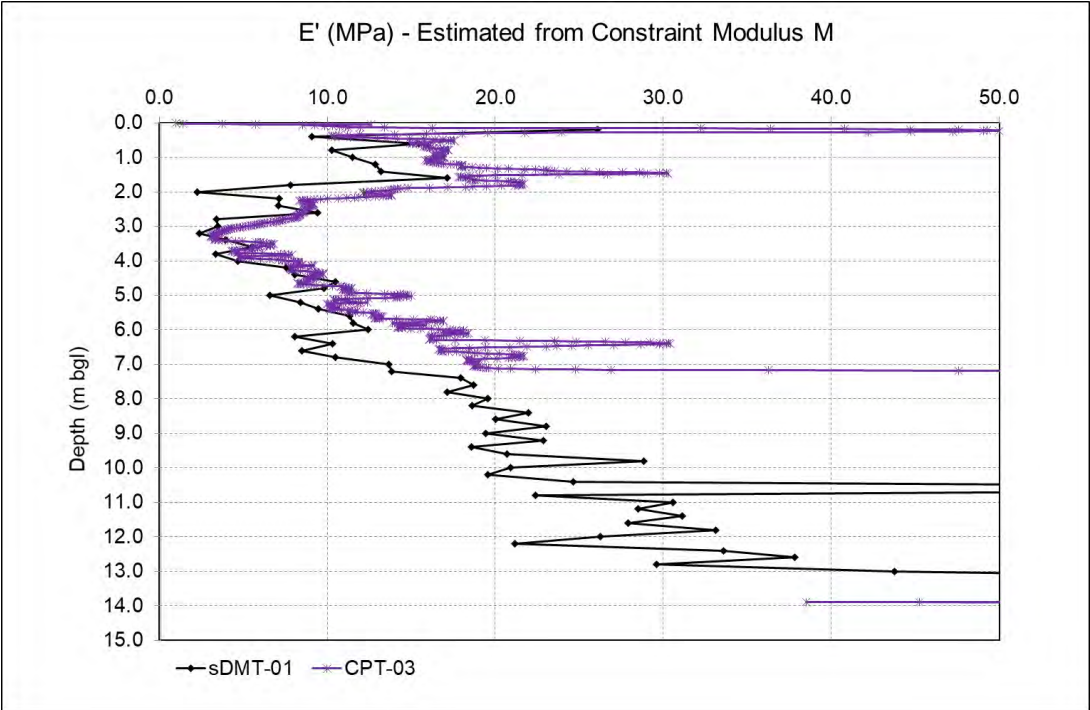
Figure 6.3 and Figure 6.4 show the Young's Modulus values estimated from constrained modulus from both CPT and sDMT data in the vicinity of the existing pond. The data indicates that the site is underlain by a desiccated crust 2m thick over softer alluvial and colluvial soils to approximately 7m.
