To: OsborneHay**Date:** 21 January 2021**Attention:** David Hay**Ref:** 63967**Subject:** Freshwater Ecology Classifications – Warkworth Plan Change Area

Warkworth South Plan Change Area

1711 and 1723 State Highway 1
36, 40, 46 and 126 Valerie Close Road

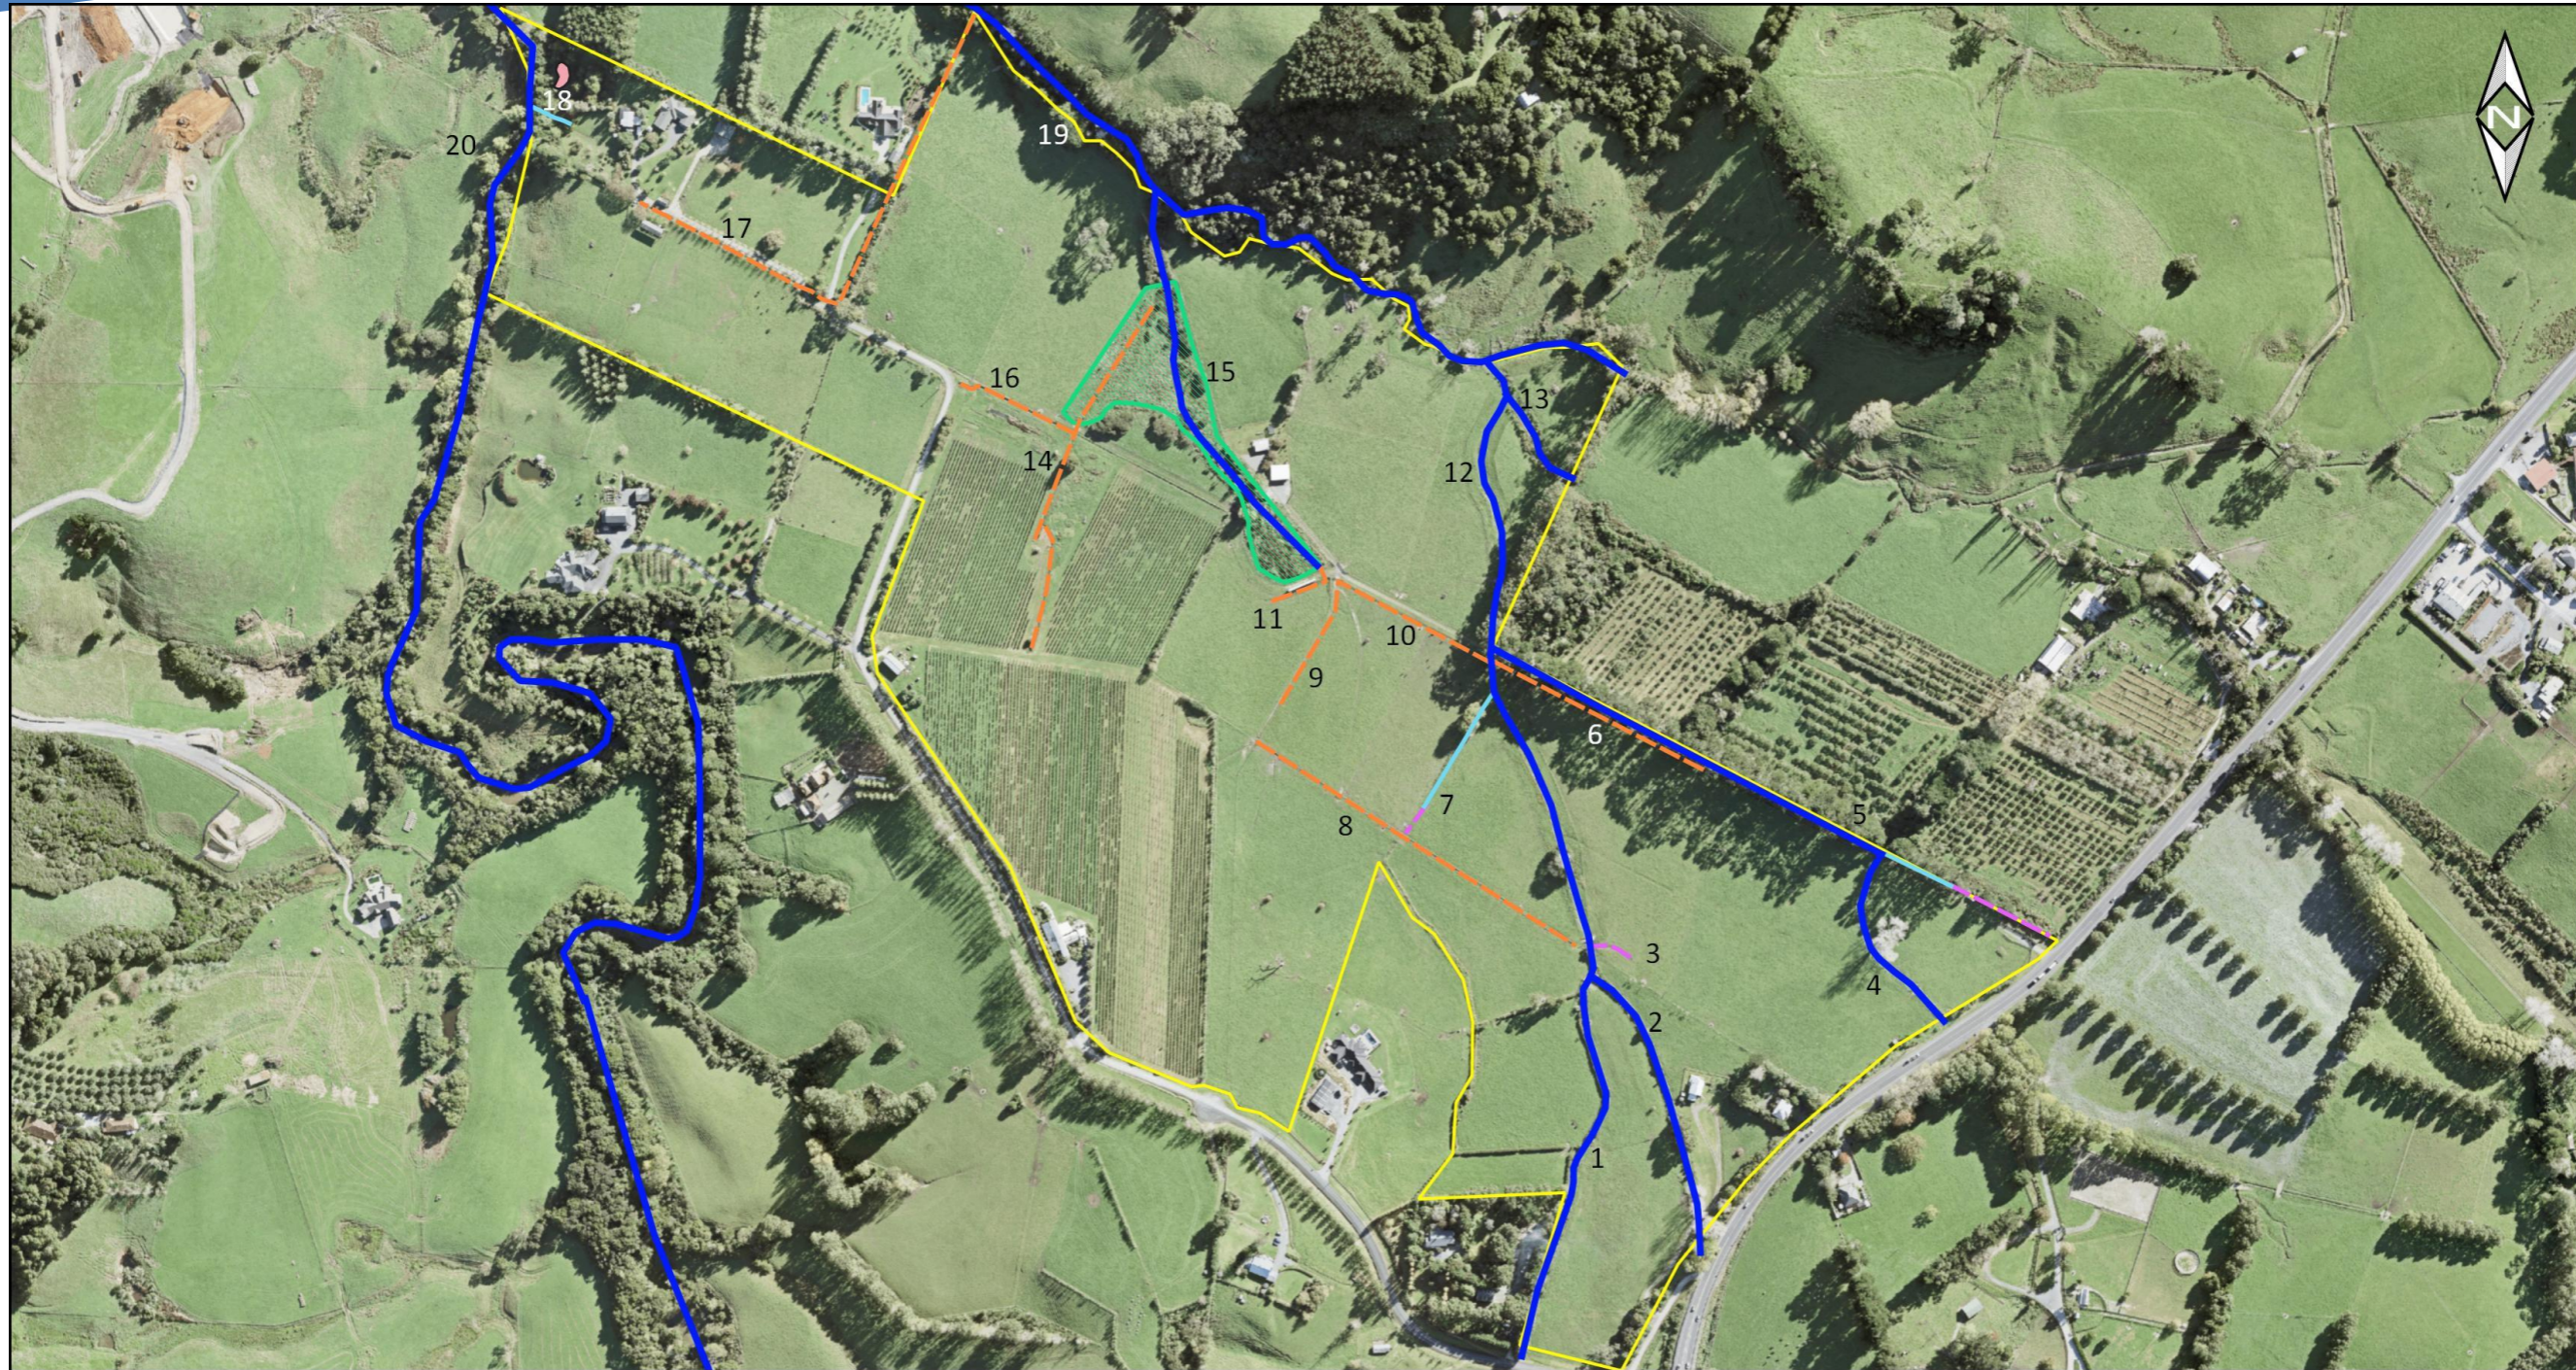
Figure 3. Ground-truthed and classified watercourses within the Warkworth South Plan Change area. Numbers correspond to Watercourse numbers in text and on photographs.

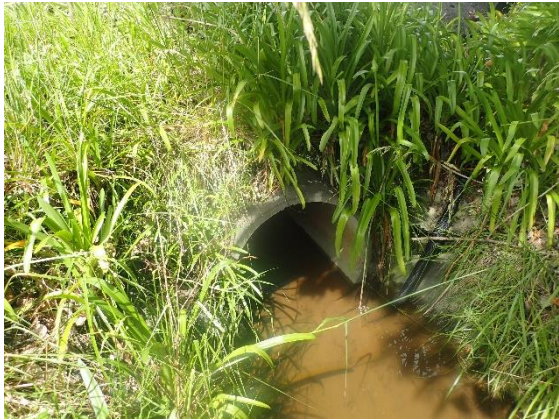
A watercourse was predicted to flow through a southern portion of 1711 State Highway 1 in a south to north direction (Figure 1). Water exited a culvert running under Valerie Close and into a well-defined channel within the site (Photo 1). The culvert was not overhanging, however appeared undersized for the size of the stream and scour was evident immediately downstream of the culvert outlet.

Photo 1. 1 – water entered via a culvert under Valerie Close.

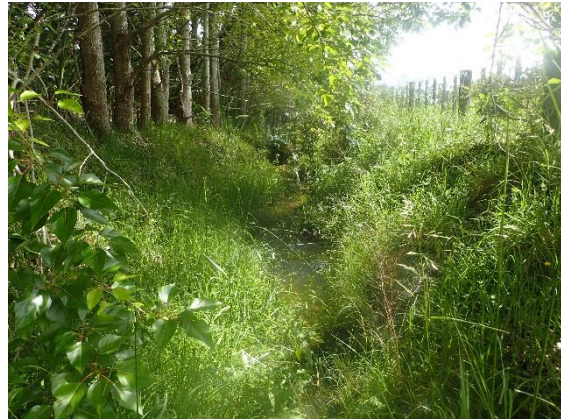
Water was slow-flowing and contained predominantly in deep runs and pools, with shallow runs occasional (Photo 2). The wetted width of the upper reach was 0.5-1.5m wide and the deepest section was 0.38m. Water was present for the entire length of Watercourse 1 and, due to the consistently deep water and large catchment size (14.5ha), the watercourse was classified as a **permanent stream** (Figure 3). The stream was straight and may have been modified (through straightening and deepening) at some point in the last century, however has existed in its current state since at least 1963 (Figures 4 and 5).

Photo 2. 1 – the stream flowed along a straight path through deep runs and pools.

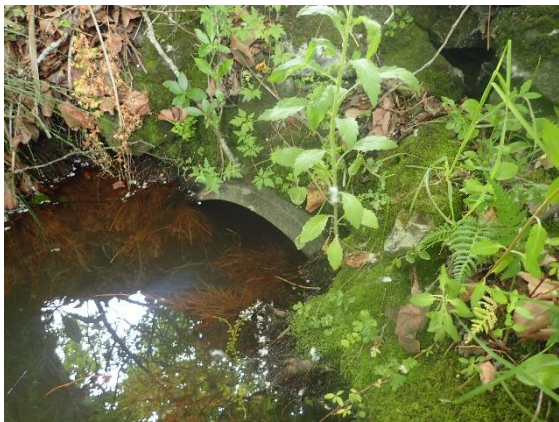
Water exited a pipe on the eastern boundary of 1711 State Highway 1. A very large pool directly downstream of the pipe contained water more than 1m deep (Photos 3 and 4). Water then flowed through a well-defined channel in a south to north direction before joining watercourse 1. Watercourse 2 was classified as a **permanent stream** (Figure 3) due to the presence of deep, continuous flowing water.

Photo 3. 2 – water entered via a culvert under SH1.

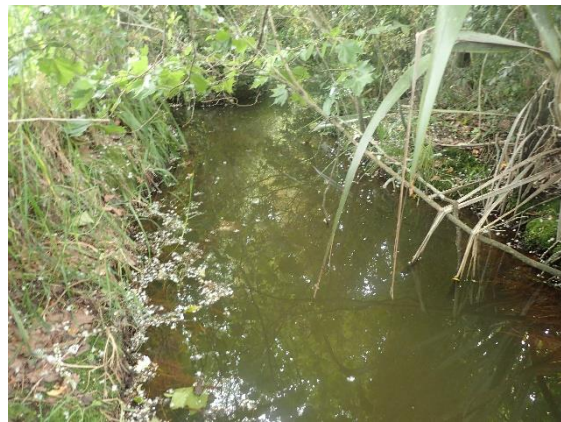
Photo 4. 2 – the stream was very deep near the culvert.

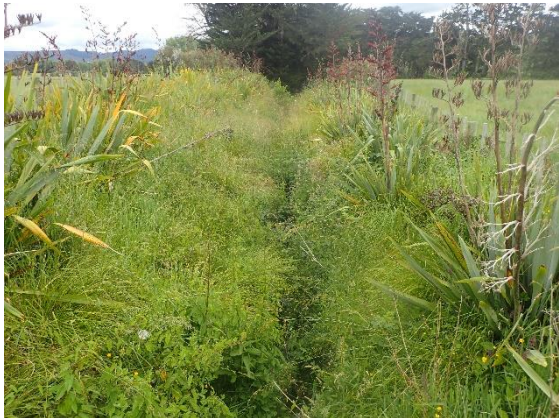
Photo 5. 1 & 2 – after the confluence of the watercourses.

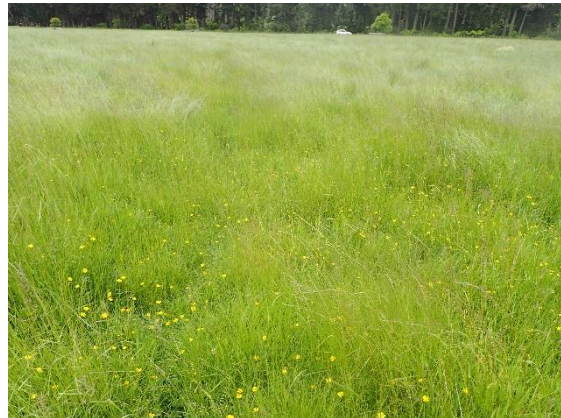
Photo 6. 3 – no stream characteristics in the area.

An overland flow path was indicated to be in the Watercourse 3 area on Auckland Council’s Geomaps. Within the area, there was a small depression however there was no well-defined channel, surface water or aquatic vegetation that would suggest a stream or wetland present in the area (Photo 6). Buttercup (*Ranunculus* sp.) grew occasionally throughout pasture grass within the area. This area was classified as an **ephemeral overland flow path** due to the lack of stream or wetland characteristics.

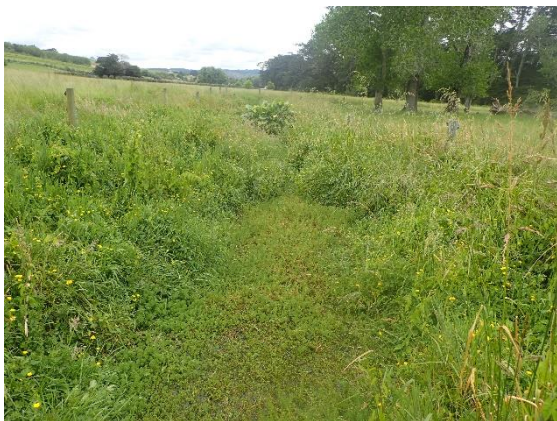
Water entered the site via a pipe under SH1. Water was shallow and the stream was often clogged with macrophytes such as parrot's feather (*Myriophyllum aquaticum*) (Photo 7). Further downstream, the stream narrowed and deeper sections were observed (Photo 8). Water then flowed through a culvert under the driveway and discharged into Watercourse 5. This watercourse was classified as a likely **permanent stream**, due to the continuous flowing water, presence of deeper reaches and large catchment size (approximately 37ha).

Photo 7. 4 – the upper reach was wide and clogged with macrophytes.

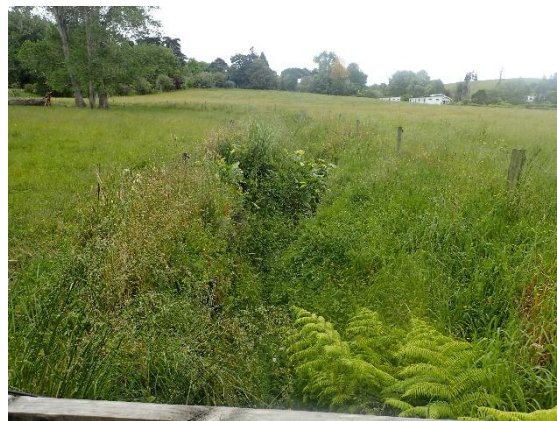
Photo 8. 4 – the lower reach was narrow and incised.

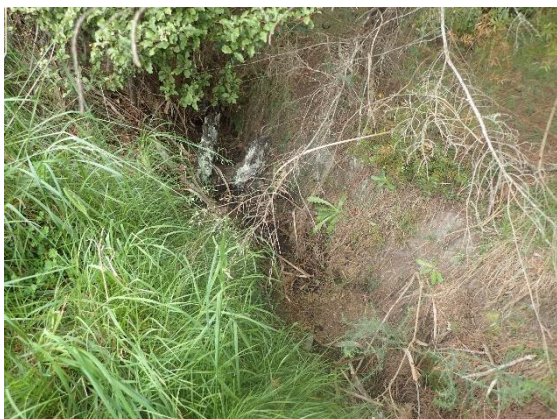
On the northern side of the driveway, a drainage channel had been constructed. The upper portion of this contained very little surface water, however a few still pools were present and there was no terrestrial vegetation growing throughout the channel width (Photo9). Whilst the channel had been clearly constructed, a flow path was likely naturally present through this area and it is expected that water has been diverted to this channel. As such, this upper portion of Watercourse 5 was considered a modified **intermittent stream**. After the confluence with Watercourse 4, water became deep and the channel was much wider (Photo 10). Banks were very steep and had been reinforced in places with wooden boards. From the confluence, the watercourse was classified as a **permanent stream**.

Photo 9. 5 – the upper intermittent reach had r small pools of water

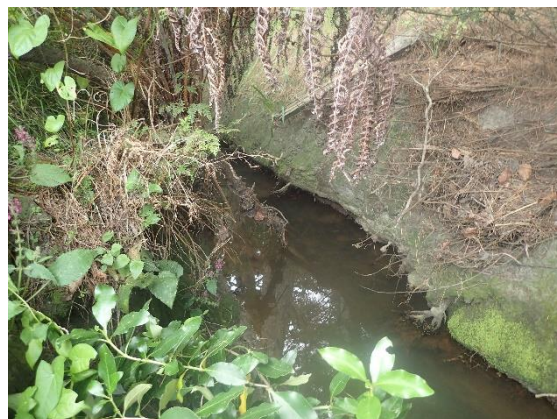
Photo 10. 5 – the lower reach was wide and water was often deep.

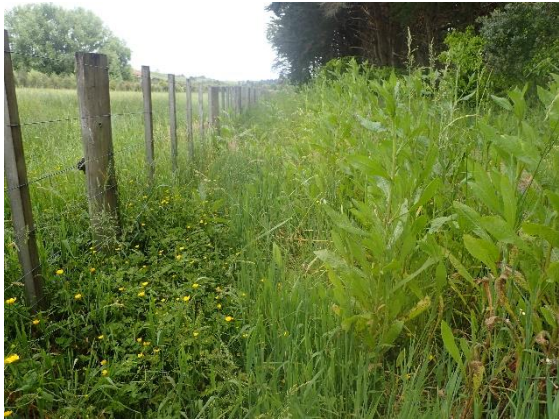
On the southern side of the driveway a second, smaller drain was observed. There was no water within this drain and terrestrial pasture grass was rooted throughout (Photo 11). Further along the western portion of the drain, Yorkshire fog (*Holcus lanatus*) grew within the channel and the base of the drain was slightly boggy. A culvert connected this drain to the larger stream on the northern side of the driveway. This drain was classified as an **artificial watercourse** which has been constructed as a roadside drain to take water from the driveway. There were no natural portions of the drain from its headwaters (no natural intermittent or ephemeral streams fed into the drain) to its confluence.

Photo 11. 6 – ditch on side of driveway

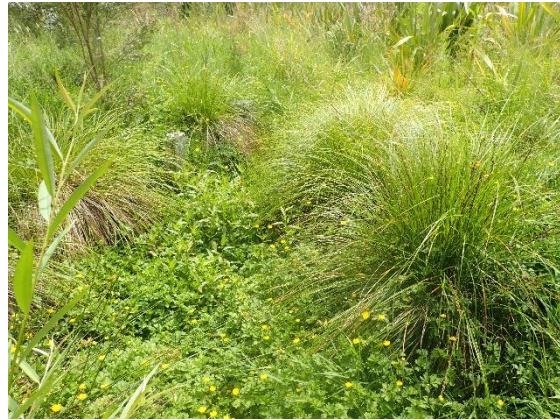
A channel that had flattened banks was present within the Watercourse 7 area, and shallow surface water flowed between deeper pools along its length. Macrophytes such as starwort (*Callitriche stagnalis*), water pepper (*Persicaria hydropiper*) and watercress (*Nasturtium officinale*) often grew within the channel (Photos 12 and 13). The flow path was relatively straight, however did not appear to have been artificially created as it was very shallow (some modification may have occurred through straitening). Watercourse 7 was classified as an **intermittent stream** due to the presence of natural pools, flowing surface water and macrophytes. This transitioned into an **ephemeral overland flow path** within the upper reach, where the channel disappeared and surface water was not present.

Photo 12. 7 – downstream reach clogged with water pepper

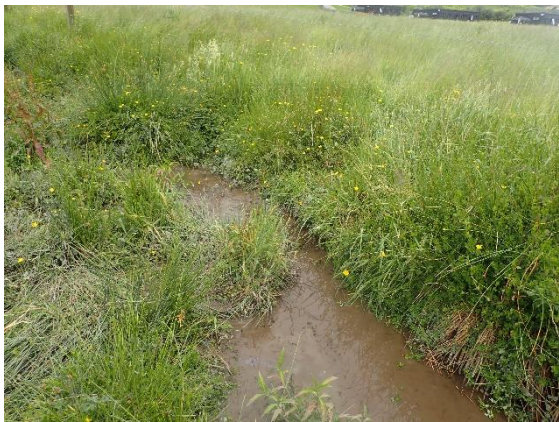
Photo 13. 7 – upstream reach had shallow pools, macrophytes and flowing water

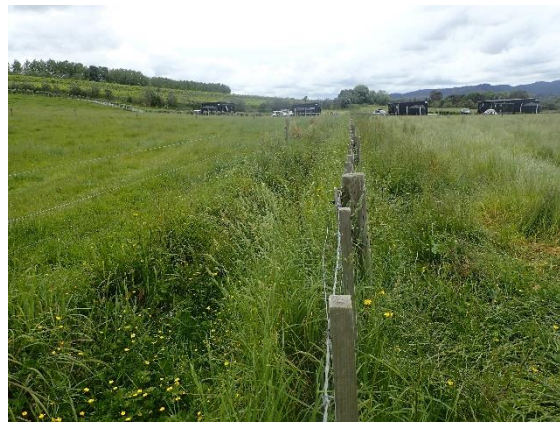
A straight, deep drain had been created, running perpendicular to Watercourse 7 (Photo 14). There was no standing water or boggy ground within the base of the drain and terrestrial pasture vegetation was rooted throughout (Photo 15). Due to the lack of stream characteristics and lack of connectivity to natural watercourses, the drain did not appear to have been a modified natural freshwater system. As such, the drain was classified as an **artificial watercourse**.

Photo 14. 8 – an artificial drain

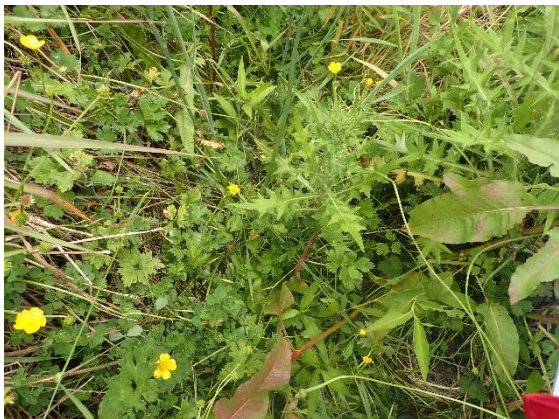
Photo 15. 8 – there was terrestrial vegetation rooted throughout and no water

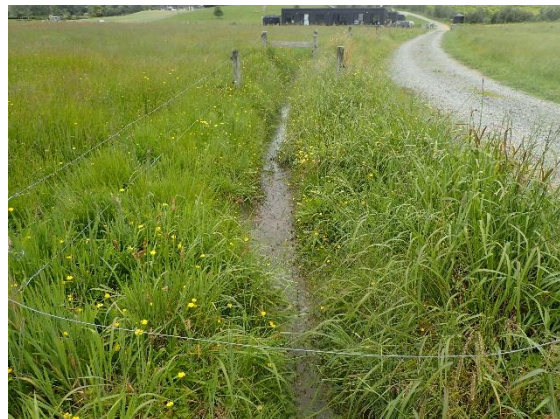
Another straight watercourse was present along the edge of a driveway (Photo 16) (driveway not shown on map). Water entered the drain through a pipe (Photo 18) that appeared to be fed by stormwater from the surrounding area as no pipe inlet or channel was present within the area upstream. Water was present within a small pool, then the channel became dry for approximately 20m, before shallow, flowing water was observed for the rest of the channel length (Photo 17). The watercourse was clearly constructed and the surrounding flat catchment and lack of upstream freshwater habitat suggest that this watercourse was entirely artificial. As such, this watercourse was classified as an **artificial watercourse**.

Photo 16. 9 – an artificial watercourse next to a new driveway.

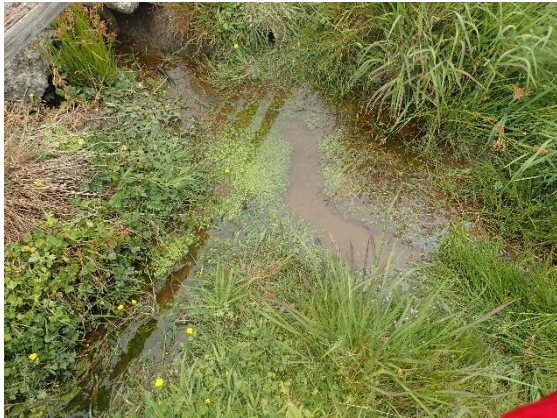
Photo 17. 9 – a pool upstream of a culvert

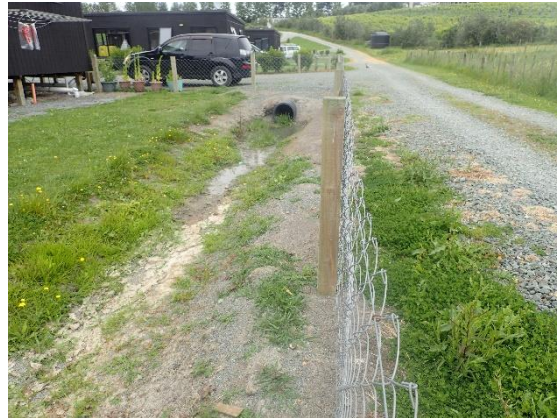
Photo 18. 9 – pipe feeding the partially dry drain

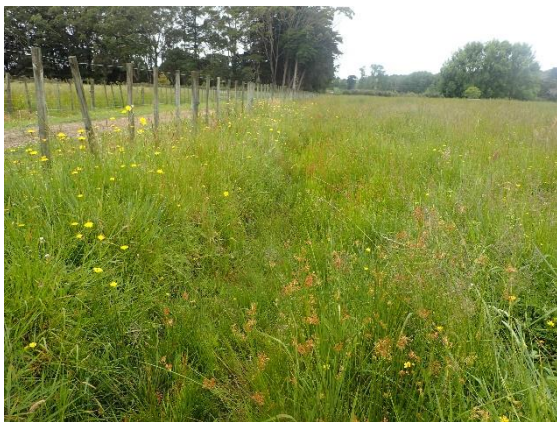
Similar to the Watercourse 6 drain (artificial watercourse), a shallow drain was present along the edge of the farm track/driveway, with shallow water flowing through the base (Photos 19 and 20). Soft rush (*Juncus effusus*) grew along the edge of the drain. This watercourse had been constructed, did not appear to have natural headwaters and did not flow along a path that would be expected to have historically have a natural stream. Furthermore, historic aerial images do not show any signs of a flow path through this area. Watercourse 10 was classified as an **artificial watercourse**.

Photo 19. 10 – drainage channel adjacent to the farm track flowing opposite to contours

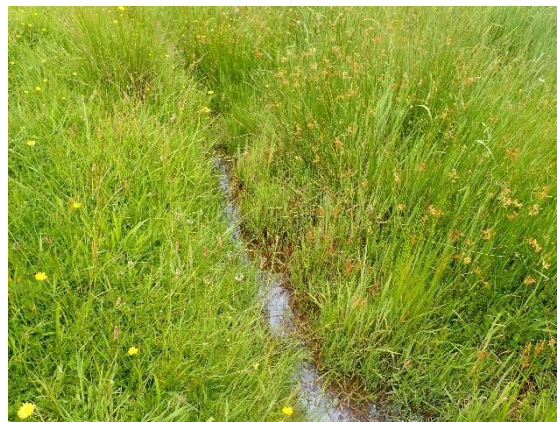
Photo 20. 10 – standing water present in some areas

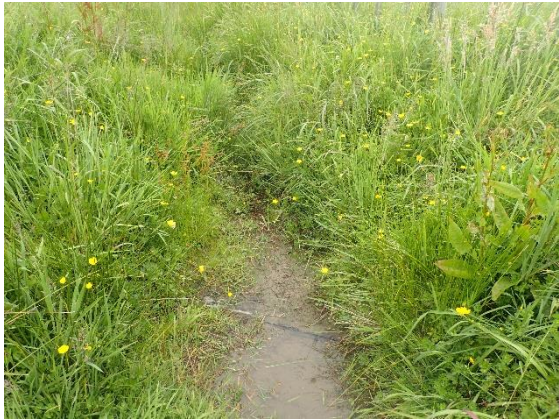
A small, natural headwater tributary was present flowing toward the wetland area (see Watercourse 15). There was a well-defined channel (Photo 22), boggy ground (small puddles of surface water) (Photo 21), and aquatic vegetation growing within the base of the channel. Watercourse 11 then joined Watercourses 9 and 10 which flowed into the wetland. Watercourse 11 was classified as an **intermittent stream**.

Photo 21. 11 – a short intermittent stream had patches of standing water

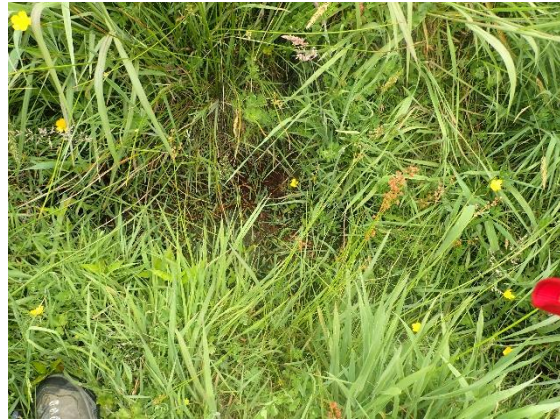
Photo 22. 11 – a well-defined channel overgrown with vegetation; mercer grass throughout

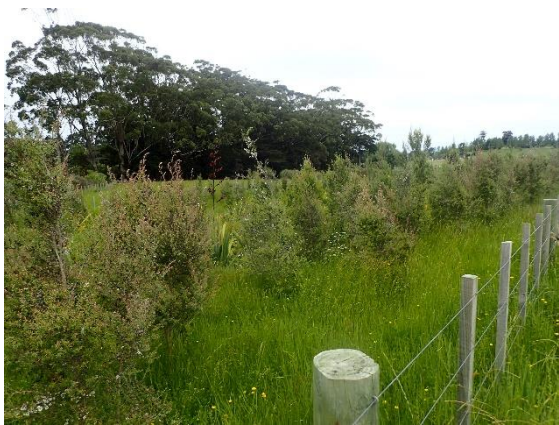
After the confluence of Watercourses 1,5 and 7, a deep channel containing water flowed in a south to north direction (Photo 24). This reach was classified as a **permanent stream** due to the presence of continuous flowing water and large catchment size. The stream had been fenced from stock and regenerating native planting was present within the 10m riparian yard (Photo 23).

Photo 23. 12 – riparian planting and fencing

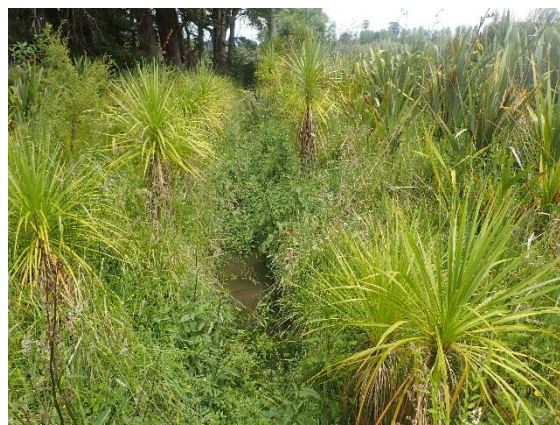
Photo 24. 12 – the stream was deep and overgrown

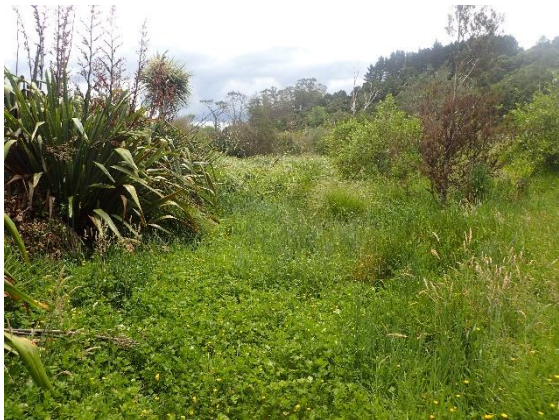
Water entered the site through a well-defined channel and flowed to the confluence of Watercourse 12. The watercourse had been fenced and the riparian yard was planted with native vegetation (Photo 25). Upstream of the site, the watercourse narrowed and was overgrown with vegetation (Photo 26). This watercourse was classified as a likely **permanent stream** due to the well-defined channel, flowing water and large catchment size.

Photo 25. 13 – water beneath overgrown buttercup

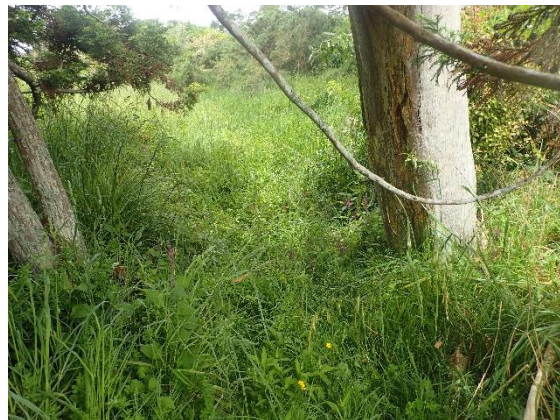
Photo 26. 13 – shallow water upstream of site

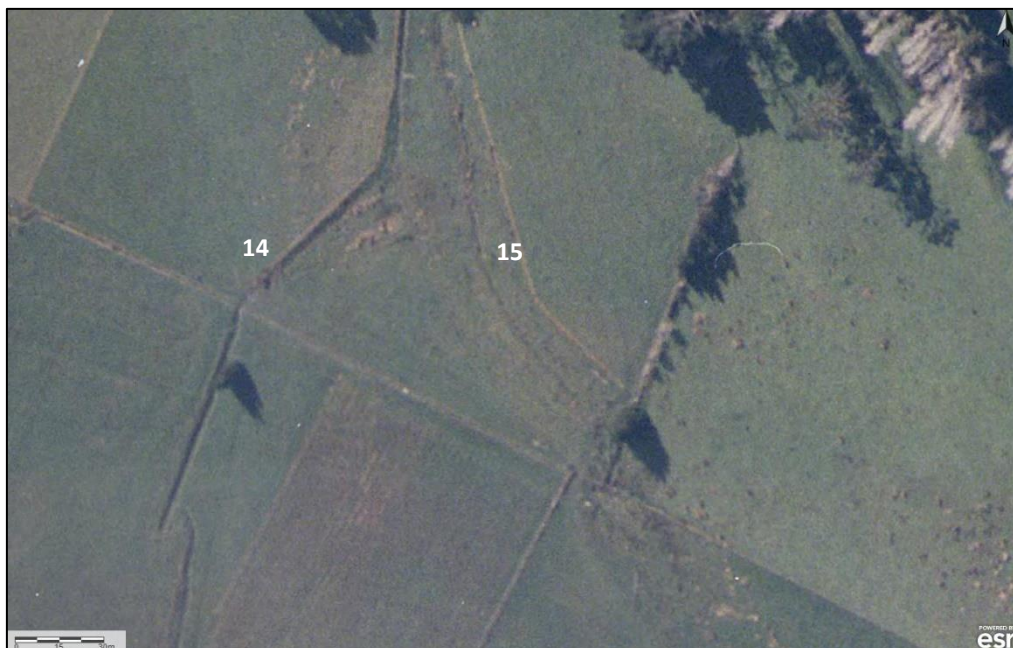
The western channel running through the area was considered a continuation of drain 14, an **artificial watercourse**. On historical aerials, it is clear the straight, deep channels have been constructed and do not appear to form part of a natural system, with no natural headwaters observed along its length.

The eastern channel is fed by three drains (9, 10 and 11). This watercourse appeared to have a small meander and contours show that this flow path is the low point of the surrounding area, suggesting water flow through here may be natural. Whilst there appeared to have been some straightening and/or deepening of the channel, the meander, contours and large catchment (approx. 5ha) suggest a natural flow path was likely present through this area prior to anthropogenic modification. As such, this watercourse was classified as a **modified permanent stream**. Water from these channels flow into a man-made pond (Photo 30), then into a narrow, well-defined channel (Photo 31). Below the constructed wetland, the narrow, well-defined watercourse was considered a continuation of the **permanent stream**. The banks and riparian yard of this channel consisted of predominantly terrestrial vegetation.

Figure 6. *Historical aerial image from 2001, showing the constructed western drain (14) and the potentially modified eastern stream (15). The wetland vegetation growing throughout the area currently, was not present in 2001. Image from Auckland Council's Geomaps.*

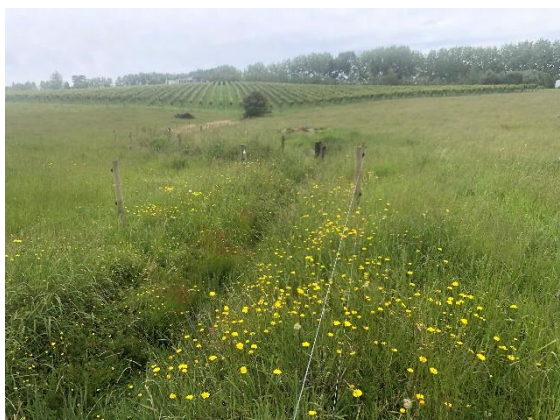
A large depression at the edge of a vineyard block marked the upper extent of Watercourse 4. A well-defined channel that lacked terrestrial vegetation within the base was present, with water occasionally observed in pools (Photo 27). Aquatic vegetation was also common within the base of the channel and scour and deposition was present within the few meanders along the watercourse. The watercourse was completely straight and very deep and did not appear to have any natural features along its length. Watercourse 14 was classified as an **artificial watercourse**.

Photo 27. 14 – the watercourse was straight and deep

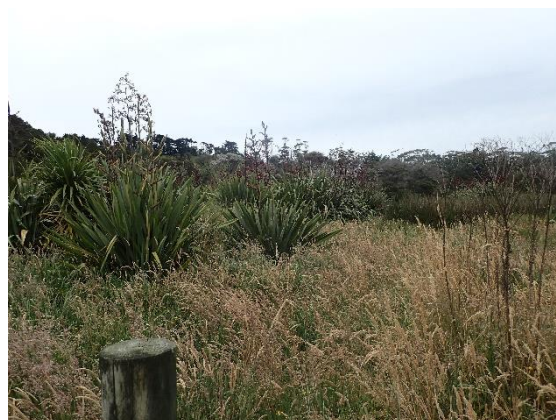
A number of watercourses flow into deep channels within a fenced area dominated by a variety of wetland vegetation (Photo 28). Some of this appeared planted, while other areas (predominantly exotic vegetation) appeared to have established naturally. Vegetation included carex (*Carex* spp.), kahikatea (*Dacrycarpus dacrydioides*), flax (*Phormium tenax*), pampas grass (*Cortaderia selloana*), Yorkshire fog (*Holcus lanatus*), giant rush (*Juncus pallidus*), broom rush (*Juncus sarophorus*), water pepper (*Persicaria hydropiper*) and crack willow (*Salix fragilis*) (Photo 29). Very few upland or facultative upland plant species were observed and the percent cover of terrestrial vegetation was less than approximately 10-20% (formal delineation was not undertaken).

Discussions with the landowner have revealed that the area containing wetland vegetation historically consisted of two watercourses running through dry pasture. Approximately 15 years ago, he fenced the area and dammed these watercourses in order to slow the flow of water. He then planted wetland vegetation throughout the area. The purpose of damming this water and planting the vegetation was to create a wetland (pers. comms.). Historical aerial images also show that the wetland vegetation currently growing throughout the area was not present in 2001 (Figure 6). As the wetland has been purposefully constructed by artificial means, the area was not considered a natural wetland and was classified as a **constructed wetland**.

Photo 28. 15 – wetland vegetation grew throughout

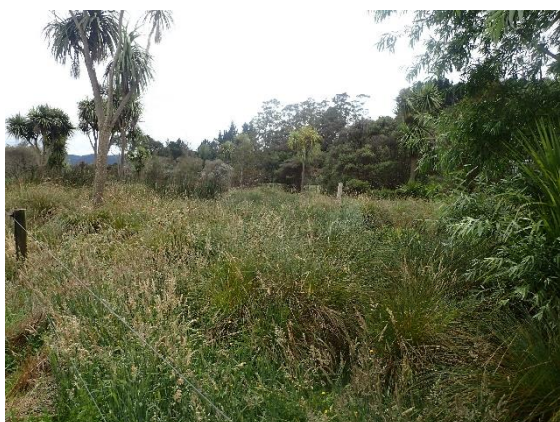
Photo 29. 15 – the wetland vegetation included natives such as kahikatea

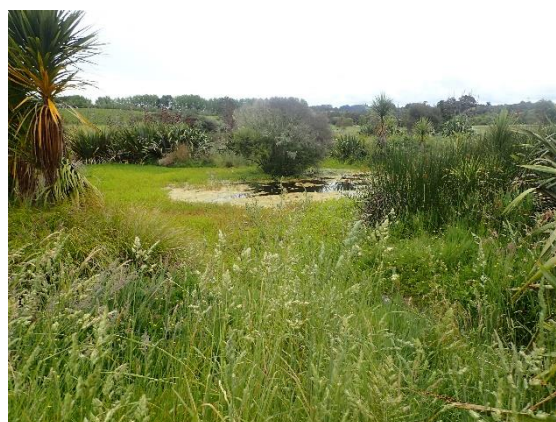
Photo 30. 15 – a pond at the downstream end of the constructed wetland

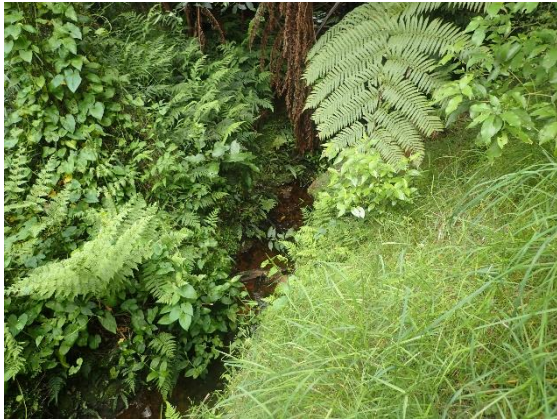
Photo 31. 15 – the stream reach below the constructed wetland had steep, incised banks

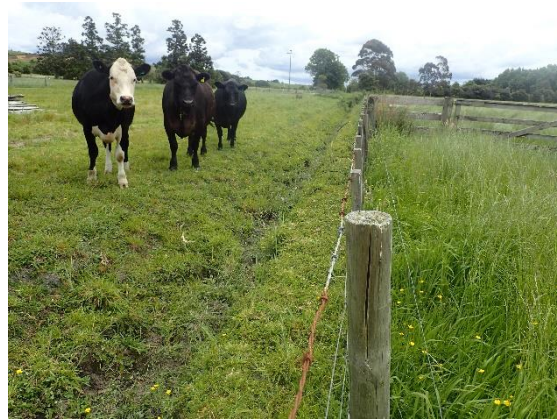
Photo 32. 16 – a shallow drain with grass growing through it

A shallow drain had been constructed along the edge of the farm track (Photo 32). This did not contain water, was ill-defined and terrestrial pasture grass was rooted throughout. This area was classified as an **artificial watercourse**.

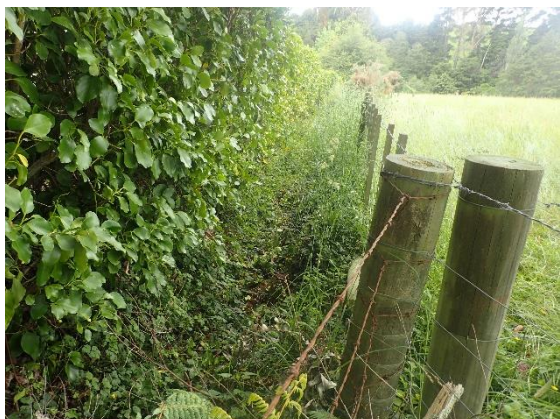
Another shallow drain was present along the edge of a driveway in the north-west corner of the site (Photo 33). This did not contain water for its entire length and had been clearly constructed (Photos 34 and 35). The lack of water suggests that no natural flow path was historically present through the area that may have been modified. As such, Watercourse 17 was classified as an **artificial watercourse**.

Photo 33. 17 – lower section of drain completely dry and straight suggesting artificial nature

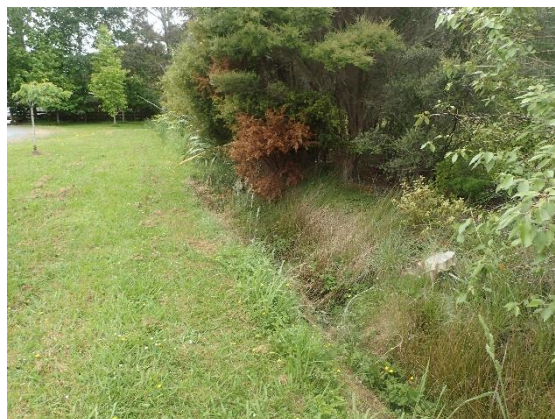
Photo 34. 17 – mid-section of drain dry; grass and some exotic rushes grew throughout

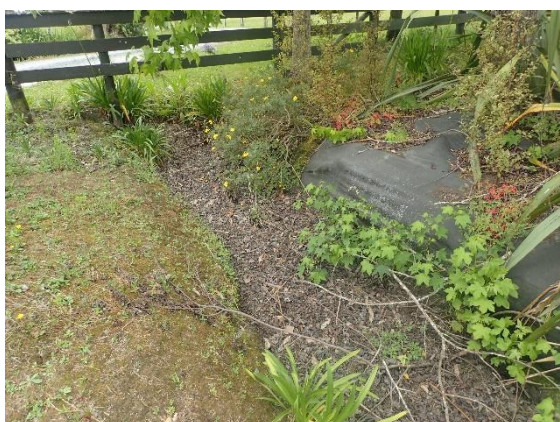
Photo 35. 17 – upper section dry, under shade there was no terrestrial (or aquatic) vegetation

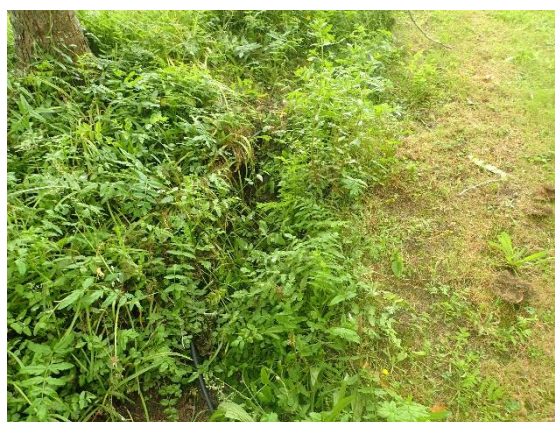
A well-defined channel containing a large amount of water celery (*Apium nodiflorum*) was observed within the backyard of a property in the north-west corner of the site (Photo 36). There was no water within the channel, however the presence of a macrophyte rooted throughout suggests that this flow path contains water frequently. The channel joined the Mahurangi River at the western site boundary. Historic aerial images also show a natural flow path within the vicinity of Watercourse 18. The upper reaches of this appear to have been piped/reclaimed with just the current short downstream section left. Due to the well-defined channel, presence of macrophytes and evidence of a natural flow path, Watercourse 18 was considered an **intermittent stream**.

Photo 36. 18 – small stream containing water celery near western boundary

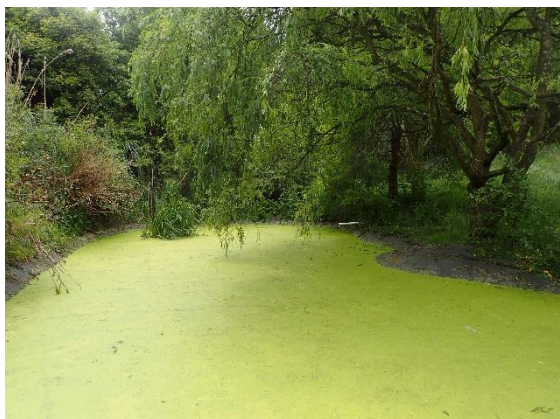
A large man-made pond was also present to the north of Watercourse 18 (Photo 37). This pond was lined with concrete/tiles and a pipe was present at its upper end. There was not natural inlet or outlet observed around the edges of the pond. This was considered an **offline, manmade pond** and not a natural freshwater feature.

Photo 37. 18 – an off-line artificial pond was located in the area

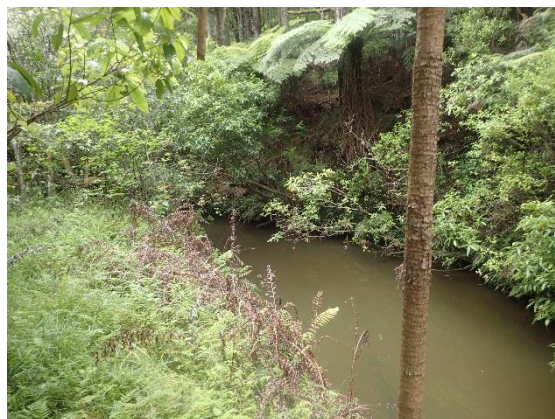
A large river flowed along the northern boundary of the site (Photo 38). This **permanent river** is the receiving waters of Watercourses 1-17 on site and is a tributary of the Mahurangi River.

Photo 38. 19 – the large river running along the northern boundary is a tributary of the Mahurangi River (right branch)
