# 278 CLEVEDON-KAWAKAWA ROAD

Prepared for Stratford Properties Ltd

Preliminary Site Investigation

April 2020

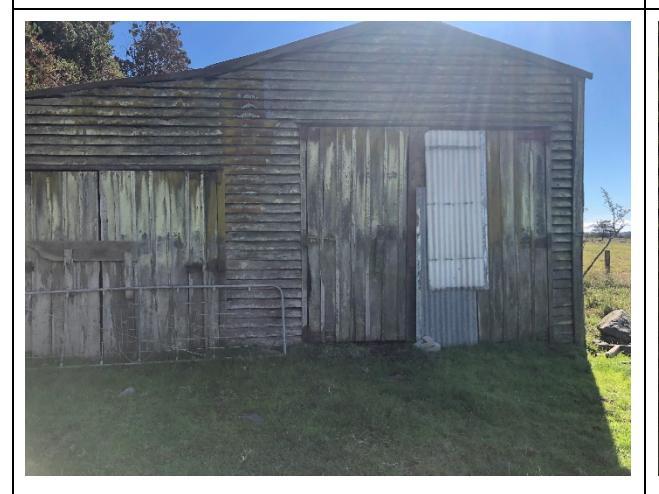
- A single shed, constructed of corrugated iron and timber, in the north-western portion of site adjacent to the site's western boundary. Adjacent to the eastern and western sides of this building are miscellaneous materials, including disused concrete, a single steel farm gate and a rusted drum/pipe;

Photo 9: Shed constructed of corrugated iron and timber building materials in north-western portion of the site. Photo taken facing north.

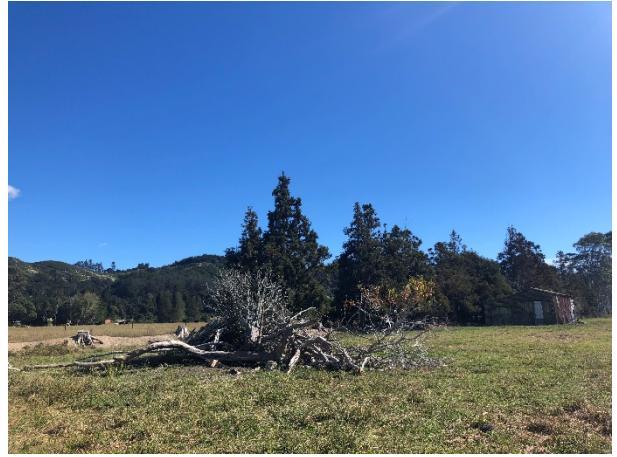
- A number of tree branches are piled in the centre of the paddock in the north-western portion of the site, adjacent to the western boundary. No evidence of previous burning activities was observed;

Photo 8: Pile of branches in north-western portion of the site. Photo taken facing north west.

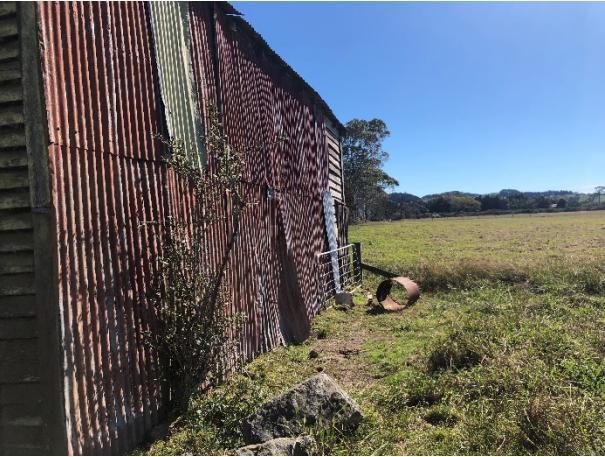
Photo 10: Eastern side of shed pictured in Photo 9. Disused concrete, steel farm gate and rusted drum/pipe present. Photo taken facing north.

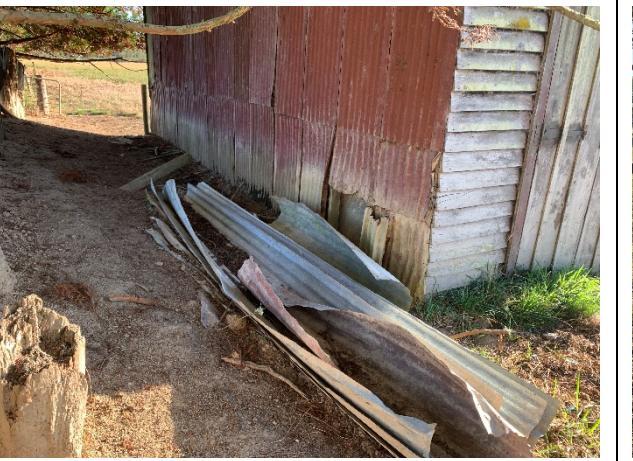
Photo 11: Corrugated iron at the eastern exterior of the shed pictured in Photo 9.

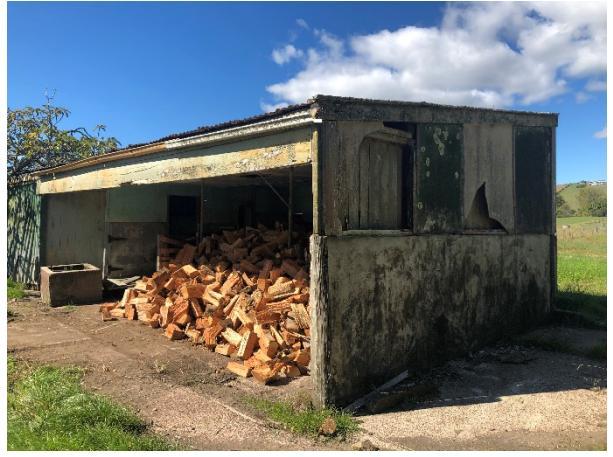
Photo 13: Stacked hay bales, small corrugated iron shed and white barn directly west of the site. Fence line represents western boundary of the site. Photo taken facing south west. Photo 14: Shed in south western portion of site adjacent to current accessway. Cladding of building is constructed of potential ACM. Photo taken facing south east.

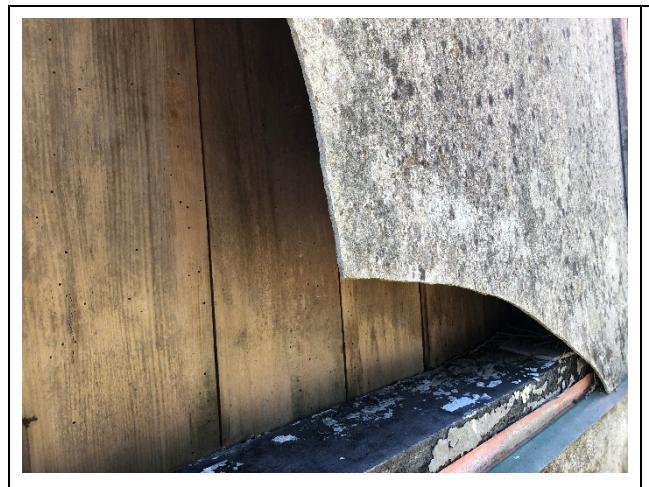
- A three walled, open shed directly south of the shed mentioned above, currently being used to store firewood. The shed has a corrugated iron roof and is otherwise constructed of timber with some potential asbestos containing material (ACM) cladding on the eastern and western exteriors of the building. Sections of the potential ACM cladding on the western exterior of the building are broken. The building rests on a concrete slab which also extends to the north and west of the building. Adjacent to the southern side of the building are pieces of disused corrugated iron, timber and fencing wire;

Photo 19: Close up of exterior of building in southwestern portion of the site, showing potential ACM.

- There is the potential for asbestos in shallow soils associated with the use of asbestos containing building materials in buildings at the site, outside of the Piece of Land. The NESCS is not applicable to the remainder of the site, outside of the Piece of Land, as long as it continues to be in use as production land. However, should removal of this building be required, an asbestos survey of the building should be undertaken and, should ACM be confirmed, the removal/demolition should be managed in accordance with the Health and Safety at Work (Asbestos) Regulations 2016, and the WorkSafe New Zealand Approved Code of Practice for the Management and Removal of Asbestos.

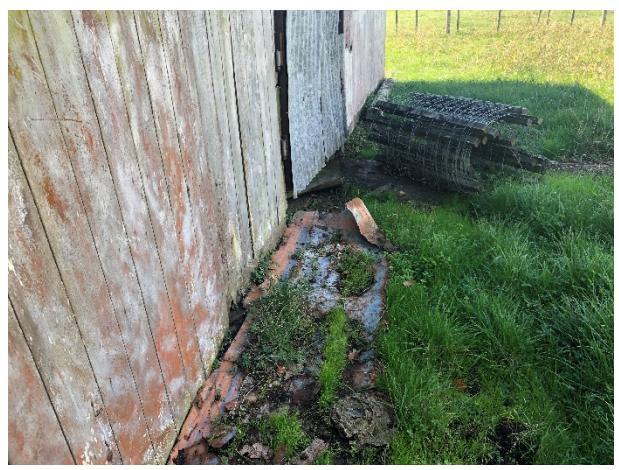
Photo 20: Disused corrugated iron, timber and wire adjacent to southern side of building constructed of potential ACM, as pictured in Photo 12.

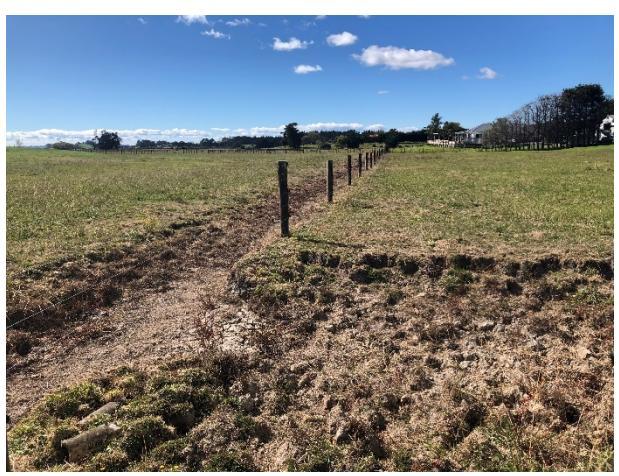
Photo 24: Dug out channel in southern portion of the site. Photo taken facing east.

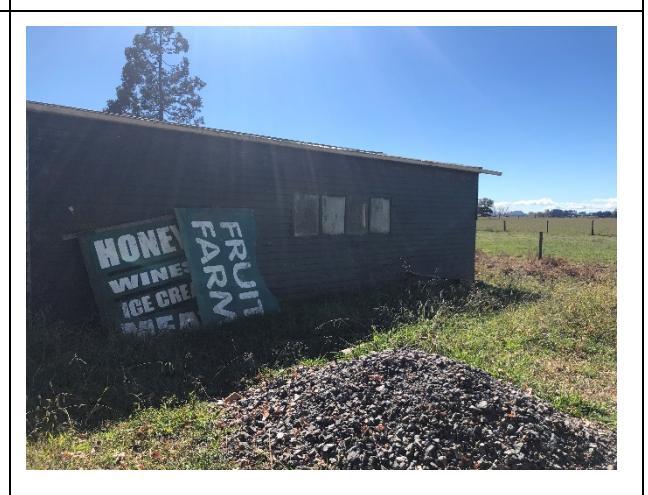
Photo 33: Green steel shed/disused pipes in the western portion of the site, south east of the large white barn. Photo taken facing west.

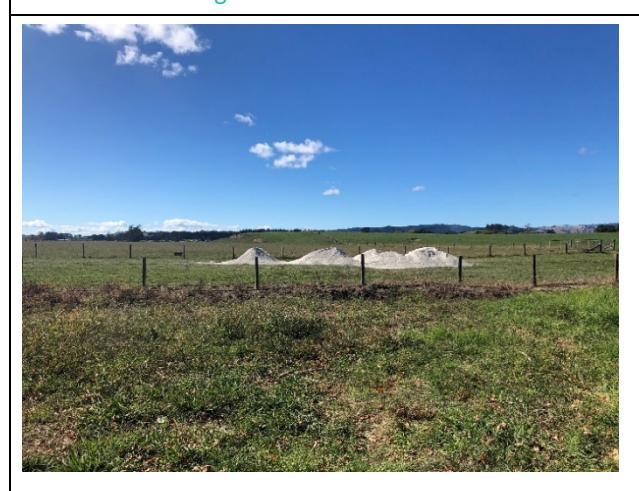
Photo 35: Covered mounds in western portion of the site, contents of which are bulk lime (as confirmed by the landowner). Photo taken facing east.

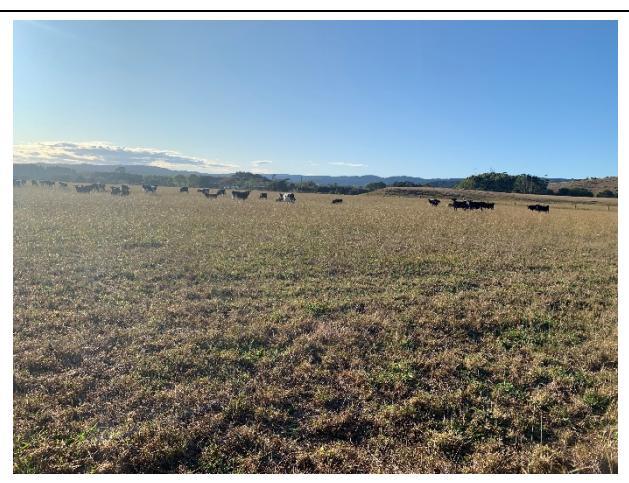
Photo 36: Distant view towards area of former mounds, taken during secondary site visit. No mounds were observed and no impact to surface soils was observed.
