# Geotechnical Assessment

48 Esmonde Road, Takapuna

Prepared for  
Kingstone Ltd

Prepared by  
Tonkin & Taylor Ltd

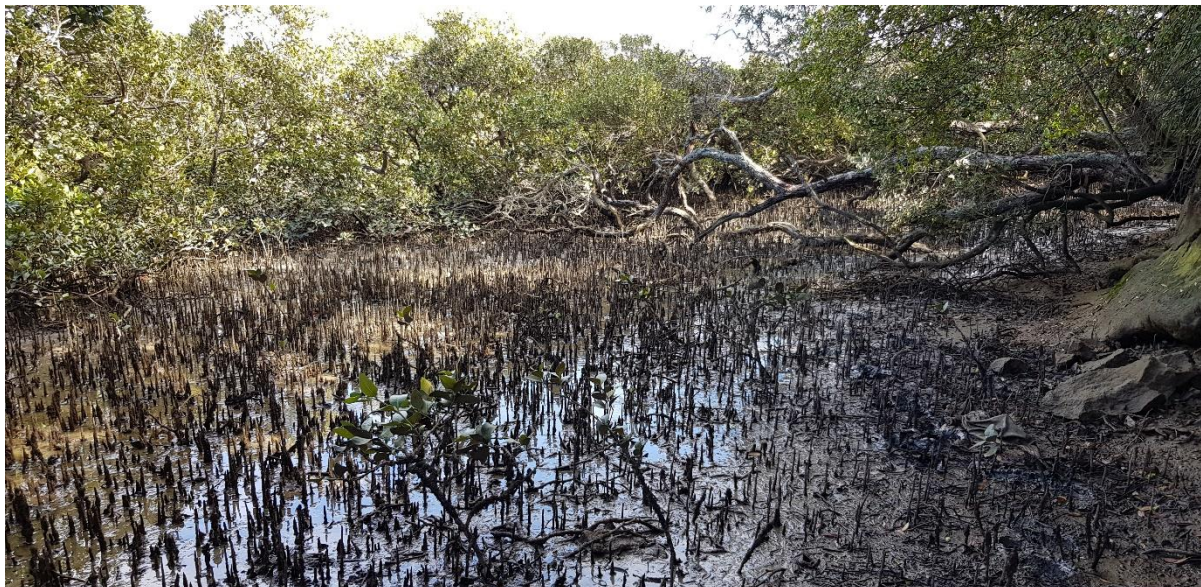
There is evidence of shallow land slippage as a process in forming the edges of the site, but we could find no geomorphic evidence of any past large-scale instability or any actual or incipient rock mass failure.

Photo 4-1. Mangrove vegetation and rock exposure at base of cliff at 48 Esmonde Road

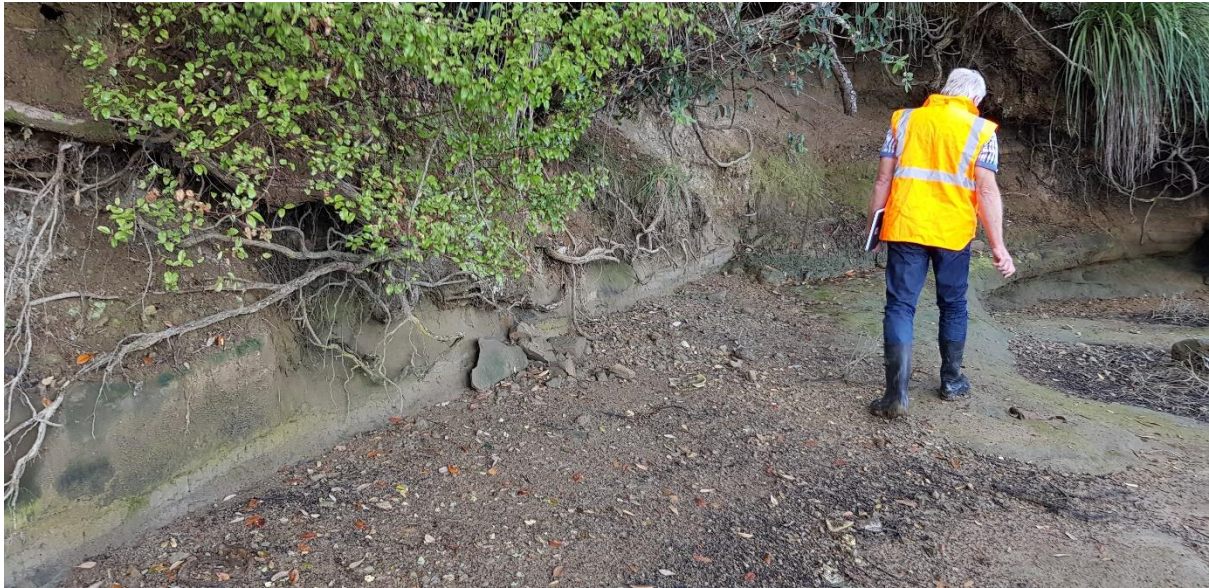
Exposures in the intertidal area surrounding the site and at the base of the low coastal cliffs during our walk over reconnaissance confirmed that the site is underlain by interbedded siltstone and sandstone of the East Coast Bays Formation. The bedding in the exposures is sub-horizontal or dipping at a very shallow angle (less than 5 degrees) to the west north-west. This is essentially the same as that observed in the coastal cliff exposure at the southern end of Takapuna Beach, and as described on the 1:25,000 Industrial series geological map.

Photo 4-2 South coast – siltstone exposure at 48 Esmonde Road

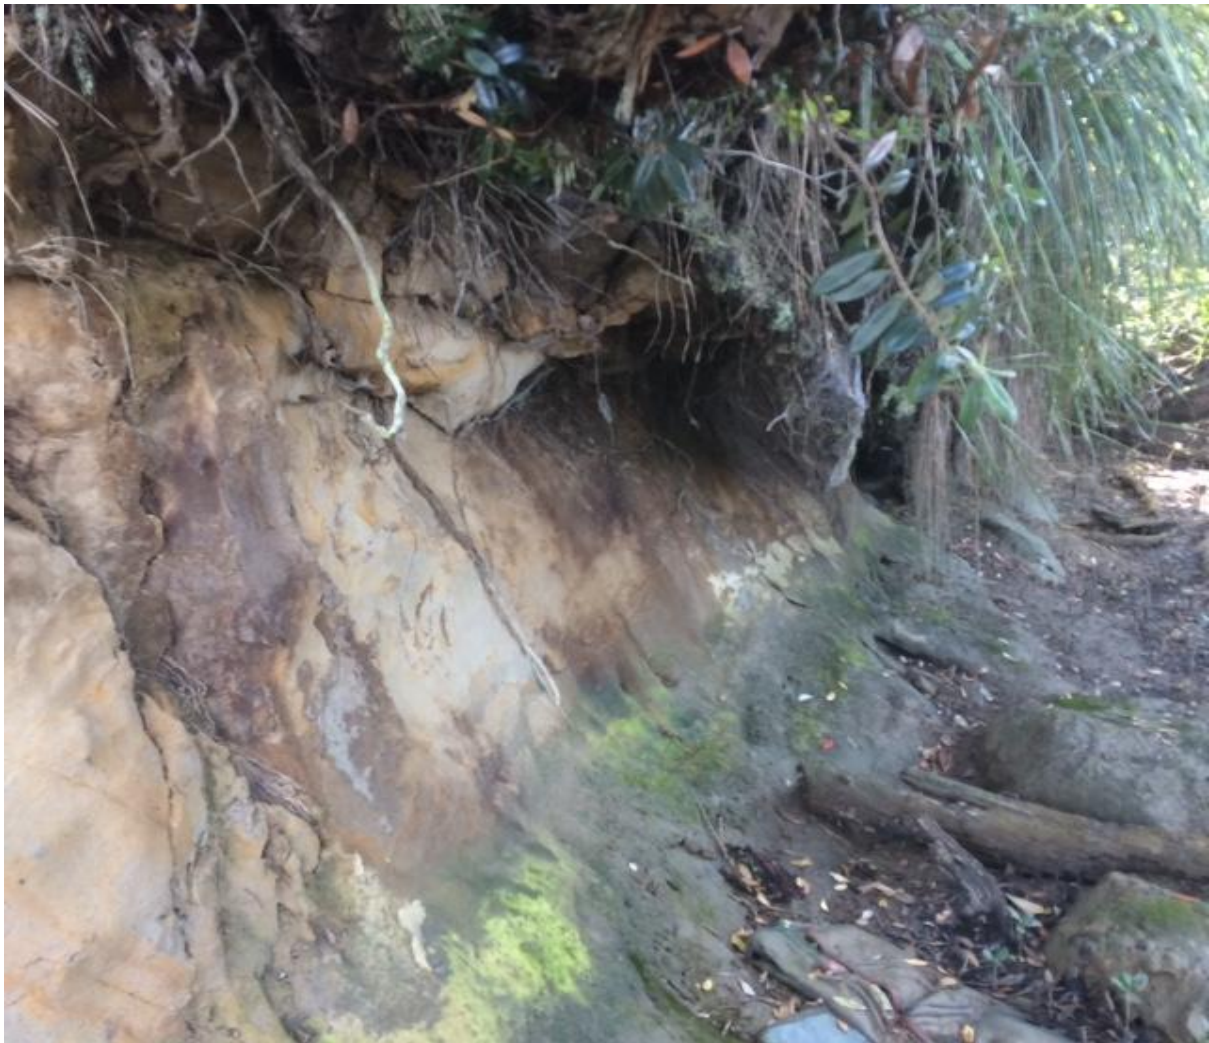
Photo 4-3 South-east coast – sandstone exposure at 48 Esmonde Road
