**Beachlands South Structure
Plan Change**

Geotechnical Report

Prepared by
Tonkin & Taylor Ltd

Date
January 2022

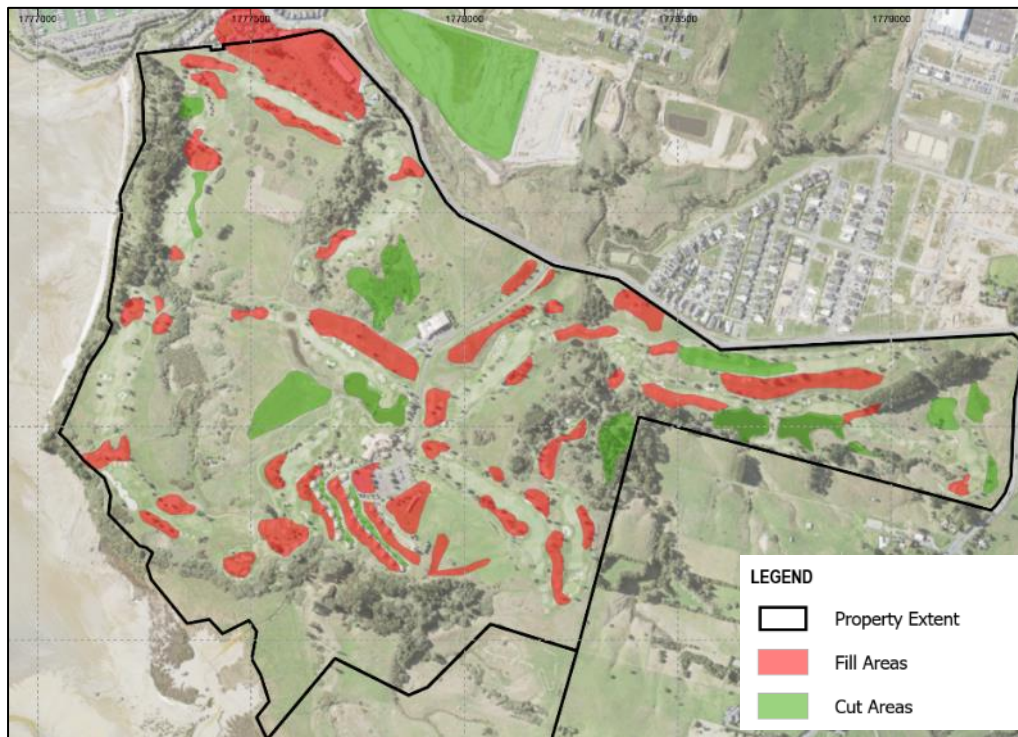
Figure 3: Areas of cut and fill, inferred from review of historical aerial photos.

It is evident in the 1996 aerial photo (Appendix B) that earthworks took place across the entire Formosa site during creation of the golf course. Interpreted areas of cut and fill are presented in Figure 3, below. The aerial photos show that a number of gully features were infilled as part of the earthworks. It is unknown what preparation was carried out, nor if underdrains were installed. Certification of the earthworks has not been found during our desktop review; however hand augered boreholes put down through the fill in 2016 by Lander Geotechnical Consultants⁴ and recently by Tonkin & Taylor in November 2021 encountered very stiff to hard silt/clay materials, indicating good compaction. Given the age of the fill, it is also likely that any settlements associated with self-weight of the earthworks should be effectively complete by now.

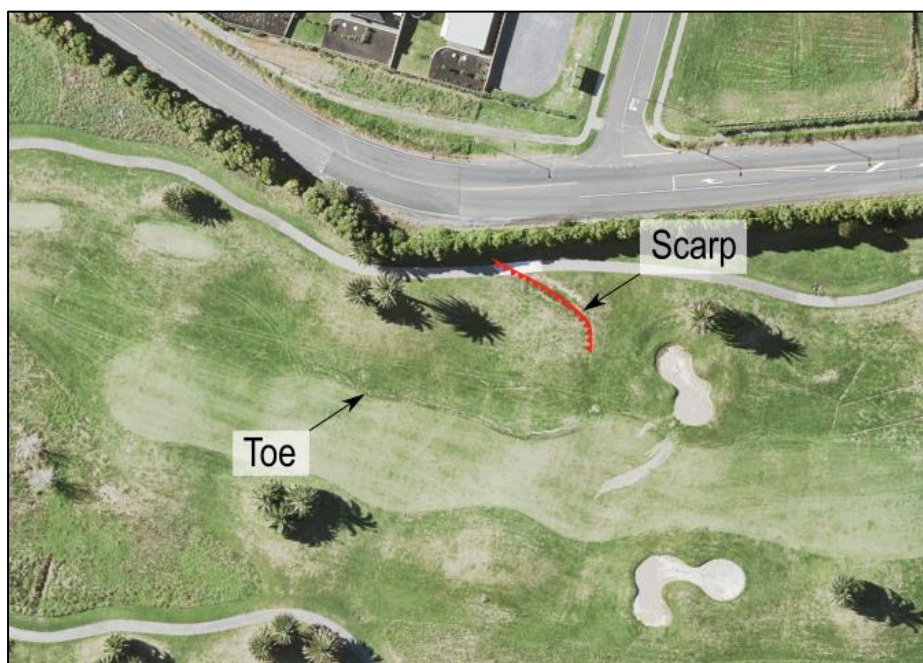
Figure 5: Aerial photo of slope failure adjacent to Jack Lachlan Drive

No other clear evidence of land slippage was observed during our brief site visit, but the potential for other areas of instability within the Formosa Golf Resort site cannot be ruled out at this stage.

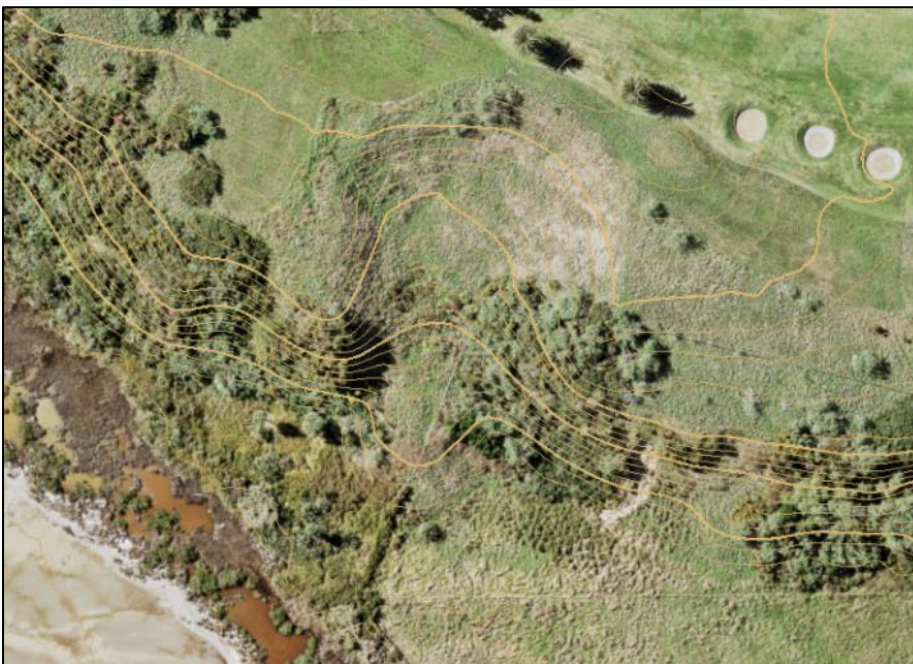
Figure 8: Contour map of coastal instability (source: LINZ).

The western edge of the plan change area consists of steep slopes down to the coast. These appear to be relatively stable, with only small areas of instability within the ECBF soils. A larger slip feature is located midway along the western edge of the Plan Change area (Figure 8), where a semi-circular evacuated feature is evident. This feature predates photographs taken in 1939 (Appendix B), and is still evident in the satellite photos today. The contour map shown in Figure 8 suggests this may be a drainage pathway, which on regression has instigated mass movement.

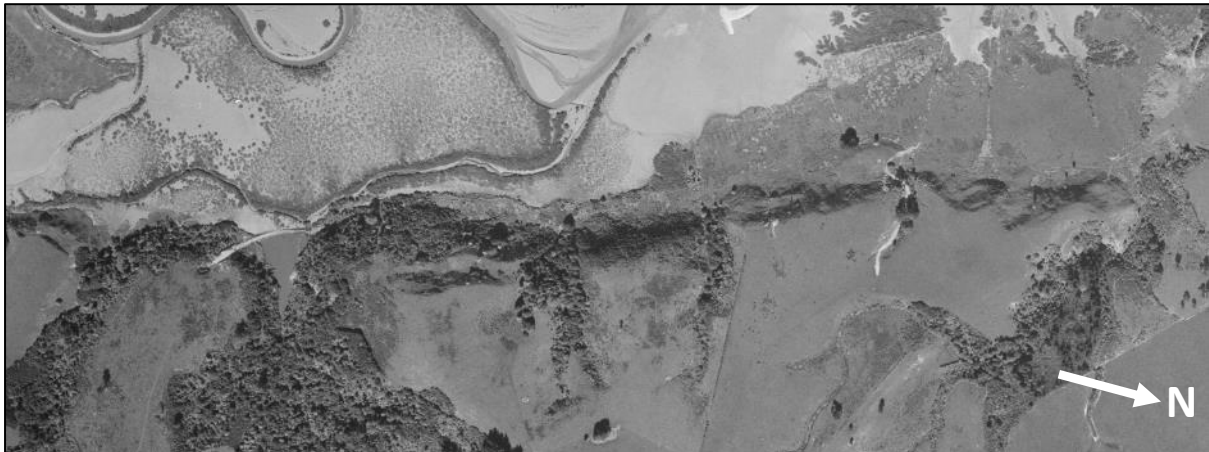
Figure 9: Aerial photo of the southern coastline (620 Precinct). Photo taken 2 November 1961. The full photo is presented in Appendix B. Source: Retrolens.

In our view, the steepness of the slope faces also tend to support the conclusion that the terraces are a result of sea level change, as a block slide in this terrain would tend to move on a shallower angled slip plane. Further assessment of this will be required at the time of future development, but in any case the indicative areas for residential development are set back to ensure they should not be affected by cliff stability. Analysis at subdivision design stage would also be required to set out Building Restriction and Limitation lines, to delineate any zones in steeper terrain where buildings may require specific geotechnical design.
