17 September 2021

Our Ref: 15211-Q

PRELIMINARY ROCK RESOURCE ASSESSMENT PROPOSED CLEVEDON QUARRY EXPANSION 646 McNICOL ROAD, CLEVEDON

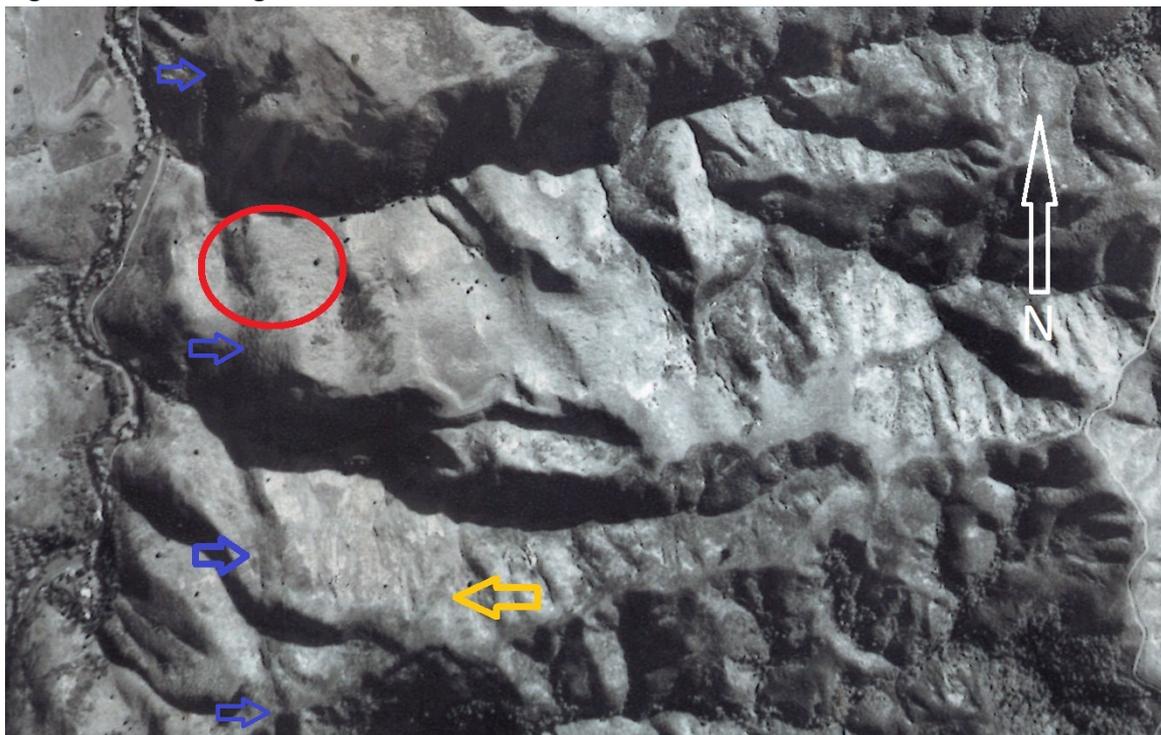
Figure 1: Aerial Image from 1944

Aerial images from 1944 show the northern portion of the property, where the quarry expansion is being considered, to be largely in pasture with some isolated patches of bush in steep gully heads to the east (see Figure 1 below).

Red circle = current Clevedon Quarry

Blue arrows = Wairoa North Fault trace

Yellow arrow = northern slope in pasture affected by significant shallow instability

Review of aerial images from 1944, when the site was largely in pasture, show extensive areas of shallow instability evident on the northern facing slopes, which may have removed some of the overburden cover (see Figure 1). These features were still visible during the site mapping beneath the pine forest, although the features have ‘healed’ to varying degrees.

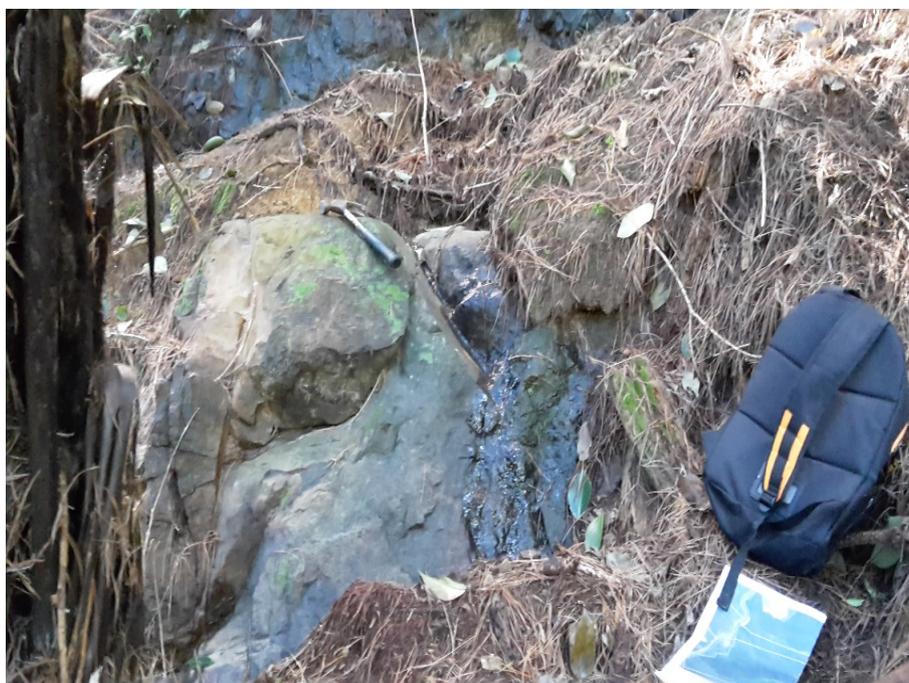
The greywackes observed in exposure are similar to that currently excavated from Clevedon Quarry, with a mix of argillite, siltstone and sandstone, likely of similar mineralogical composition to Clevedon Quarry. Exposures inspected in the streams within the property often included a relatively significant amount of fine sandstone, which generally produces a superior aggregate compared with argillite. However, due to the sandstone condition and resistance, it may be preferentially exposed in streams giving a non-representative indication of its relative occurrence.

Photo 1: View of greywacke fine sandstone, rounded by stream water flow

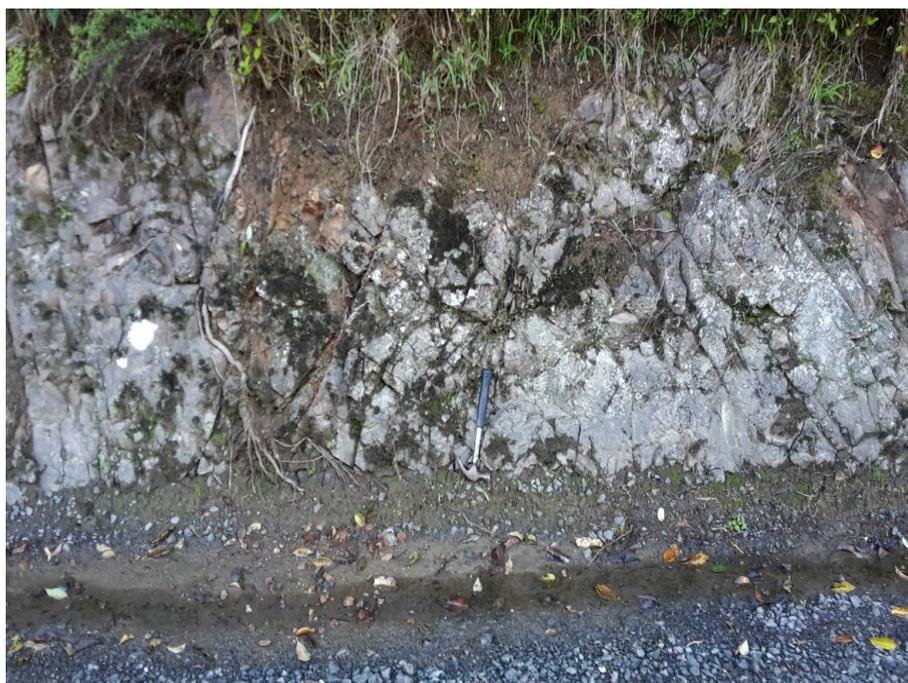
Inspected rock exposed in streams was often moderately to slightly weathered and strong to very strong in accordance with the New Zealand Geotechnical Society Guidelines for description of rock based on exposure inspections. The rock is jointed similar to that seen in the current quarry faces. Bedding is not easily discernible but would appear to be steeply dipping to sub-vertical. Bedding may not have a significant impact on resource extraction. Macro-fabric within the rock appears from limited exposure to have a predominately north-east to east north-east orientation, which is similar to the current quarry.

Photo 2: Moderately strong siltstone with minor sandstone exposed adjacent to McNicol Road

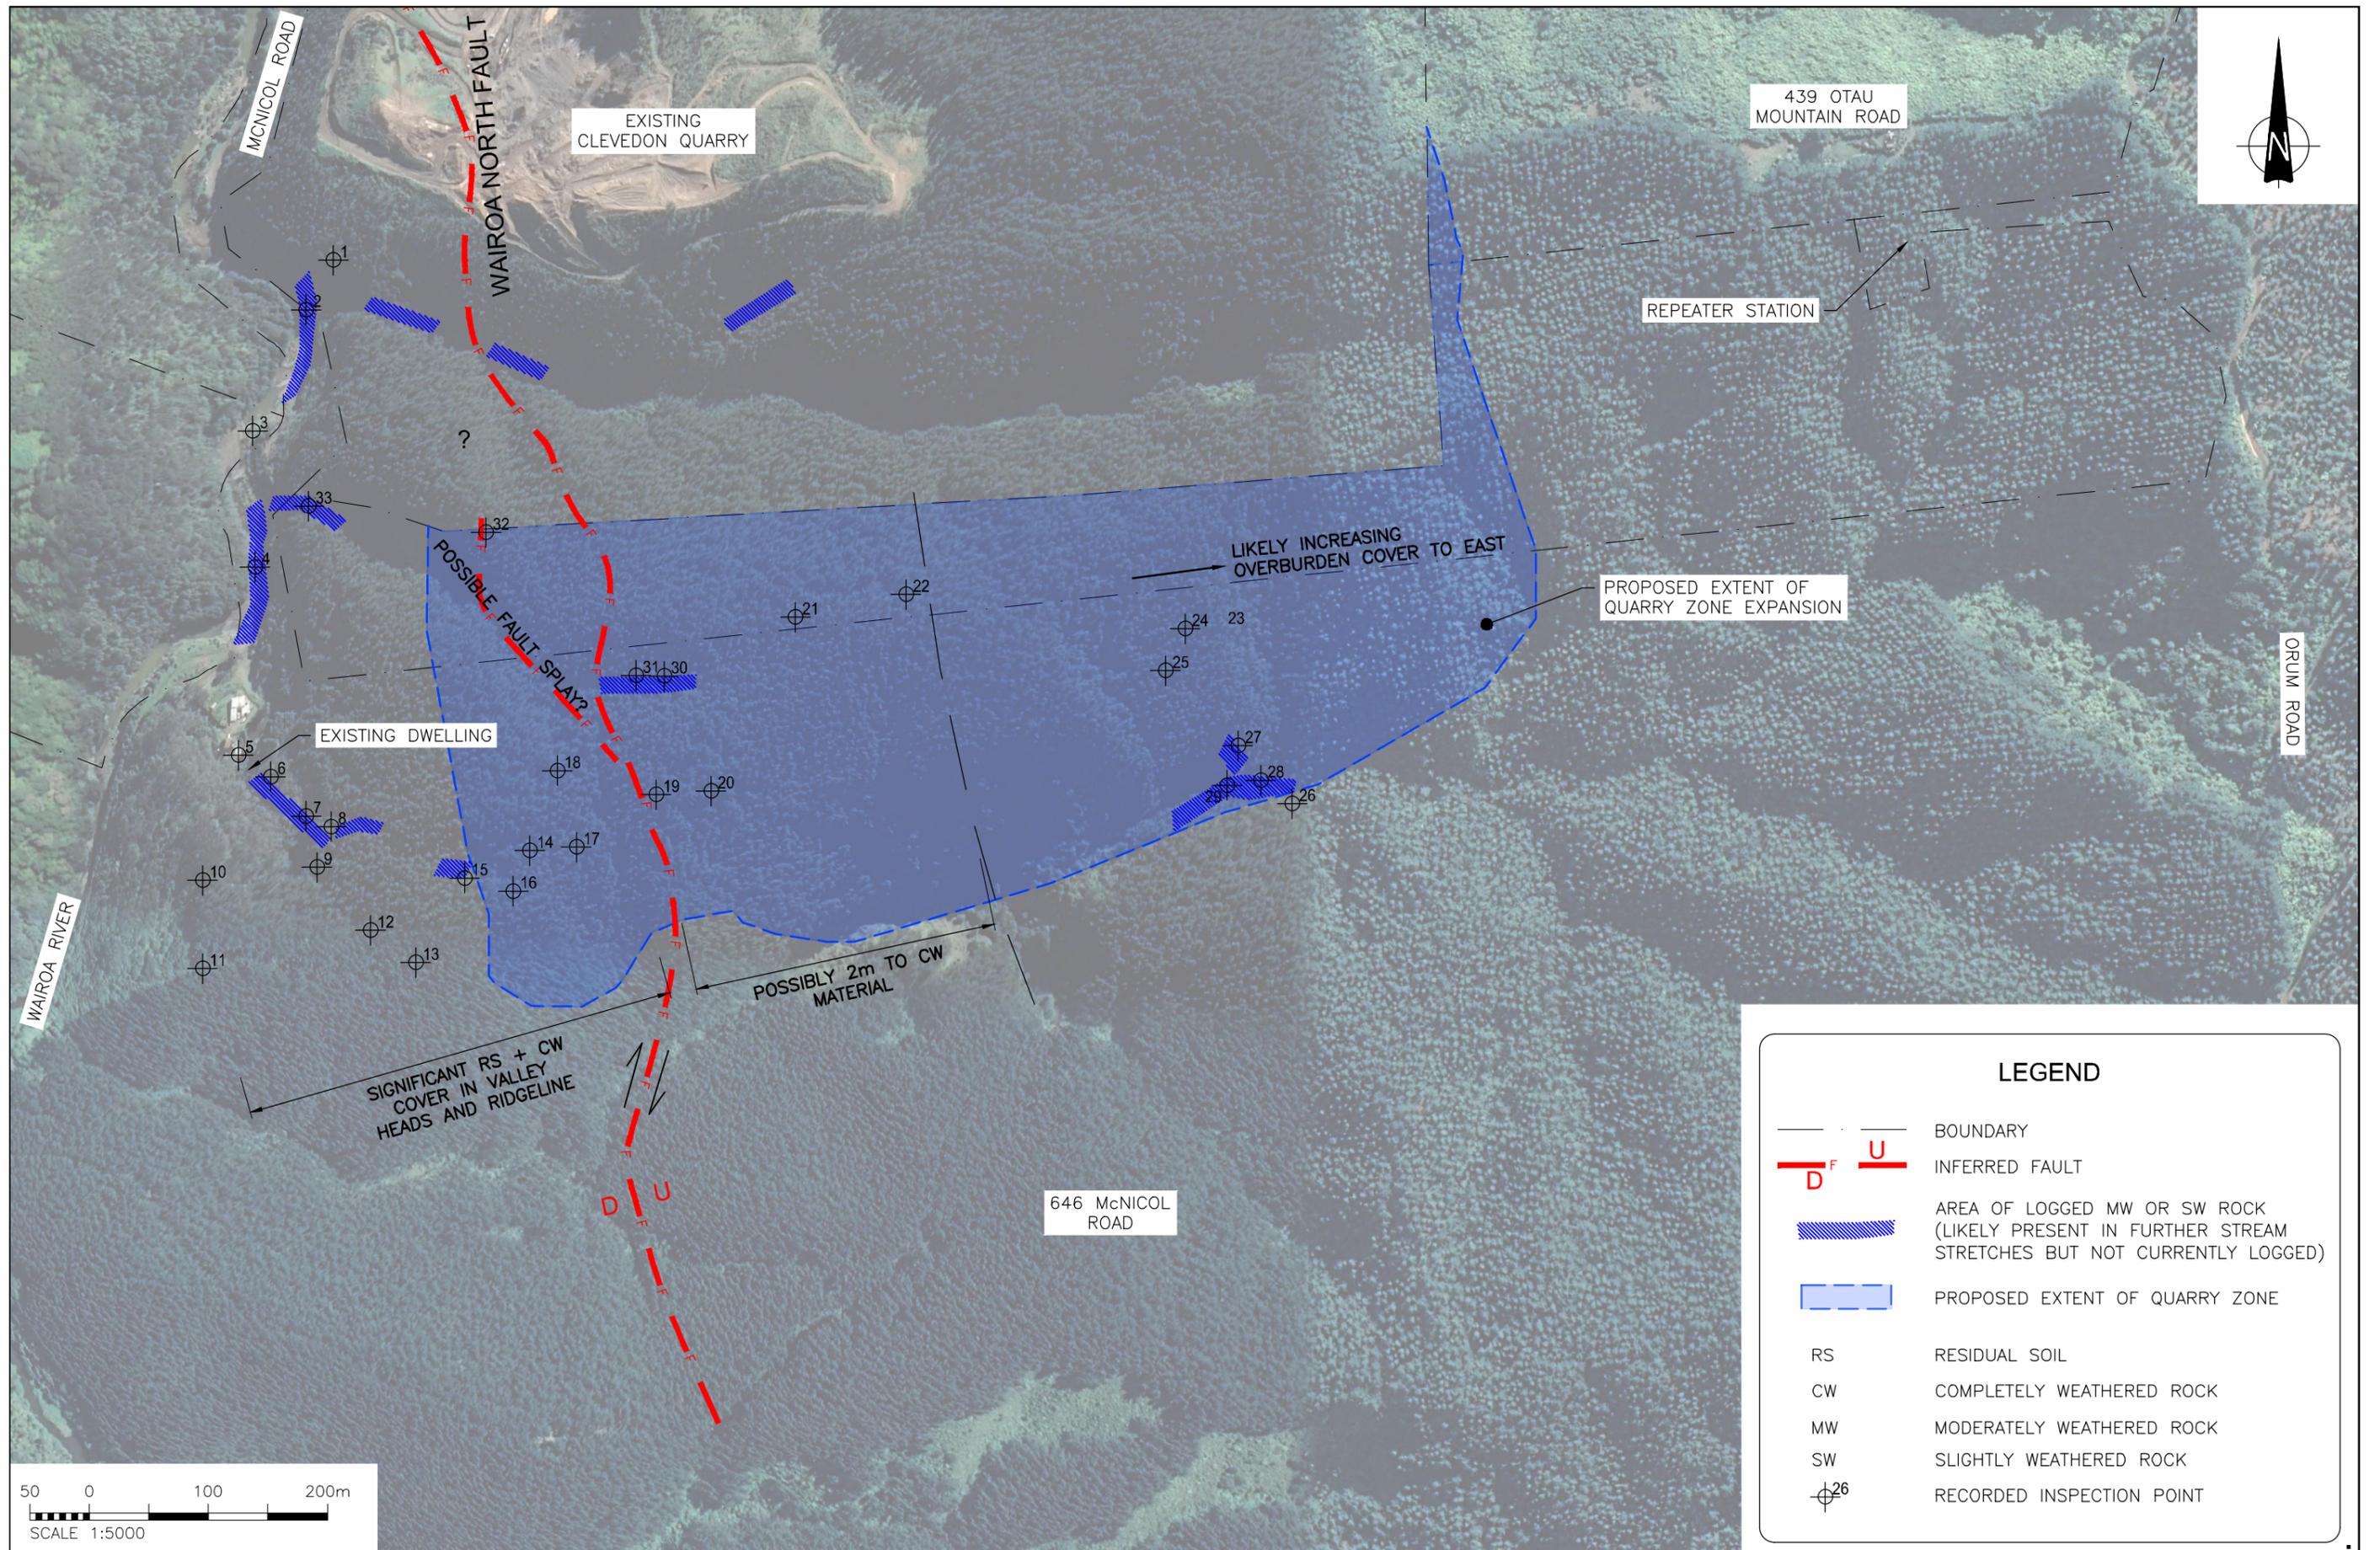
CADFILE	DRAWING No.	REV.
15211-14	15211-14	1
SCALES (A3)	ACENZ	
1:5000

The Wairoa North Fault continues south from Clevedon Quarry through the property. This potentially active fault has a surface expression, and thus, can likely be located to a reasonable level of accuracy on-site. Its inferred position from this initial assessment is shown on RILEY Dwg: 15211-14, attached. This fault was drilled through by recent investigations at Clevedon Quarry and found to have enhanced weathering penetration to some 30m below ground level. Trigonometry indicates the fault zone could be up to 10m wide, however, the related Waikopua Fault at Whitford Quarry has a fault zone witnessed to be significantly smaller (1m) with a broken rock zone up to 20m wide. Similar to the Waikopua Fault, the Wairoa North Fault may have splays with associate enhanced weathering adjacent to them.

LIKELY INCREASING OVERBURDEN COVER TO EAST

POSSIBLY 2m TO CW MATERIAL

SIGNIFICANT RS + CW COVER IN VALLEY HEADS AND RIDGELINE
