Arboricultural Assessment of Effects

A concrete pathway, boardwalk and bridge construction, along with upgrading an aggregate track.

Tamaki Path, Stage 2 – Point England

Date 28 March 2024
Job ref # 2758

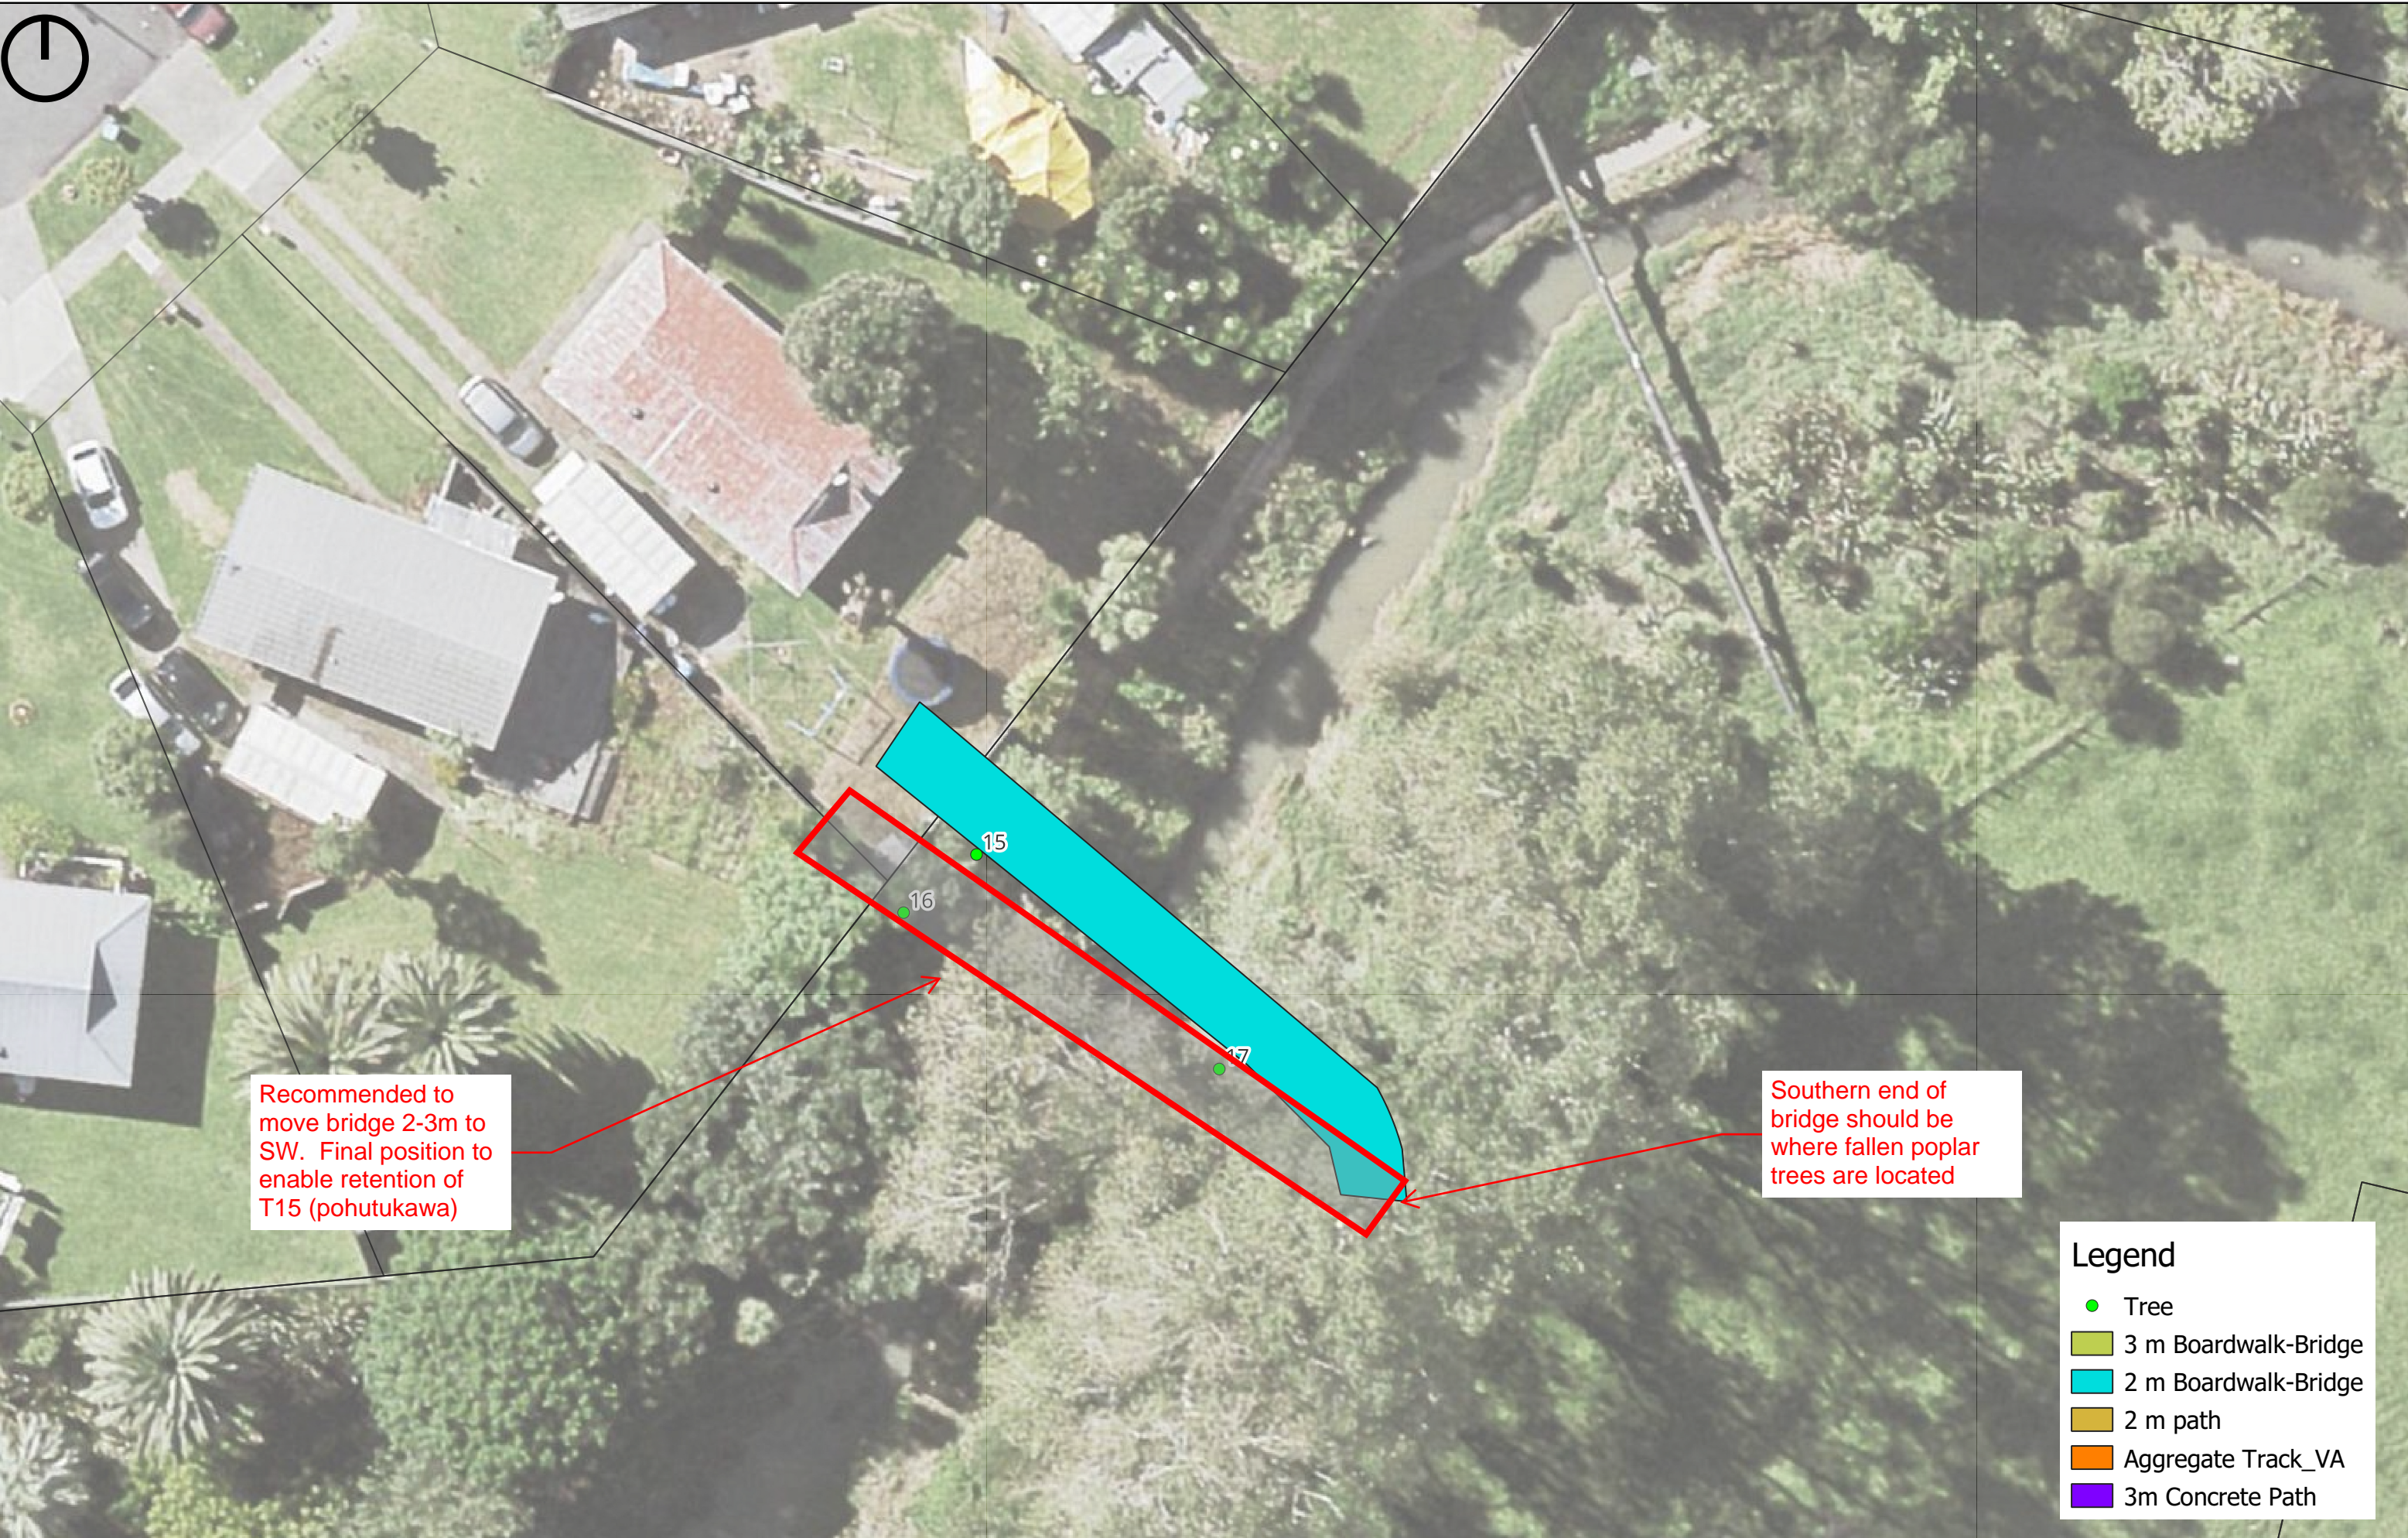
Drawing: 2758_001_A

- 4.4 Within the reserve, some 2 m from the property boundary is a semi-mature pohutukawa of good condition. Of the trees noted within the reserve, this, and other immediately surrounding native trees, are some of the more mature within the park.

- 4.5 Currently the bridge is proposed on the trunk edge, where removal would be required. There is scope to push the bridge at least 2 m to the southwest, where potential impacts will be significantly reduced. With the suggested new position of the bridge, only minor canopy pruning will be required (i.e. pruning that will have minimal impact on tree health and shape).

Recommended to move bridge 2-3m to SW. Final position to enable retention of T15 (pohutukawa)

Southern end of bridge should be where fallen poplar trees are located

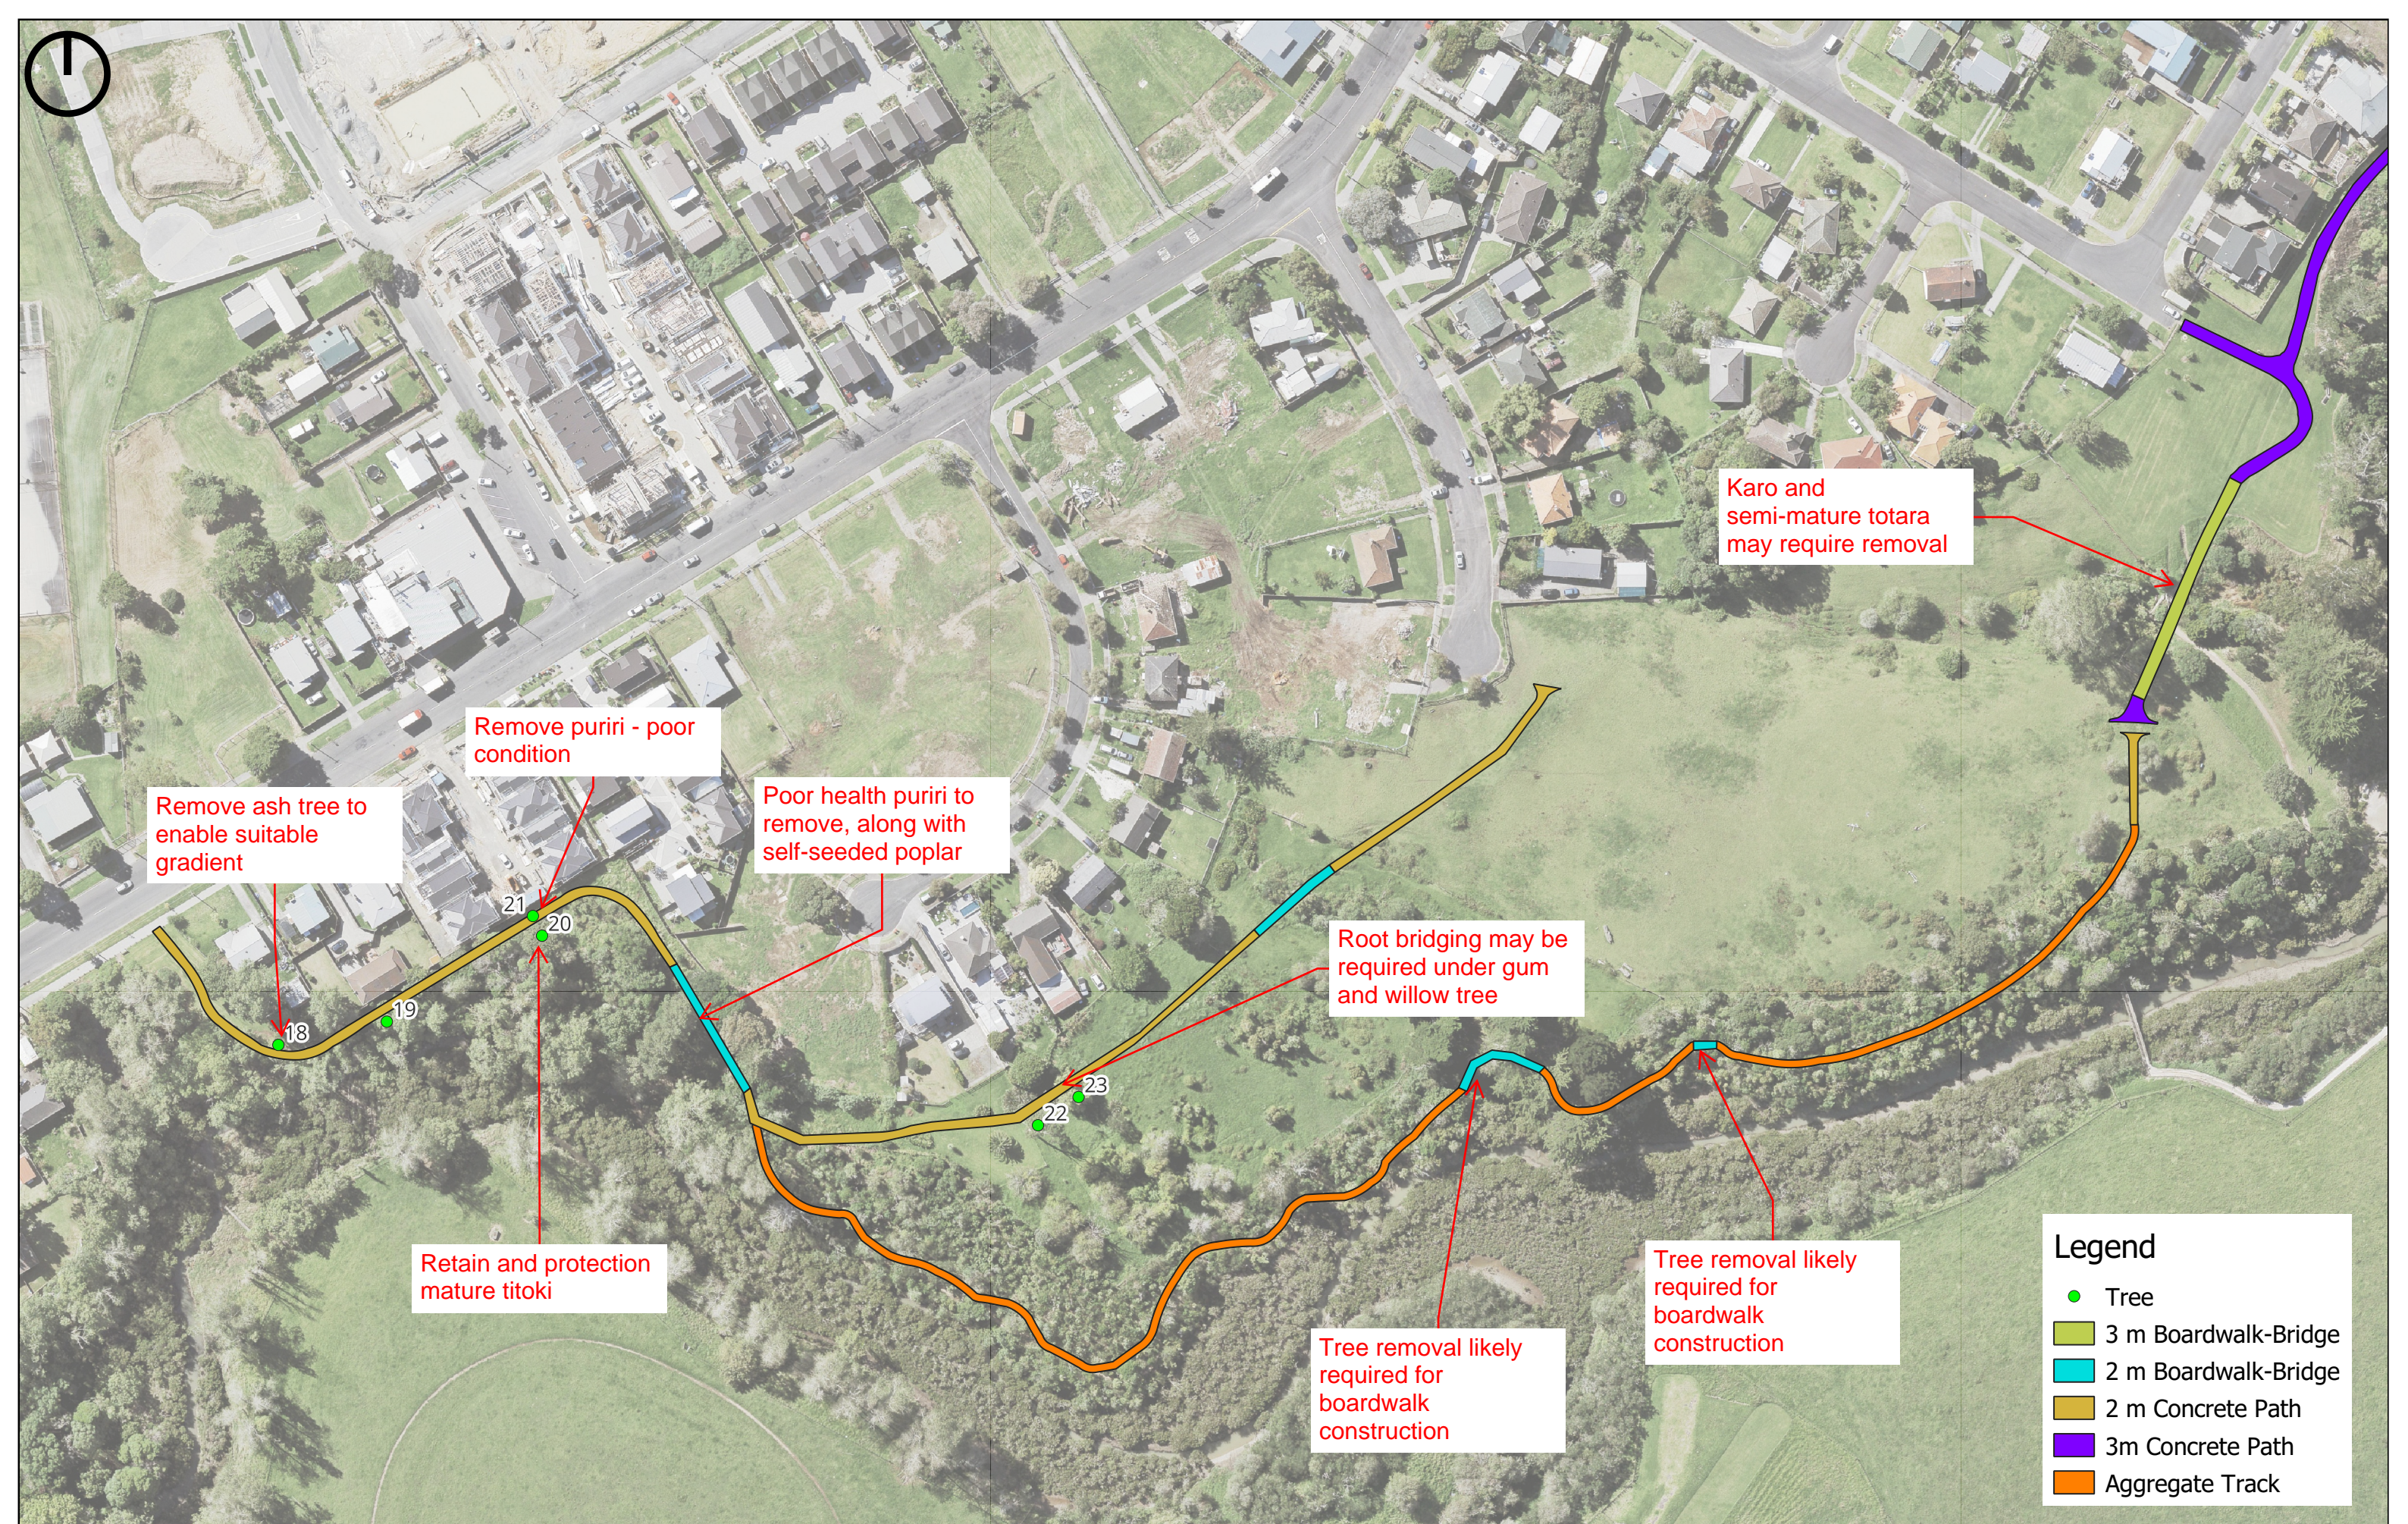
Drawing: 2758_002_A

Remove ash tree to enable suitable gradient

Remove puriri - poor condition

Poor health puriri to remove, along with self-seeded poplar

Karo and semi-mature totara may require removal

Root bridging may be required under gum and willow tree

Retain and protection mature titoki

Tree removal likely required for boardwalk construction

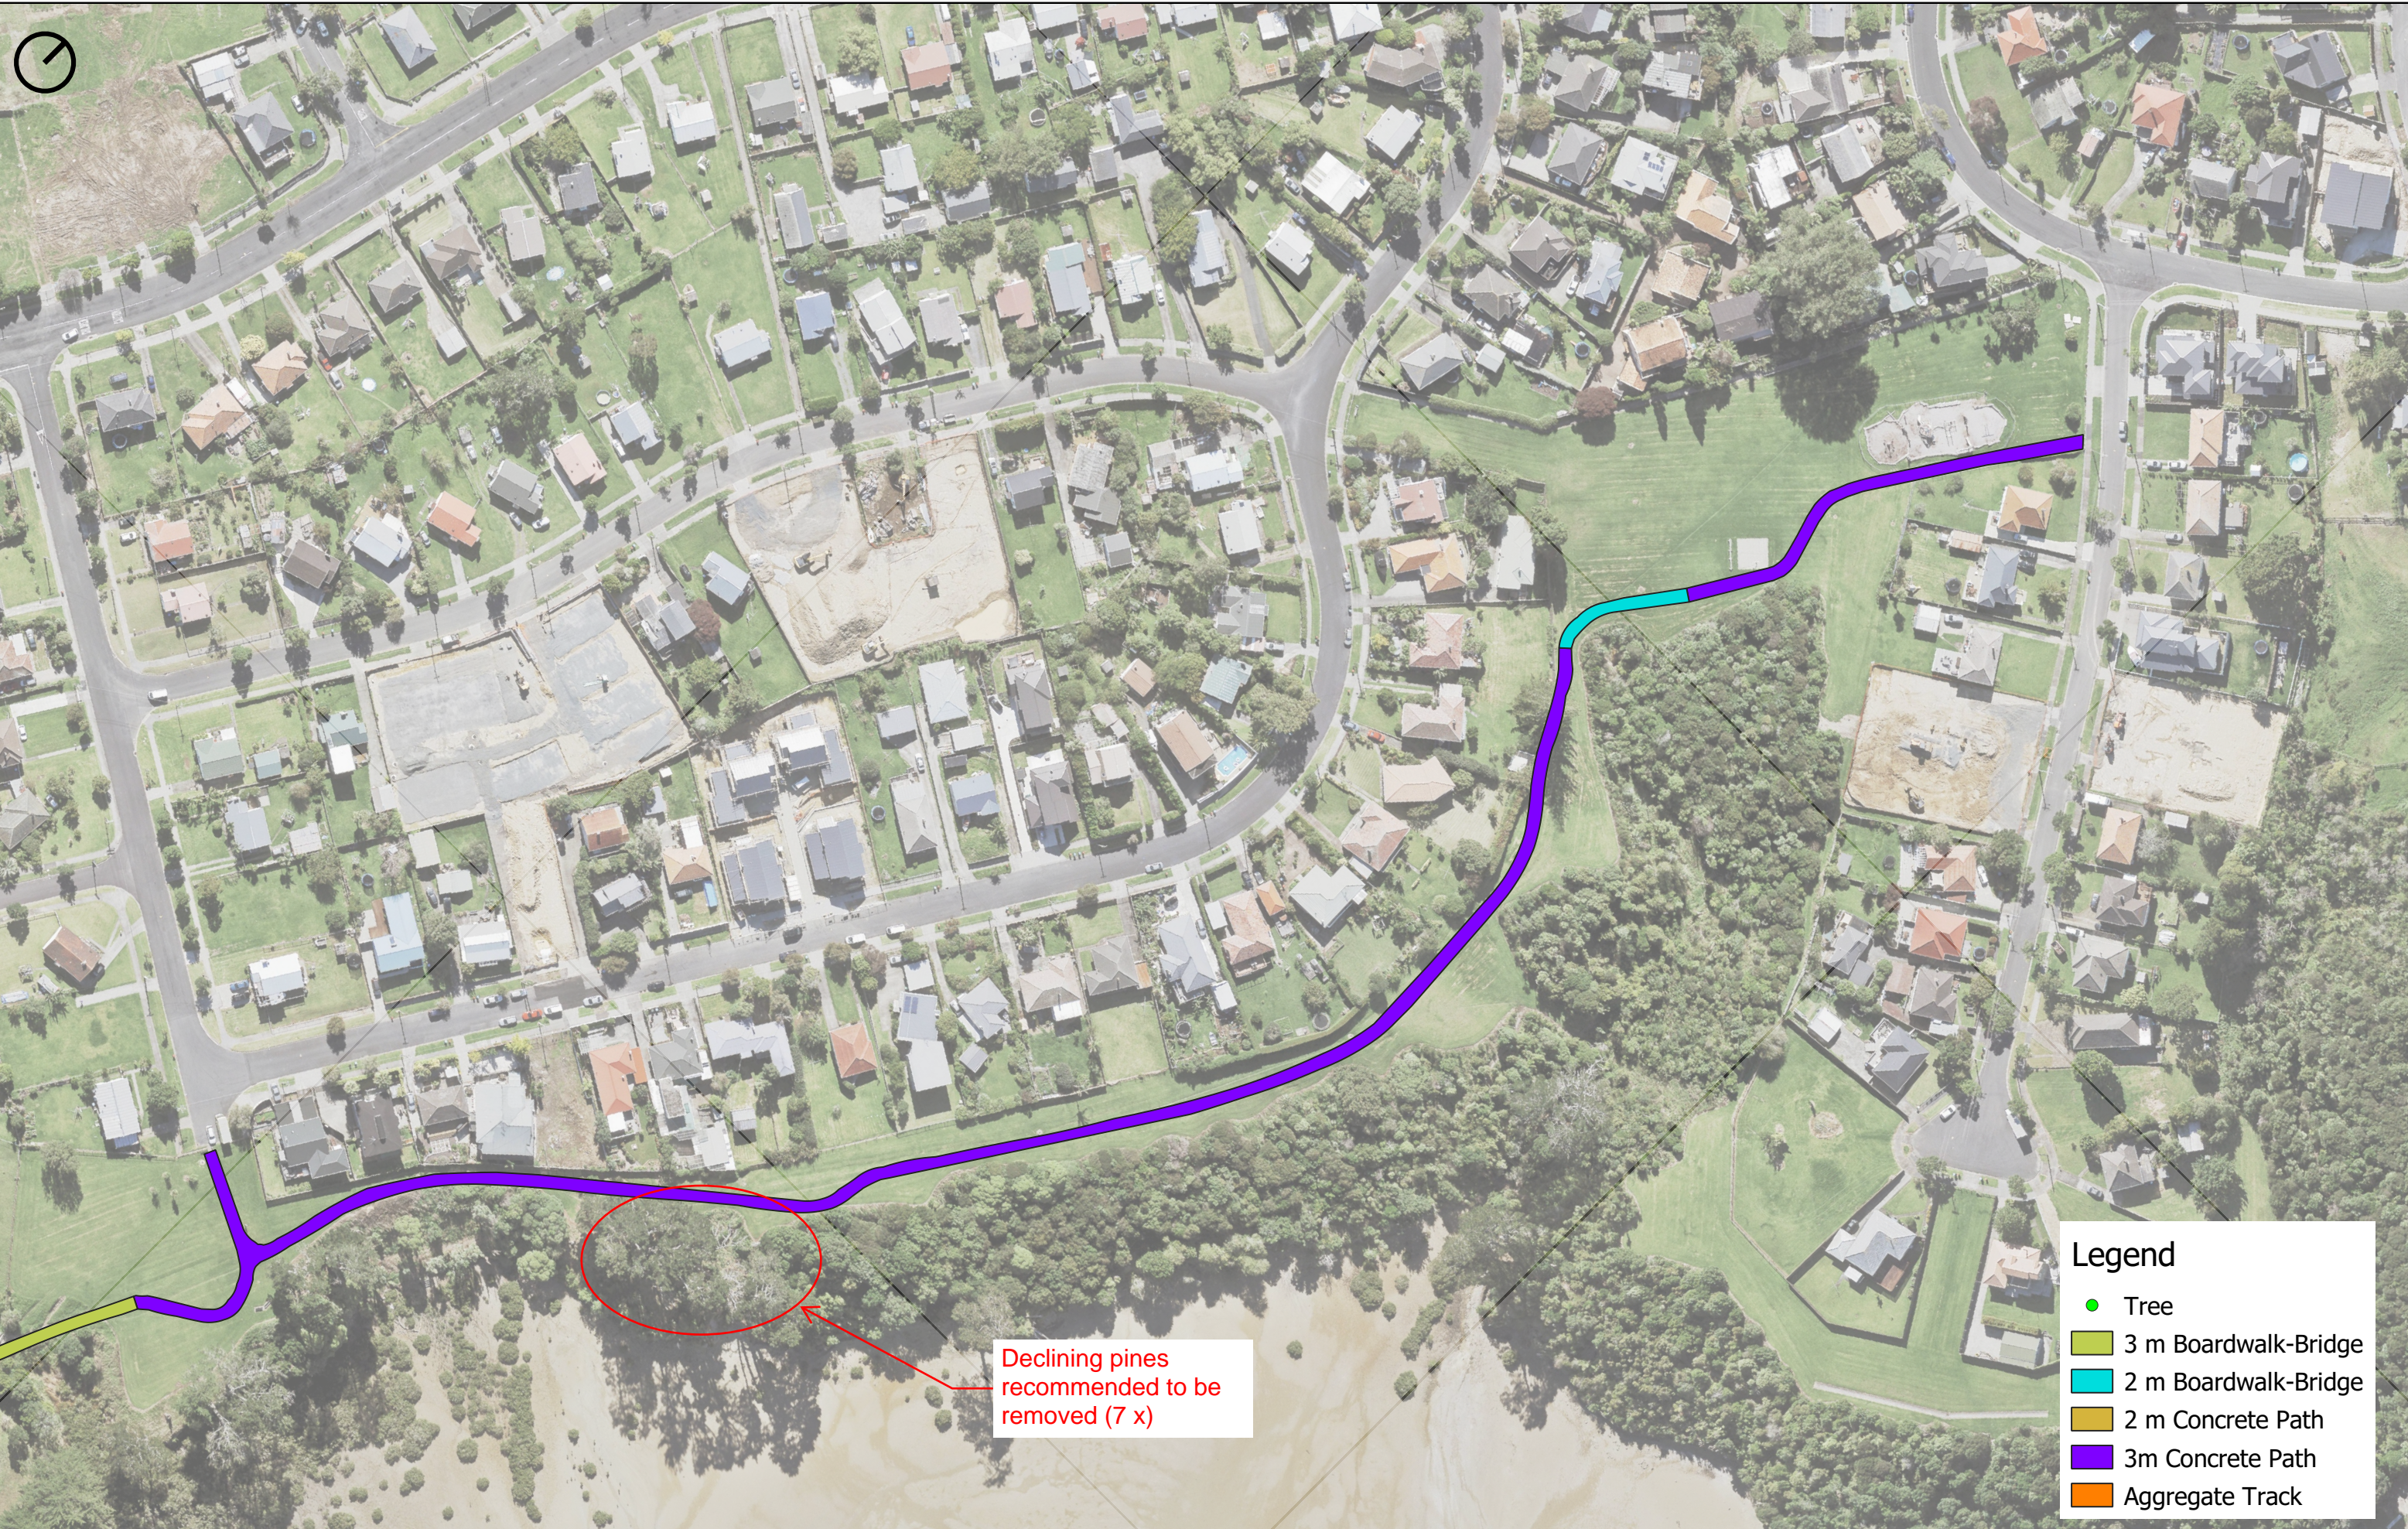
Drawing: 2758_003_A

- 4.16 A 3 m wide section of pathway runs behind the private properties along Silverton Avenue. To the rear of 50 to 52A, and near the coastal bank, is a stand of seven mature pines. I have reviewed historical images available online, and it is clear this group of pines are declining, with evidence of relatively rapid decline occurring in the last 24 months. One of the pine trees canopy entirely has brown needles (indicating the tree has very recently died), and the remaining show early signs of the needle discoloration. Having reviewed the historical images, it is my view that the remaining pine trees are likely to be dead or in poor health within the next five years.

Declining pines
recommended to be
removed (7 x)
