Arboricultural Assessment of Effects

A concrete pathway, boardwalk and bridge construction, along with upgrading an aggregate track.

Tamaki Path, Stage 2 – Point England

Date 28 March 2024_V2
Job ref # 2758
Reviewed by Tracey Funnell

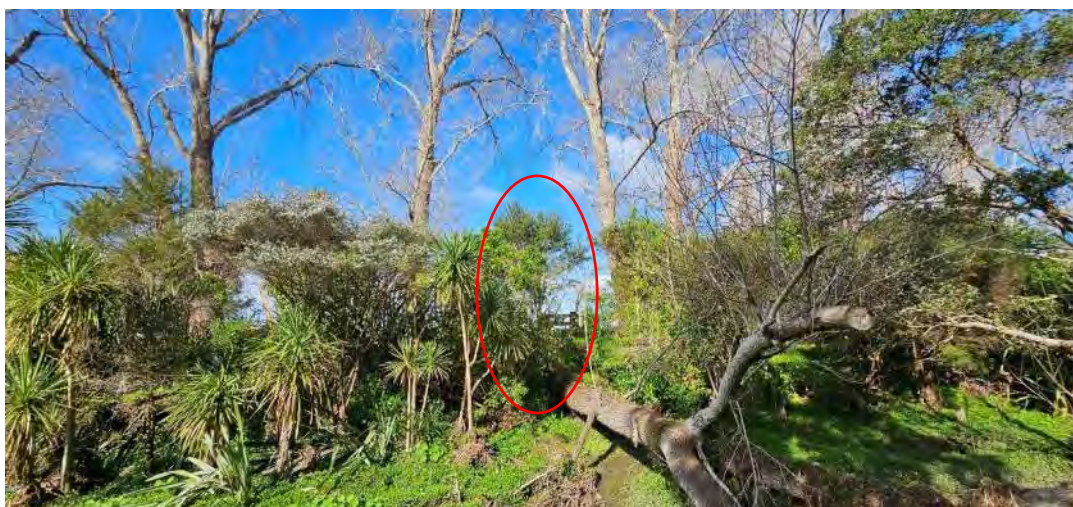
On the southern side of the bridge, the landing will be positioned where a fallen poplar is located, taking advantage of the resulting cleared area. The removal of one 5 m or so tall kanuka, and smaller cabbage tree and mahoe will be required (figure 2), however, the position minimises the need to removal additional vegetation.

Figure 2 – Landing to be positioned where fallen poplar is located. Kanuka, whiteywood and cabbage tree for removal circled

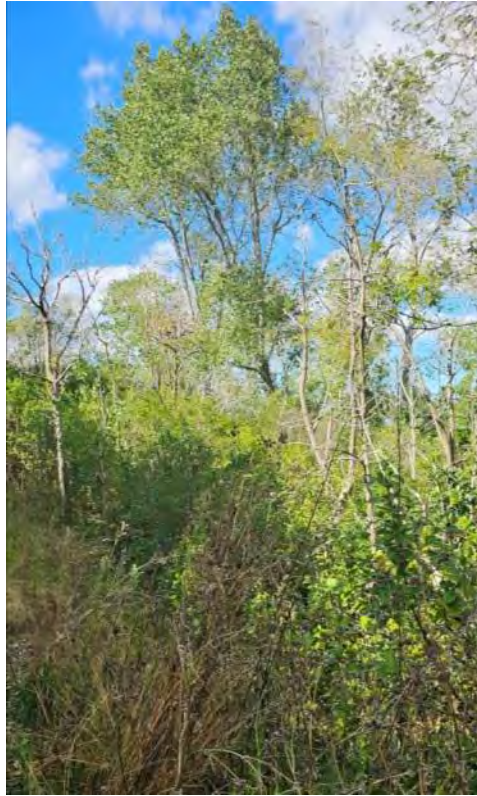
- 4.7 A second 38 m or so long boardwalk is proposed to the rear of 5 to 7 Teuila Grove, in an area that is dominated by weedy plant species, and small native plants such as mahoe and kawakawa. Several mature poplar trees are further west of the bridge; however, other self-seeded poplar trees are adjacent and within the alignment of the bridge, and these will require removal (Figure 3). In addition to this, an early mature puriri tree, which is in poor health, will require removal. Arboriculturally, the puriri is not a specimen considered to warrant mandatory retention, and its removal can be mitigated with replacement planting.

Figure 3 – Smaller self-seed poplar for removal

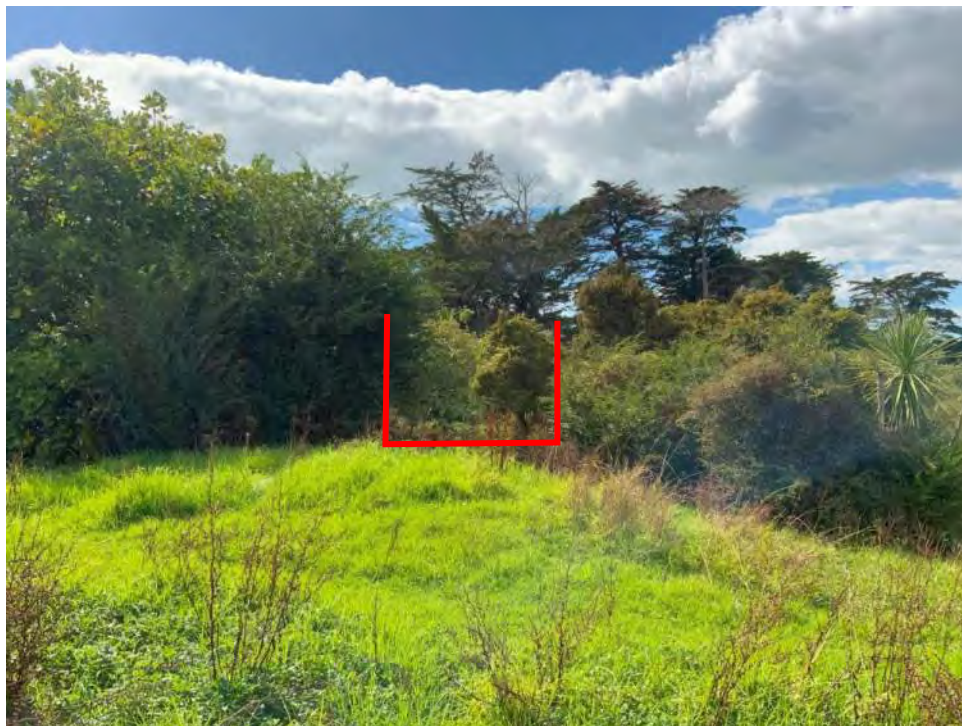
- 4.8 Midway along TP 2, the aggregate track passes over a stream and was wet underfoot at the time of inspection. As part of the renewals, it is proposed to construct a new boardwalk. Near the boardwalk alignment is a large fallen macrocarpa that will require removal. In addition to this, the occasional smaller native plant may require removal, and it is my view this removal will be relatively unnoticeable.
- 4.9 To the north of this boardwalk, and within TP 3 alignment, a 23 m or so long boardwalk will be constructed over an overland flow path. The alignment of the boardwalk will span across an area dominated by privet, with the occasional mapou, and removal will be required. None of this vegetation is arboriculturally remarkable (Figure 4).

Figure 4 – Approximate location of boardwalk

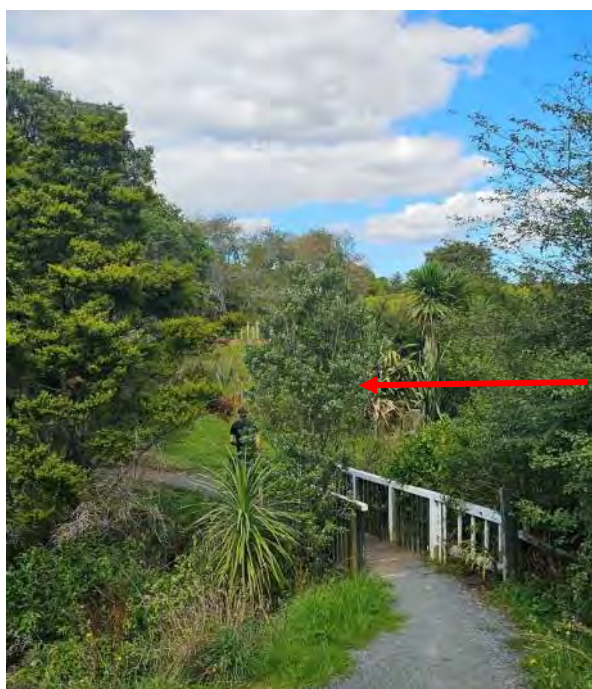
- 4.10 The last bridge/boardwalk of significance within the Project area is a 16 m long bridge, with an 18 m and 28 m boardwalk leading up to it from each side. The boardwalk is to replace a steep section of existing track and small bridge. To ensure the new structure is all-accessible, the height will be increased, with a maximum gradient being no more than 5%. The alignment is also to be straightened over the stream.
- 4.11 Immediately adjacent to the existing bridge is a semi-mature karo tree that has self-seeded under the bridge and formed a sweeping trunk from underneath (figure 5), to have a trunk that is immediately adjacent to the structure. This karo will require removal to construct the new bridge. There is a good opportunity to undertake enhancement native planting adjacent to the stream, which will mitigate the tree removal.

Figure 5 – Karo for removal

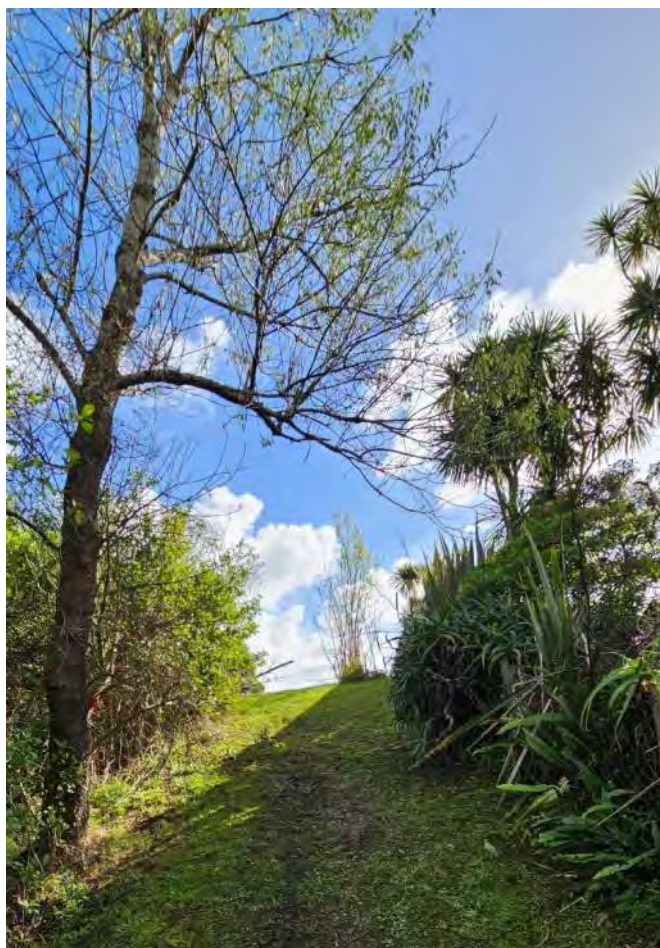
- 4.12 Several 2 m and 3 m wide concrete pathways are proposed to be constructed along the entire length of the project area. The southern most section of the concrete path will commence from adjacent to 104 Taniwah Street, connecting into an existing concrete path. Along the private property boundary, the site drops relatively steeply to the existing track network, and in order to construct the path with an adequate grade, a retaining wall will be required to be constructed within the reserve. The earthworks to construct the retaining wall will compromise the health and longevity of an 8 m or so tall ash tree (Figure 6), which is overall a fair specimen. Relocating the path to another location will impact a greater number of trees, therefore, from an arboricultural perspective, the current alignment is the preferred.

Figure 6 – Ash tree proposed to be removed

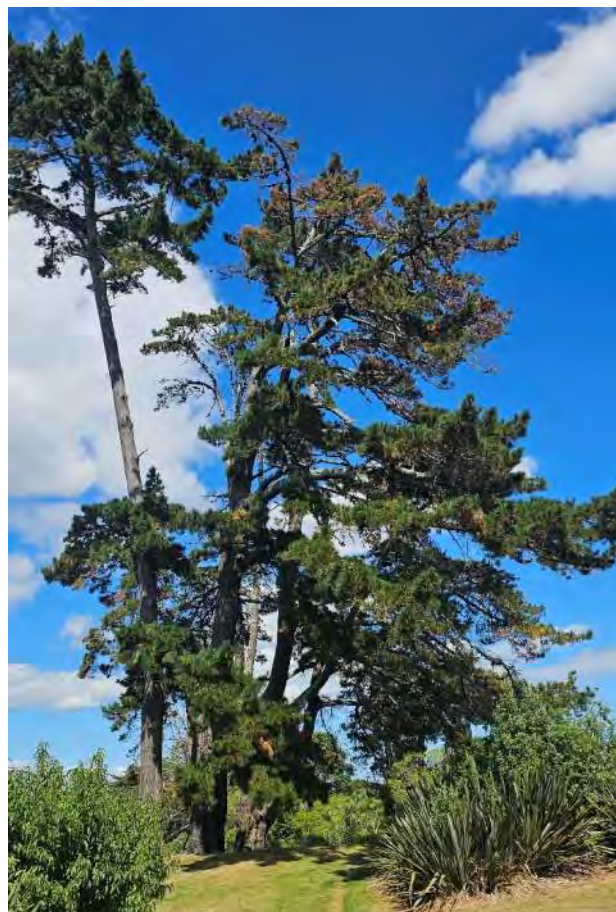
4.16 A 3 m wide section of pathway runs behind the private properties along Silverton Avenue. To the rear of 50 to 52A, and near the coastal bank, is a stand of seven mature pines (Figure 8). I have reviewed historical images available online, and it is clear this group of pines are declining, with evidence of relatively rapid decline occurring in the last 24 months. One of the pine trees canopy entirely has brown needles (indicating the tree has very recently died), and the remaining show early signs of the needle discoloration. Having reviewed the historical images (examples provided in Appendix E), it is my view that the remaining pine trees are likely to be dead or in poor health within the next five years.

Figure 8 – Pines proposed to be removed

4.17 The path alignment adjacent to the pines needs to navigate steep and undulating topography to provide a suitable gradient. To achieve this, a degree of cut and fill will be required, and given the depths of site cuts to achieve the gradients, the earthworks will encroach some 6 to 8 m away from the pine tree trunks. With declining tree health and the earthworks to achieve the suitable gradient, tree removal is required and, in my view, a prudent outcome. Replacement planting will be required to mitigate the tree loss.

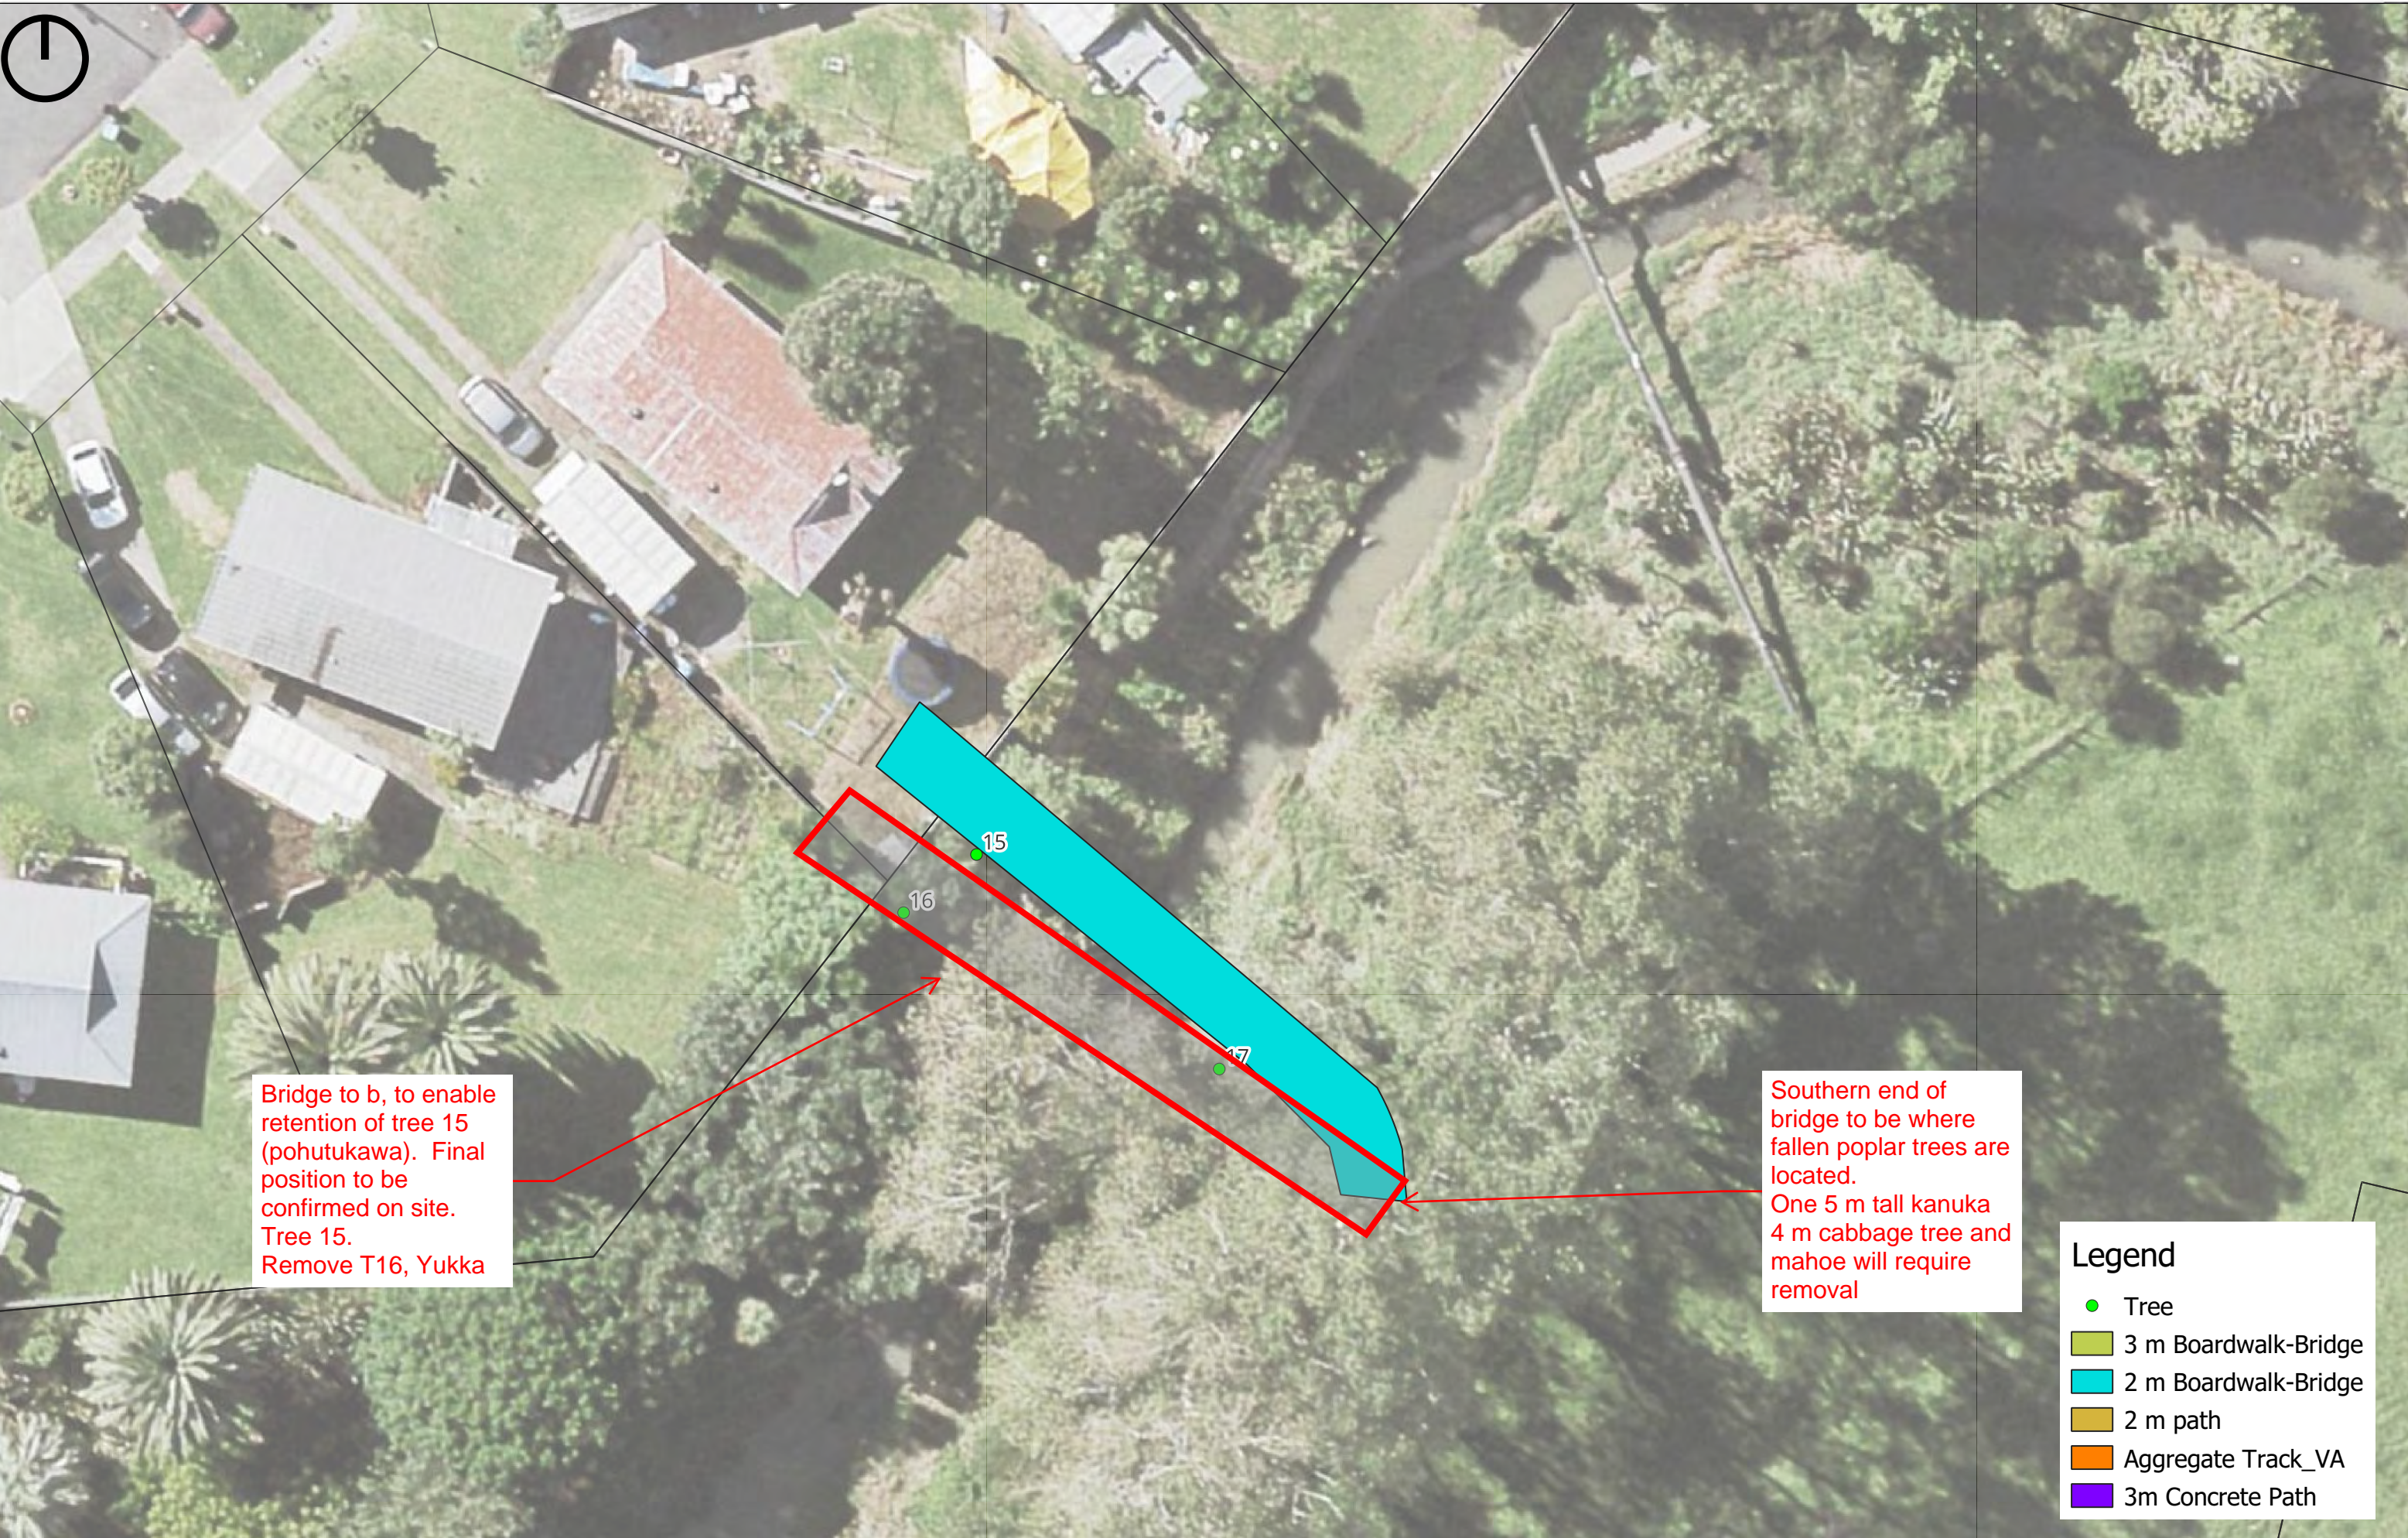
Drawing: 2758_001_A

- 4.4 Within the reserve, some 2 m from the property boundary is a semi-mature pohutukawa (tree 15) of good condition. Of the trees noted within the reserve, this, and other immediately surrounding native trees, are some of the more mature within the park.

- 4.5 Currently the bridge is proposed on the trunk edge, where removal would be required. There is scope to push the bridge at least 2 m to the southwest, where potential impacts will be significantly reduced. With the suggested new position of the bridge, only minor canopy pruning will be required (i.e. pruning that will have minimal impact on tree health and shape).

Bridge to b, to enable retention of tree 15 (pohutukawa). Final position to be confirmed on site.
 Tree 15.
 Remove T16, Yucca

Southern end of bridge to be where fallen poplar trees are located.
 One 5 m tall kanuka
 4 m cabbage tree and mahoe will require removal

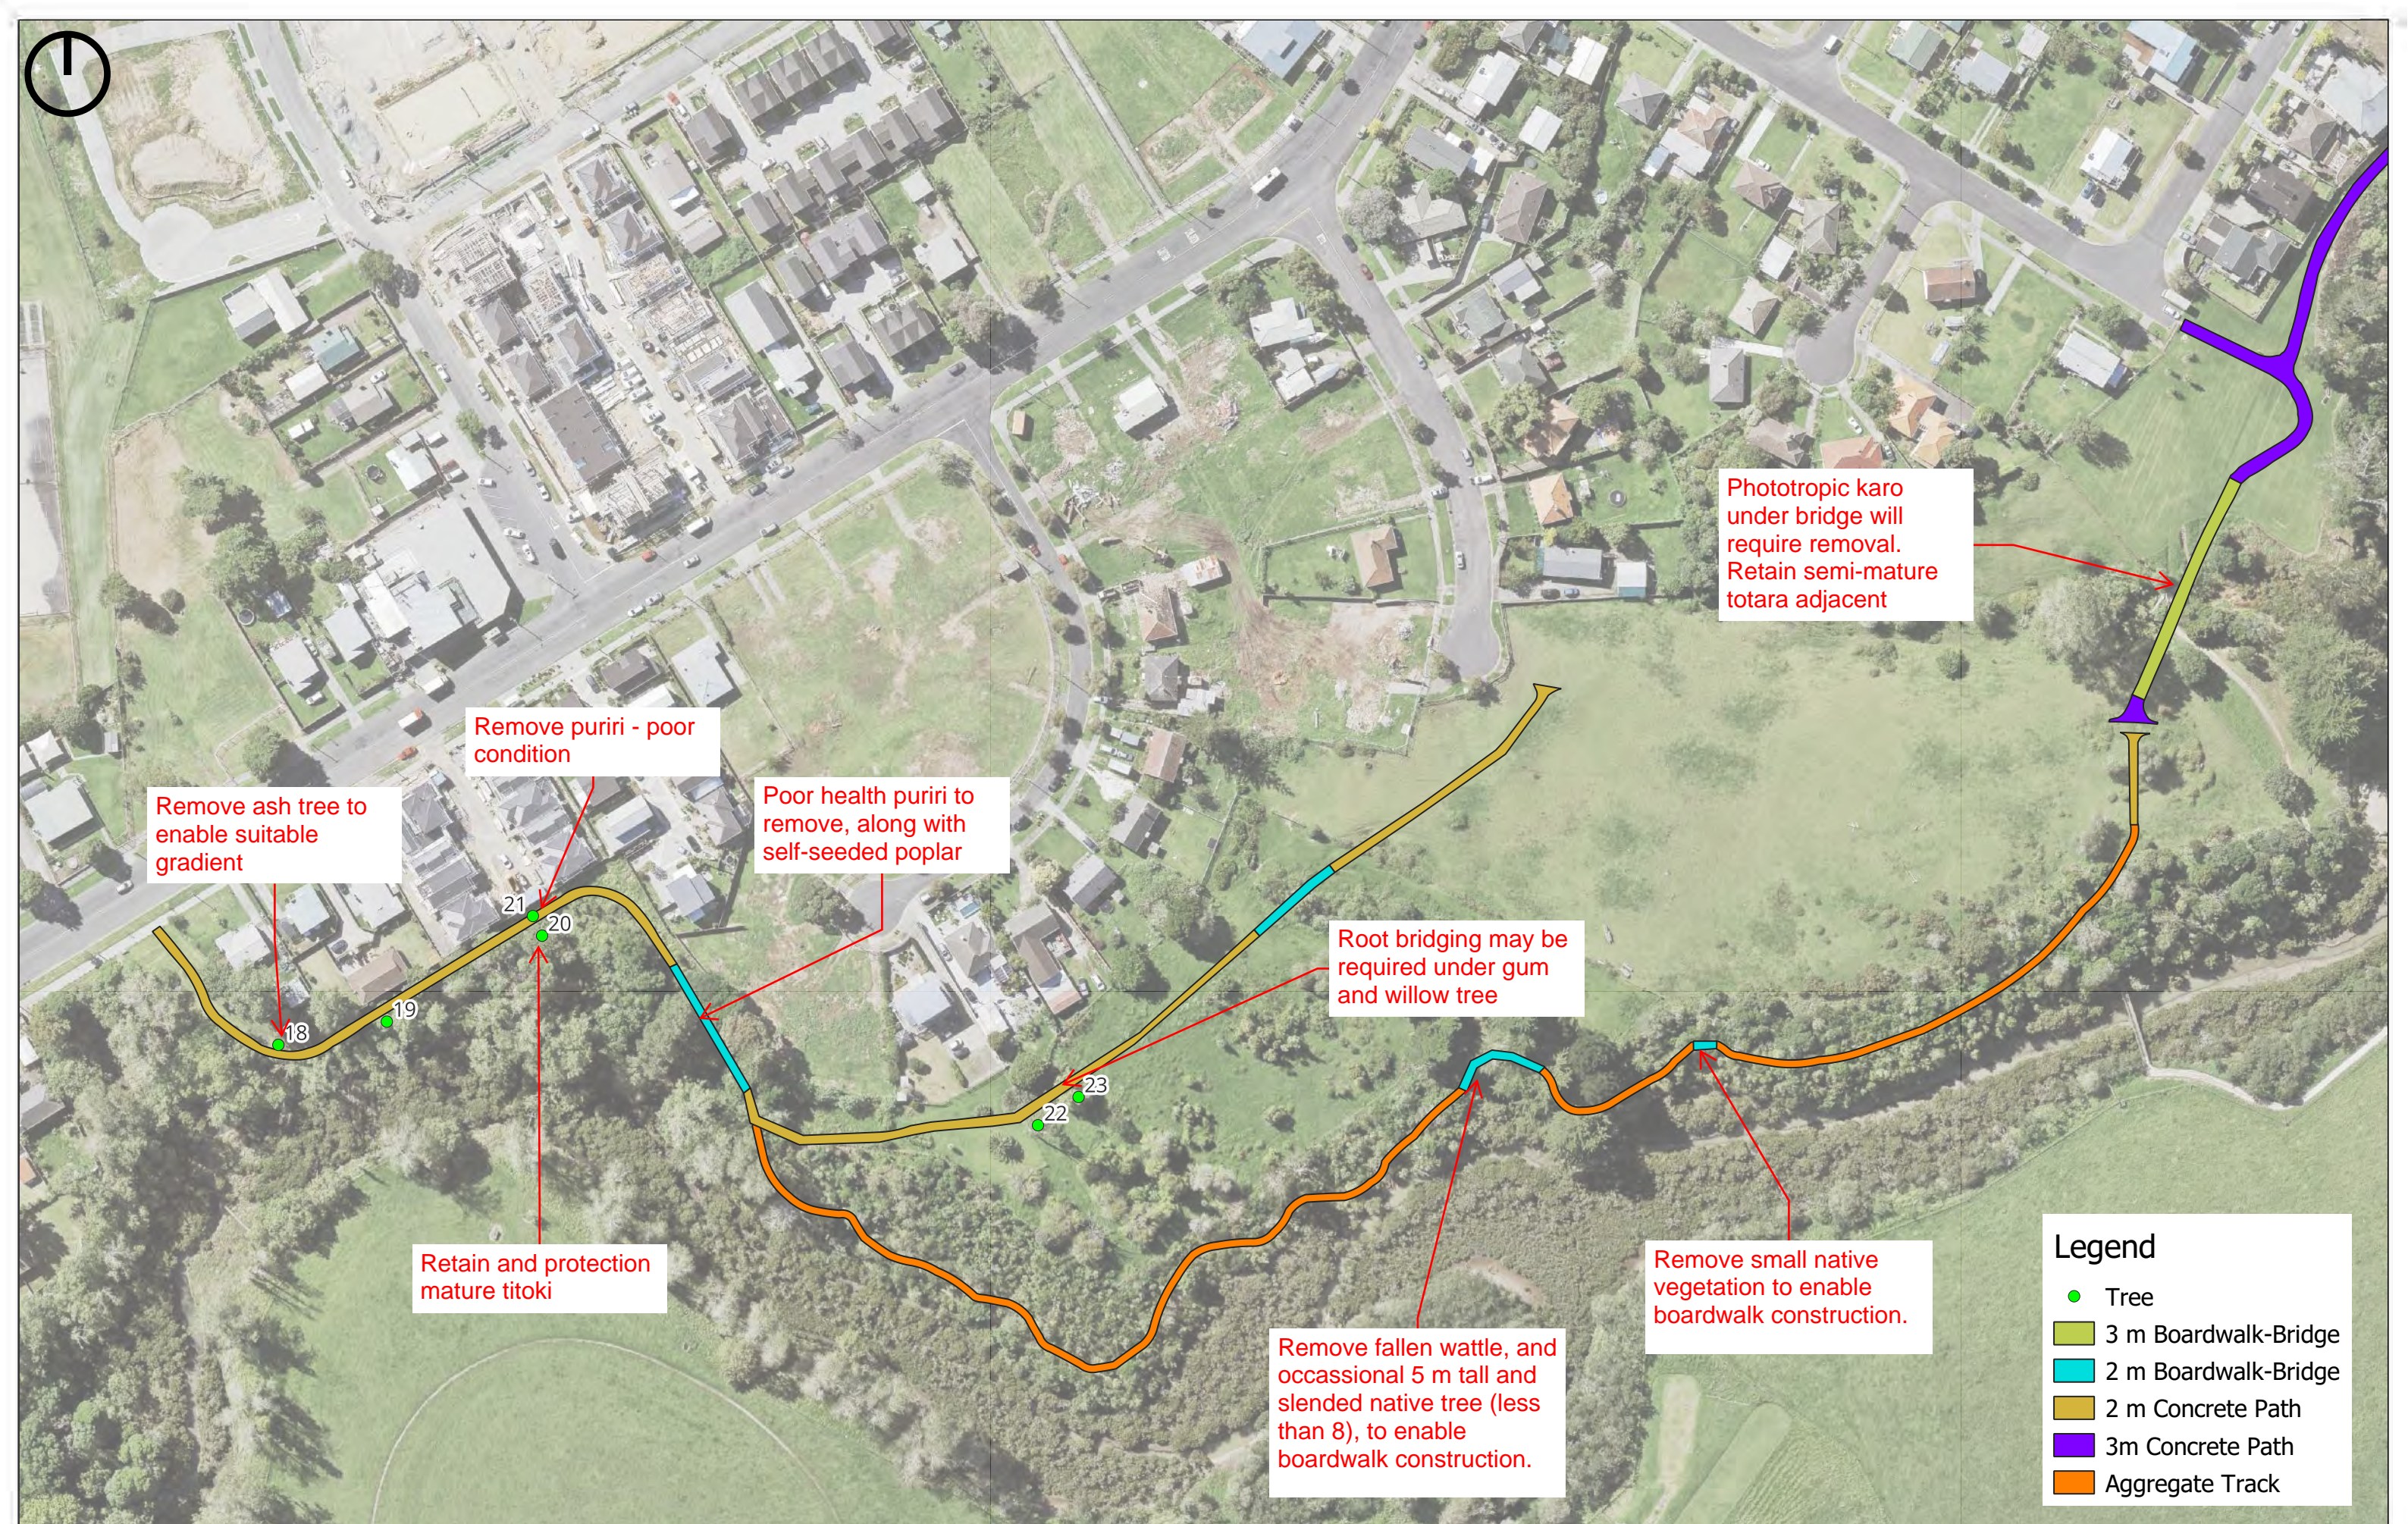
Drawing: 2758_002_A

Phototropic karo under bridge will require removal. Retain semi-mature totara adjacent

Remove puriri - poor condition

Remove ash tree to enable suitable gradient

Poor health puriri to remove, along with self-seeded poplar

Root bridging may be required under gum and willow tree

Retain and protection mature titoki

Remove fallen wattle, and occasional 5 m tall and slended native tree (less than 8), to enable boardwalk construction.

Remove small native vegetation to enable boardwalk construction.

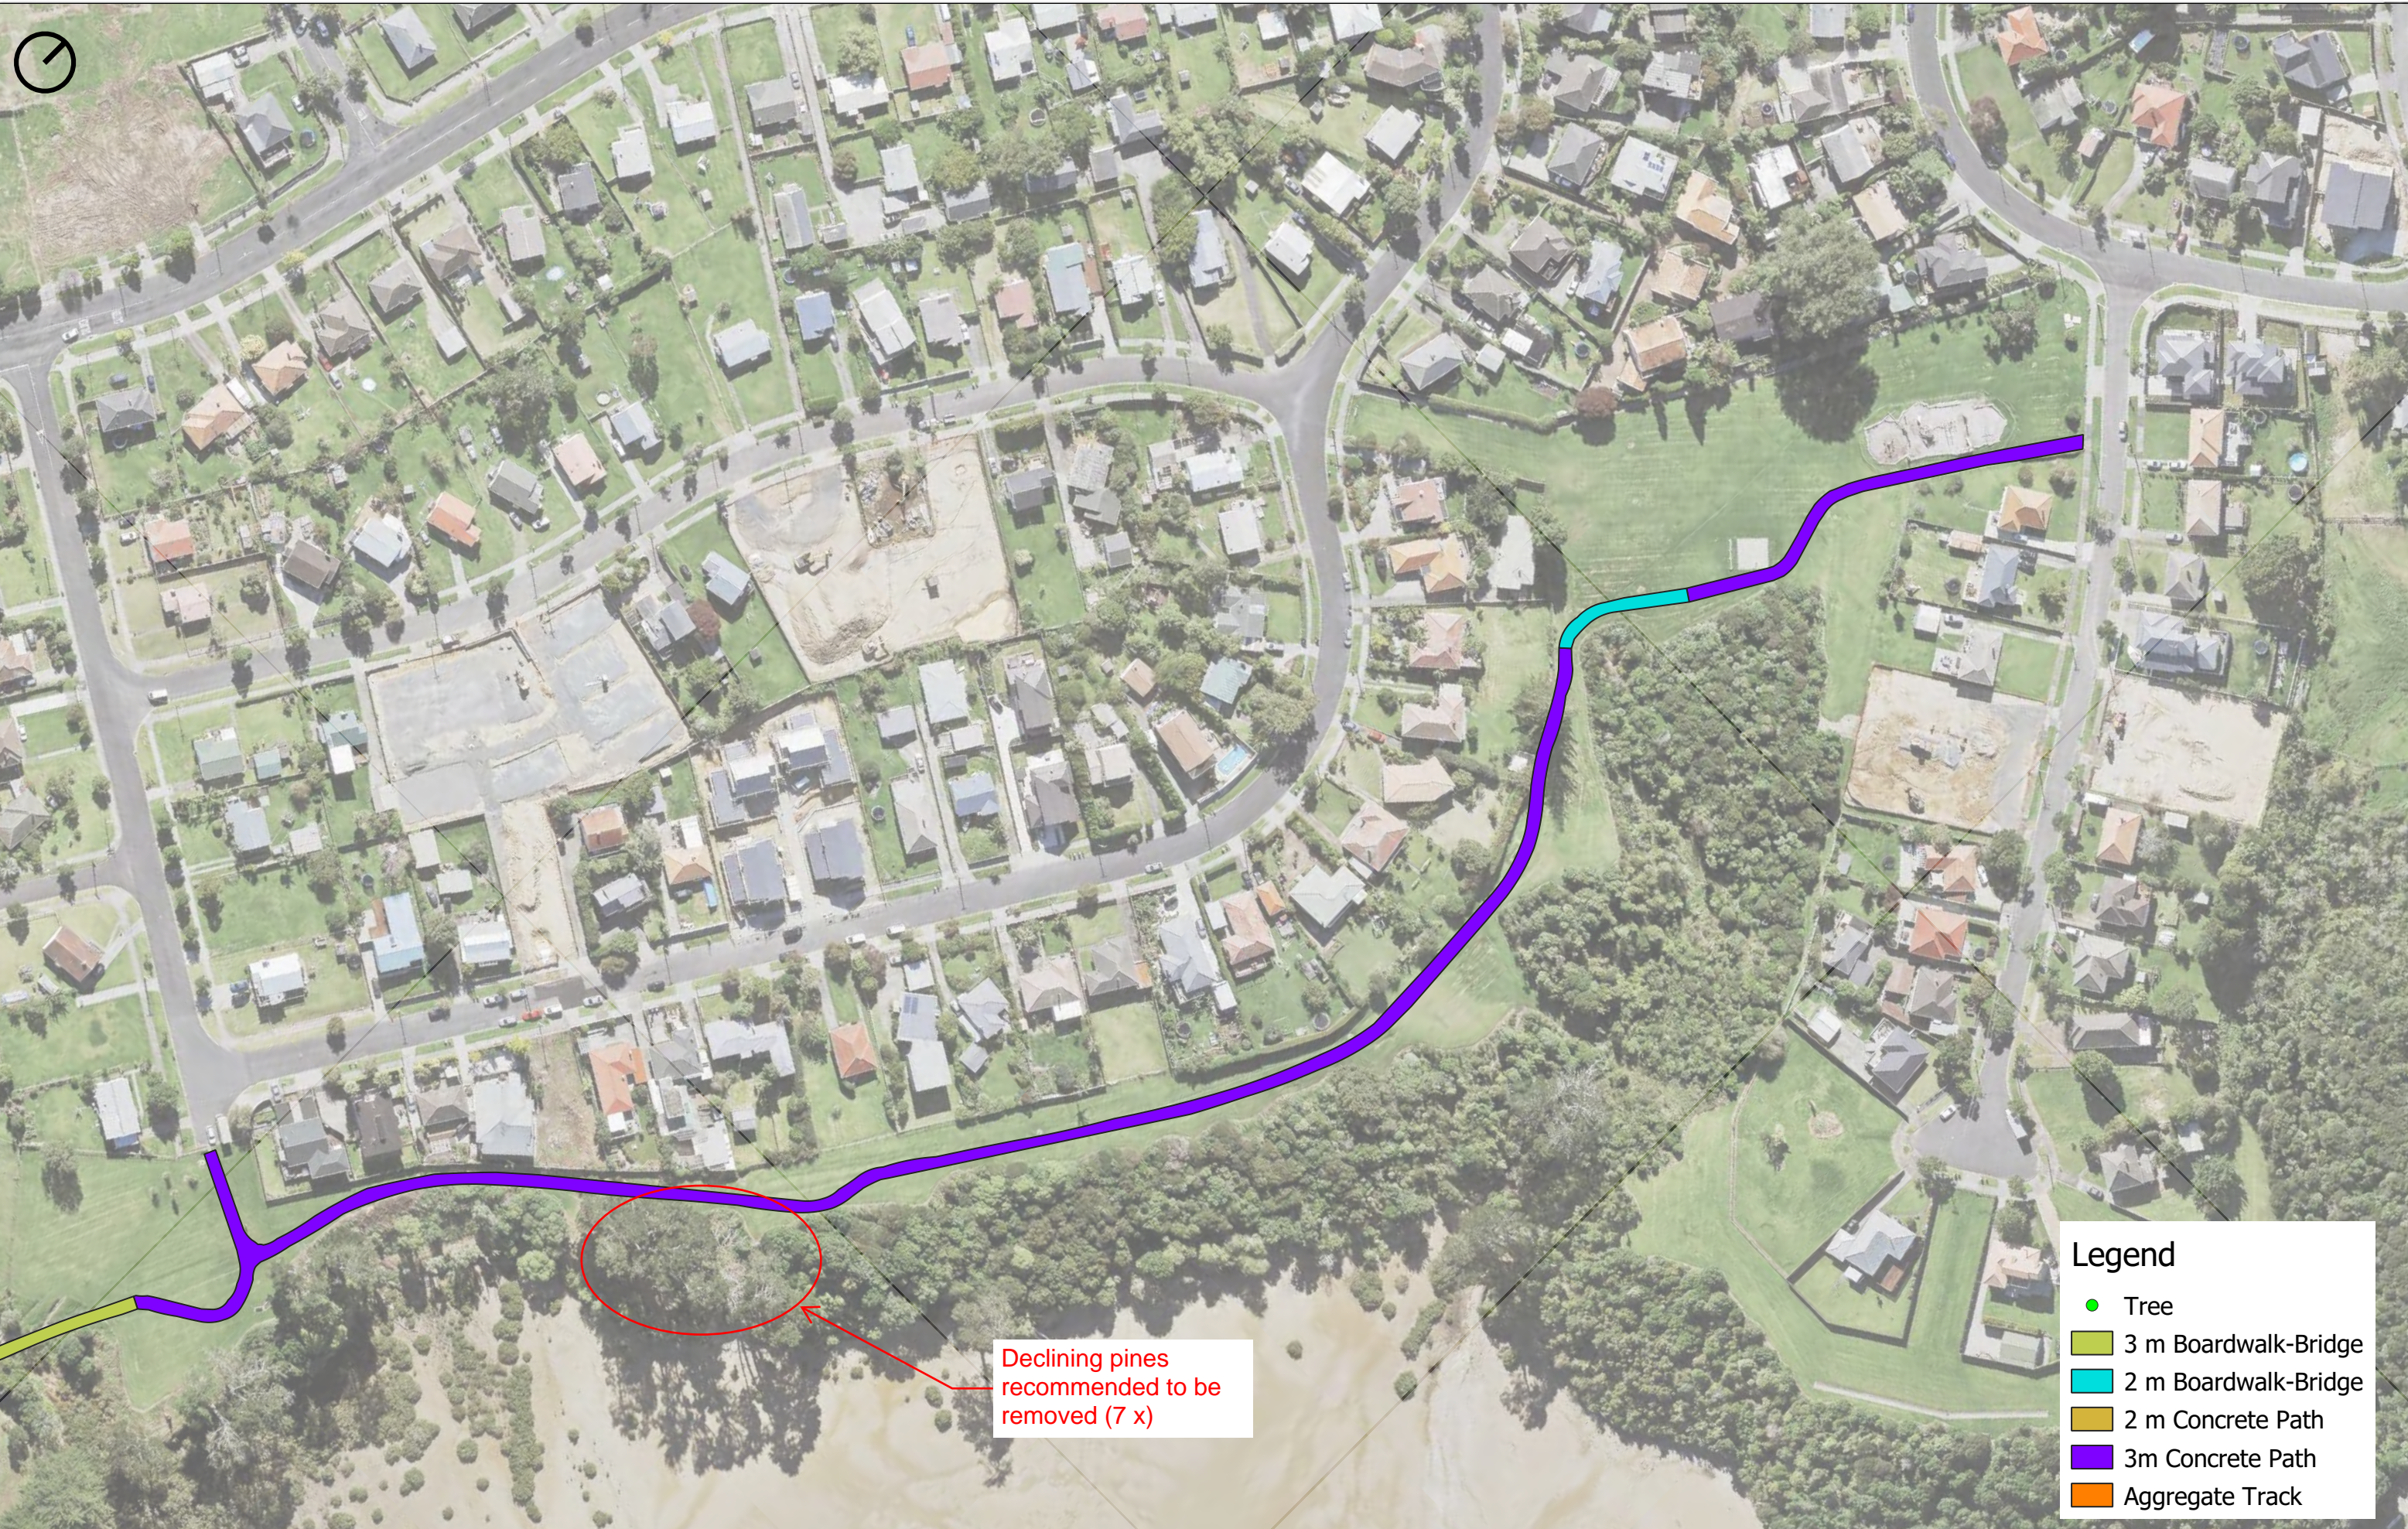
Declining pines
recommended to be
removed (7 x)
