3 December 2025

G00417

PROPOSED FILL FACILITY DEVELOPMENT AT 362 JONES ROAD, HUNUA – LANDSLIDE HAZARD RISK ASSESSMENT REPORT FOR NORTH FILLING AREA

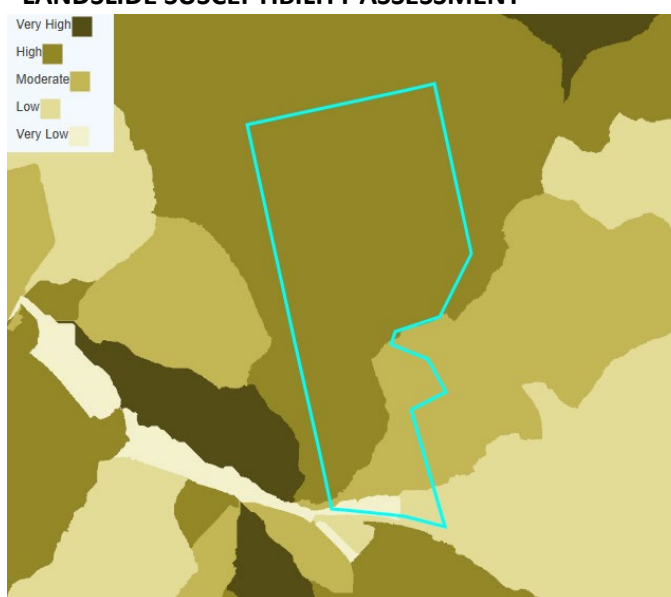
FIGURE 1: AUCKLAND COUNCIL GIS LARGE SCALE LANDSLIDE SUSCEPTIBILITY ASSESSMENT

The Auckland Council GeoMaps software indicates that, with respect to landslide hazards, the northern part of the subject site is defined as “High Susceptibility” by the Level A Large Scale Landslide Susceptibility Assessment. The northern part of the site is generally defined as “Low Susceptibility” by the Level A Shallow Landslide Susceptibility Assessment with a localised area within the north-eastern corner defined as “Moderate to High Susceptibility”.

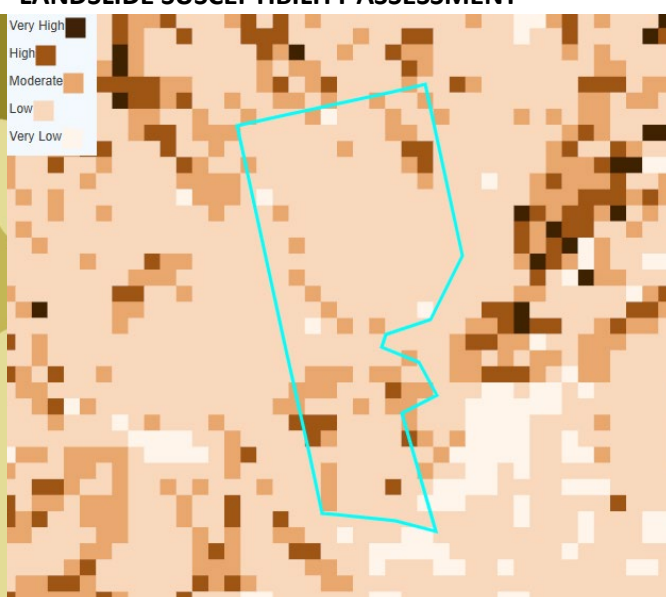
FIGURE 2: AUCKLAND COUNCIL GIS SHALLOW LANDSLIDE SUSCEPTIBILITY ASSESSMENT

It is noted that, from a review of Appendix 24 of PC120 of the AUP, should the Auckland Council Landslide Susceptibility maps indicate that the site has a Medium, High or Very High susceptibility classification, a landslide hazard risk assessment is required.

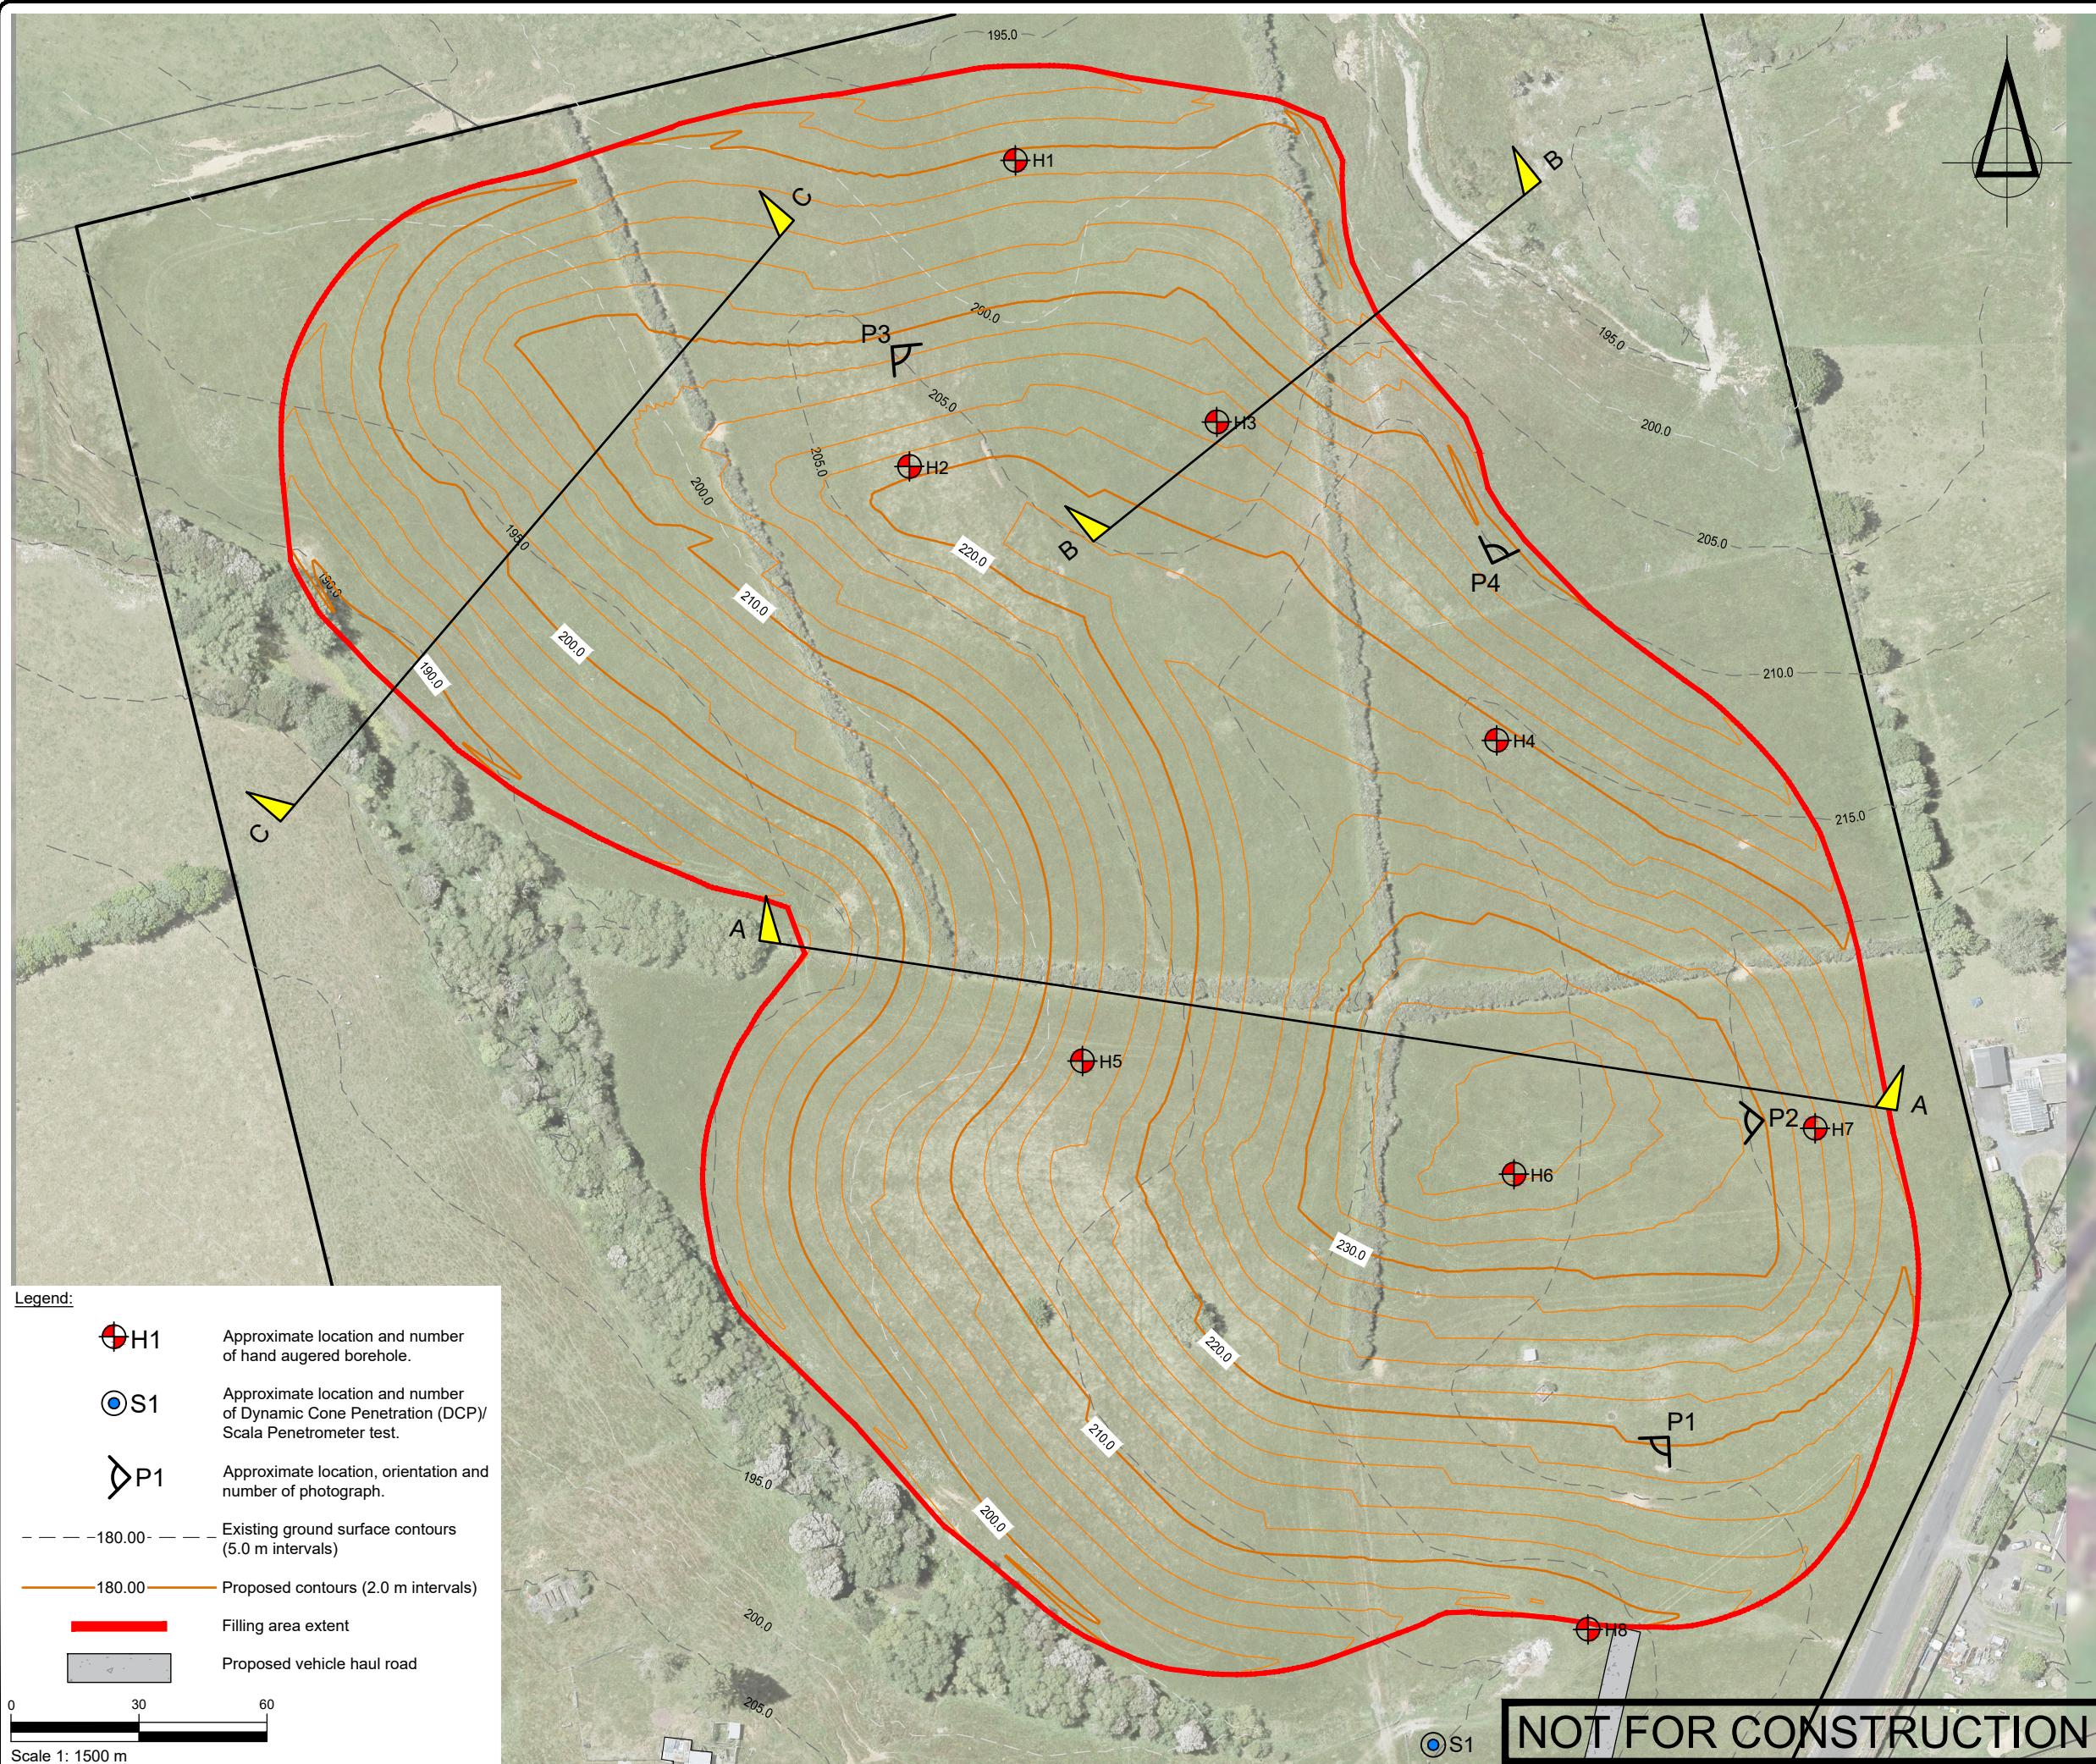
TITLE
PROPOSED
NORTH FILLING AREA
SITE PLAN

Given the foregoing susceptibility classifications for the site, a landslide hazard risk assessment has therefore been undertaken, in accordance with Appendix 24 of PC120 of the AUP, on the existing moderately steep gully side slope, represented by Cross Section BB presented in the October 2024 report, and located in the north-eastern corner of the subject site, as shown on the appended Fraser Thomas Ltd drawing G00417/2.

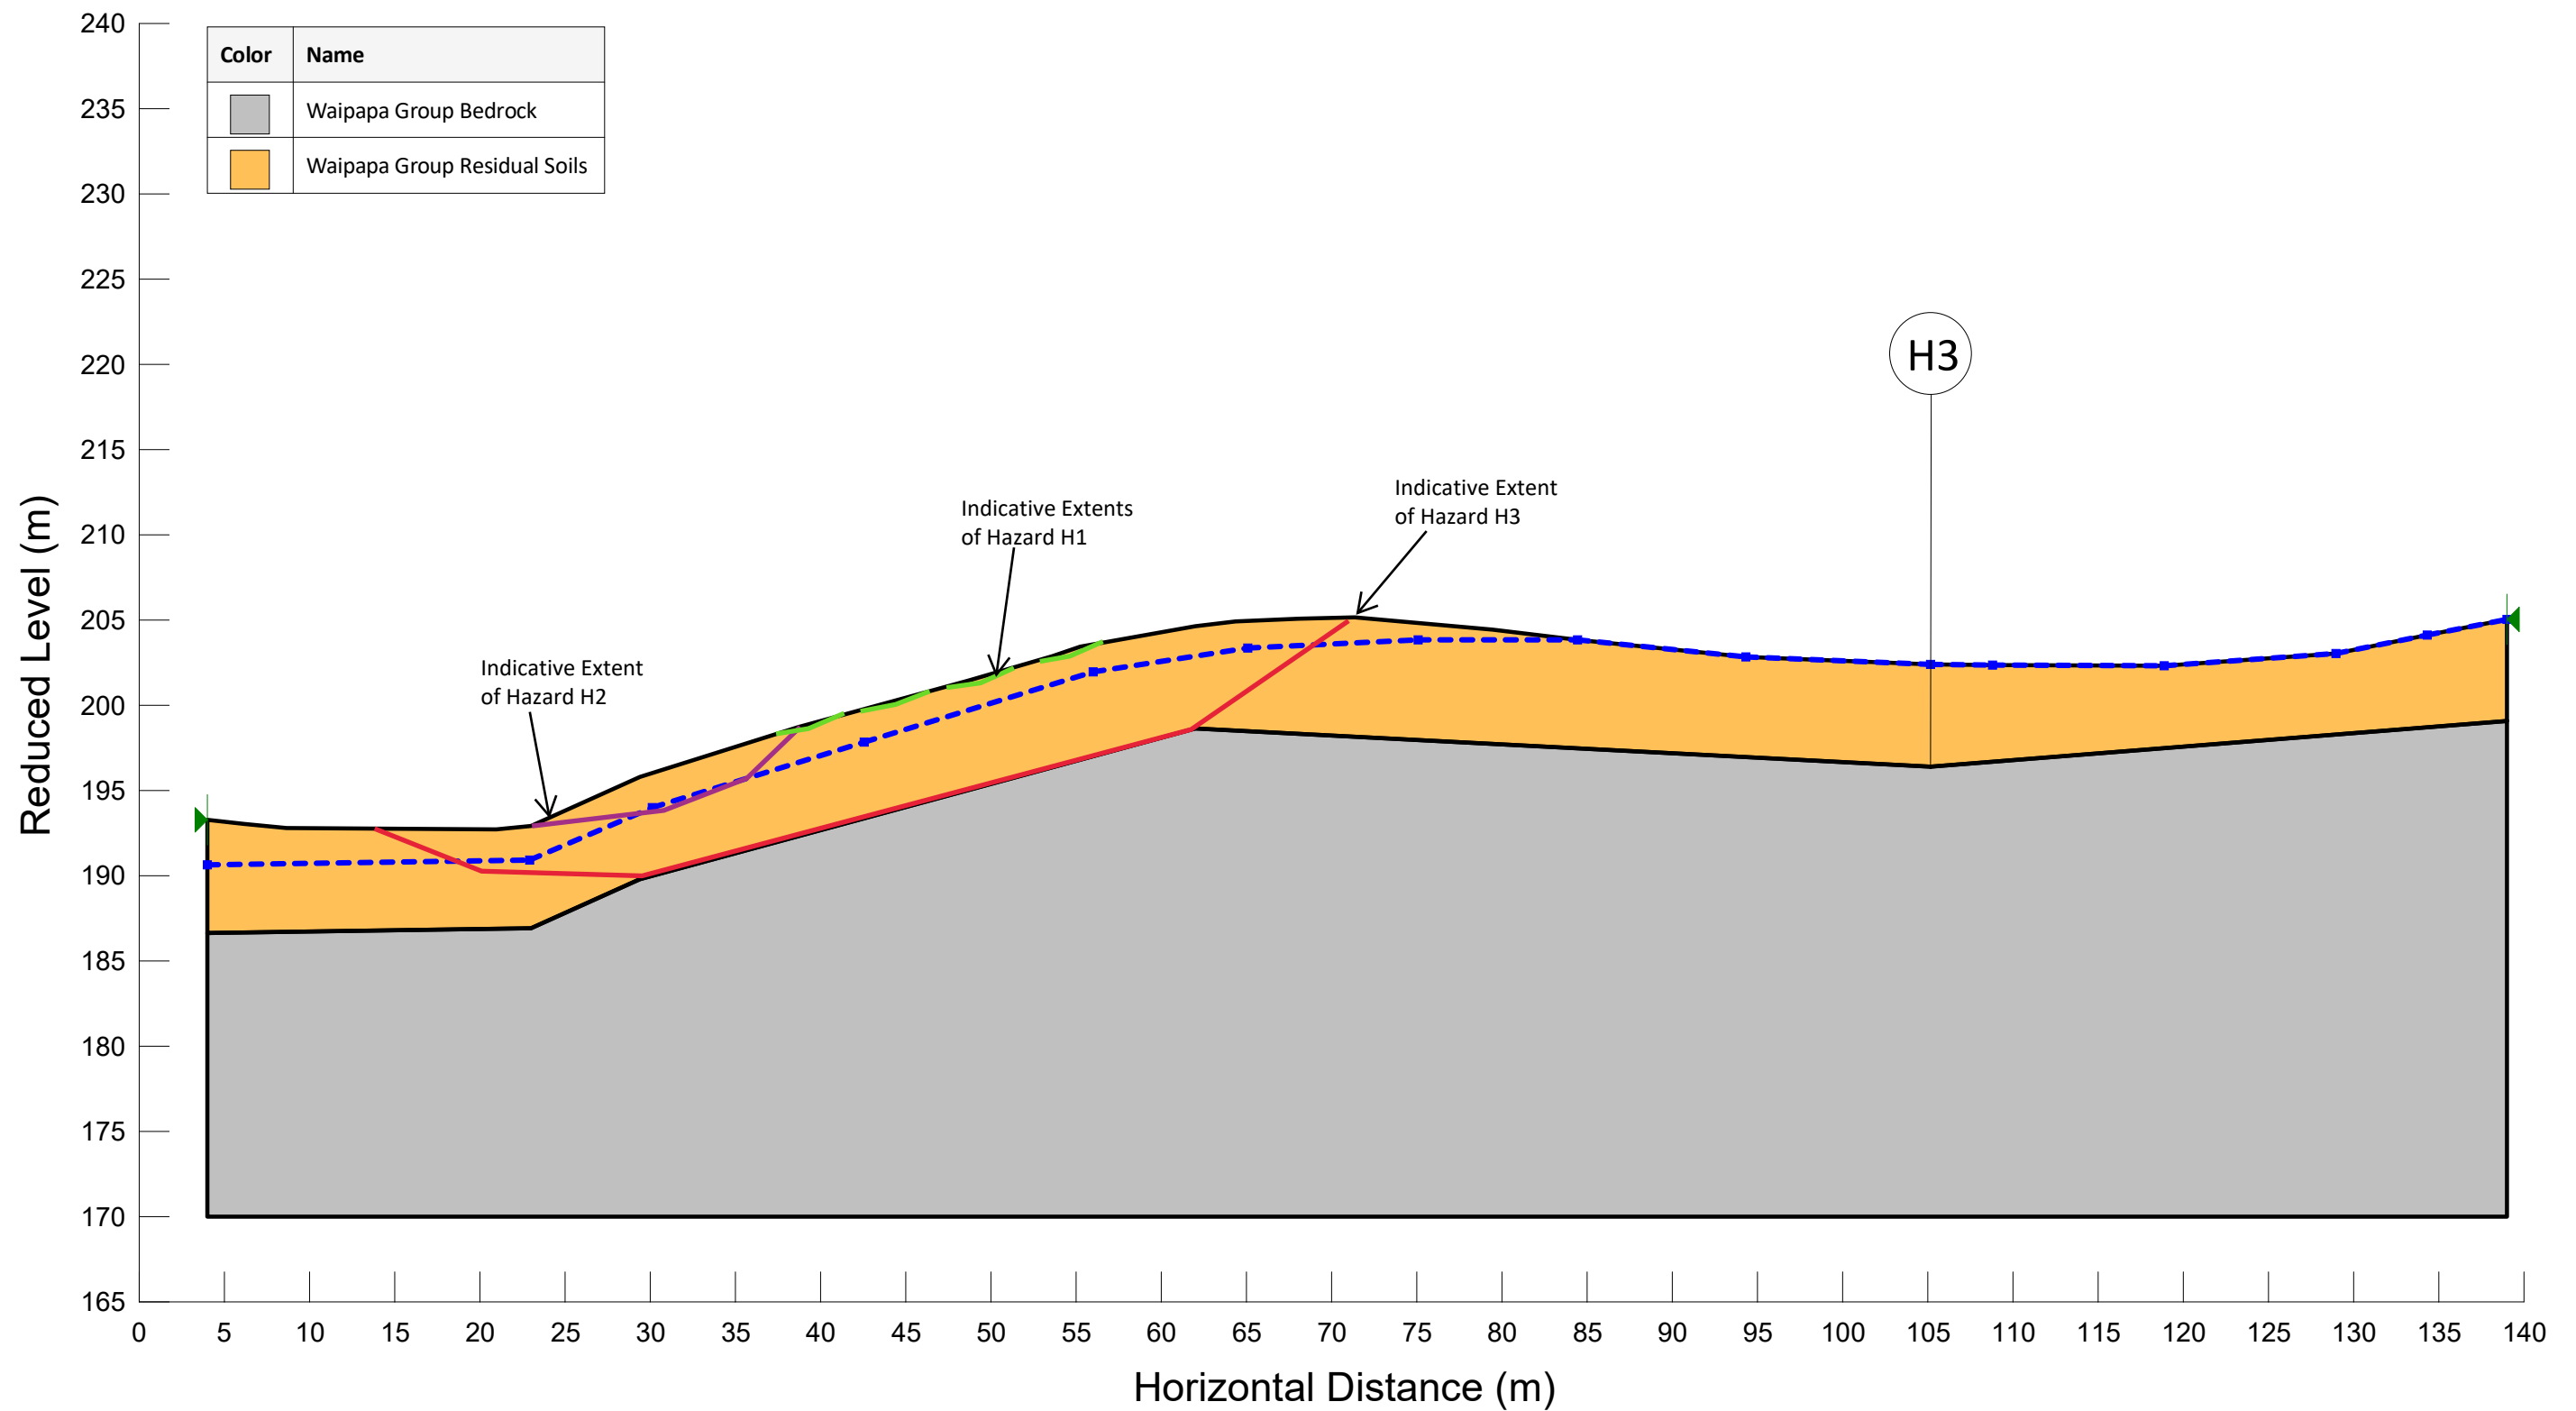
CROSS SECTION BB - ENGINEERING GEOLOGICAL MODEL AND INDICATIVE HAZARDS SECTIONS

Based on our review of the available information and adopted engineering geological model, three potential landslide hazards were defined; a high likelihood (H1), median likelihood (H2) and the maximum credible event (H3), which could adversely affect the existing gully side slope in the north-eastern corner of the site. The landslide hazards are shown on the appended annotated Engineering Geological Model drawing.

Hazard No.	Brief Description of Slope Stability Hazard
H1	Surficial soil creep movement, affecting the upper 0.5 m of the gully side slope. Failure would not be noticeable and may lead to an accumulation of topsoil material at the base of the gully, i.e. recent alluvium, over a prolonged time period.
H2	A rotational or translational landslide within the residual soils, affecting the lower part of the gully side slope. Failure would likely be slow moving and landslide debris would accumulate in the base of the gully.
H3	A rotational or translational landslide within the residual soils, extending to the underlying bedrock, affecting the whole gully side slope. Failure would likely be slow moving and landslide debris would accumulate in the base of the gully.

Hazard No.	Likelihood Category	Consequence Category	Risk Classification
H1	Likely	Insignificant	Low (acceptable)
H2	Unlikely	Insignificant	Low (acceptable)
H3	Barely Credible	Minor	Low (acceptable)
