Our Reference: P -002665  
11 March 2025

## 22 and 22A Summit Drive, Mount Albert Geological Assessment for Resource Consent

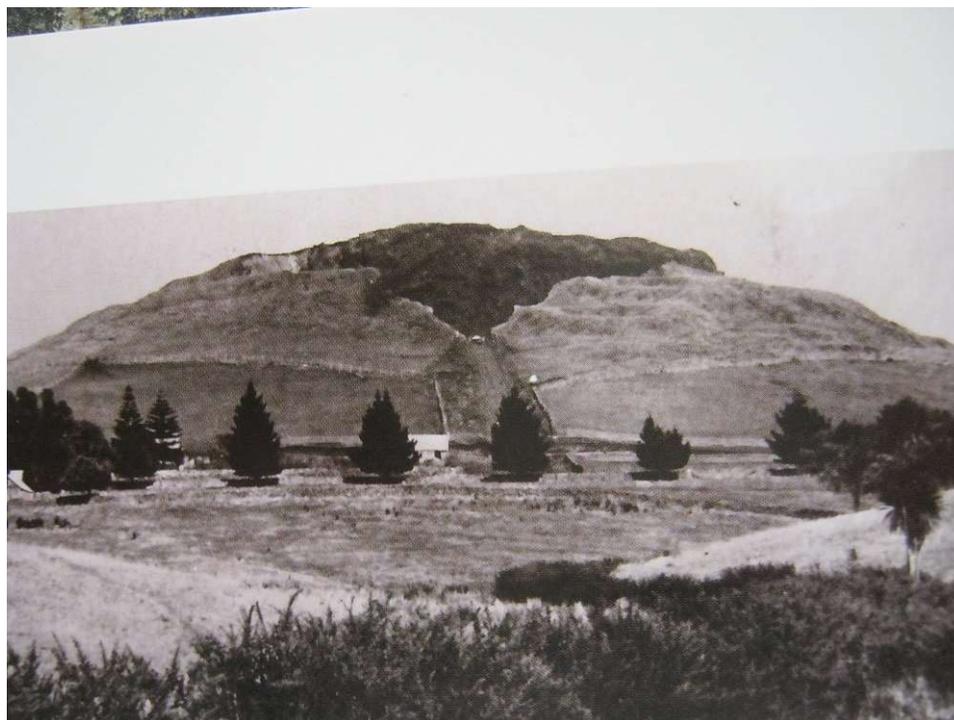
**Figure 4: North Side of Ōwairaka in the 1890's during early stages of scoria quarrying**

The upper 15 m to 20 m of scoria and volcanic material was quarried from the top of the maunga, with 1.5 million cubic metres removed between 1860 and 1959 (See figure 4 above). The two upper cones of the maunga were further modified by installation of water reservoirs and sports fields with the quarried crests/cones. The quarrying, reservoir installation, roading and residential construction on the lower slopes have destroyed or damaged almost all pre-European, and Māori occupation features<sup>3</sup>.

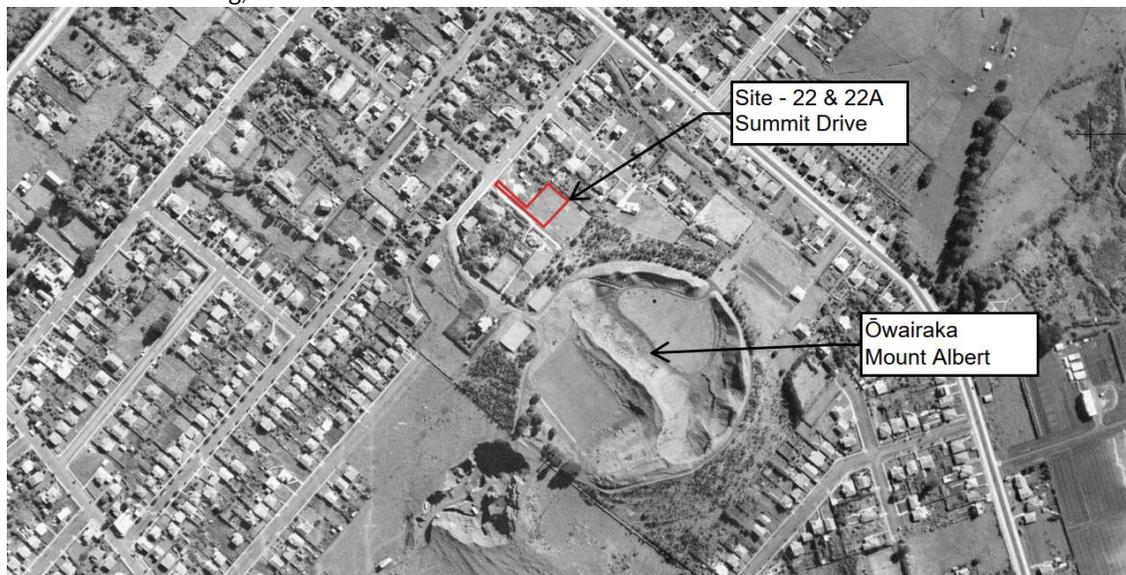
Further to the above information, Initia have undertaken a review of aerial photography and a site walkover of the property. Historic aerial photography was sourced from Retorlens.co.nz, providing images from 1940, 1955, 1961, 1966 and 1975. These images identify that the site was formed into a fenced residential section from before 1940. The site has been cleared of vegetation and appears to have been treated as a garden lot (see figure 5 below).

**Figure 5: 1940 Aerial photo showing the site as a fenced residential section**

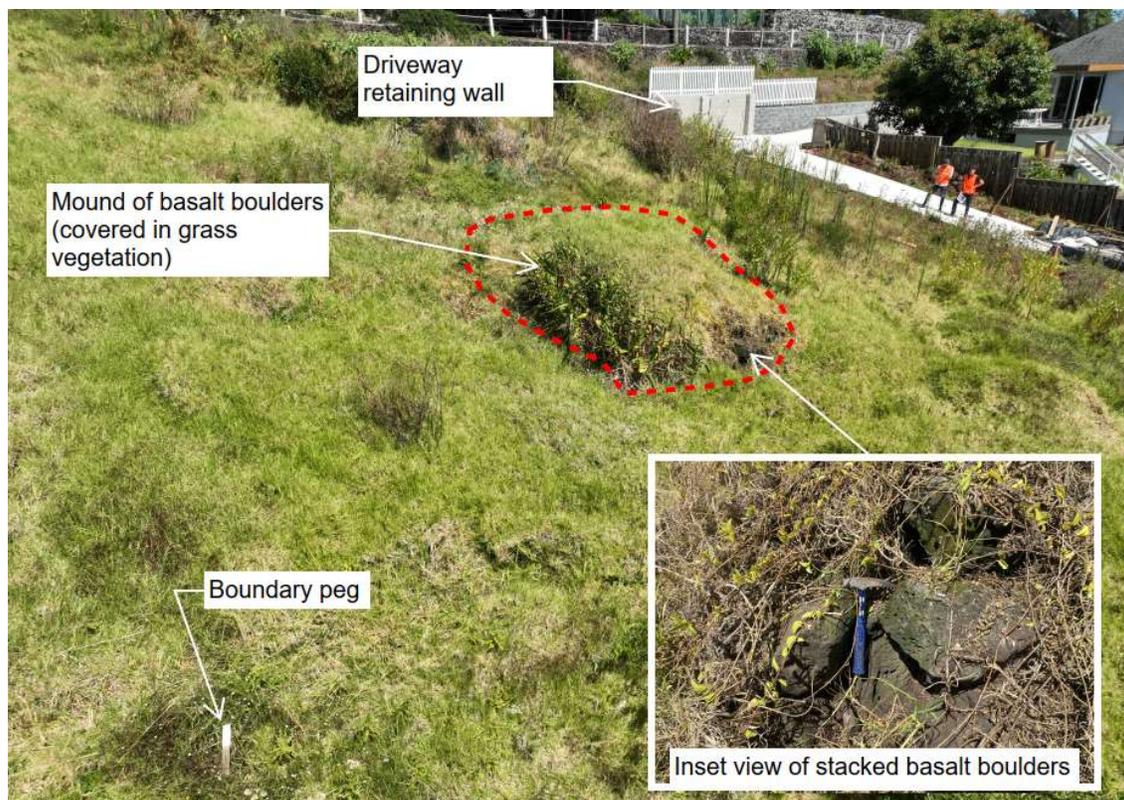
Our site walkover identified a small mound feature in a central part of the lot. Removing some of the grass coverage revealed a stacked mound of basalt boulders (refer to Figure 6 for a site photo of this feature). We closely inspected the basalt exposed (to determine if it could be in-situ and reflect the underlying geology). We however identified that the basalt boulders do not interlock and have been stacked in a mound. This is therefore inferred as a manmade feature from clearing the ground surface of large boulders, and collecting in one area. In consultation with the project archaeologist (Clough & Associates), while we have no exact indication of the age of this mound, it is likely associated with the clearance of fields for farming in the late 19<sup>th</sup> century or subdivision works that occurred from 1911 or could also have been deposited more recently. It is noteworthy, that an archaeological investigation carried out by Clough & Associates at 24 Summit Drive also identified a similar feature which likely was linked to farming, or associated with the deconstruction of a former scoria wall<sup>4</sup>.

**Figure 6: Site photo of vegetation coverage and stacked mound of basalt boulders**

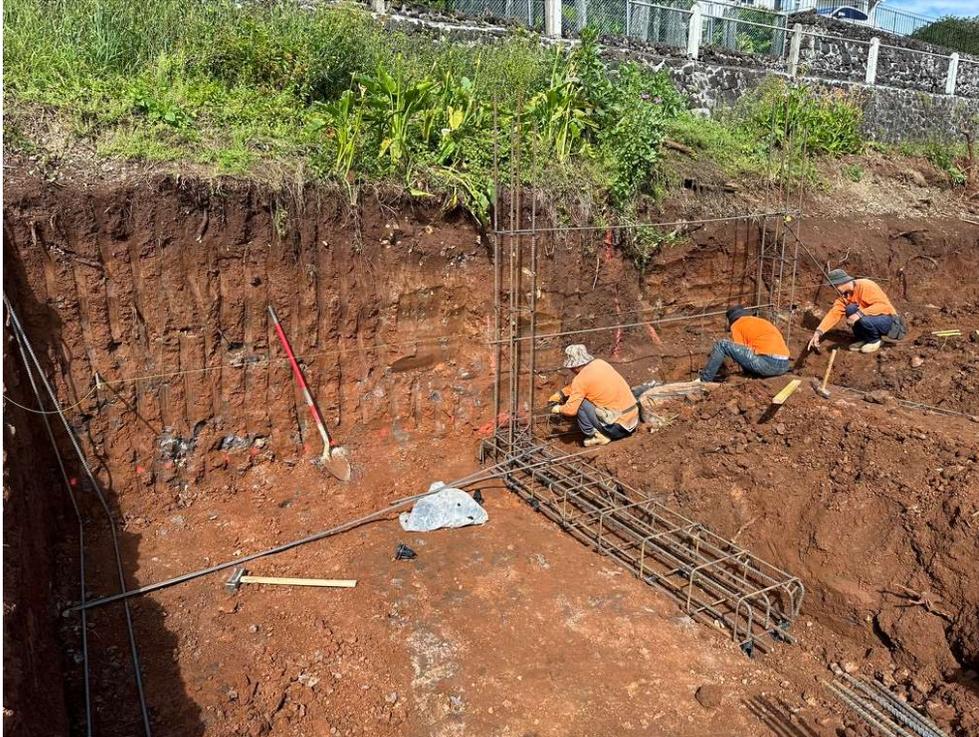
Furthermore the client has forwarded photo evidence of excavations from 2023 at the time of construction for a retaining wall along the current driveway access to the site (see figure 7 below) which supported the consented establishment of the two legal allotments at the site. The exposure is predominantly a dark reddish brown ash and scoria deposit, and boulders of dark grey basalt (bombs/inclusions) can be seen in the cut face.

**Figure 7: Photograph of excavations and construction of the current driveway and retaining wall on site (2023)**

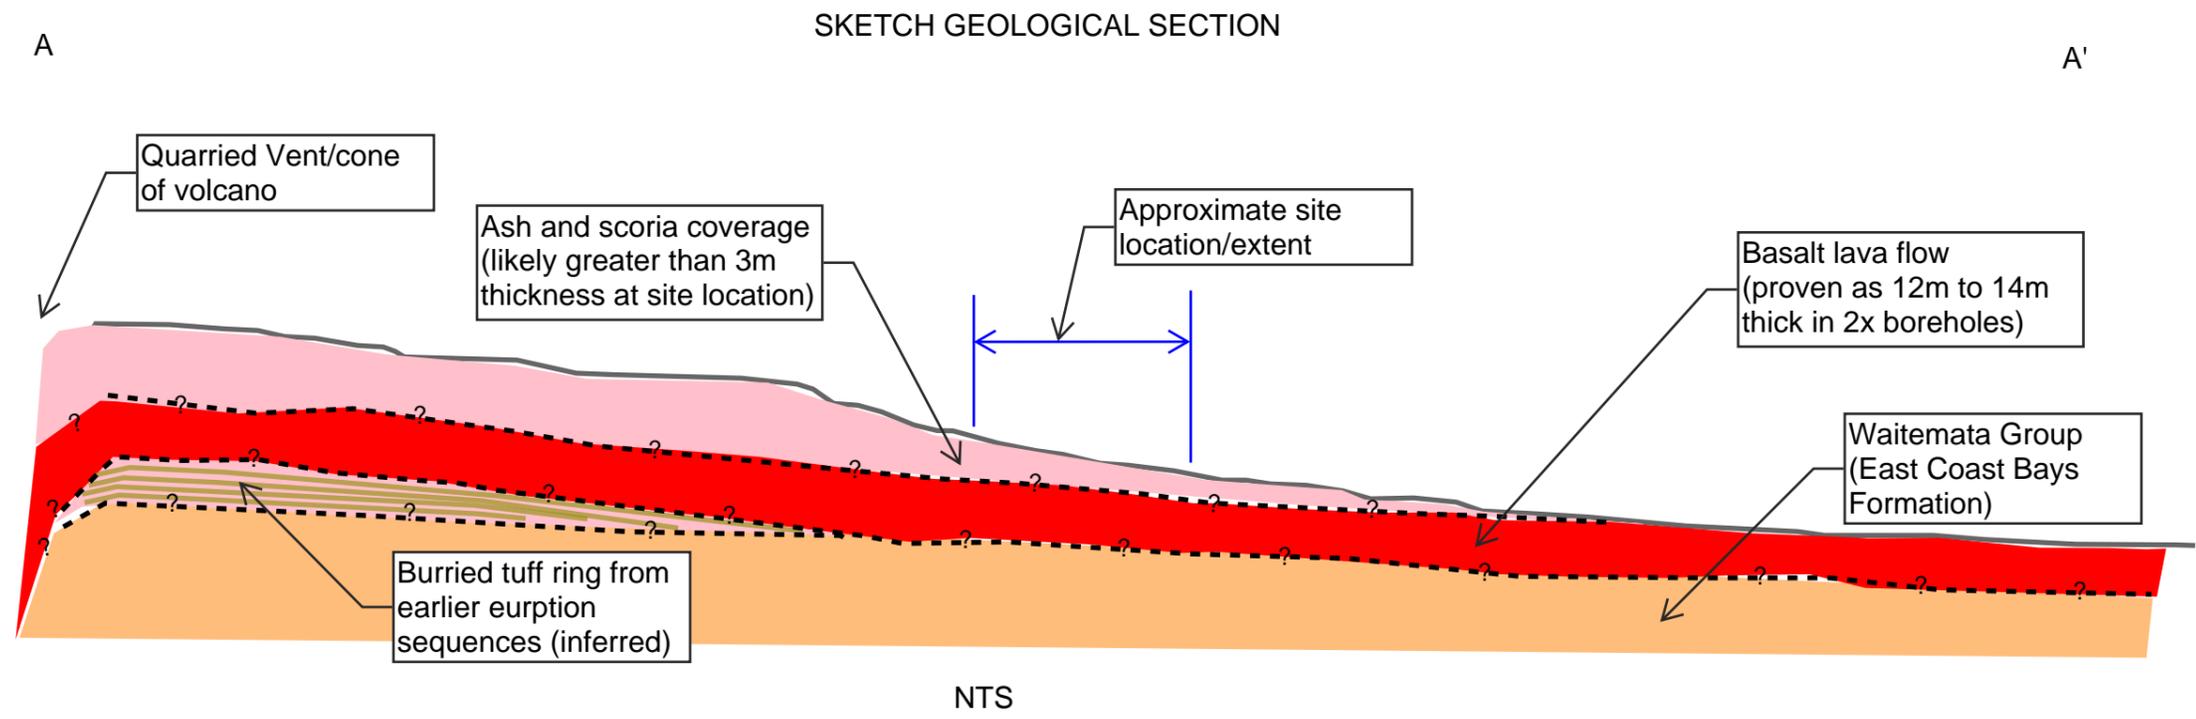
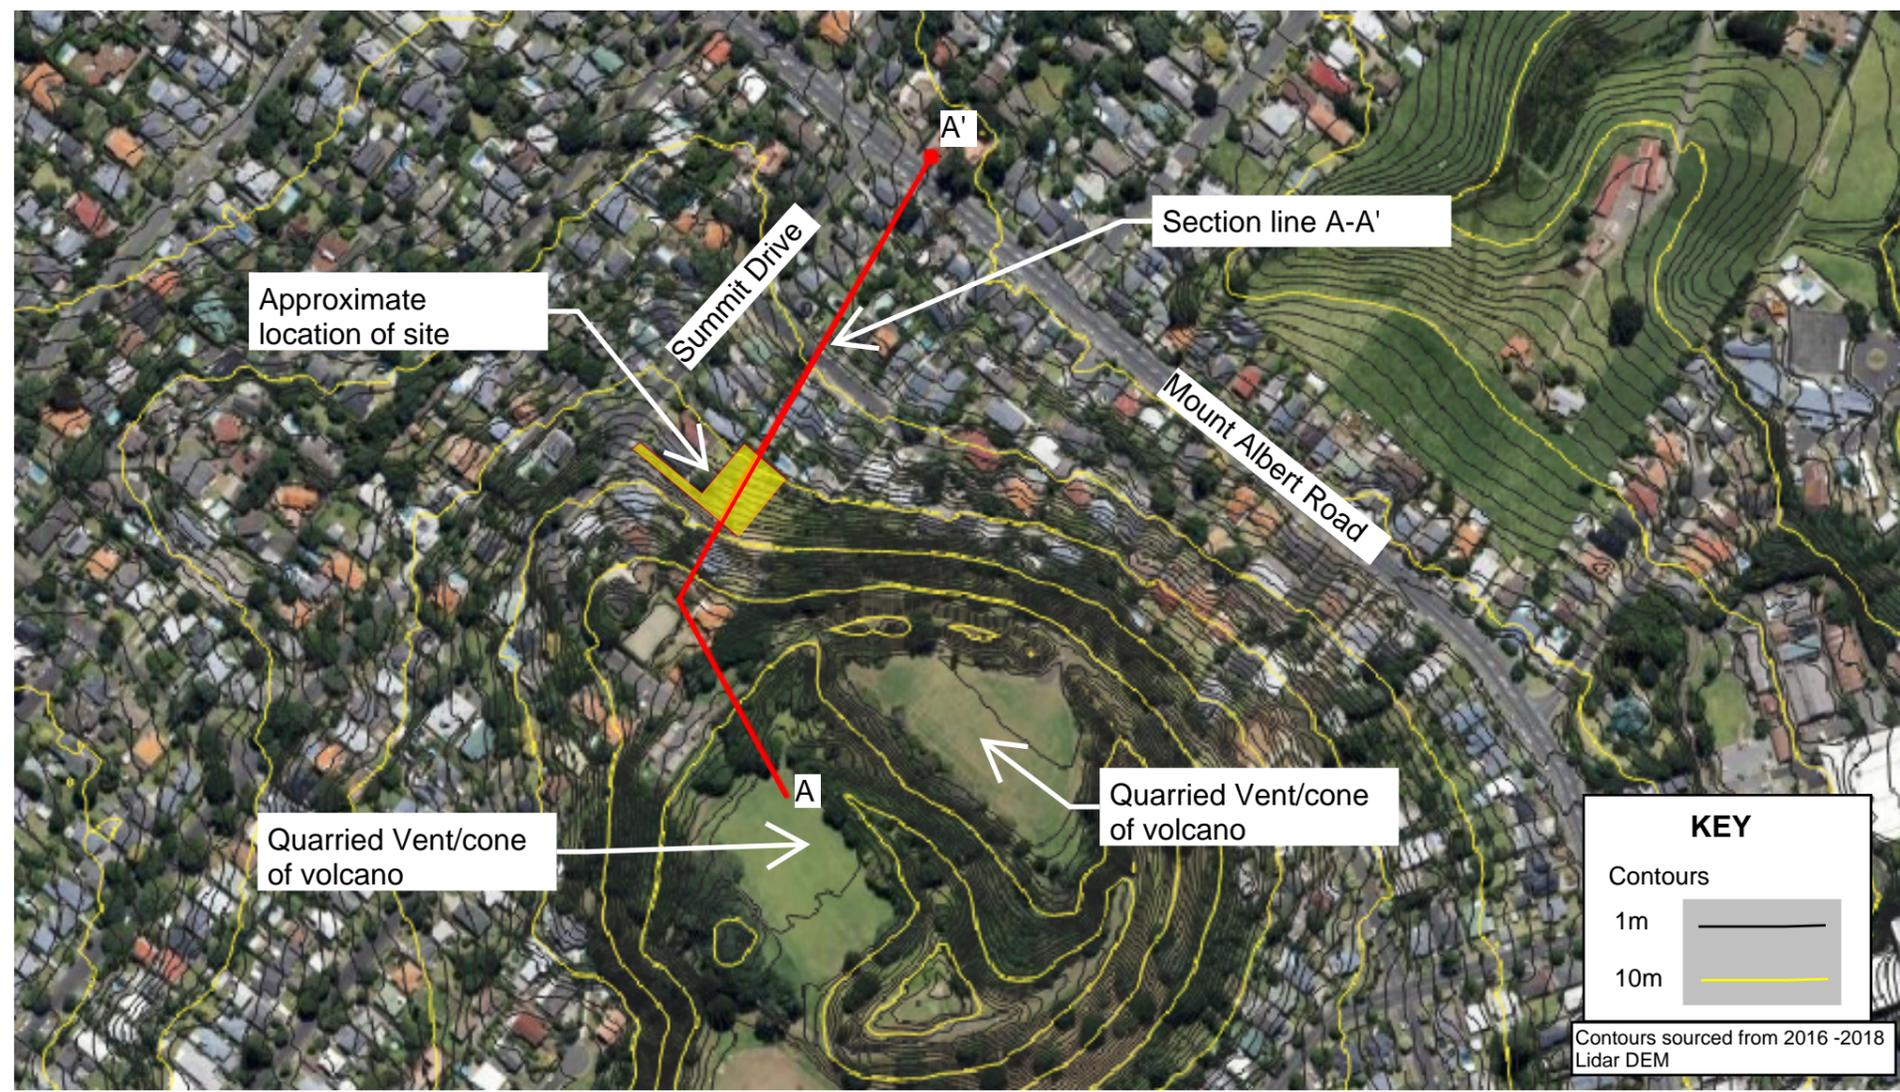
## **Appendix B: Sketch Geological Cross section**

Based on the desktop review information discussed above we have drafted a sketch geological section of the wider site. This is a sketch only, and should not be relied upon as a detailed geotechnical cross-section. It has been provided to give a visual guide of the likely geological layering and structure of the volcano, and also as basis for discussion of the geological value and potential or likelihood encountering outstanding natural features. This section is attached in Appendix B
