Arboricultural Assessment of Effects and Tree Protection Plan

For
Stormwater improvements including new pipes, culverts, and
swale drains – STAGE 1

at
**Tui Street and surrounding roads, Blackpool, Waiheke
Island**

Prepared by Andrew Benson (Ph.D., BSc, FdSc)
Urban tree ecophysiologist
Date 3 June 2025
Job ref # 2998

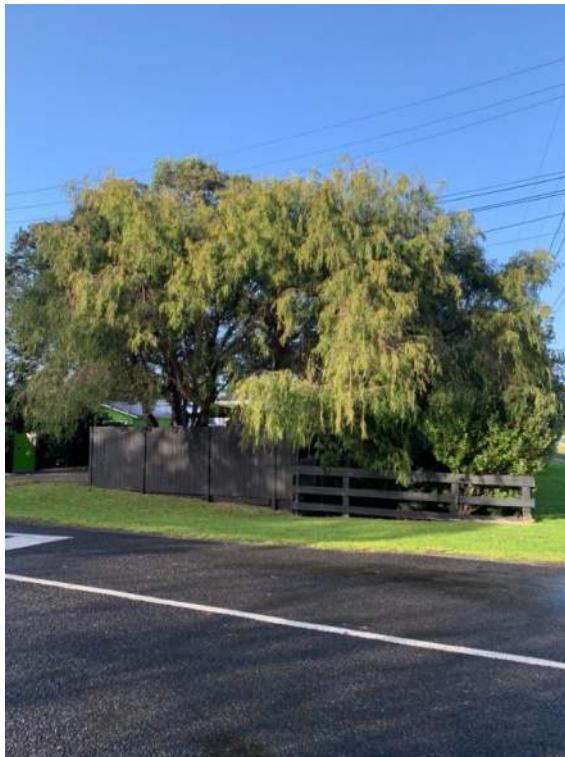
Figure 2: Willow myrtle tree (tree 4)

5.9 Excavations in the berm outside number 11 Rata Street will impact the root systems of a willow myrtle (*Agonis flexuosa*) (tree 4) and a pōhutukawa (*Metrosideros excelsa*) (tree 5). Woody roots (approx. 50 mm diameter) from these trees were seen in the grass berm, which provides an indication of what will likely be encountered when the proposed graded channel and a culvert under Rata Street are constructed. The impacts to both trees will be a root loss-induced water stress, likely affecting the willow myrtle more severely than the pōhutukawa, because the willow myrtle is closer to the proposed excavations (e.g., more of its root system will be impacted) and the willow myrtle is less tolerant to root cutting than the pōhutukawa, in my experience. The willow myrtle may show signs of localised crown sparseness in the five or so years following the works.

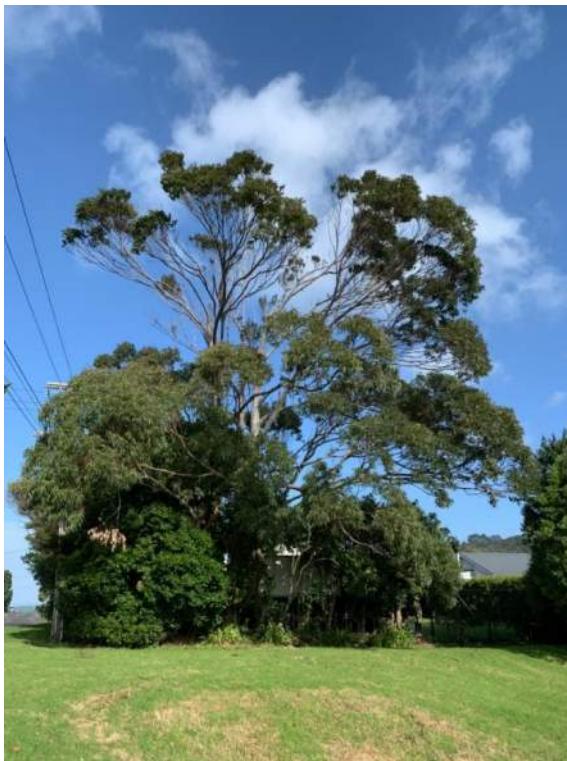
Figure 3: Eucalyptus tree (tree 70)

5.11 In a public reserve at 19 Moa Street, there is a 13 m-tall *Eucalyptus* tree near the southern boundary (tree 70). According to the design drawings, an 1,800 mm-diameter concrete pipe will be installed in this location with a 2.6 m-deep invert level. This will mean the trench will need to be shored, which will involve placing steel trench shields either side of the trench to prevent collapse. In contrast to shallow trenches where small (100 mm diam.) pipes and ducts can be carefully installed beneath surface roots of nearby trees, trench shields and other shoring systems preclude this, as all roots spanning the trench need to be cut and removed to install the trench support system. For the *Eucalyptus* tree, this will mean indiscriminate root loss along the edge of the trench. The impacts to the *Eucalyptus* tree will be a severe and chronic root loss-induced water stress. The current vitality of this tree is fair, and I estimated that up to 15% of its live crown is missing, likely due to invertebrate parasitism. The consequences of the root loss to this tree will most likely initiate a protracted decline in overall vitality and its eventual demise, likely over the ten years following the works. During that time, as increasing volumes of deadwood emerge in the tree, it will need to be removed, particularly where it overhangs the adjacent utility wires and the road / private property.
