**WESTERN SPRINGS NATIVE BUSH
RESTORATION PROJECT
ANNUAL REPORT**

MARCH 2023

Contract Report No. 5850b

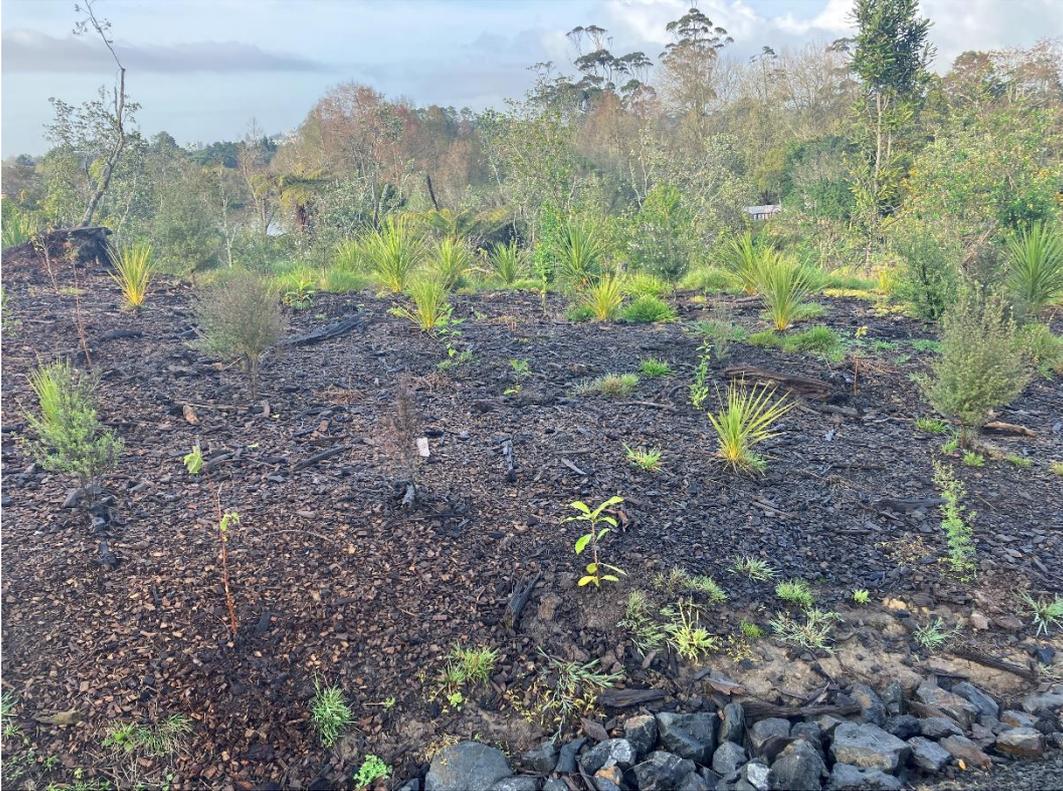
Infill planting to replace rabbit-browsed plants and plants that failed to establish within the cleared areas of Planting Area A (Figure 1) was undertaken in September 2022 (Plate 3). The number of each species planted is presented in Table 3.

Plate 3: Infill plants (foreground) among established plants within the upper areas of Planting Area A. 19 September 2022.

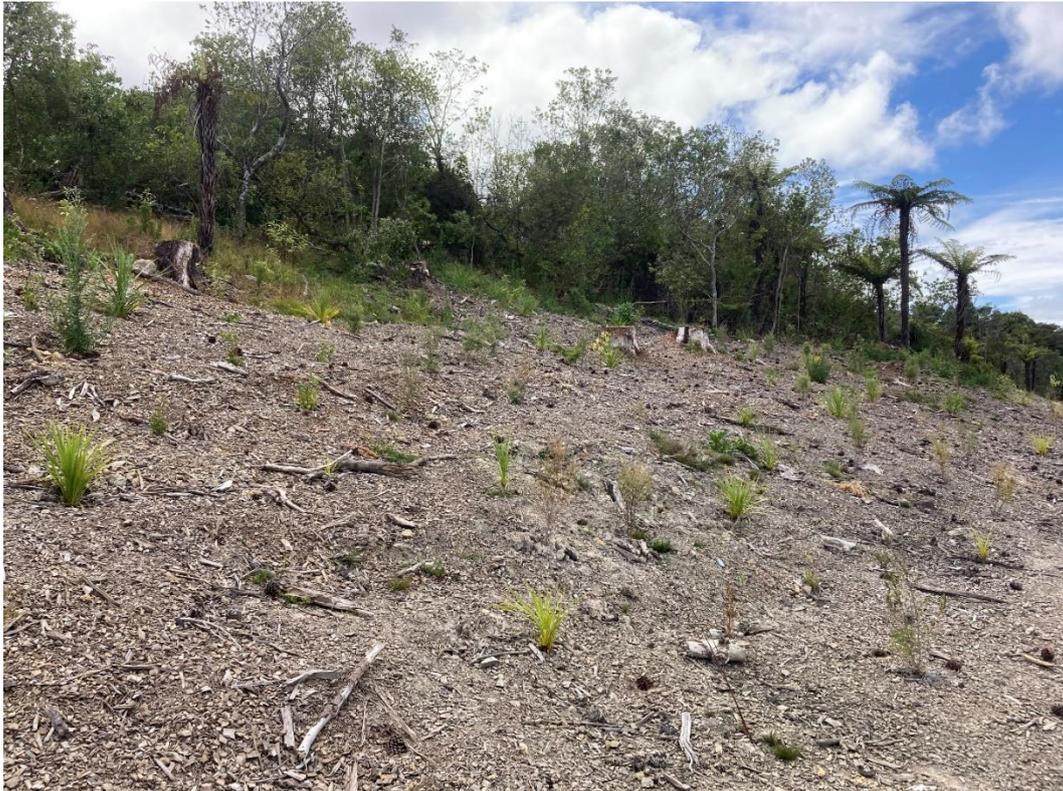
Plant growth within exposed areas in the east of Planting Area A (Figure 1) has naturally been slower (Plates 7 and 8). Soil conditions and rabbit browse in the first weeks after initial planting also contributed to slower growth rates in this area. Rabbit control has since been undertaken at the site by Council and plants are now well-established.

Plate 7: Initially slow plant establishment rates within the higher, exposed parts of the cleared area within Planting Area A. 1 February 2022.

- Plant Year 2 canopy species within suitably sheltered areas of the site as planned.
- Monitor and assess the slip site behind 16 West View Road and decide whether replanting should occur, and if so, when.
- Further monitor plant establishment within the cleared area over the next year and assess whether further infill planting is required in 2024 to ensure canopy closure over the whole site will be achieved.
- Assess any planting requirements after installation of the proposed loop track is completed.

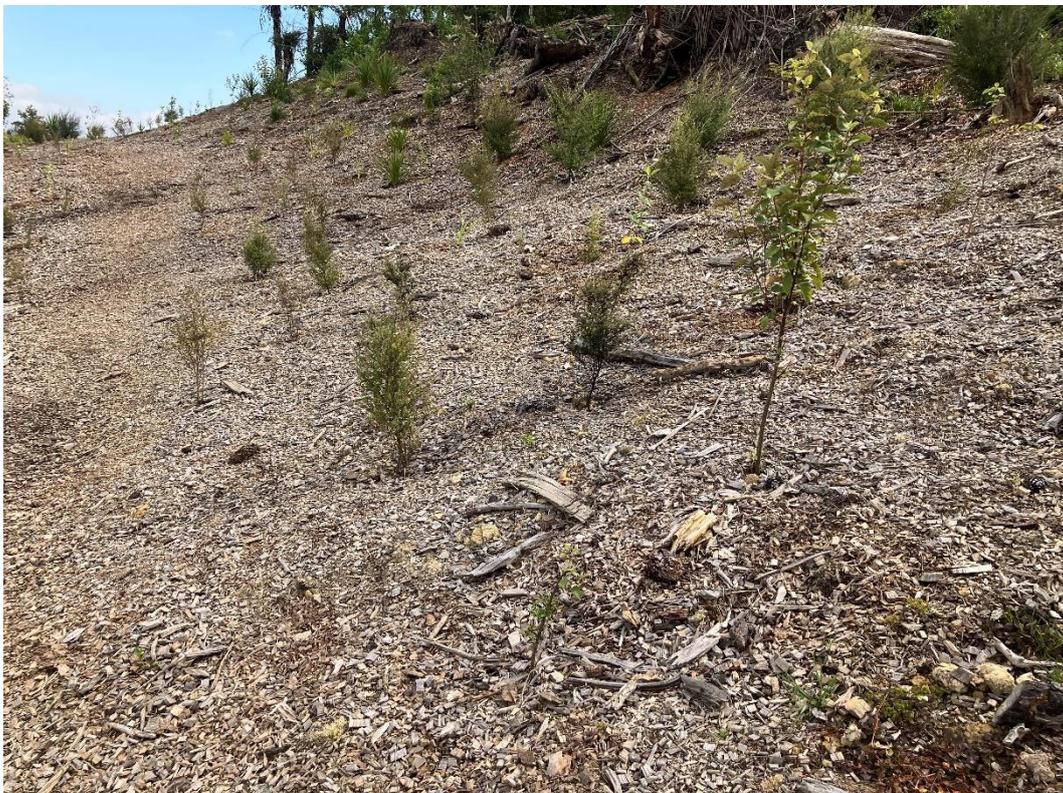
Plate 8: Indigenous plant establishment within exposed cleared areas of Planting Area A. 20 September 2022.

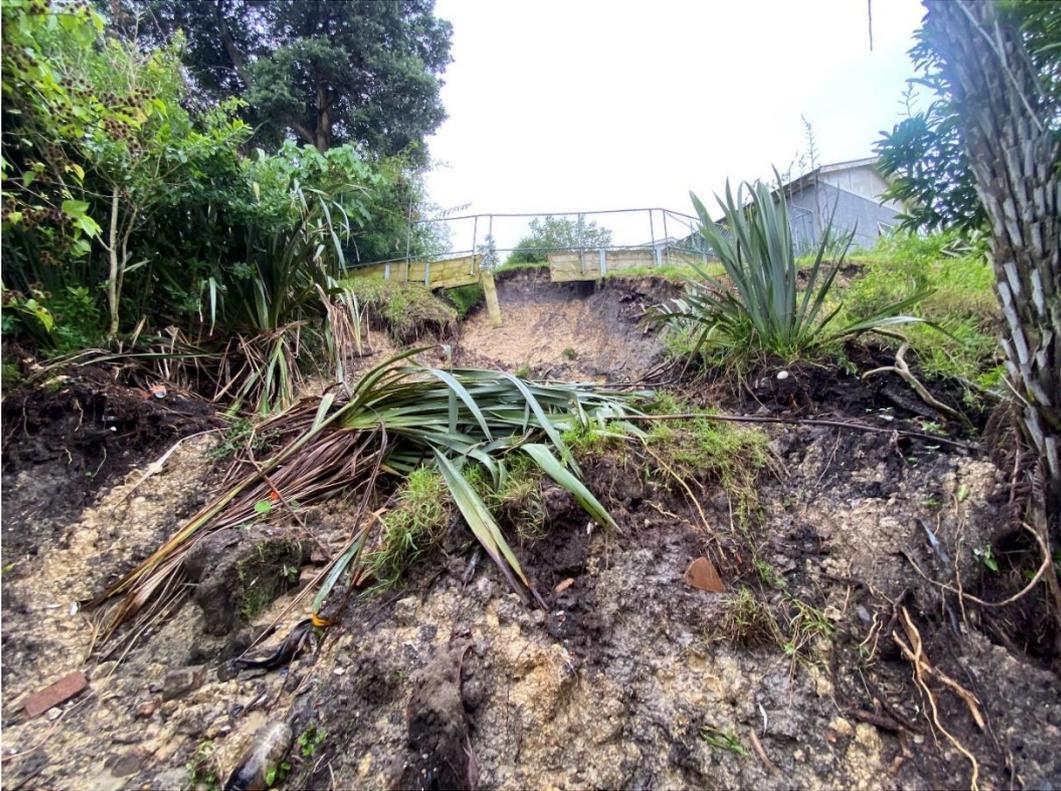
A slip has occurred below the property at 16 West View Road following the extreme rainfall event on 27 January 2023 (Plate 9) and covers an area where vegetation was both present prior to pine removal and planted since.

Plate 9: The slip behind 16 West View Road. 1 February 2023.

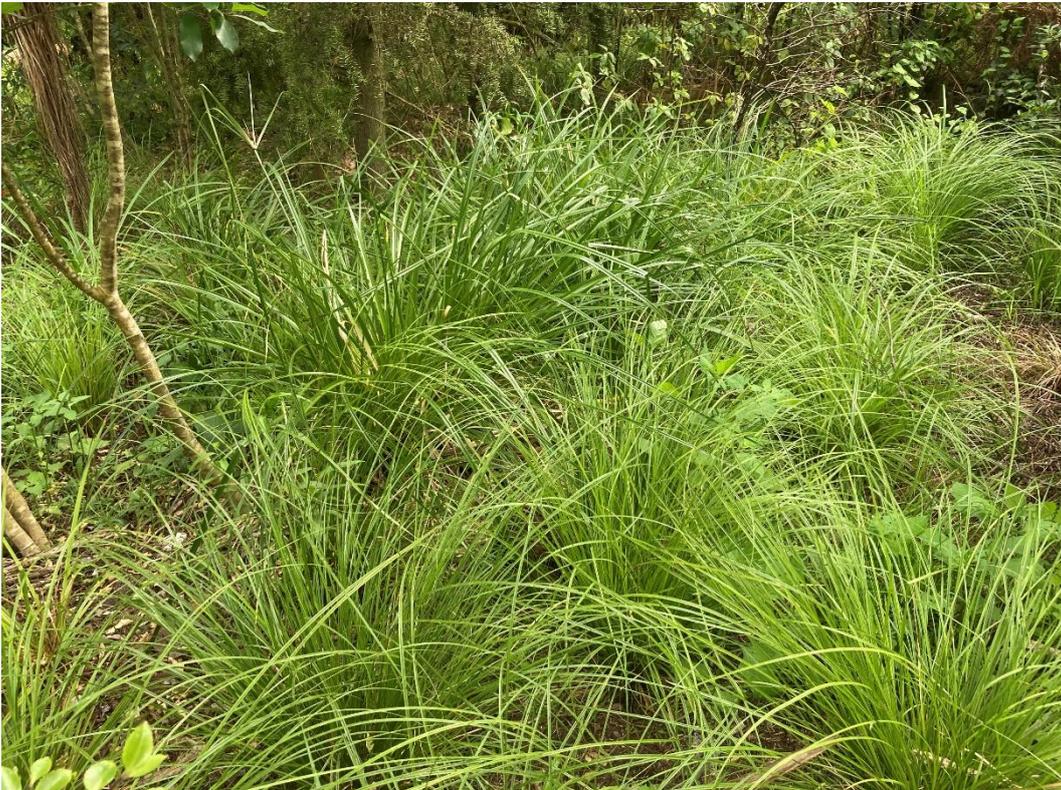
The true right floodplain of Motions Creek (Planting Area D) has been revegetated with 2,110 closely planted sedges and 530 trees and shrubs (Table 1) following pest plant control. Plants are well-established and a continuous sedge canopy cover has occurred over most of Planting Area D (Plate 10). Crack willow and other pest plants that were formerly present within Planting Area D have been successfully controlled (Plate 11). Pest plants such as palm grass and nasturtium are controlled during regular maintenance visits to ensure the ongoing restoration of the floodplain is achieved.

Plate 10: Indigenous sedge establishment along the true right floodplain of Motions Creek (Planting Area D). 1 February 2022.

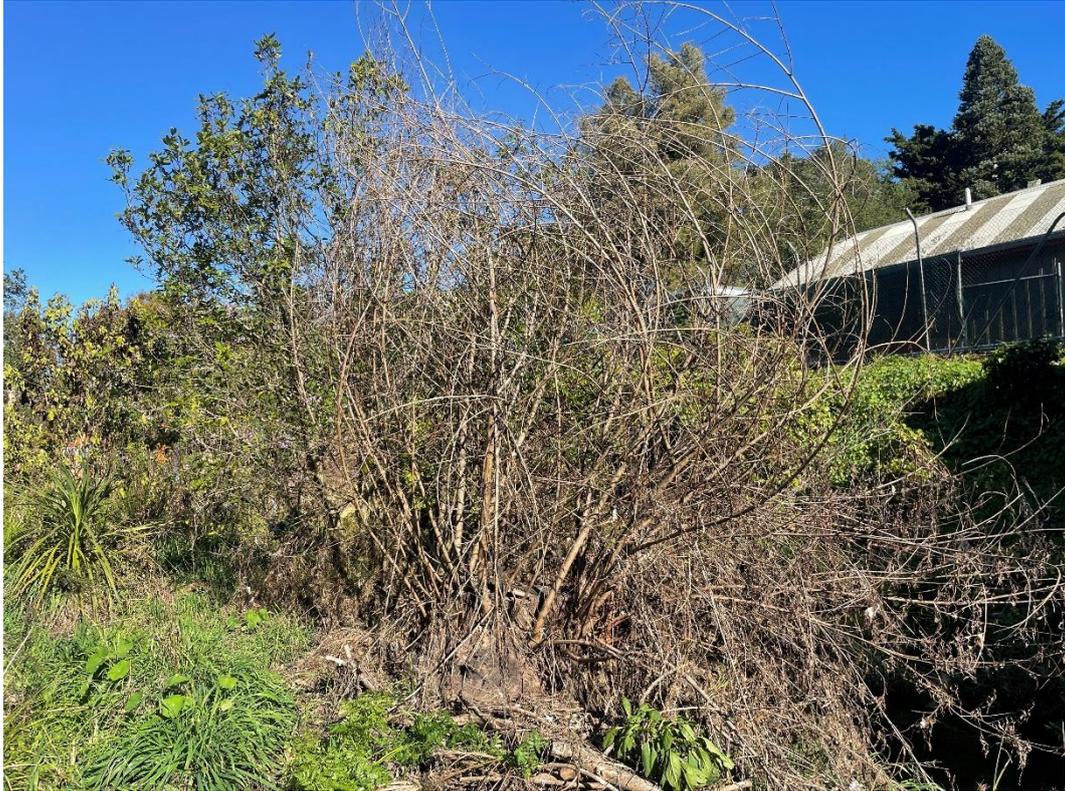
Plate 11: Controlled crack willow on the true right side of Motions Creek.
12 May 2022.
