Arboricultural Assessment of Effects and Tree Protection Plan

For
Removing a dam and culverts, and replacing a wastewater
pipe using a wastewater pipe bridge and a staging platform

in
Blake Road Reserve, Māngere

Date 31 October 2024
Job ref # 3053
Reviewed by: Craig Webb

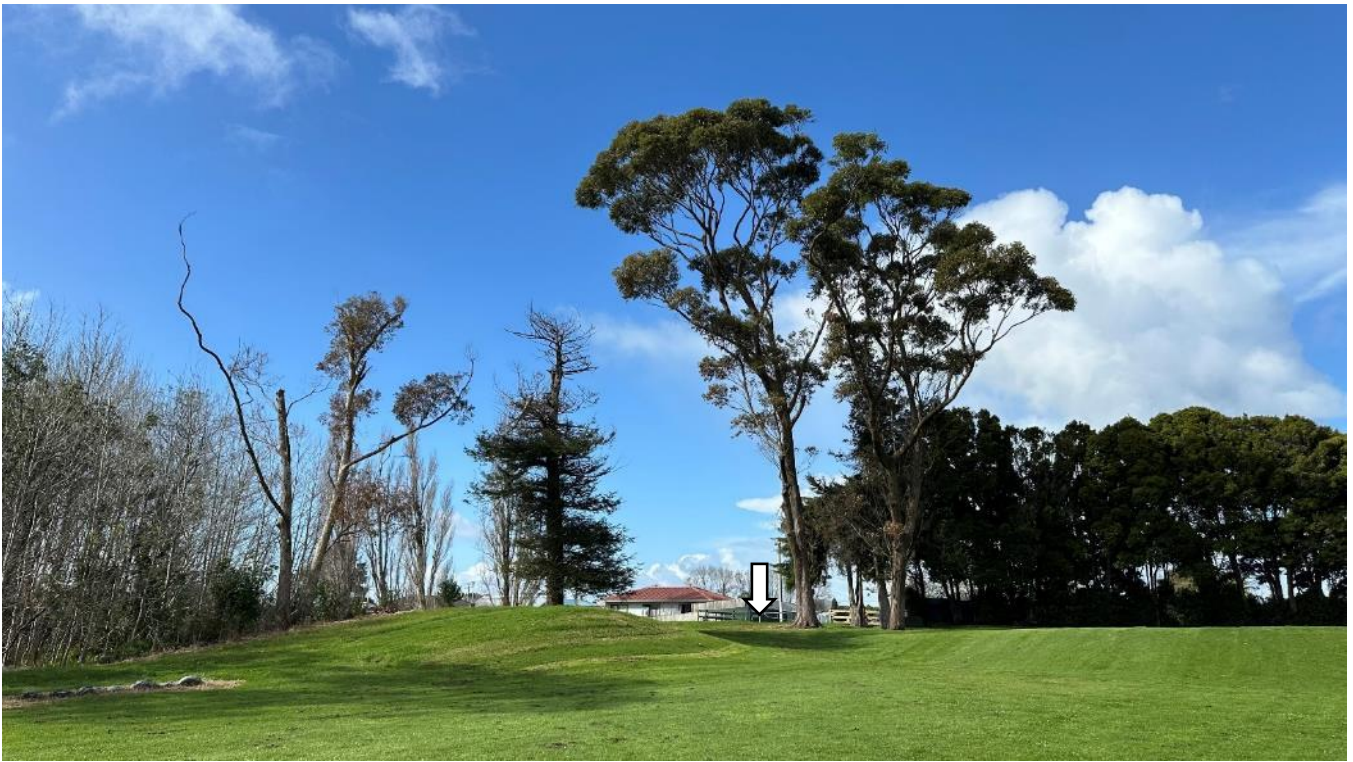
Figure 3: Blake Road entrance (arrow). The trees on the right of the entrance are the two gum trees (3 and 4) and the two cypress trees (1 and 2) (04/09/2024)

- 5.3 With respect to the proposed construction entrance from Blake Road, during the site meeting in June, I advised the construction management team that, the group of four trees (1-4) at the reserve entrance was a group of trees worthy of preservation through design and construction management. In that regard, the haul road / access road has been oriented to favour the preservation of these trees, although one Category C redwood tree (tree 9) will likely need to be removed. Tree 9 is growing atop a soil bund / low bank that will probably need to be cut to form the haul road into the site in order to avoid a tight turning radius that would otherwise mean trees 1-4 (or some of them) would need to be removed.

- 5.5 Whilst the removal of trees 1-4 can likely be avoided, the site access road will require works to be undertaken in their root zones. Outside of the section of concrete slab, the haul road will need to be established by first laying a carpet of wood-chip mulch to the soil (approx. 100 mm thick), then adding a sheet of geofabric, and then using a cellular confinement mesh such as GeoWeb¹ into which aggregates can be placed (e.g., Figure 7). Then, the underlying root zone of the gum trees (and others) will remain undamaged, or with minimal damage. Some localised anaerobiosis of the soil could be expected after 15 months as the wood chip breaks down, but the soil will recover once the site is disestablished. The mulch can be left in-situ to avoid accidental soil stripping when the haul road is removed.

- 5.6 Pile excavations for the concrete section will need to be done so in conjunction with the supervising arborist, selecting pile locations strategically around the trees' major woody roots. Localised root cutting is acceptable. Cutting major woody roots or structural roots is not. On the basis that the haul road is established this way, the impacts to the gum trees and cypress trees (trees 1-4) will be little more than short-term hydraulic stress from which they will recover. Adding mulch to their root zones would be beneficial and help to alleviate the impacts of root disturbance.

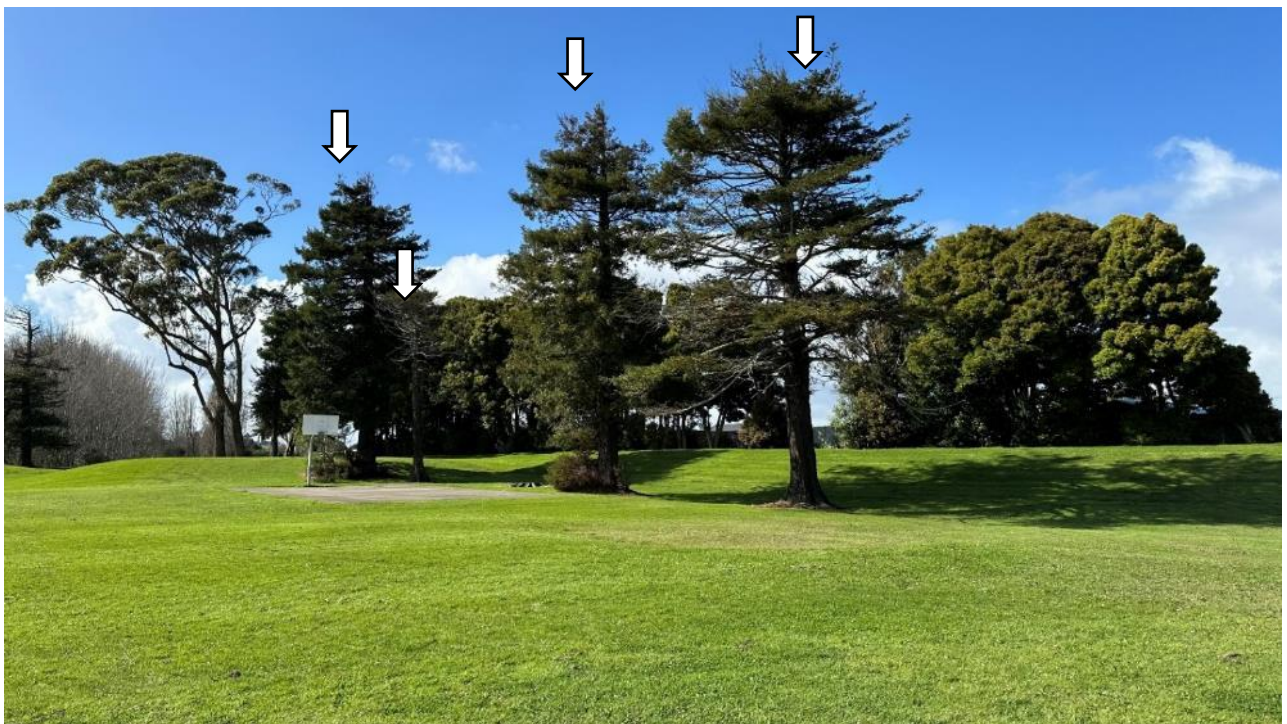
Figure 4: Four redwood trees (arrowed). Left to right, 11 to 14 (04/09/2024)

- 5.7 The eastern site compound is the larger of the two site compounds, and encapsulates three of the redwood trees, being trees 12, 13, and 14. During the June site visit, I discussed the pipe welding process with the construction team, and it was described to me that the pipe sections would need to be laid out and welded in line, approximately, with the piers on which they will ultimately be placed. Essentially, the pipe will be constructed, lifted off the ground with cranes, and then moved into place along the tagging and onto the piers. The three redwoods are on this alignment, and so to be able to weld the pipe sections to the correct length, the redwoods will need to be removed. Whilst it is not currently anticipated, it is possible that the embankment on which they are growing will need to be locally excavated to form level ground on to which the pipes can be welded. Either way, the organic soil horizon (the upper 100 mm) will almost certainly be damaged. The stumps of the redwoods will also likely need to be removed, either by wrenching / excavating, or by way of stump grinding. The impacts will be that three of the four redwood trees (12-14) will be removed. Whilst it is not currently anticipated, if soil stripping is required in the vicinity of tree 11, it may sustain root zone impacts from cutting and benching of the slope and surrounding soil that will result in chronic water stress. Some reduction in the tree's overall vitality including twiggy dieback and crown sparseness, could be expected over the five to ten years following the project. A layer of cured wood chip mulch laid under the tree would help to alleviate some of the stress effects and promote new fine root growth.

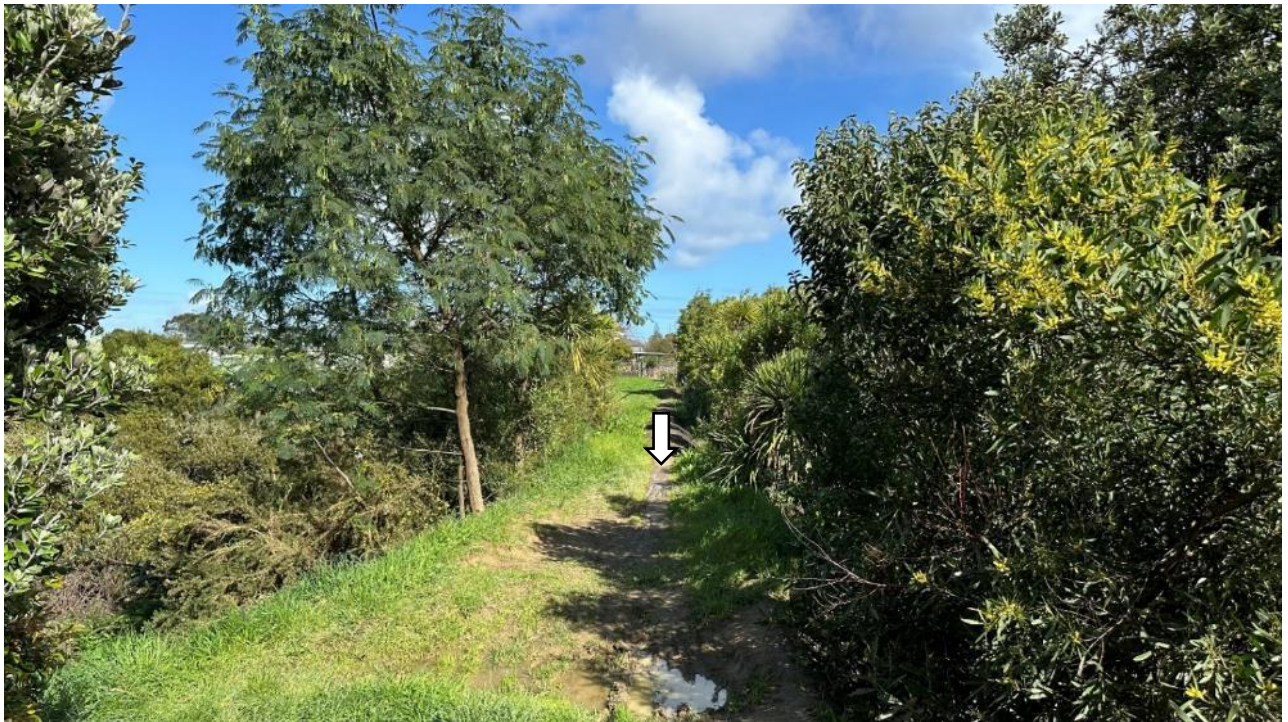
Figure 5: Looking west from the crest of the existing dam. The top of the concrete wastewater pipe can be seen (arrow) (04/09/2024)

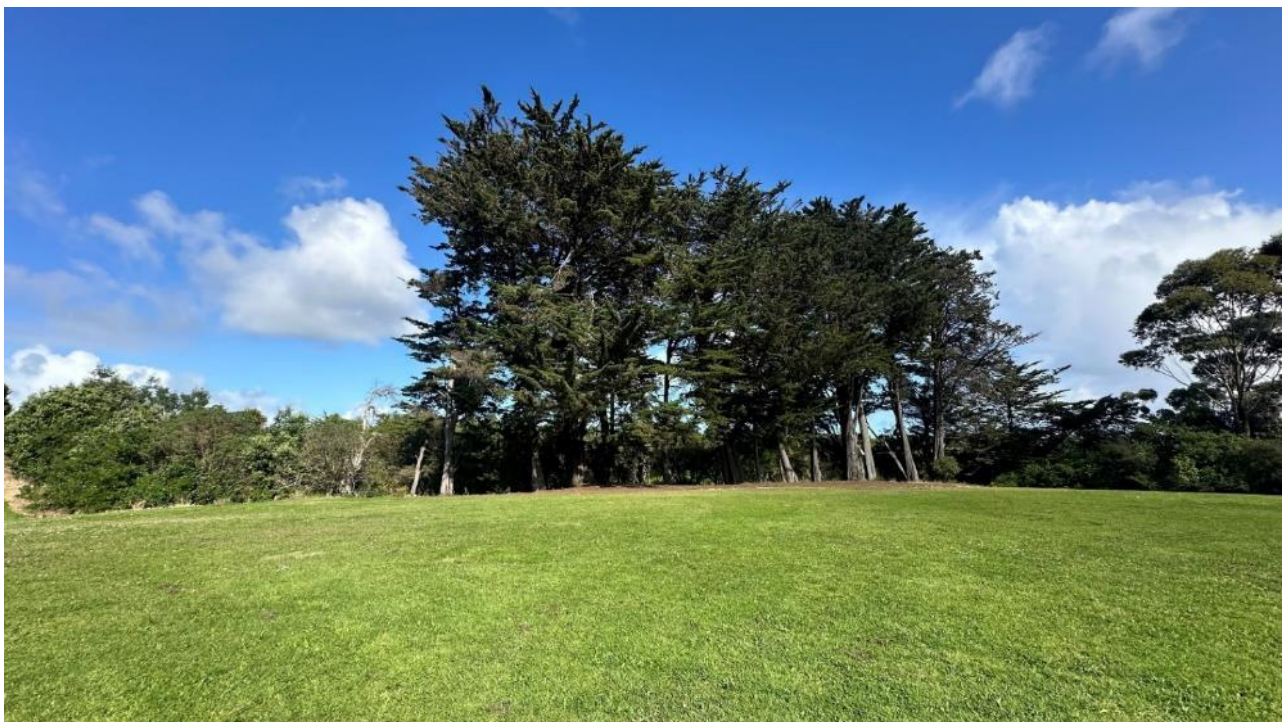
Figure 6: The row of Monterey cypress trees (04/09/2024)

- 5.8 The row of cypress trees will not be within the construction compound, but the staging will be erected within approximately 5 m of the southern cypress tree (tree 15). The dead cypress tree, which has not been included in the survey, will be removed, and conceivably tree 15 will need to be removed as well. The remaining cypress trees are anticipated to not need to be removed but will likely sustain some minor to moderate degree of root zone disturbance from construction traffic and piling. The impacts of such disturbance could result in some brief stress on the trees, but each is in good vitality at the moment, and none are expected to noticeably deteriorate. This is contingent on the site compound being established outside of their tree protection zones and no soil stripping taking place within them.

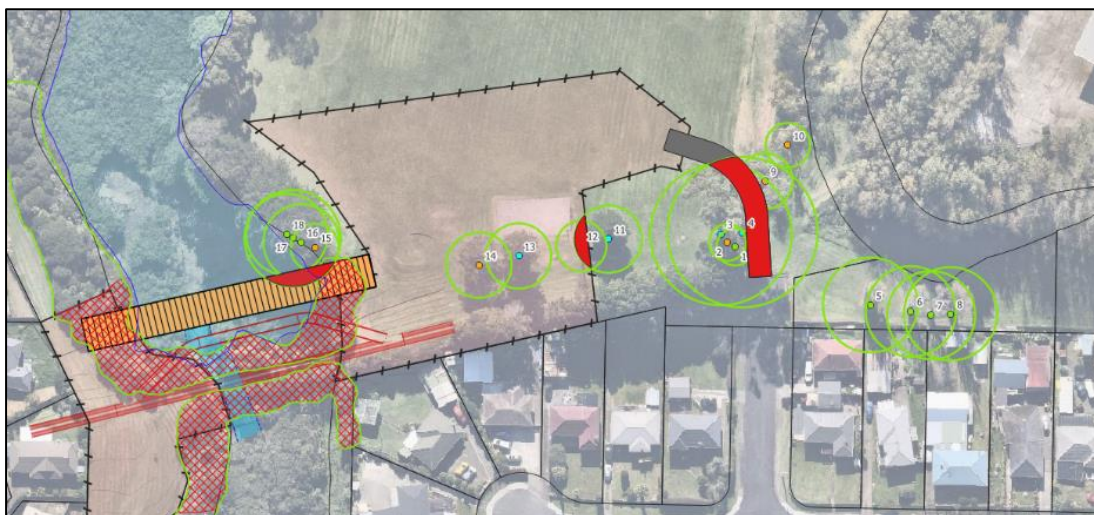
- 7.5 A geospatial analysis of the proposed site features reveals that between 1% and 17% of the protected root zones of trees will be disturbed. However, what cannot be revealed is the diameter of the roots that will be encountered when the site compound is established and when the haul road is built. If the haul road construction is overseen by an appointed arborist, the other Permitted Standards are met, and the recommendations contained in Section 9 of this report are followed, then the work would likely meet the Permitted Standard criteria. If one or more of the Permitted Standards are not followed (e.g., if the access road from Blake Road is formed without a supervising arborist present or roots greater than 80 mm in diameter are severed from any tree), then the Permitted Standards will not be met. Conservatively, and to ensure the necessary consents are in place, the Permitted Standards will not be met.

Figure 8: A screenshot from a geospatial analysis depicting protected root zone (green circles around trees) incursions (red areas).
