Arboricultural Report

KiwiRail Wiri to Quay Park

on
Notice of Requirement

Date	9 July 2020
-------------	-------------

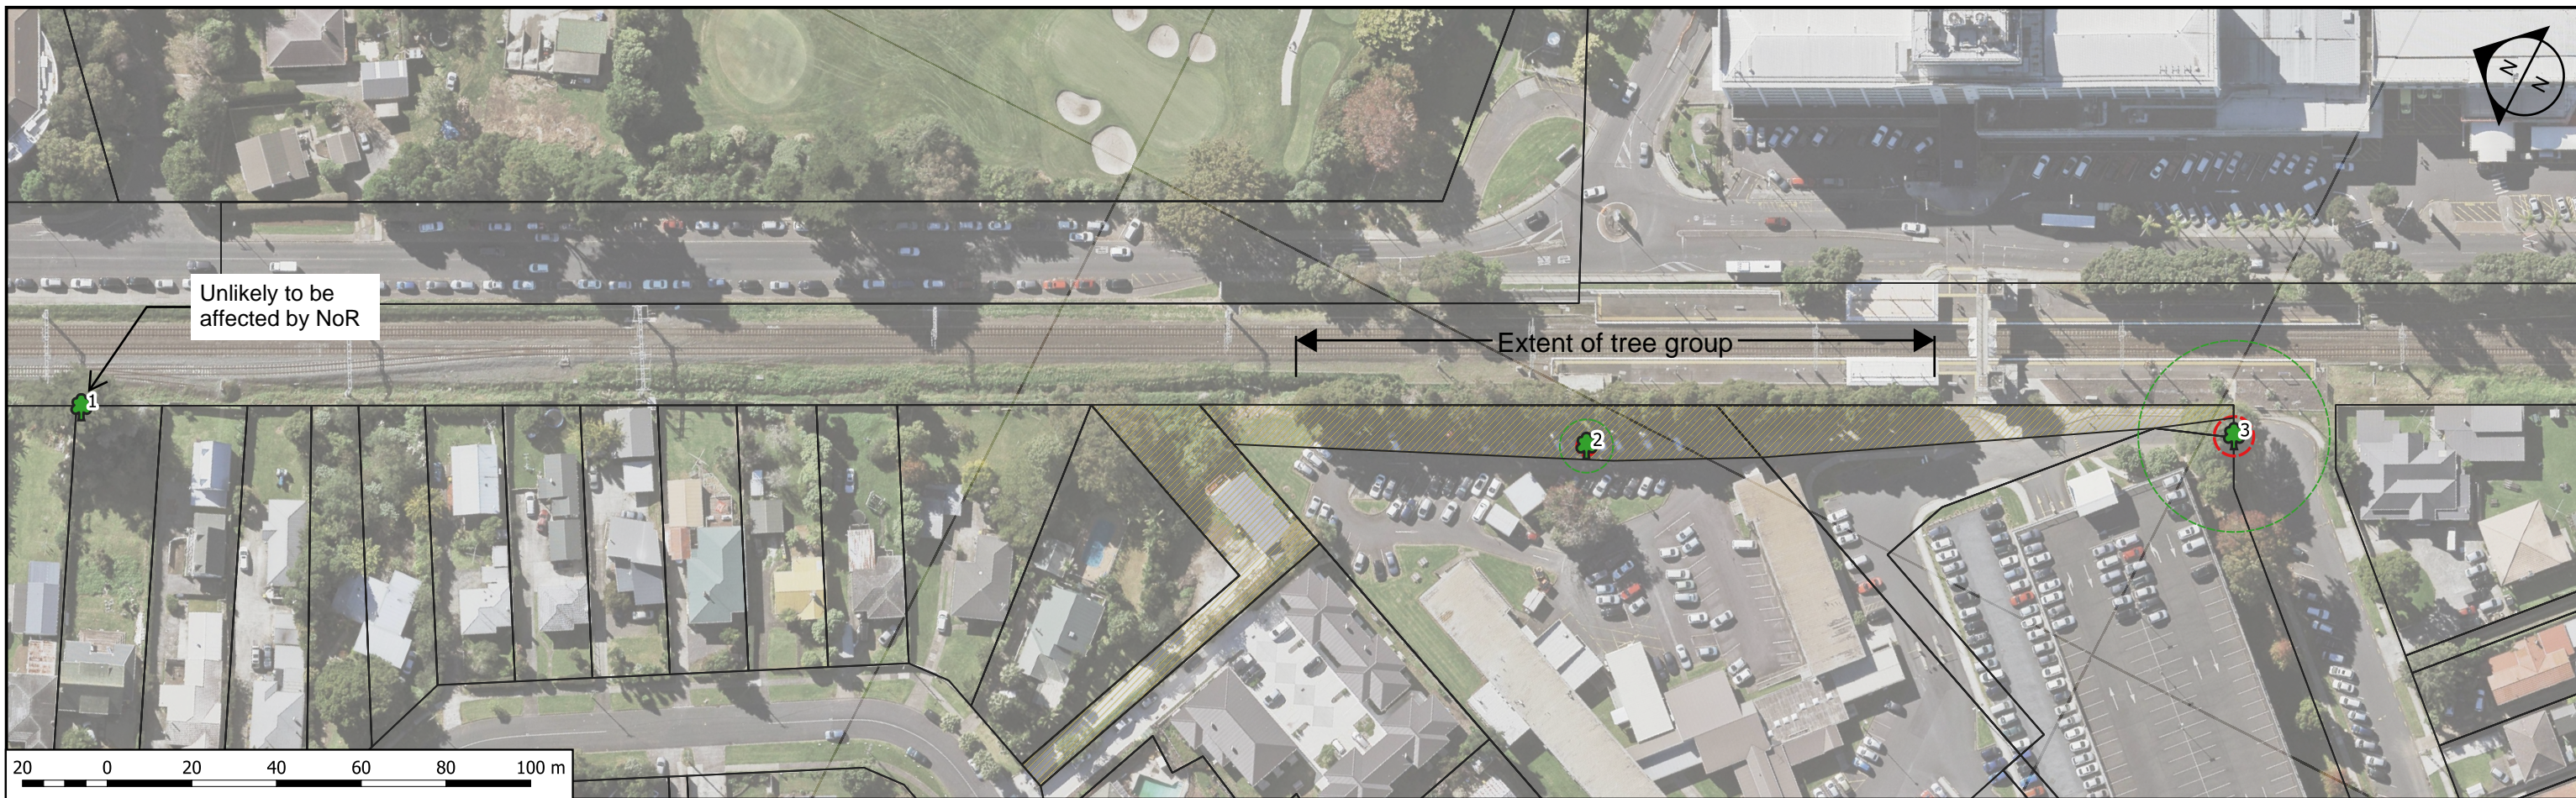
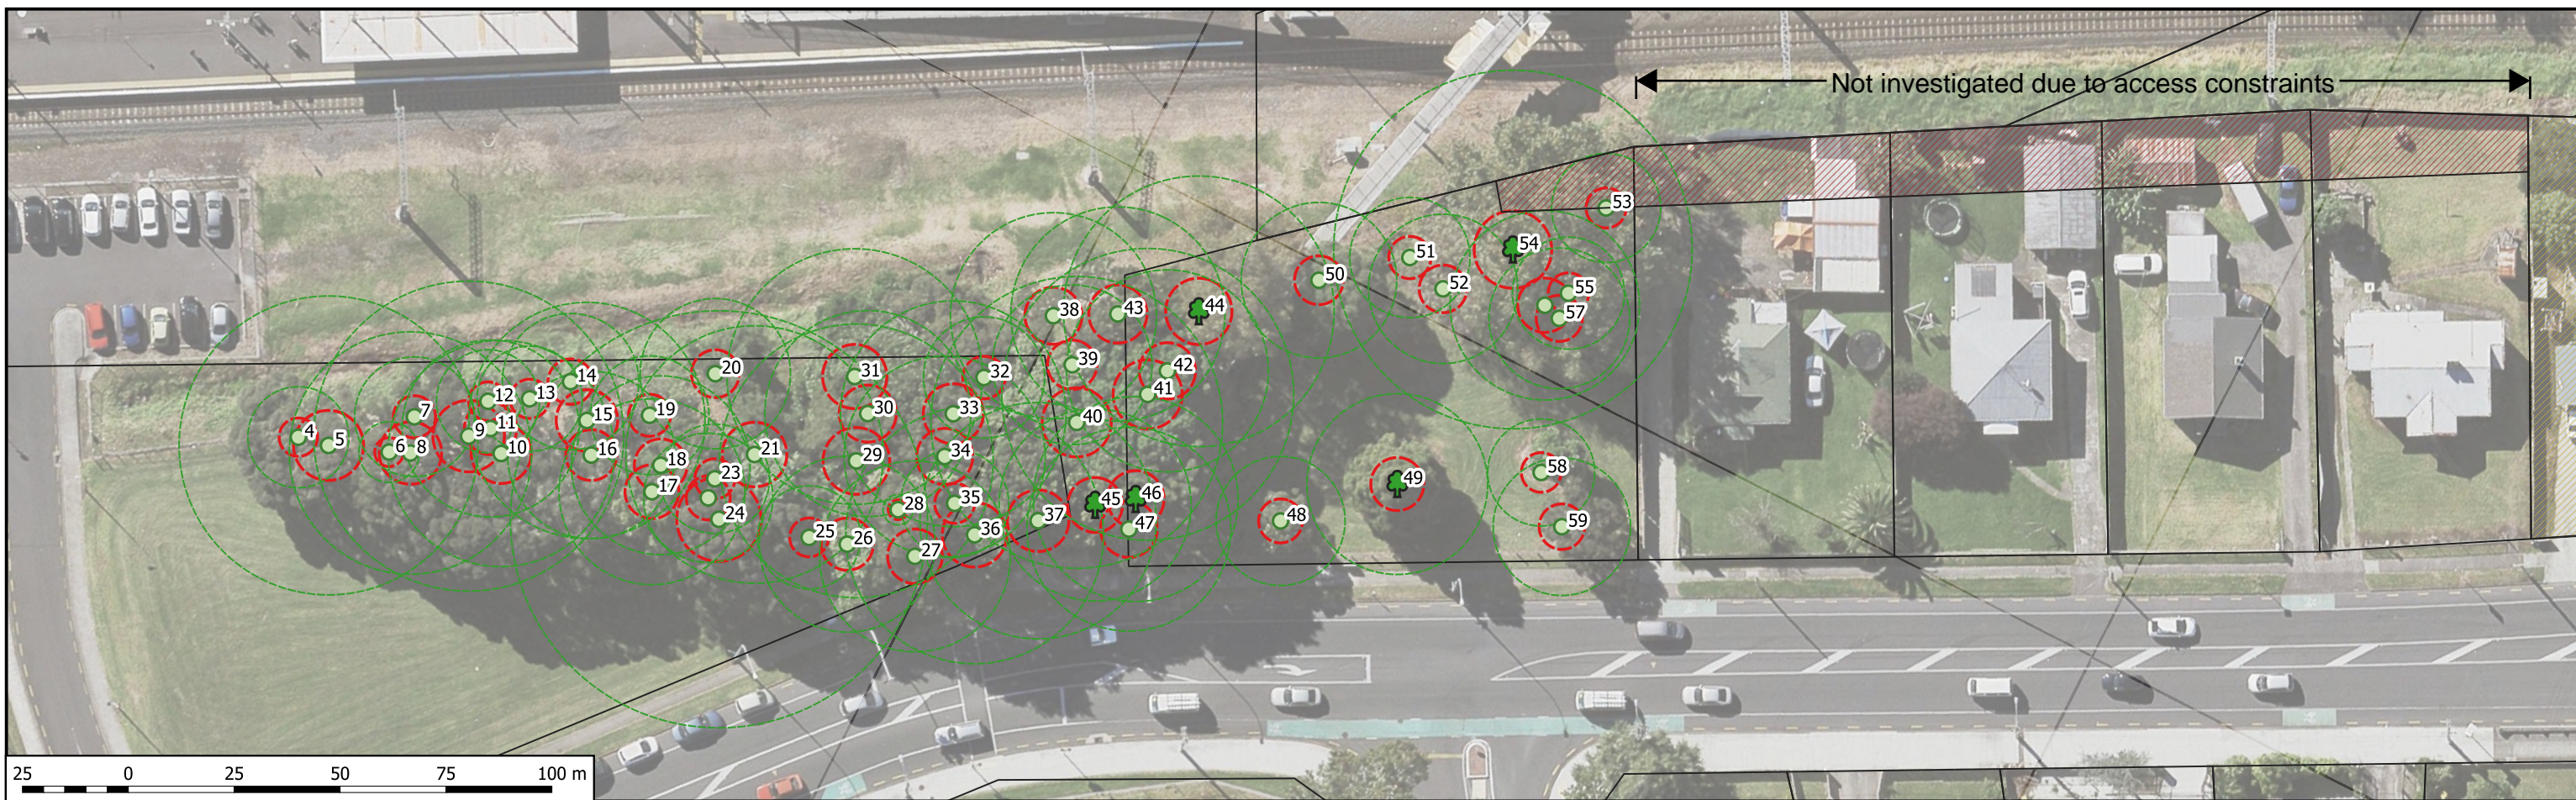
Job ref	1642
Drawing	001
Rev	B
	16/06/2020

- 8.1 At the two accessible locations, we undertook a tree survey to identify tree species, locations, and dimensions, and to undertake the notable tree assessments. An inventory of these trees is appended to this assessment with the corresponding tree numbers depicted on the site aerials (1642_001 and 002, rev B).

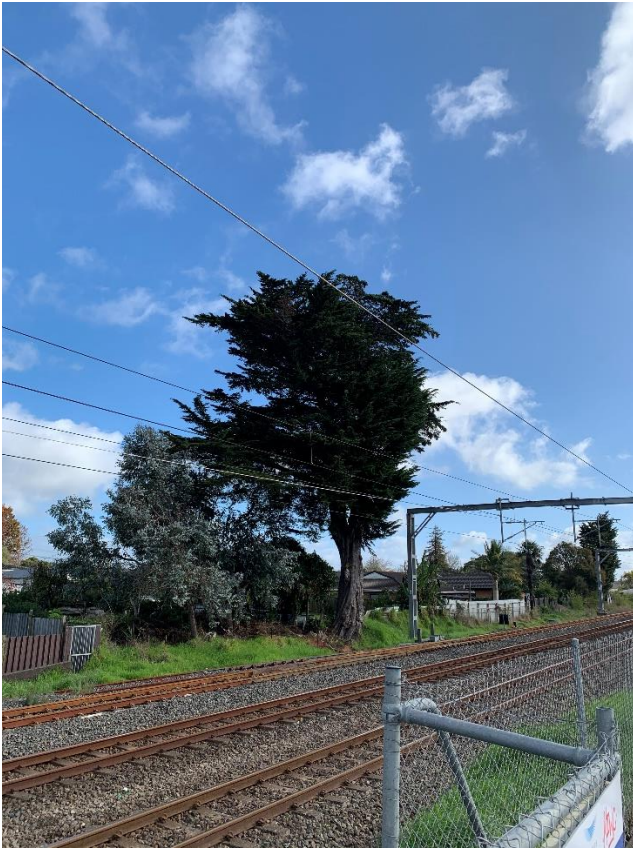
Photo 1: Tree 1 (Monterey cypress)

- 8.2 At Middlemore, trees 1 (Monterey cypress), 2 (49 x Japanese red cedar) and 3 (Himalayan cedar) were recorded as being worthy of notable status. Within the 1.5 km² area surrounding these trees, the dimensions were recorded for n = 0 Monterey cypress, n = 4 Japanese red cedars and n = 12 Himalayan cedars, to establish the average dimensions for these species in this location. Tree 1 will not be affected by the NoR land take, although looks to be growing within the rail corridor (based on the location of a fence). Tree group 2 is within an area of permanent occupation (a new station platform) and will therefore require removal unless an alternative can be found. It is unclear where these trees are growing precisely (either within the current designation or within hospital land). Appropriate remedial measures should be adopted to address the environmental impact and loss of local amenity which will occur as a result of removing these trees. Tree 3 is outside of the land take area at Middlemore, yet the alterations for the new platform will be within the tree's root zone area. Given the tree's current growing environment (road reserve), making inferences about the effects of the land take and later construction would be conjectural at best (see 9.8).

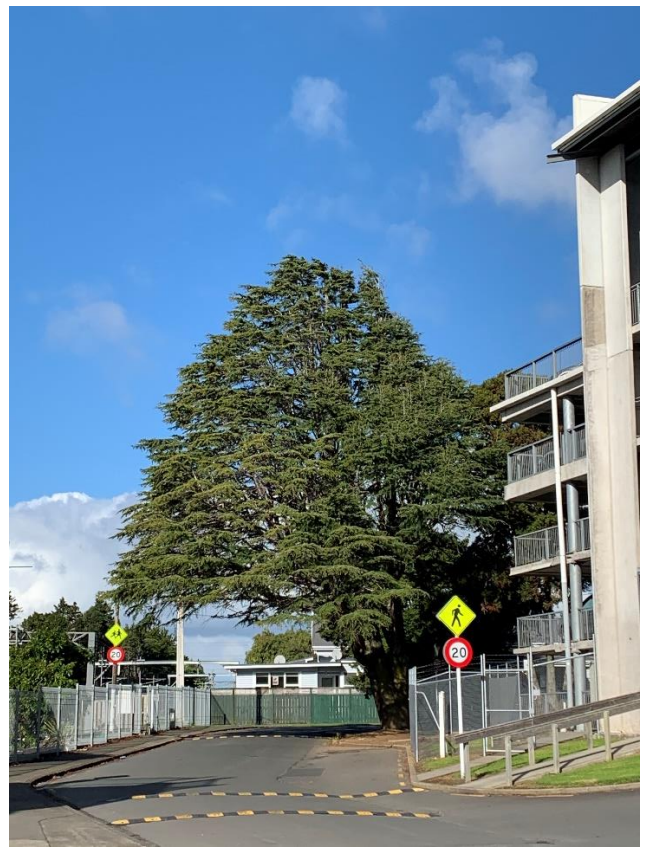
Photo 2: Tree 3 (Himalayan cedar)

- 9.3 At Middlemore Station, the land-take area occupies 34m² of tree 3’s (Himalayan cedar) AUP-defined protected root zone² area (8%). Without invasive methods, e.g. exploratory excavation, it is impossible to confidently state the diameters of roots which would likely be encountered in this footprint, and so conservatively, this encroachment must be considered under E16.4.1 (A8). Operationally, the tree is likely to require live crown removal to achieve required clearances from the rail corridor and associated infrastructure. Conservatively, E16.4.1 (A6) needs to be considered.

- 9.9 At Middlemore, the new platform will be within, or in close proximity to the root zone of tree 3 (Himalayan cedar). We do not believe that surface permeability and the tree's access to available soil water will be greatly affected as much of the root zone is covered in asphalt, but the detailed design of the platform will need to consider root structures. The use of piles is an effective way of constructing elevated structures in tree root zones, where the piles are positioned strategically around roots.

- 9.14 In terms of the operational needs of the rail corridor and the associated ongoing effects to trees, providing the detailed design and engineering for the platform at Middlemore are prepared in acknowledgement of the tree's root system, the ongoing effects are expected to be negligible, and limited only to regular maintenance of the crown, i.e. pruning to achieve required clearances. At Papatoetoe Station, trains running on the new line will be pushed closer to the trees than at present. The ongoing effects of which are likely to include a requirement for crown pruning, to achieve required clearances. Overhead pylons would need to be strategically positioned to avoid conflict with the tree(s). For the purposes of the NoR, this is not a material consideration, but will need to be addressed later when the design is progressed and methods to work around and preserve trees are considered.

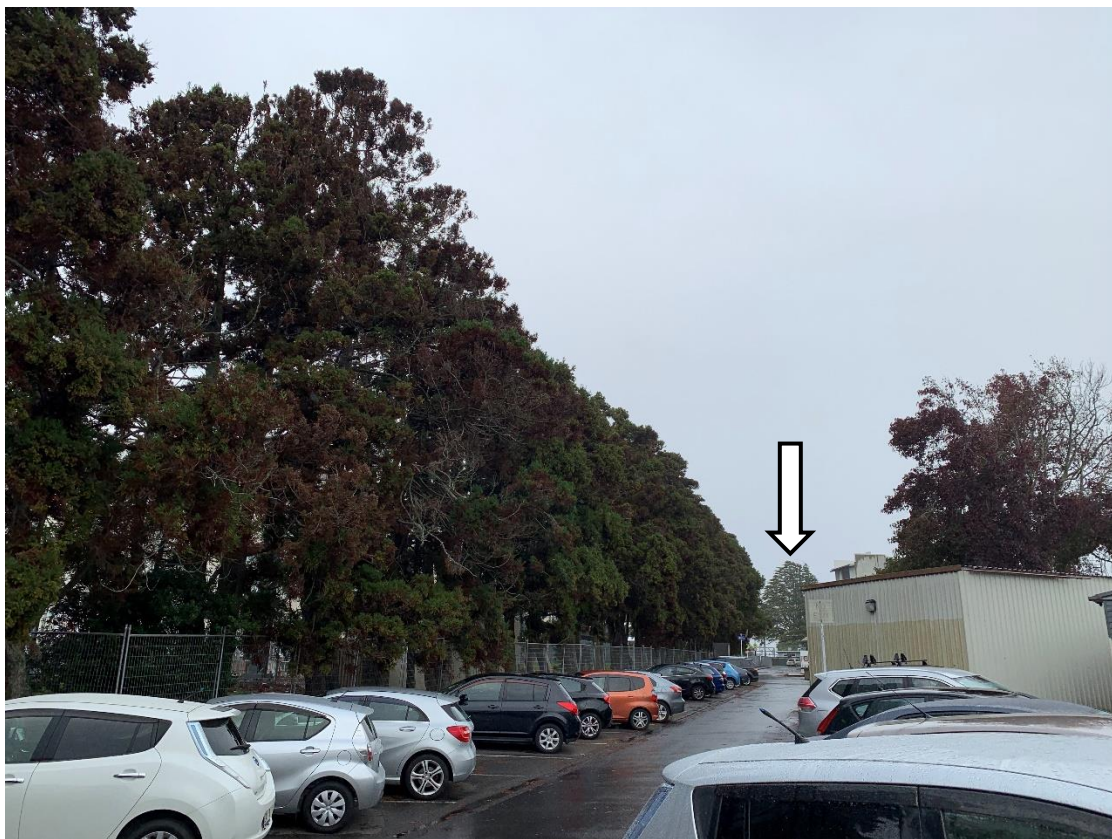
Photo 3: Tree 2 (49 x Japanese red cedar). Tree 3 can be seen in the background (arrow)

- 9.7 In terms of direct effects of the NoR, tree group 2 (49 x Japanese red cedar) and tree 53 (rimu) will need to be removed. In consideration of the ecosystem services provided by trees, and specifically carbon sequestration, we consider that the loss of these trees requires appropriate remedial planting, to achieve sustainability goals and align with KiwiRail's 'Carbon Zero Programme' and Auckland Council's 'Low Carbon Strategic Action Plan'. We have discussed this later in section 11.

- 11.4 The remedial planting therefore needs to achieve this same value of stored carbon by 2050 if carbon neutrality is to be achieved, and the actual effects of tree removal are to be addressed in a sustainable fashion. Allowing for 3% mortality, this equates to 12, 45-L trees planted in a such way that they can achieve optimum final dimensions. Planting locations and the long-term future development of the trees is critical to the success of the carbon offsetting. Trees which are incapable of achieving large dimensions in the given time period will not achieve the required value of stored carbon and thus not achieve carbon neutrality. Given the spatial constraints of the rail corridor, planting this number of trees to meet this specification may be unachievable. Ideally a nearby public reserve would be identified and through negotiations with Auckland Council’s Community Facilities department, one or more locations could be selected for planning.

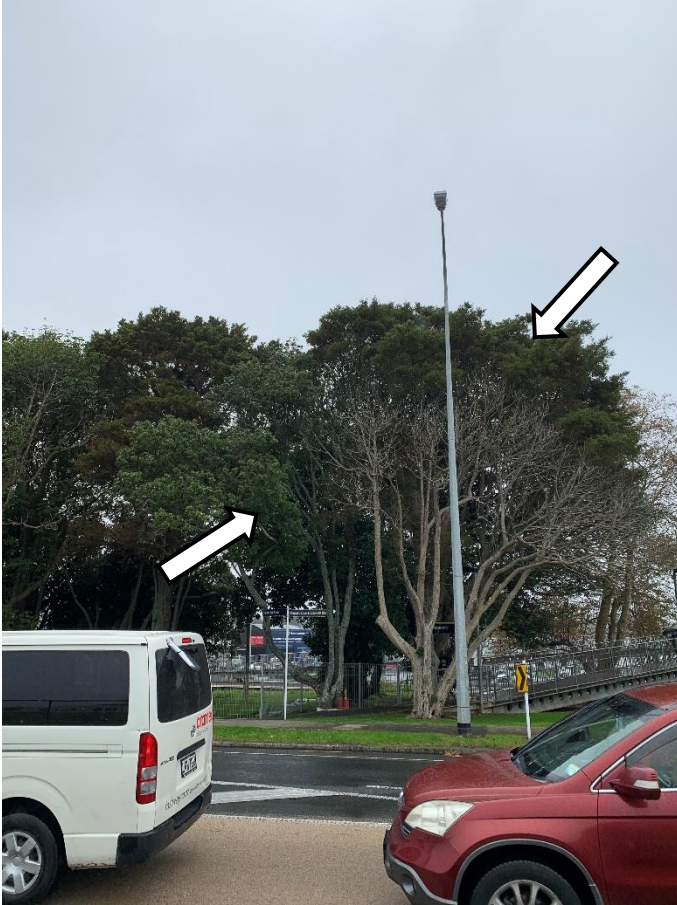
Photo 4: Trees 45 (titoki, left) and 46 (totara, right)

- 8.4 In the open space area to the south, 17 trees were recorded which achieve protective status by virtue of their dimensions. Four of which (44, oriental plane; 46, totara; 49; Japanese red cedar and 54, London plane) scored highly enough to be considered for notable status. Within the 1.5 km² surrounding area, the dimensions were recorded for n = 13 titoki, n = 14 totara, n = 0 Japanese red cedar, n = 0 oriental planes and n = 14 London planes, to establish average dimensions for these species in this location. Only tree 54 will be affected by the (temporary) land take footprint, although the specifics of this remain unknown at this stage. Tree 53 (rimu) is within the footprint of the (temporary) land take and we suspect that it will require removal to accommodate the temporary occupation. The tree is juvenile and suppressed, and inappropriately positioned under tree 54 to ever achieve its optimum final dimensions. Remediating the removal of this tree can be achieved over a short temporal scale with a minimum of three new 45-L grade trees.

Note: The dead tree in the foreground is not tree 46

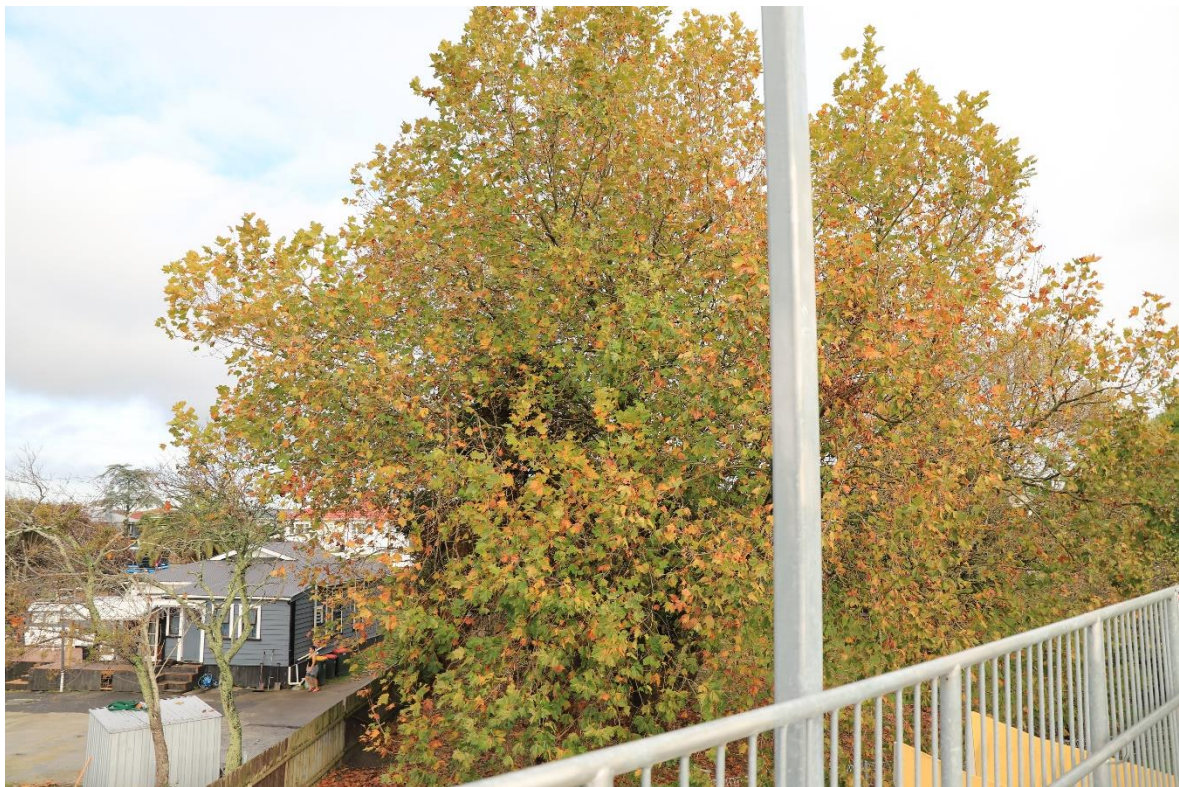
Photo 6: Tree 54 (London plane)

- 9.5 The NoR temporary occupation footprint also encroaches into tree 54’s (London plane) AUP-defined protected root zone area. The level of encroachment is 35 m² (11%). Given that the incursion is on the periphery of the tree’s structural root zone, the likelihood of encountering roots meeting the descriptions outlined in E16.6.2 is considered very high, and therefore this activity must be considered under E16.4.1 (A8). Similar to tree 3, live crown removal is conceivable to achieve harmonious operation of the rail corridor, which would need to consider E17.4.1 (A6).

- 9.11 The scope and magnitude of the temporary occupation footprint is unknown, but by definition because it is a transient activity, tree 54 (and its neighbours) should be actively preserved, as these are long-lived organisms that will provide many benefits into the future, long beyond the duration of the corridor upgrade. Negative effects which could arise as a result of root losses, or damage to surrounding soils include water stress symptoms and compromised physiological function (Benson et al., 2019a; Benson et al., 2019b, c), which can predispose trees to future, co-occurring stresses (e.g. drought) (Fini et al., 2020).

- 9.12 We have discussed tree preservation methods in section 11. In general, these need to include trunk protection (to prevent impact injuries) and ground protection (to prevent root damage) as well as soil improvement (such as wood-chip mulch) to help offset the effects of soil disturbance and changes to hydrology.
