**K201046-1a**  
**10 August 2021**

**GEOTECHNICAL FEASIBILITY REPORT**  
**FUTURE RESIDENTIAL DEVELOPMENT THROUGH THE PROPOSED**  
**ZONE CHANGE PROPOSAL**  
**57 SCHNAPPER ROCK ROAD**  
**SCHNAPPER ROCK**

**Geotechnical Feasibility Report**  
**Future Residential Development Through The Proposed Zone Change Proposal**  
**57 Schnapper Rock Road**  
**Schnapper Rock**

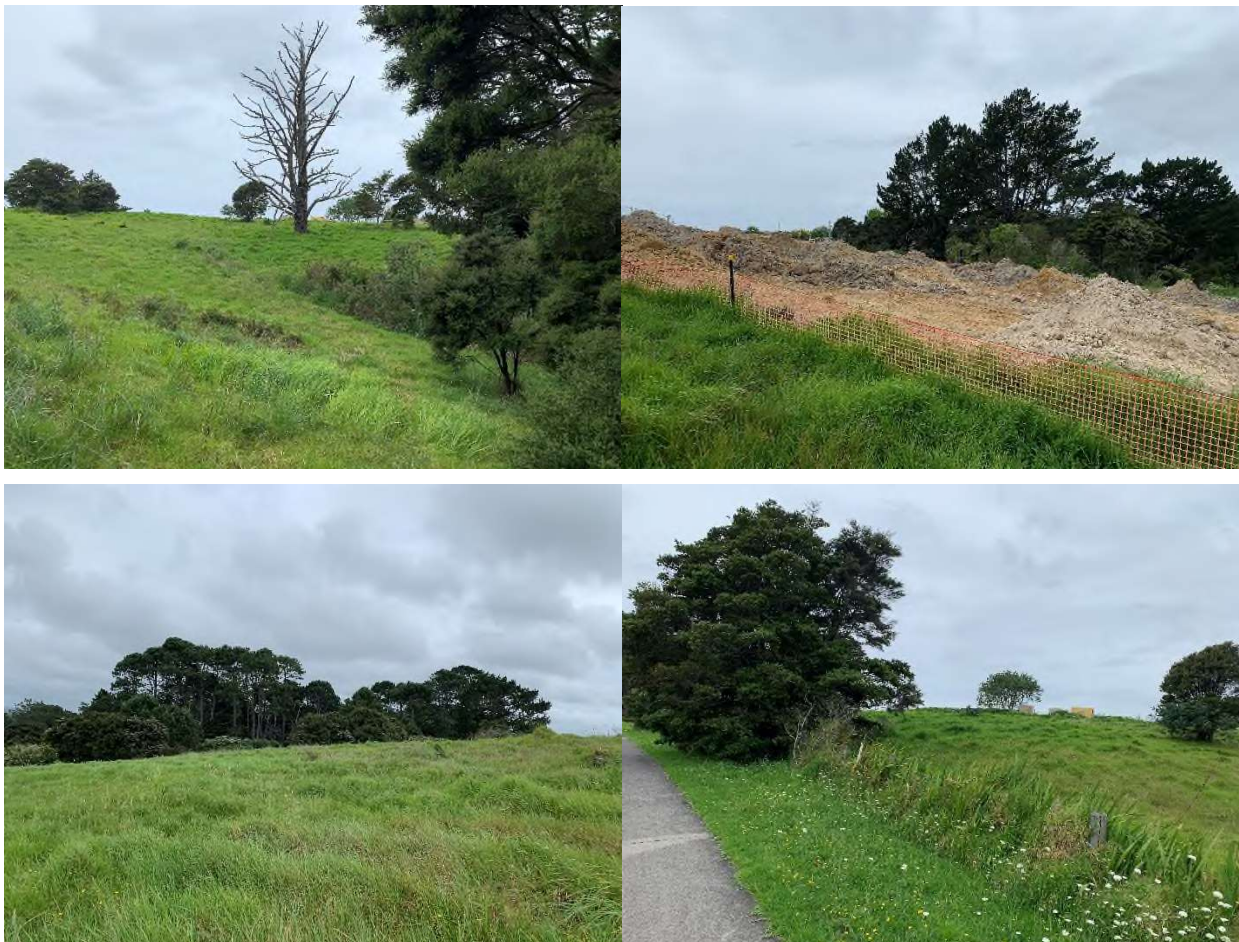
As indicated on our site plan attached as Sheet KGA 1, the site topography is typically characterised by a south trending gully through the western portion of the site (Image 1), and a south trending overland flow path within the southern corner of the site. The side slopes of the western gully typically range in gradient between 1V:3H and 1V:4H, with an area of over steepened ground up to 1V:1.5H, near where the gully intercepts the western site boundary.

There is also a broad gully present within the neighbouring property to the east at 55 Schnapper Rock Road. Within a portion of this gully is a large head scarp, which extends right up to the northeastern site boundary, over a length of approximately 70m. This head scarp is currently densely vegetated. The area directly upslope of the head scarp is currently being earth worked as part of the adjacent development; with a number of clay stockpiles present (Image 2).

The remainder of the site away from the above features (central and northern portions) generally comprises gently sloping to near level ground (Image 3 & 4).

**Image 1 (Top Left). Head of Western Gully looking North. Image 2 (Top Right) Vegetated Head Scarp along the eastern site boundary, with earthworks upslope looking Northeast. Images 3 and 4 (Bottom) Gently sloping ground within the central and northern portion of the site.**

In general, it is considered that minimal filling should occur upslope of the western gully, and especially upslope of the existing head scarp along the eastern site boundary.

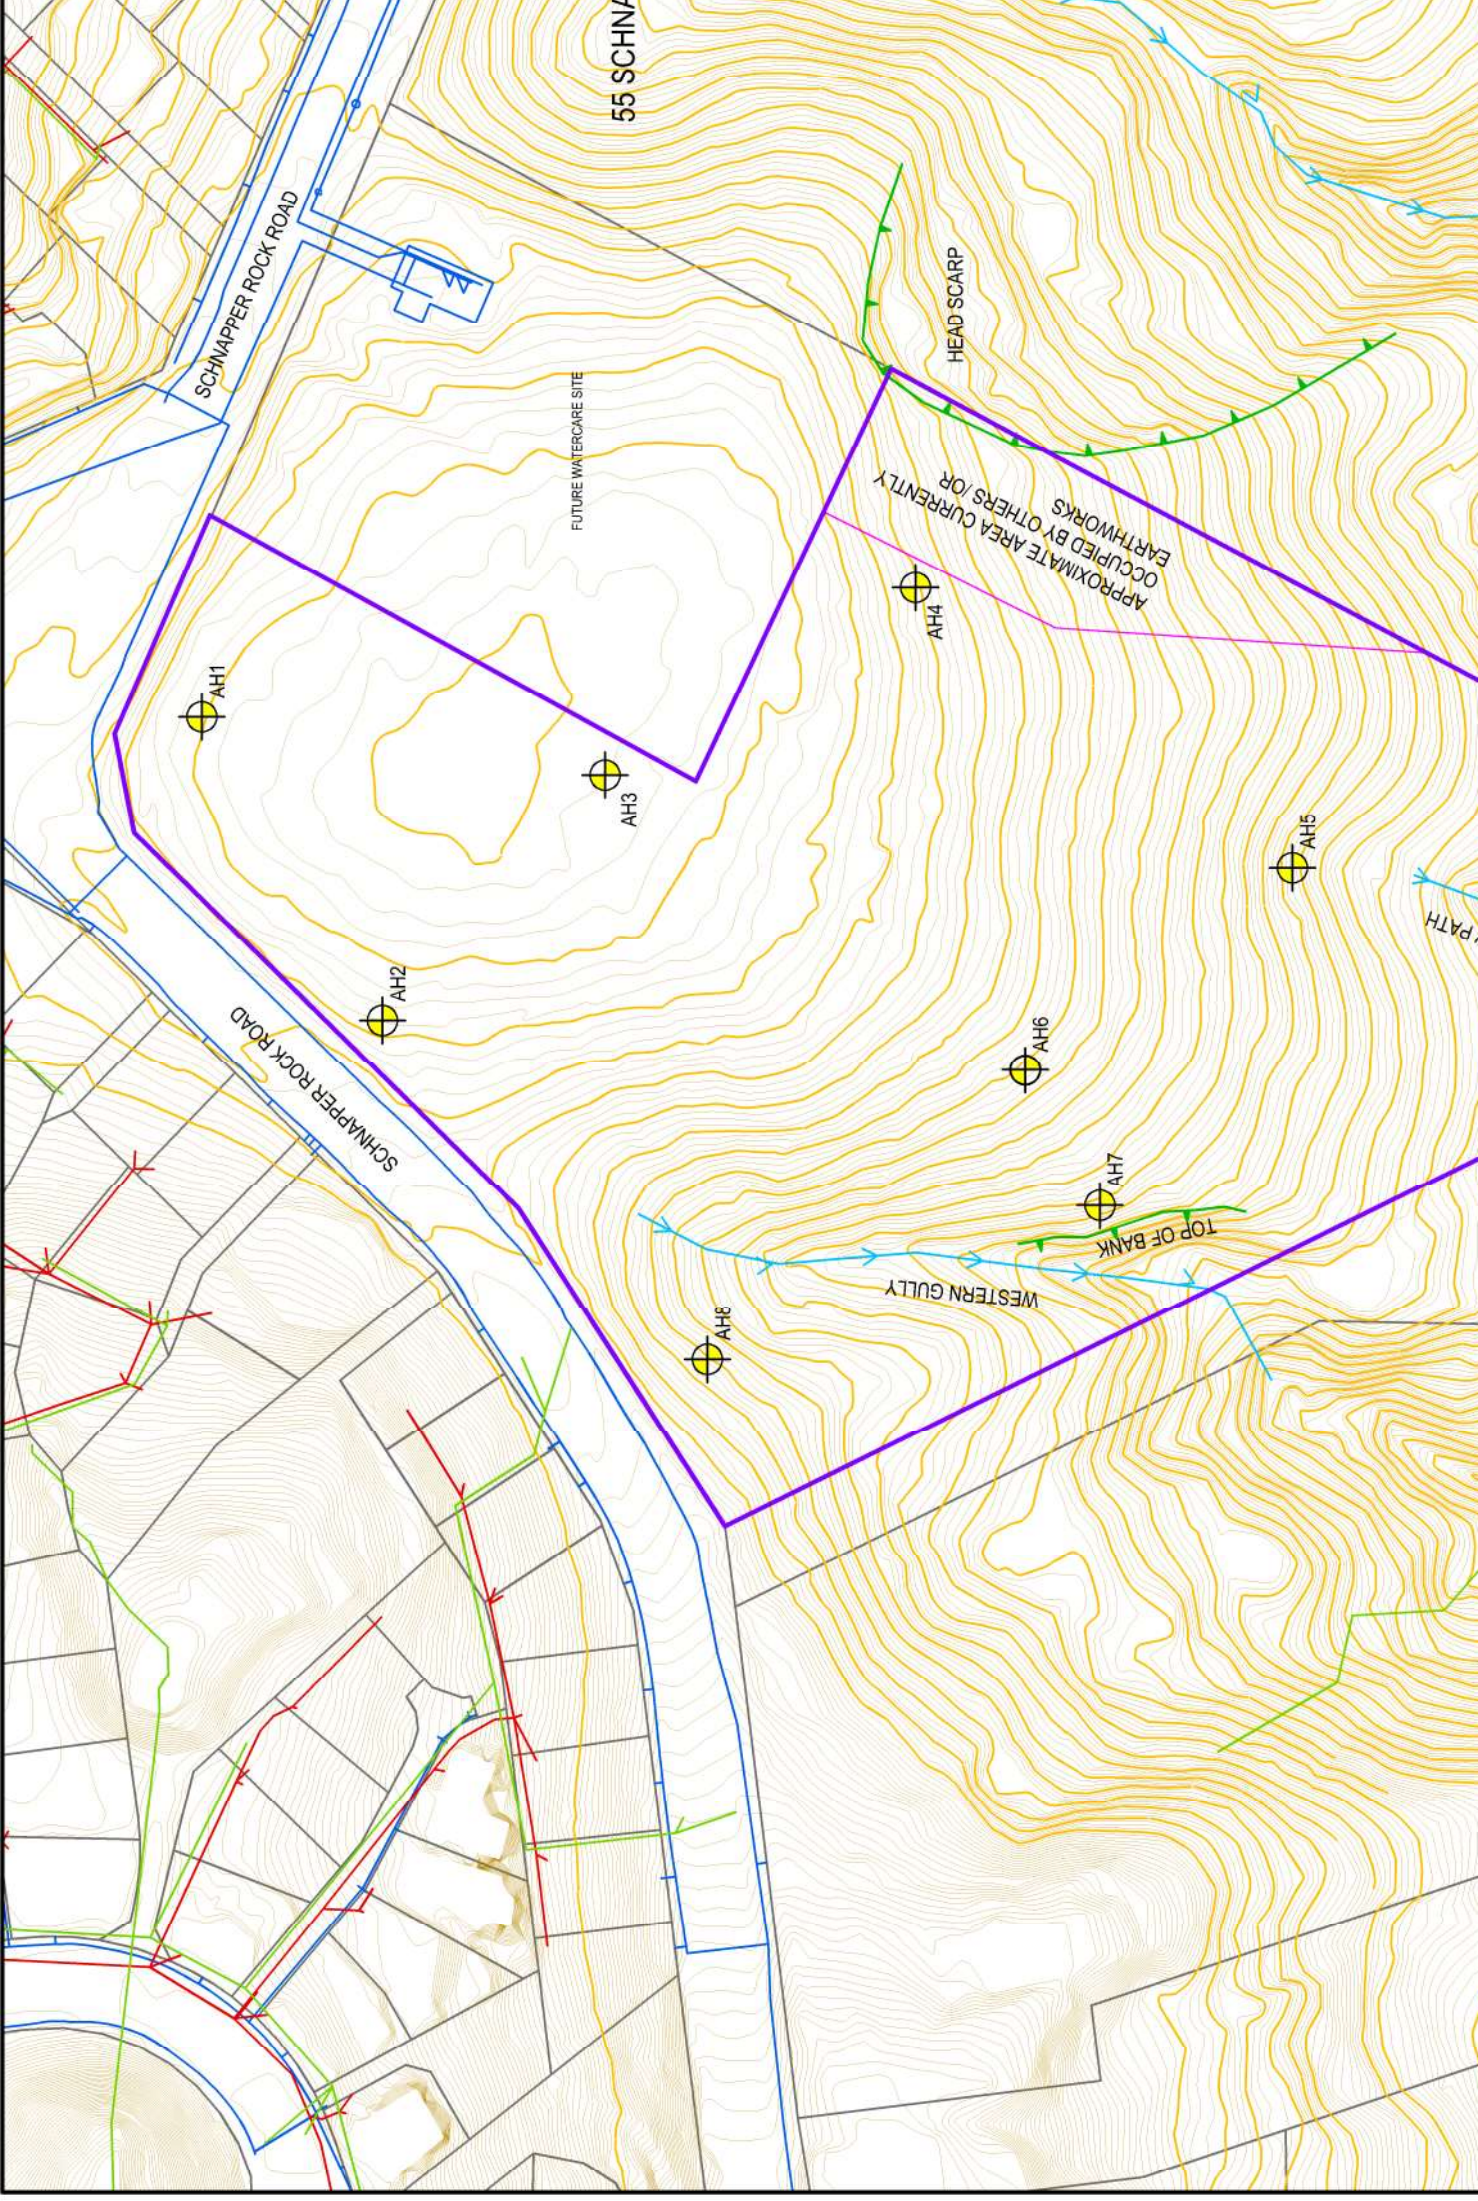
To confirm the findings of our desktop study, the subsurface conditions on site were explored by drilling eight hand auger boreholes, designated AH1 to AH8 between the 5 and 11 of November 2020. The approximate borehole locations are shown on our attached site plan, Sheet KGA 1. The borehole locations were selected to provide a general indication of the subsurface ground conditions across site.

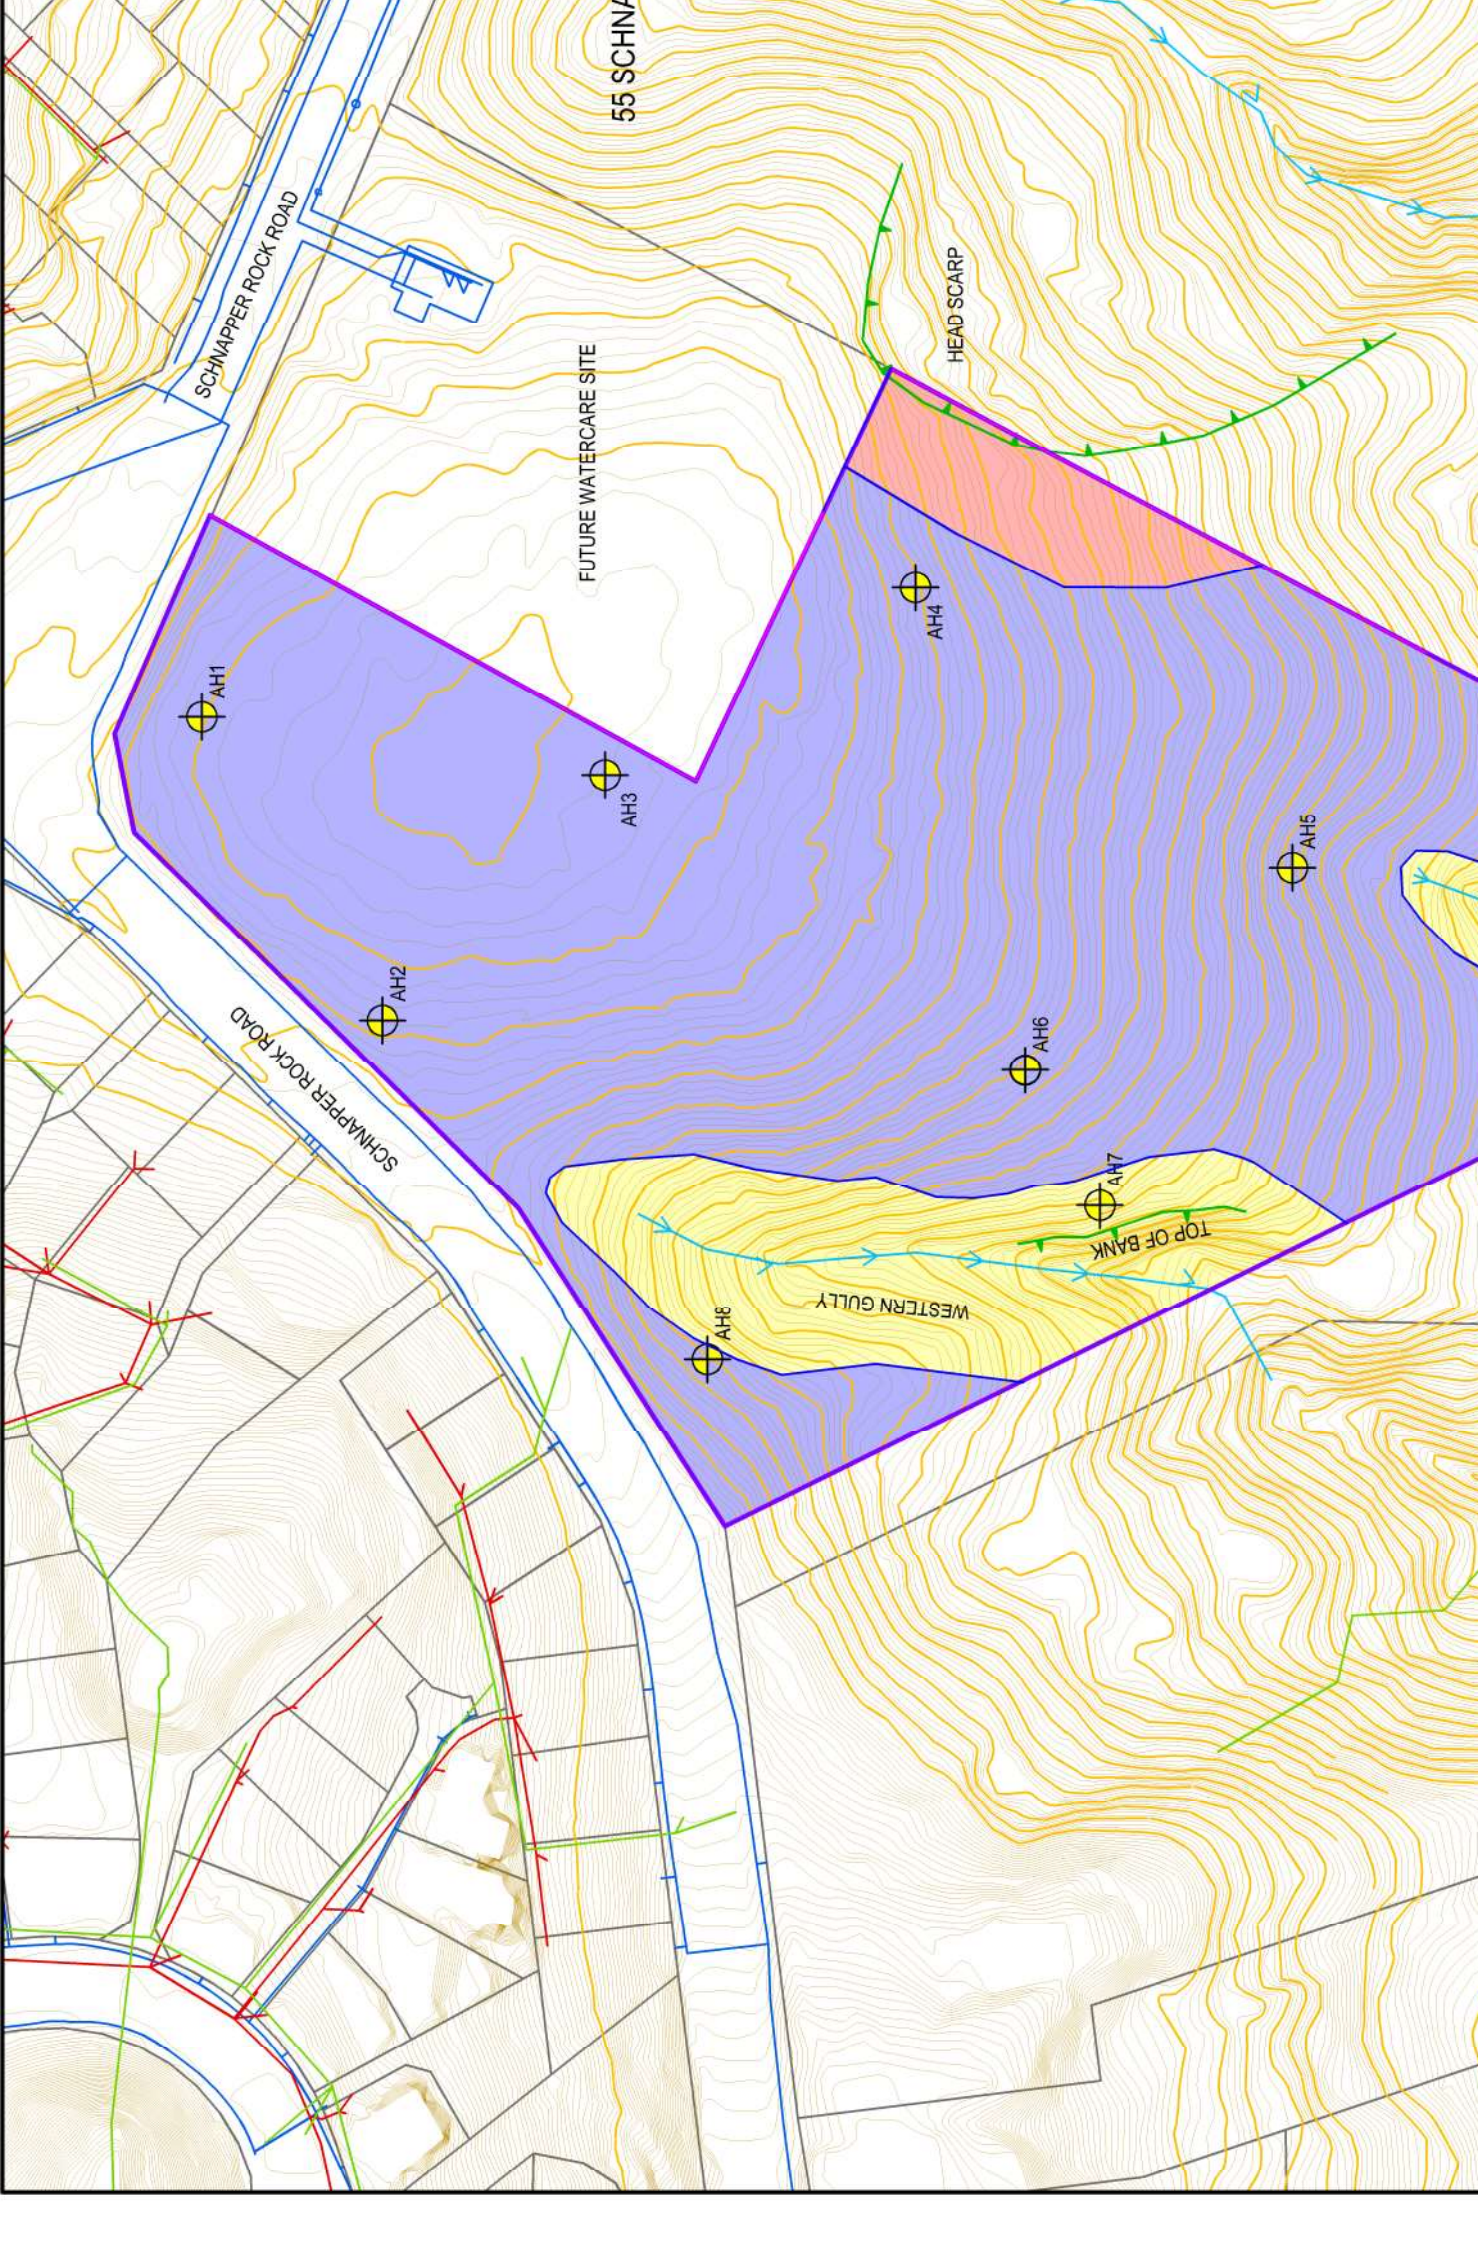
As part of this assessment, we have carried out a qualitative assessment of the sites stability and general feasibility for future development. Based on our visual assessment undertaken on-site, along with a review of the desktop data, the site has been separated into three zones:

**Zone A:** Zone A comprises the relatively benign portions of the site, which should otherwise generally be suitable for future development, without specific slope stability assessment. Geotechnical investigation and associated considerations will still need to be given to the general formation works in this zone. Future development within these areas would mostly likely comprise conventional shallow foundations.

**Zone B:** Zone B comprises areas which we consider could generally be suitable for future development, providing that further development specific geotechnical investigation, slope stability analysis and design is carried out to prove the viability of building platforms here. These areas typically comprise ground steeper than 1V:4H (where Auckland Council requires quantitative slope stability analysis to be carried out), or areas directly adjacent to the existing overland flow path and western gully watercourse. Future development within these areas could require piled foundations.

**Zone C:** Zone C comprises the area directly upslope of the head scarp feature located along the eastern site boundary. This area would generally not be suitable for future development without specific geotechnical investigation and design, and potentially may not be suitable for intensive development at all. An in-ground palisade wall and/or alternative remedial options would be required to provide for stable building platforms within this area.

An indication of the above areas are provided on our Zoning Plan attached as Drawing KGA 2.
