26 May 2023

Auckland Shooting Club C/- Terra Group 79 Grafton Road Auckland 1010

Geotechnical Addendum - 287 Tuhirangi Road, Makarau, Auckland (Our Reference: 13704.001.001_03)

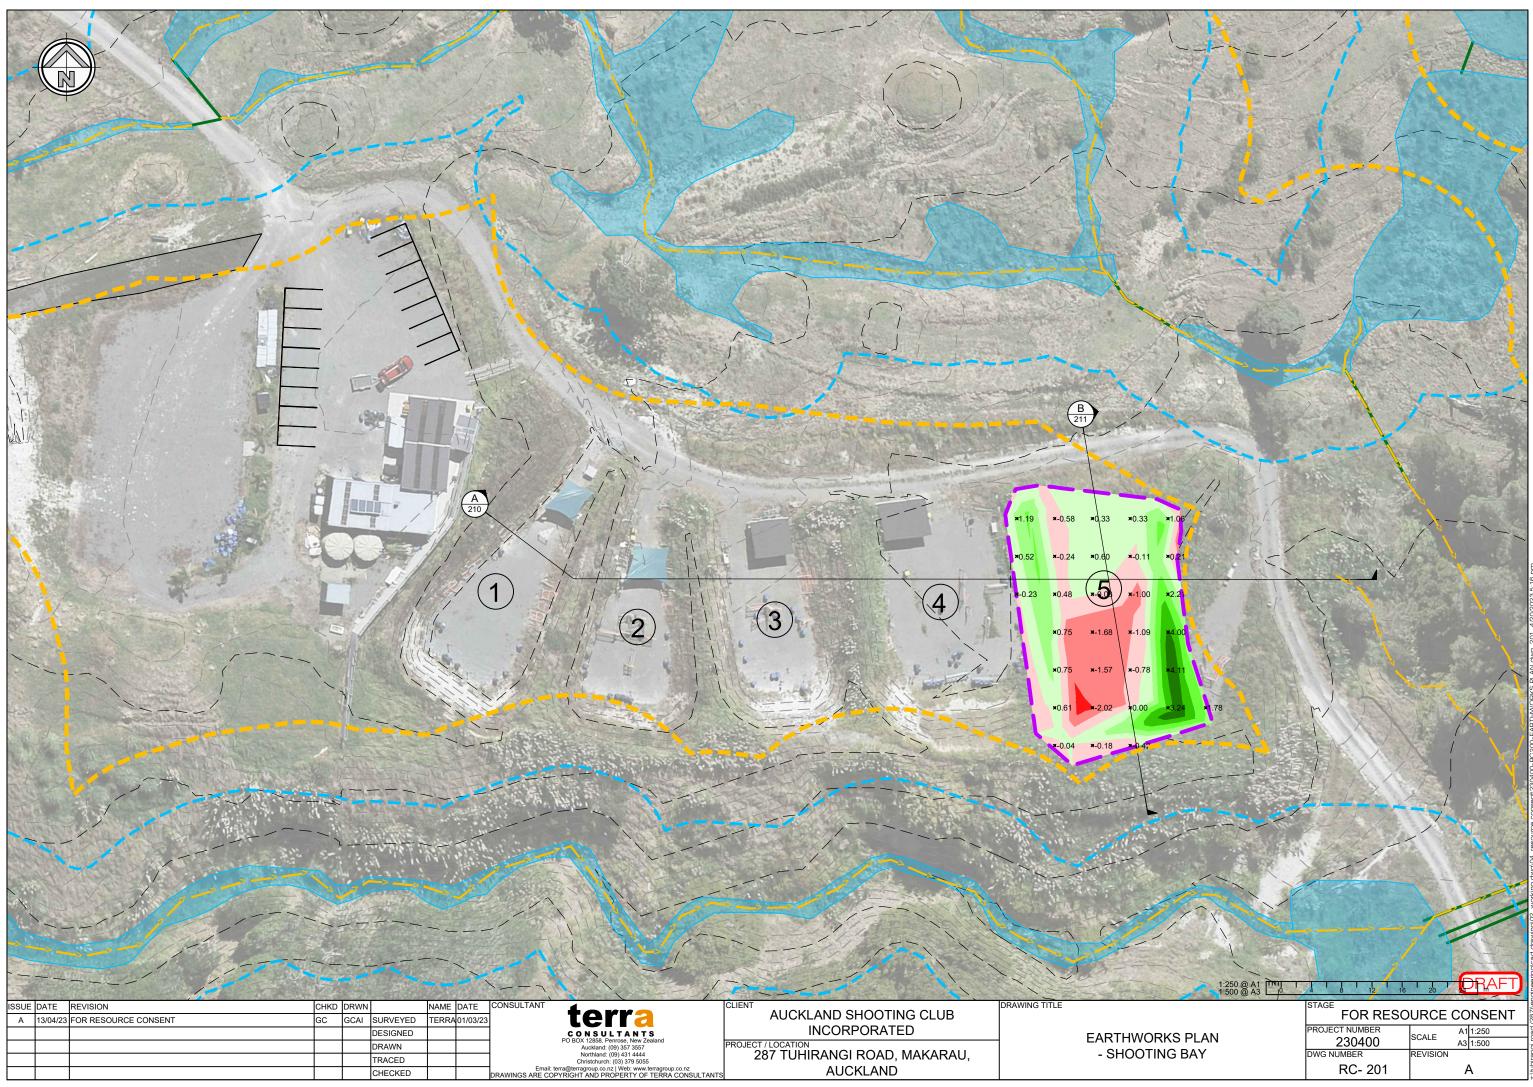
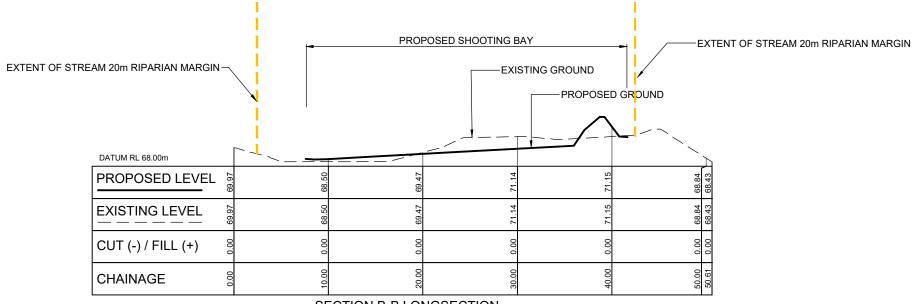
SECTION A-A LONGSECTION CH: 0.00m TO CH: 120.76m 1:250H 1:250V @ A1 (DOUBLE FOR A3)

- Earthworked bunds for the existing Shooting Bays (1 to 4) had been formed at angles between approximately 40 and 47 degrees to the horizontal and were between 3 m and 7 m high.
- The southern-most bunds associated with Shooting Bays 1 to 4 have been formed between 16 and 22 m from the edge of the Kotipu Stream, with the slope between the stream and these bunds measured (from the provided Terra plans) to be approximately 30 degrees to the horizontal.

- Proposed cut and fills of up to 2.1 m and 4.1 m respectively above existing ground levels. Maximum extent of fills are shown to be located in the southeast portion and maximum cuts are shown to be in the southwest portion of Bay 5.

• The construction of Shooting Bay 5 will include three earth bunds (along the western, eastern and southern sides of the shooting bay) proposed to be formed at approximately 45 to 60 degrees to the horizontal and up to 3 m high.

To avoid risk to the stream environment, i.e., adverse effects on ecological values and flooding, we propose that the bunds be rehabilitated to achieve the slope recommended in the previous ENGEO report. The rehabilitation should be undertaken under ENGEO supervision.

We recommend earthworks associated with Shooting Bay 5 be observed and tested by a suitably qualified geotechnical professional to a minimum of CM3 level.

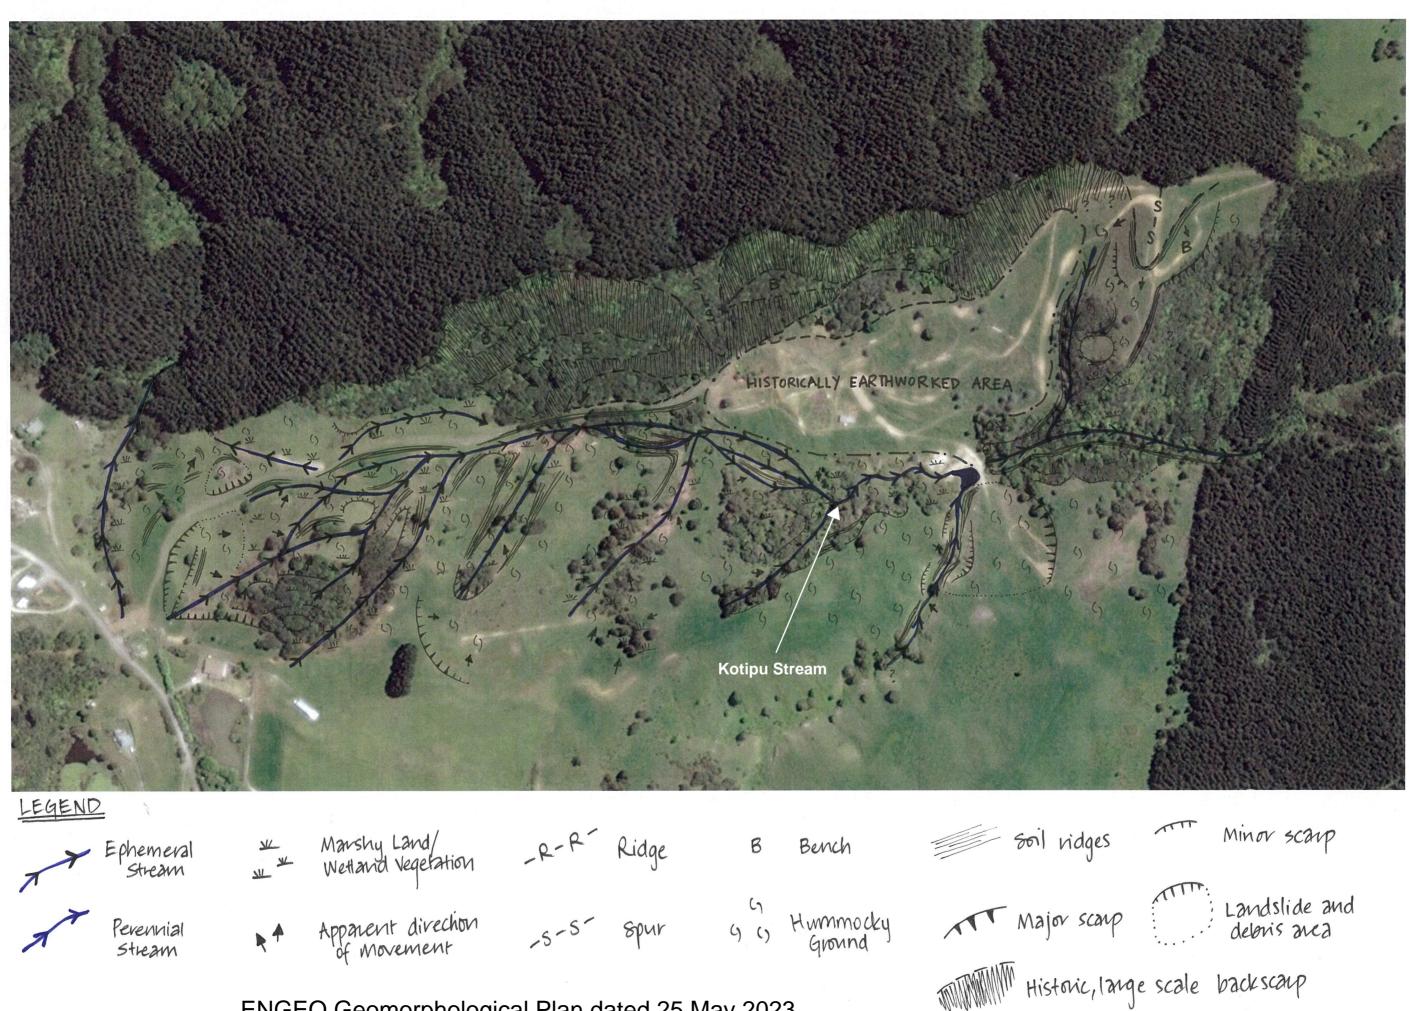
ENGEO Geomorphological Plan dated 25 May 2023

The previously prepared ENGEO reports identified evidence of active and historic instability in the form of shallow- and deep-seated instability across the site (predominantly in the northern part of site), these features are shown on the attached geomorphological plan.

The proposed road widening and passing bay are located at the base of an area previously mapped as being subject to slope instability.

The existing Shooting Bays 1 to 4, the carpark and proposed Shooting Bay 5 are located within an area previously mapped as having undergone historical earthworks. Obvious signs of historic instability were not mapped within the vicinity of Shooting Bay 5.

As the proposed driveway widening and passing bay are located in an area of potential instability (and cuts are proposed which may de-buttress the northern slope), we recommend that further geotechnical investigation and slope stability analysis is completed in these areas to assess the suitability of the proposed works and provide associated geotechnical recommendations to achieve the desired outcome without increasing the chance of instability in the area.

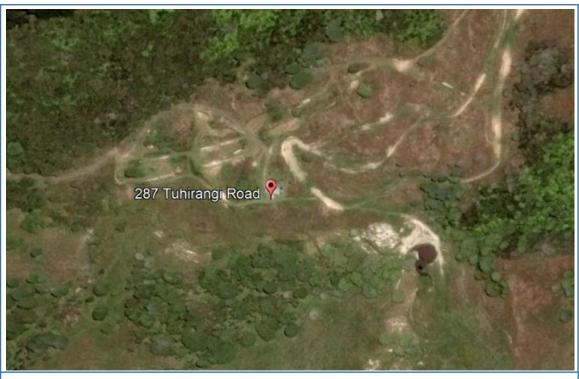
Photo 1: Aerial photograph from December 2015

- In December 2015, a network of motocross tracks had been formed across the site and a building constructed within the central portion of the site.
- In February 2017 earthworks appear to have commenced in the vicinity of proposed Shooting Bays 1 to 5. By March 2017 it appears the construction of Shooting Bays 1 to 2 was underway.

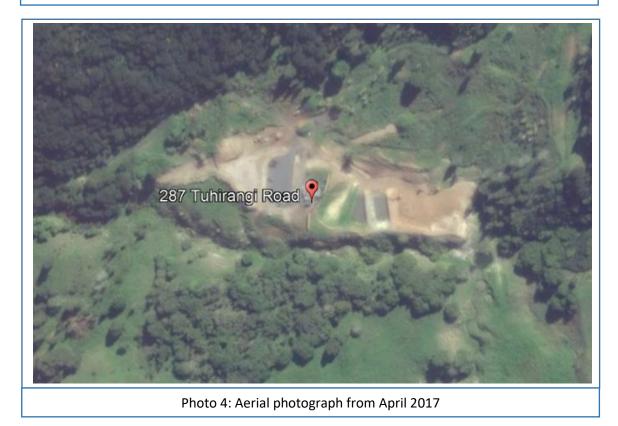
- In April 2017 it appears that Shooting Bay 3 had been constructed and that earthworks plant were constructing Shooting Bay 4 at the time of the aerial photograph. The carpark appears to be covered in hardstand at this time. Earthworks appeared to be underway to the west of the carpark.

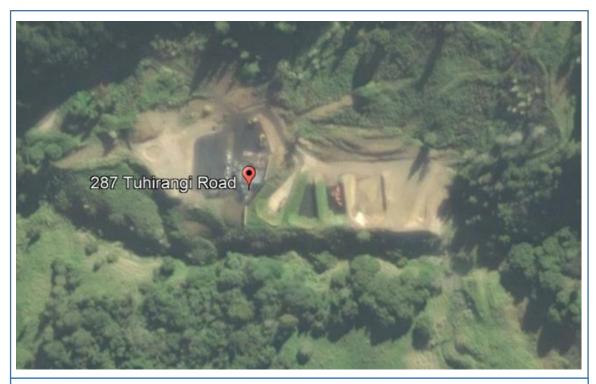
Photo 5: Aerial photograph form June 2017

- In June 2017 it appears that earthwork plant was located within Shooting Bay 3 and that construction of Shooting Bay 4 appeared to be underway. Formed bunds associated with Shooting Bays 1 and 2 appear to be vegetated with grass at this time.

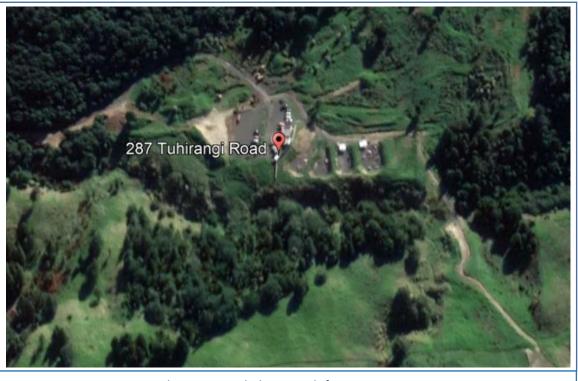
Photo 6: Aerial photograph form May 2018

- In May 2018 small structures appear to be constructed in the northern parts of Shooting Bays 3 and 4 and multiple vehicles appear to be in the carpark at this time. The road to the north and a farm track / gravel road have been constructed to the east of the shooting bay areas. Formation of the new accessway appeared to have commenced by May 2018.

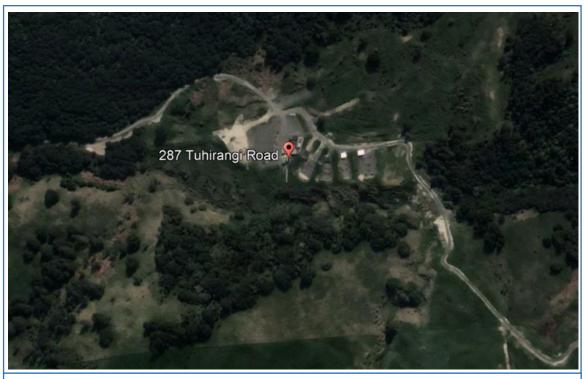
Photo 7: Aerial photo from September 2018

- The roadway extending to the north and east of the shooting bays appeared to have had hardstand placed and was more defined in September 2018.
- Construction of the narrow Shooting Bay 5 appeared to have commenced prior to February 2019.

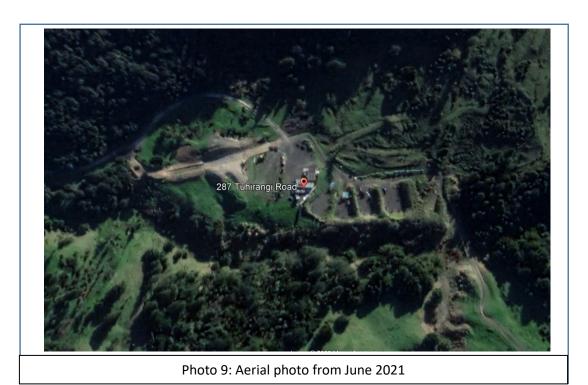
- In June 2021 additional earthworks associated with the new access appeared to have been carried out.

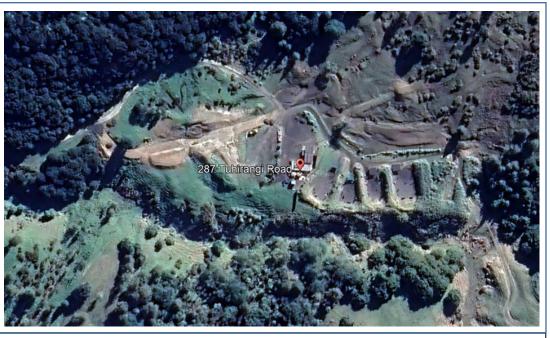
Photo 10: Aerial photo from August 2021

• Further earthworks associated with the western accessway appeared to have been underway in August 2021.
