GEOTECHNICAL INVESTIGATION REPORT

Project No.	G00417	Approved for Issue		
Version No.	1	Name	A G J Stuart	
Status	Final	0: 1		
Author	C A Webster	Signature		
Reviewer	A G J Stuart	Date	14 October 2024

PROPOSED FILL FACILITY DEVELOPMENT AT 362 JONES ROAD, HUNUA

SCARBRO ENVIRONMENTAL LTD

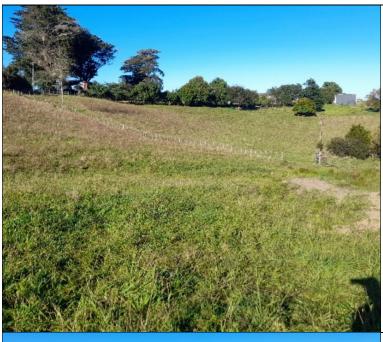
Photograph 1:

Looking south-west, towards the existing east-west trending ridge separating the northern and southern parts of the site and associated up to circa 12 m high, moderately steep, northerly aspect gully side slope, with an overall slope angle of circa 17° to the horizontal (1V:3.3H).

Note: benched and hummocky topography, inferred to be indicative of historic shallow seated slope instability, was noted within the moderately steep, gully side slope.

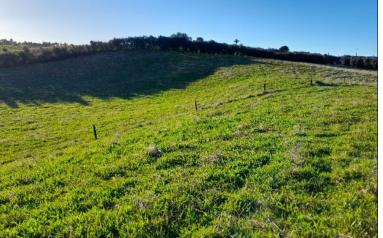
Photograph 3:

Looking south-east, from the northern part of the site, towards an up to an approximately 8 m high, moderately steep, up to 19° to the horizontal (1V:2.9H), north-westerly aspect slope.

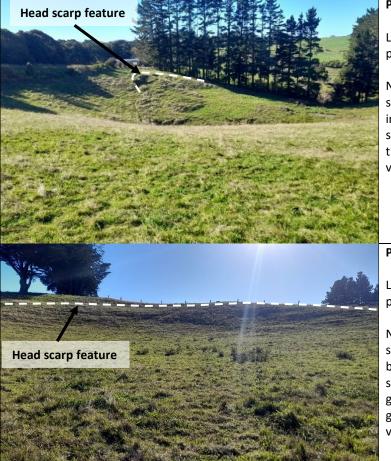
Photograph 5:

Looking south-east from the central part of the site.

Note: up to 25 m wide arcuate head scarp feature, inferred to be indicative of historic shallow seated slope instability, was noted within the gully side slope at the time of the visual appraisal.

It is therefore recommended that further geotechnical investigation, appraisal and reporting be undertaken, specific to the proposed cleanfill profiles, in order to provide recommendations on slope stability and settlement considerations specific to the proposed South Filling area development, prior to any filling operations occurring within the South Filling area.

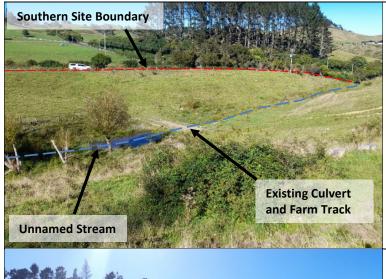
Photograph 7:

Looking south-west from the spur located in the southern part of the site.

Note: existing culvert and farm track enabling vehicular access across the east-west trending unnamed stream.

As discussed in Section 2.0 of this report, it is understood that the existing farm track and associated culvert, located in the southern part of the site, that provides vehicular access across an unnamed stream will be replaced as part of the construction of the haul road with a bridge, likely to be supported on deep piled foundations.

As discussed in Section 5.3 of this report, soft to very stiff Recent alluvial sediments were encountered in Borehole H19 to a depth of approximately 1.8 m below the existing ground surface. It is our opinion that the Recent alluvial sediments will not be a suitable founding stratum for any proposed bridge foundations.

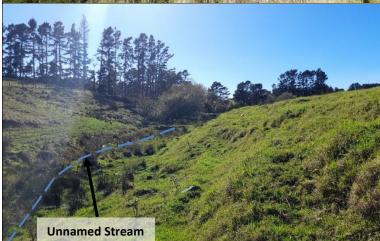
Photograph 8:

Looking east from the south-western corner of the site.
